# Performance of masonry buildings during the 20 and 27 December 2007 Bala (Ankara) earthquakes in Turkey

S. Adanur

Karadeniz Technical University, Dept. of Civil Engn., 61080, Trabzon, Turkey

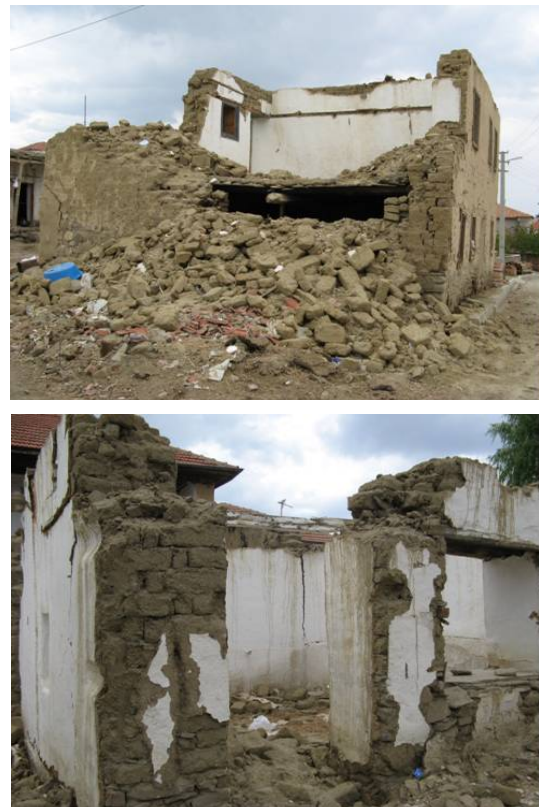
The 20 and 27 December Bala (Ankara) earthquakes caused significant damage to Bala and its vicinity. The two earthquakes struck the buildings within seven days. A large proportion of the non-engineered masonry buildings completely collapsed or were heavily damaged, as shown in Figs. 8 and 9.

Fig. 8. Examples of completely collapsed masonry buildings.

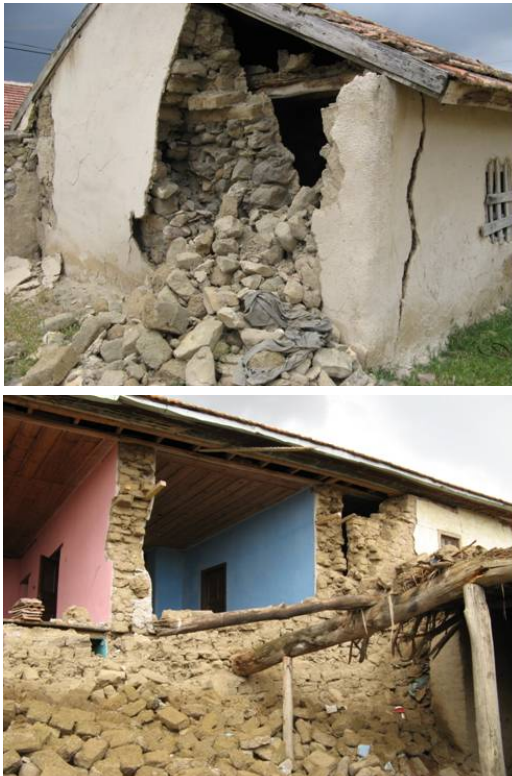
**Fig. 9.** Examples of heavily damaged masonry buildings.

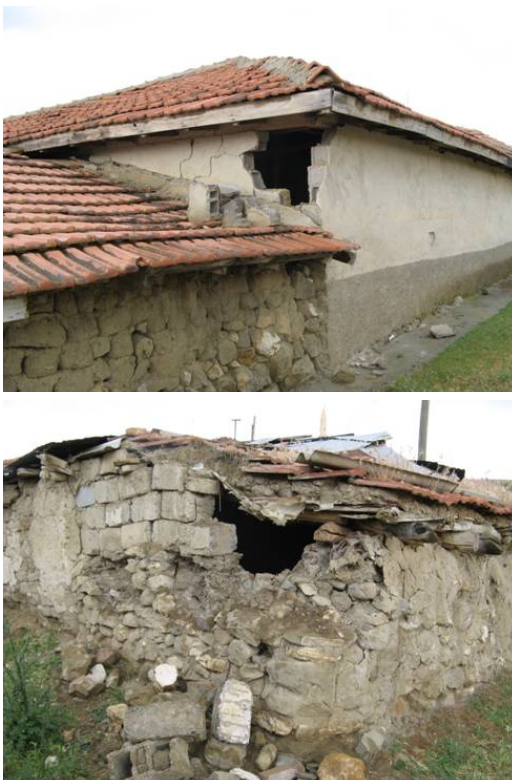
The collapse of the building corners are shown in Fig. 10. The corners were badly fractured and the stones collapsed. The failure pattern may be essentially characterised as out-of-plane failure. This mechanism is due to the lack of connection between orthogonal walls and between walls and floors or roofs. According to the Turkish Earthquake Resistant Design Code (2007), reinforced concrete horizontal bond beams shall be provided at places where slabs are supported by walls, such that they shall be cast monolithically with the slabs. The width of the horizontal bond beams shall be equal to the width of the wall and their height shall not be less than 200 mm. However, horizontal bond beams were not used in the collapsed and damaged masonry buildings observed in the affected area. On the other hand, although there is no information in the Turkish Earthquake Resistant Design Code (2007) about using horizontal wooden bond beams in the stone masonry buildings, it was observed that there were several stone masonry buildings with horizontal wooden bond beams in the affected area, as shown in Fig. 11. There was no damage

**Fig. 10.** Examples of failure of masonry building corners.

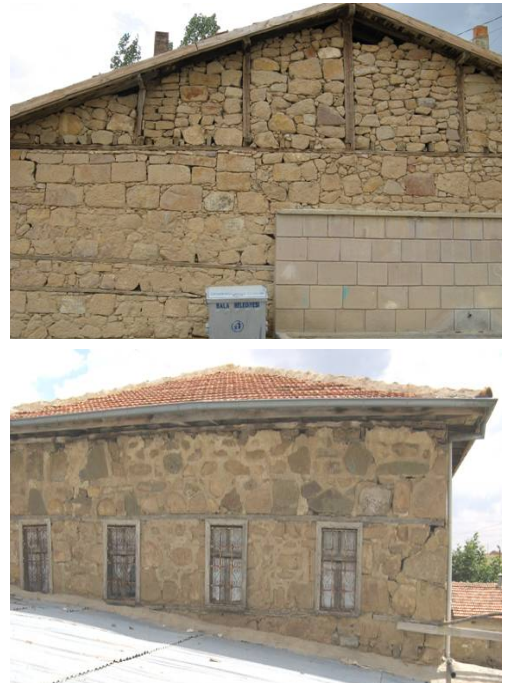
**Fig. 11.** Examples of masonry buildings formed by horizontal wooden bond beams.

or even low damage in these masonry buildings. Based on this observation, it can be said that horizontal wooden bond beams increase the seismic behaviour of stone masonry buildings.

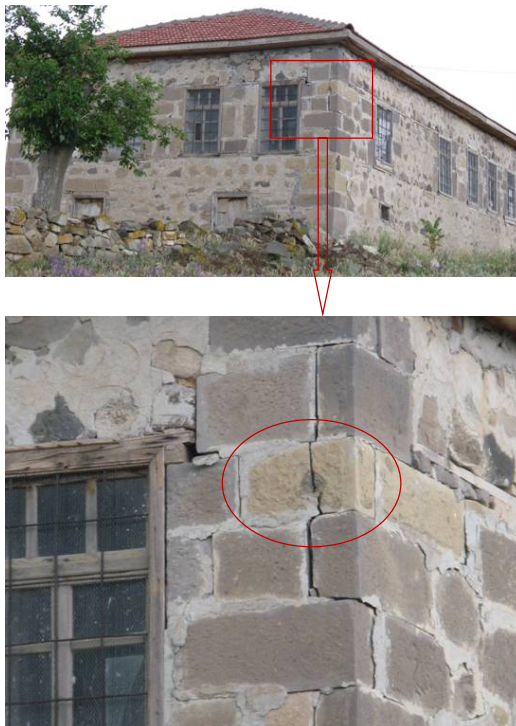
According to the Turkish Earthquake Resistant Design Code (TERDC, 2007), masonry materials used in the construction of load-bearing walls must be natural stones, solid bricks, bricks with vertical holes, solid concrete briquette, mud bricks, etc. The minimum compressive strength of masonry structural materials must not be less than 5 MPa on the basis of gross compression area. Compression strength of natural stones used in basements must be at least 10 MPa. However, some of the masonry buildings in the affected area were formed by low strength stones. One of the most important reasons for the damage is that the stones used in the walls had a low strength (Fig. 12).

**Fig. 12.** Example of failure of low strength stone on a masonry building.

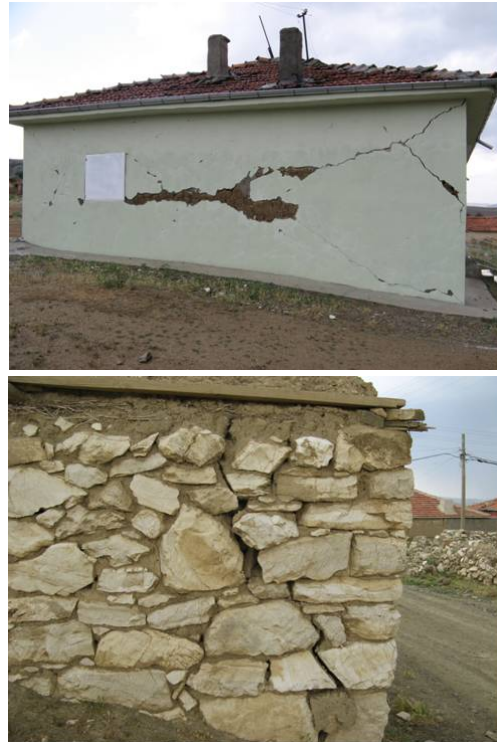
**Fig. 14.** Examples of diagonal shear cracking on the structural walls.

its out-of plane stiffness. Three modes of shear failure in non-reinforced masonry are: diagonal tension cracks form through the mortar and masonry units; sliding occurs along a straight crack at horizontal bed joints; and stepped cracks form alternatively from head joint to bed joint. Shear cracking on the structural walls was observed in most of the masonry buildings, as shown in Figs. 14–15.

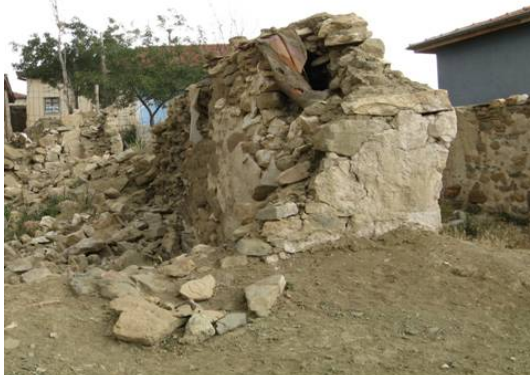
Many stone walls were constructed with stones placed in a random manner. These do not have the usual layers (or courses) seen in brick walls. These uncoursed walls have two exterior vertical wythes of large stones, filled in between with loose stone rubble and mud mortar. The cavities within the walls and clayey mud mortar were another source of damage, as shown in Fig. 13.

**Fig. 13.** A masonry wall with cavity and mud mortar.

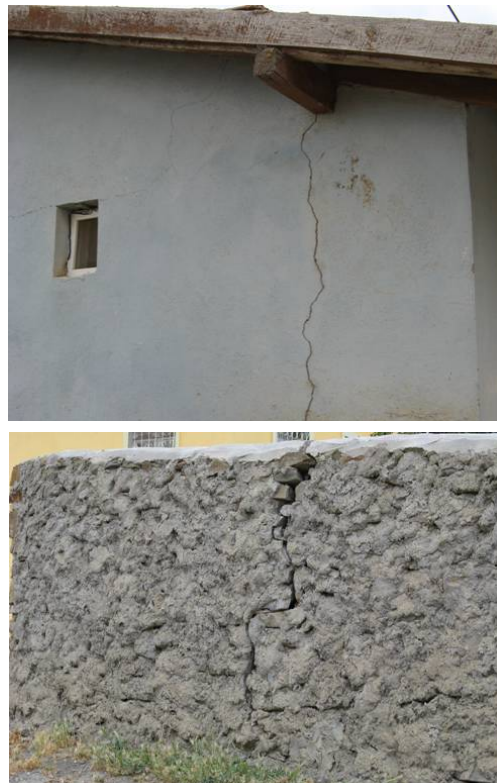
**Fig. 15.** Examples of shear cracking under vertical shear force on the structural walls.

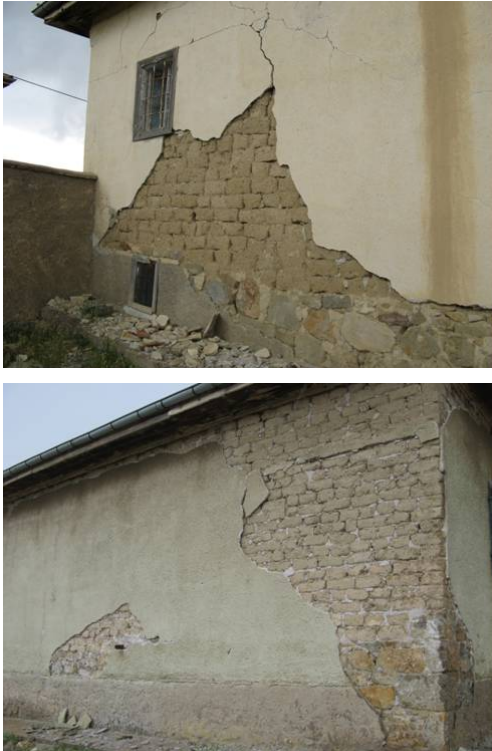
Modes of failure in masonry walls also include out-of-plane failure (swellings) where loads act perpendicular to the wall's face. The out-of-plane failures (swellings) occurred on the structural walls during the earthquakes, as shown in Fig. 16.

**Fig. 16.** Examples of out-of-plane failure (swelling) on the structural walls.

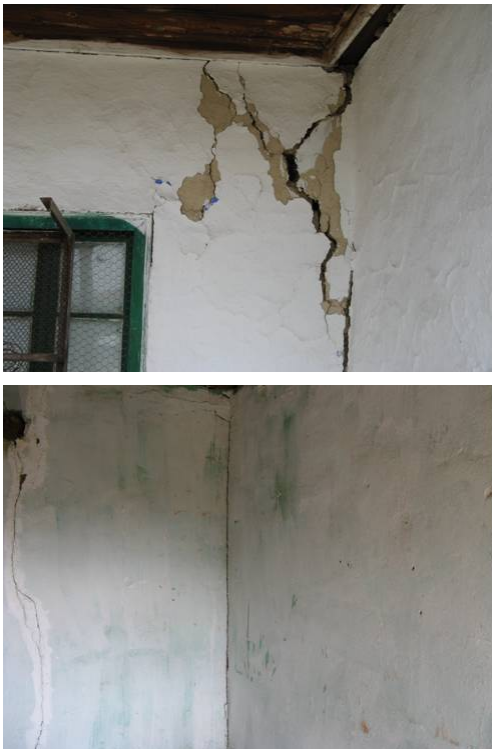
**Fig. 17.** Examples of openings between the structural walls.

During an earthquake, the lateral loads increase the shear forces in the walls and in the wall-to-wall connection. A lack of connection details was observed in the damaged buildings. It can be seen from Fig. 17 that openings between 5–50 mm occurred at corners of the structural walls during the earthquakes.

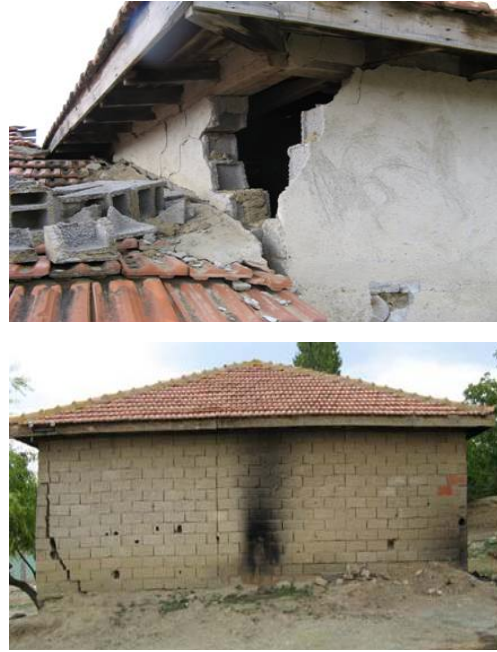
**Fig. 18.** Examples of masonry buildings formed by concrete briquette with vertical holes or lightweight concrete briquette.

According to Turkish Earthquake Resistant Design Code (2007), concrete briquette with vertical holes or lightweight concrete briquette must not be used in the construction of load-bearing walls of masonry buildings. However, there were several masonry buildings formed by these type concrete briquettes in the affected area. Most of them were damaged during the earthquakes (Fig. 18).

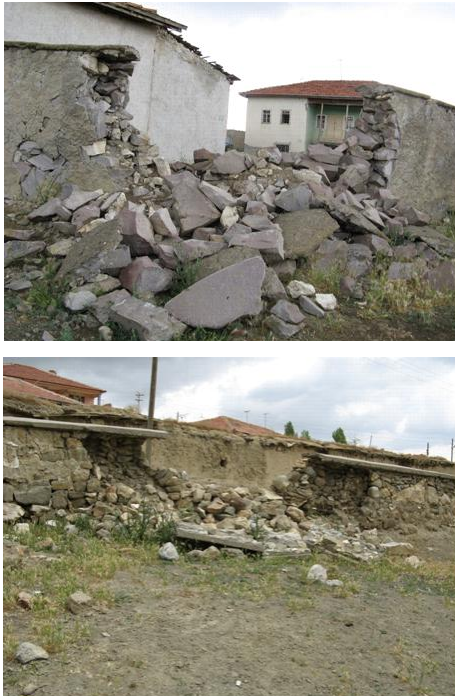
According to Turkish Earthquake Resistant Design Code (2007), height of the fence made of masonry materials shall not be more than 1.0 m. But, there were many damaged fences constructed more than 1.0 m in height in the affected area, as shown in Fig. 19.

Fig. 19. Examples of damages on the stone masonry fences.

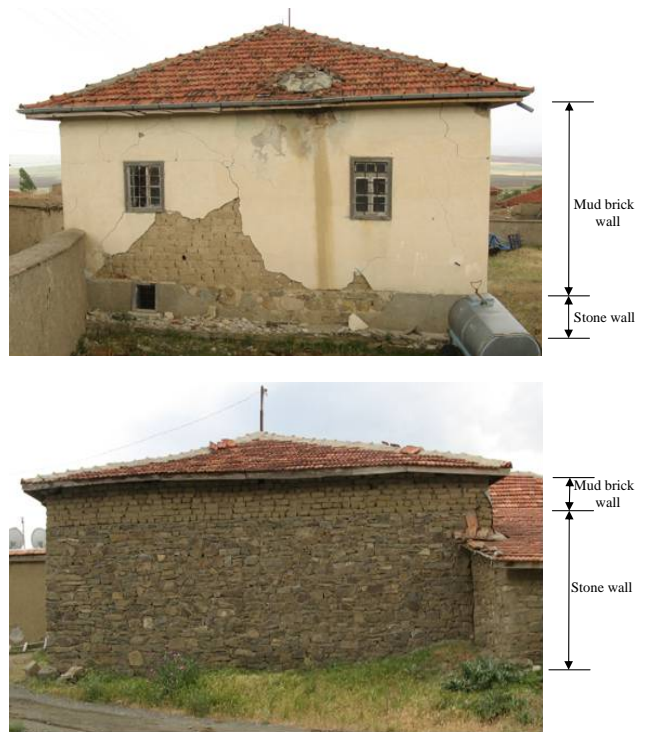
Fig. 21. Examples of mixed type masonry buildings formed by stones and mud bricks.

Two different mixed type masonry buildings formed by stones and mud bricks are shown in Fig. 21. It can be seen from Fig. 21 that dynamic behaviour of mixed type masonry buildings changed depending on the ratio between the stones to mud bricks. Earthquake resistance of mixed type masonry buildings increased with increasing stone ratio.

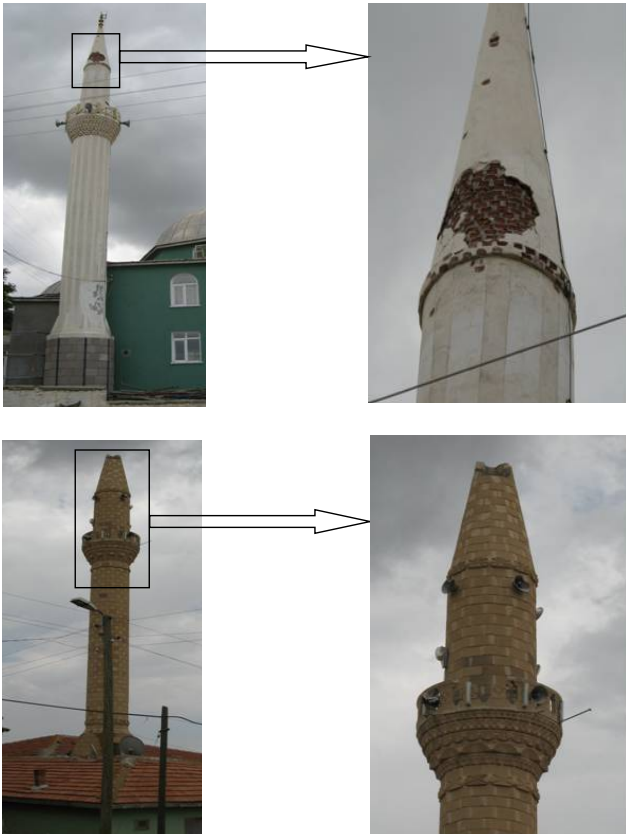
Minarets are tall and slender structures and they are vulnerable to seismic loading. In the Turkish style, the parts of a minaret are the footing as a base; pulpit, transition segment, cylindrical or polygonal body as a shaft; balcony; upper part of minaret body; spire and flag. There was at least one minaret in each village in the affected area. Many of the minarets were constructed using masonry materials like stone and baked clay brick. Several minarets were damaged during the earthquakes, especially its flag and spire as shown in Fig. 20.

Fig. 20. Examples of damages on the slender masonry buildings.

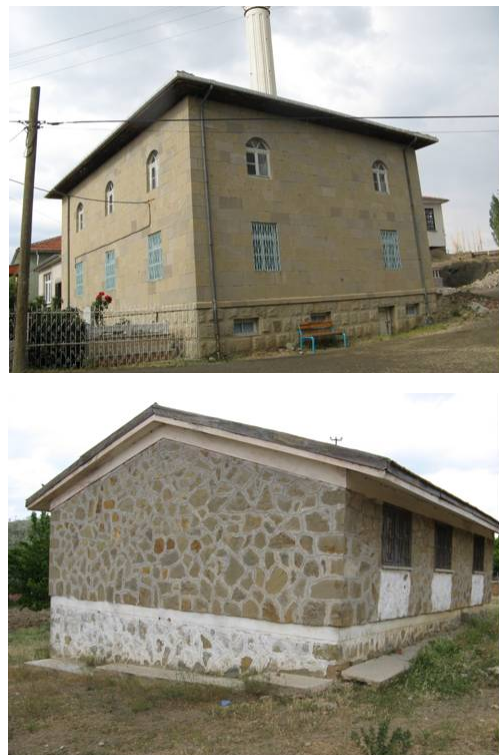
Fig. 22. Examples of undamaged masonry structures.

Generally, it is seen that the structural performance of the masonry buildings in the affected area was not adequate during the earthquakes. However, there were also some observations of good performance. Some examples are given in Fig. 22. This was mainly due to proper care and good workmanship during the construction.
