Engineering geologic assessment of the slope movements and liquefaction failures of the 23 October 2011 Van earthquake ($M_w = 7.2$)

A. Karakaş, Ö. Coruk, and B. Doğan

Kocaeli University, Engineering Faculty, Department of Geological Engineering, İzmit, Kocaeli, Turkey

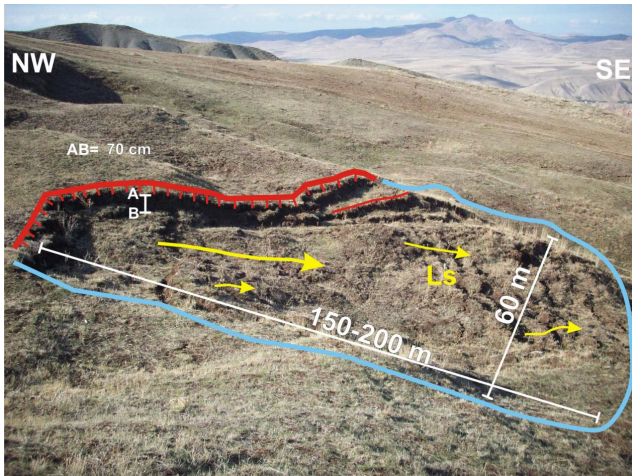
Fig. 5. A view from a landslide on a slope located west of Lake Erçek.

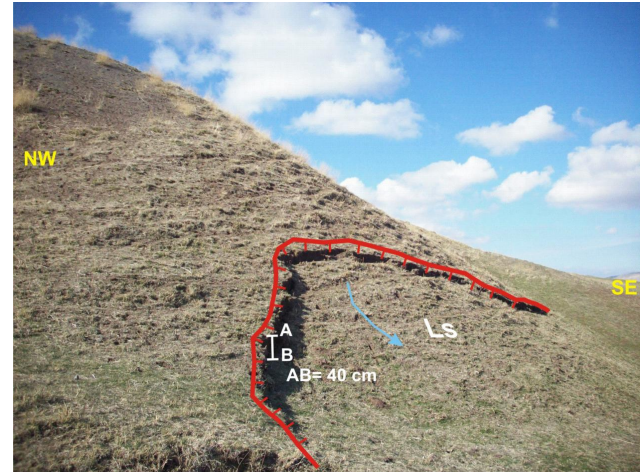
Fig. 6. A view from a confined landslide on a slope located north-west of Kozluca village.

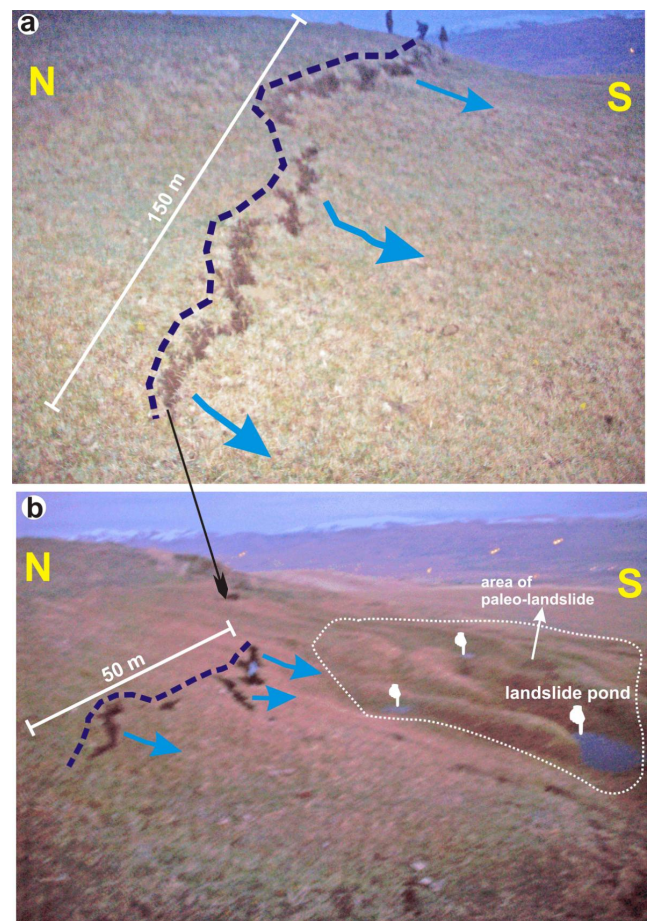
Fig. 7. The largest landslide with a 60 cm maximum scarp observed in the south of Çomaklı: (a) view of the east section of the landslide, (b) view of the west section of the landslide with a paleo-landslide and landslide ponds.

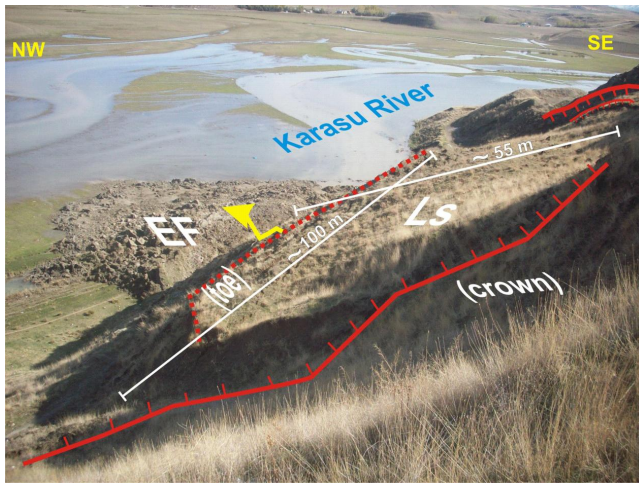
Fig. 8. A view from an earthflow and landslide that developed in Karasu Delta.

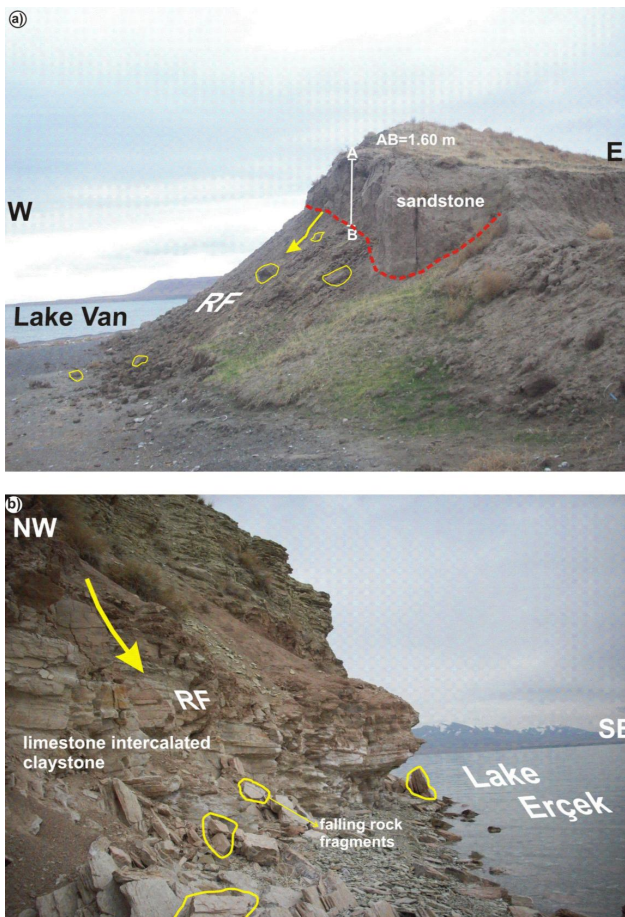
Fig. 9. (a) Rockfalls observed in a slope with sandstone lithology around Çitören village and (b) rockfalls observed in a slope with limestone–claystone lithologies at the western side of Lake Erçek.

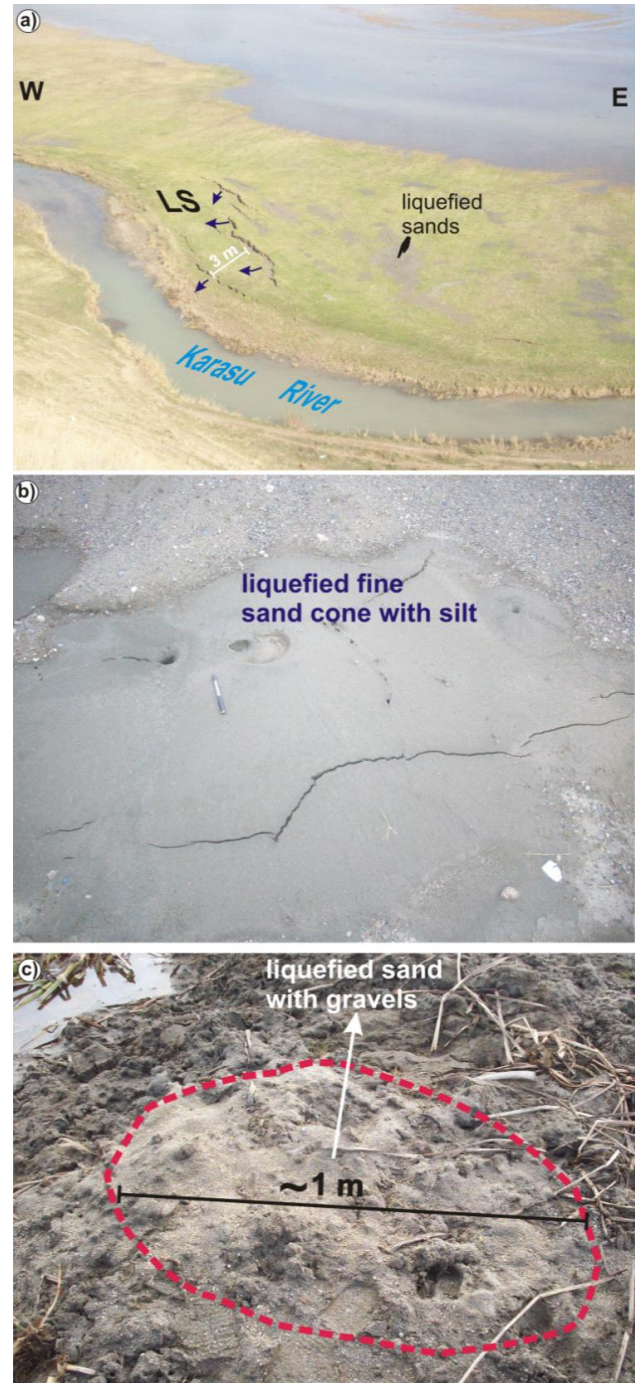
Fig. 10. (a) Sand boils and ejection of liquefied soils into the surface through a ground crack in Karasu Delta, (b) sand cone of liquefied fine-grained soil in the eastern shores of Lake Van around Çitören village, and (c) sand boil of liquefied sand with gravels in the northern shores of Lake Van around south of Çelebibağı.

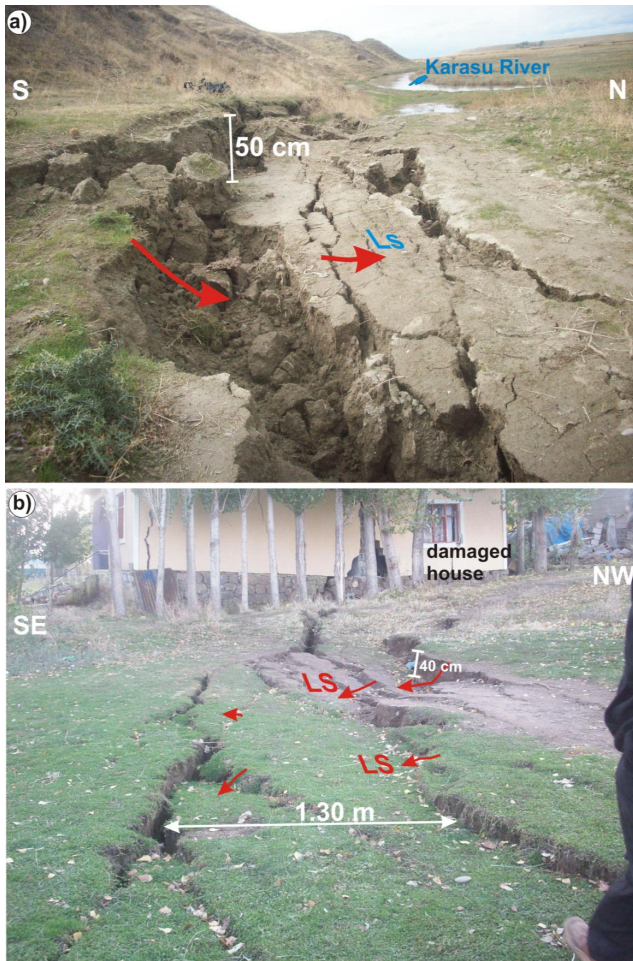
center to Erciş and its surroundings. Horizontal displacements ranged from a couple of meters (1–2 m) to several meters (5–10 m) with associated settlements from a couple of centimeters (1–2 cm) to several centimeters (max. 50 cm) in the field (Fig. 11a). A limited number of houses were only damaged due to lateral spreading in Çelebibağı, Erciş (Fig. 11b). Lateral spreading in one location was accompanied by landslide in Erciş, Çelebibağı. Liquefied soil layers accompanied by low inclination in the topography (3–5°) and free face towards Lake Van caused lateral spreading in the Çelebibağı location.

Fig. 11. (a) Lateral spreading that developed around the shore of Karasu River in Karasu Delta and (b) lateral spreading that developed under a house in Çelebibağı, Erçiş.

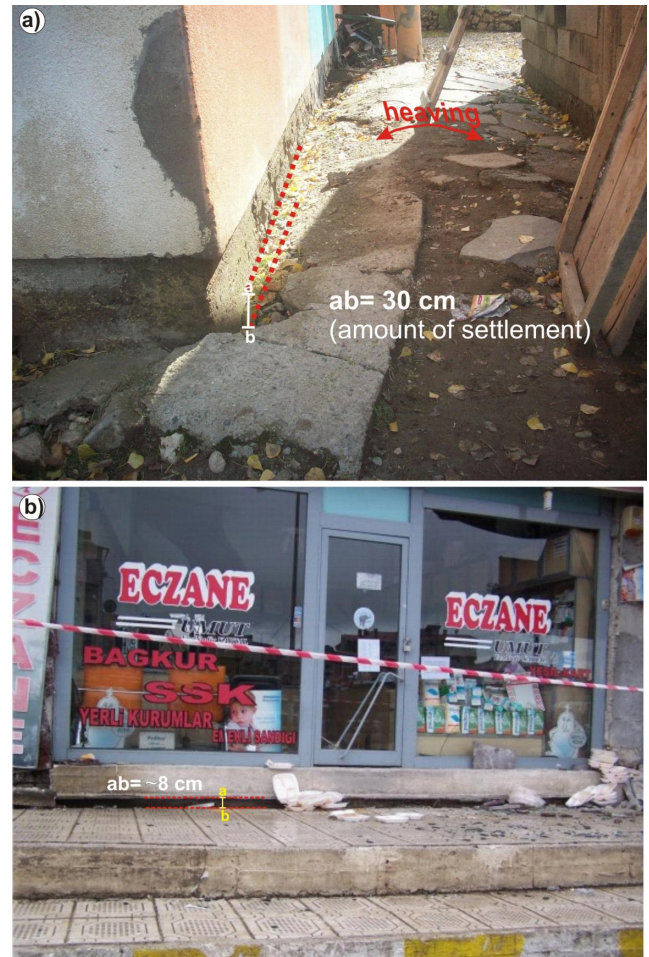
One of the effects of liquefaction was damage to the main water pipeline. The soil liquefaction and lateral spreading broke a section of the main water pipes installed to deliver water to Van Yüzüncü Yıl University main campus and some parts of the city of Van in Topaktaş, located NW of the main campus (see Fig. 1). This resulted in the failure of water distribution to university campus and some parts of the city for a week. Ground settlements due to liquefaction were observed in several locations during the fieldwork, of which two are mentioned here as representative examples: in Çelebibağı, Erciş, where a house settled downward approximately 30 cm (Fig. 12a), and in Erciş county center, some buildings and paved areas settled from 2 cm to 8 cm (Fig. 12b).

Fig. 12. (a) Liquefaction-related settlement that occurred under a house at Çelebibağı, Erçiş and (b) liquefaction-related settlement at the mid-part of the Erçiş Basin (CGE, 2011).
