# “A multi-disciplinary approach to a side-flash lightning incident to human beings in the Basque Country”

**Abstract.** On 31 August 2011 a lightning incident affecting two human beings was registered in the Basque Country (northern Spain). The two individuals were sightseeing in the Painted Forest of Oma (province of Biscay, Basque Country) when an approaching thunderstorm forced them to look for shelter under the lowest branches of one of the trees. A lightning discharge in that exact place caused serious injuries to the couple, consisting of the loss of consciousness, superficial burns, a tympanic membrane perforation and a broken clavicle. The investigation presented in this paper was carried out in order to find out the causes by which the couple was hit by the lightning discharge and why the injuries were superficial and did not kill them. Using the data available by the lightning detection networks in the Basque Country and the information available by the weather radar, the exact place where the lightning discharge occurred could be found, the mechanism of lightning injury was classified and the episode was reconstructed.

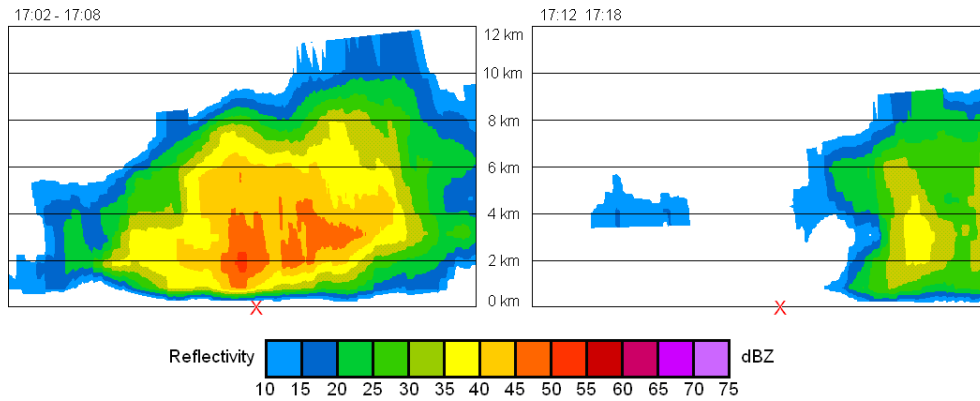
The vertical cuts provided by the weather radar show the same situation. The lightning discharge is represented as a red cross in Fig. 2. The picture before the accident shows a much higher vertical development of the thunderstorm over the forest, whereas the picture at the moment of the accident shows the stratiform region over the forest once the convective region has moved forward. The instant of the lightning discharge corresponds to the second vertical cut, and therefore, it can be associated with the stratiform region of the thunderstorm. The data obtained from the weather radar matches the testimony of the injured people, who related how they were already wet when the lightning struck.

Fig. 2. Vertical cuts of the thunderstorm over the forest (red cross).

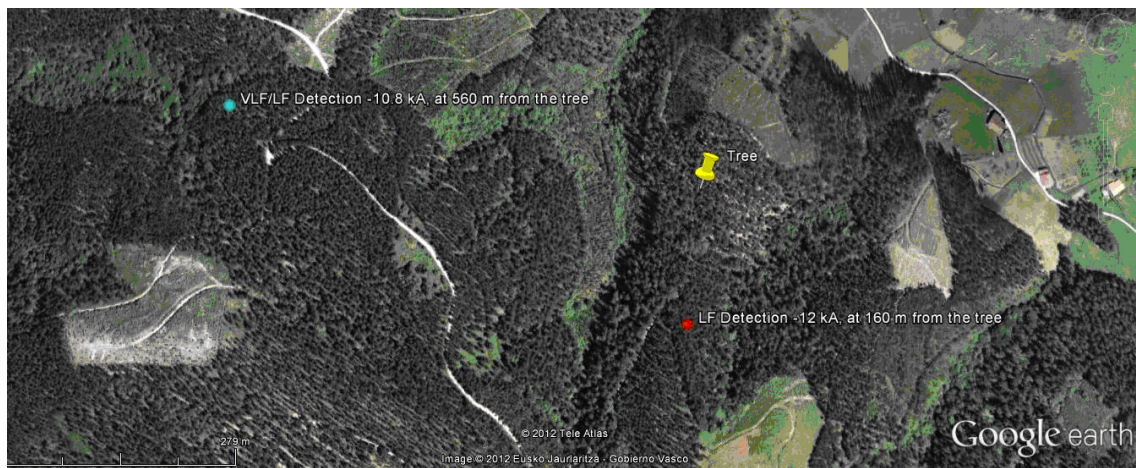
The cloud-to-ground lightning discharge associated with the accident as it was detected by the Linet Network (VLF/LF) (green) and the Basque Country Lightning Detection Network (LF) (red) networks are represented in Fig. 3, showing a good correlation with the exact place of the accident. According to this figure, the two networks located a negative cloud-to-ground discharge with an intensity higher than  $-10$  kA. None of them are exactly located over the affected trees, but, especially in the case of the LF network, the accuracy is very good, with a deviation of only 160 m.

Fig. 3. Location of the lightning discharge that caused the accident as it was located compared to the two networks.

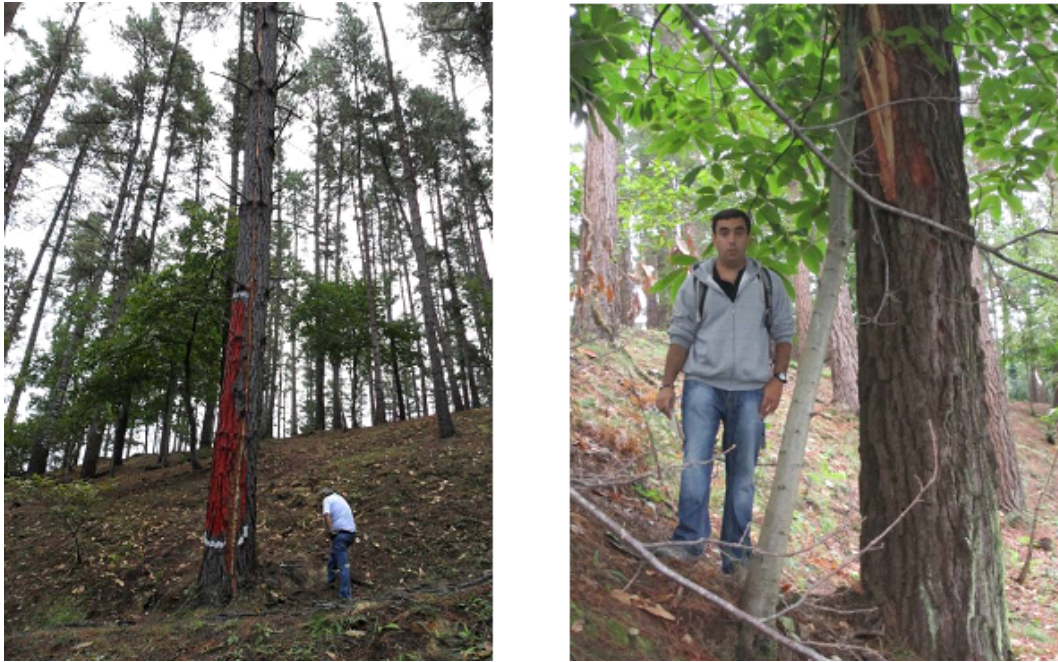
**Fig. 4.** Wound over the *Pinus radiata* (left) and over the dead trunk (right).

by the discharge covers it from the tip to the bottom, leaving a double strip over the bark. This was a live tree, and the bark was wet due to the rainfall. The pass of the lightning current caused the breaking of the bark and the double strip that remains over the trunk.

This second tree is located about ten meters away from the painted one, and it presents a unique stripped wound on the bark. It is located over a slope, 2 to 3 m away from the main path, and the lowest part of the trunk presents at first sight a cover made of branches at about two meters over the ground. Actually, these branches do not belong to the tree that suffered the lightning impact but to another close tree. The trunk that suffered the direct lightning impact is not a live tree; it is a dead trunk that has remained standing close to other trees in the forest.

trunk was studied, it revealed that it does not reach the floor. It stops at a height close to that of the wounded man, coinciding to his testimony, as he related that the lightning discharge impacted directly in his shoulder. Then the lightning current flowed over the surface of the dead tree, because it was the wettest part of it, and then an electric arc was produced between the bark and the man's shoulder. Therefore, we now consider the six different mechanisms by which lightning injures a victim (Blumenthal, 2012a): directly, touch potential, side flash, step potential, upward streamers and the electroblast effect. The mechanism of lightning injury in this case is assumed to be a side flash due to the fact that the lightning discharge stroke first entered the tree and then it jumped to the bodies.

As can be seen in Fig. 4, the wound on the *Pinus radiata* reaches the ground, whereas the wound on the dead trunk stops slightly over a man's height similar to the injured walker's height.
