# Causes and consequences of the sinkhole at El Trébol of Quito, Ecuador – implications for economic damage and risk assessment

Received: 12 January 2016 – Published in Nat. Hazards Earth Syst. Sci. Discuss.: 5 February 2016

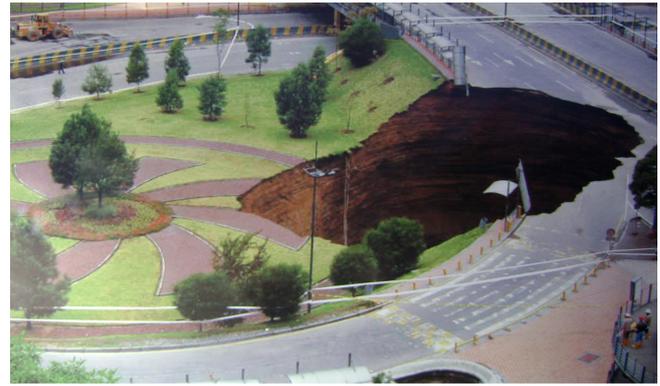
of great proportions was observed in the Trébol traffic hub (Fig. 2). In the first few minutes, the sinkhole started to generate in the form of a crater with a diameter of 30 m (Fig. 3). The collapse continued to grow in the following days until the final dimensions of this almost round sinkhole reached approximately 120 m in diameter and some 40 m of depth, revealing the base of the sinkhole, and the Machángara River (Fig. 4).

**Figure 2.** Initial stage of sinkhole at El Trébol.

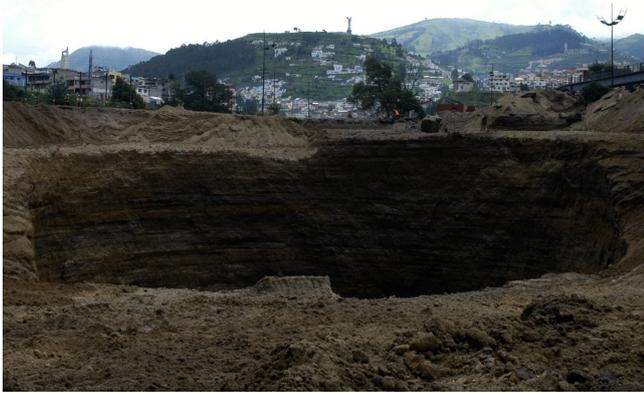
**Figure 3.** Panoramic view of the final stage of the sinkhole at El Trébol. On the background the Panecillo volcanic dome.

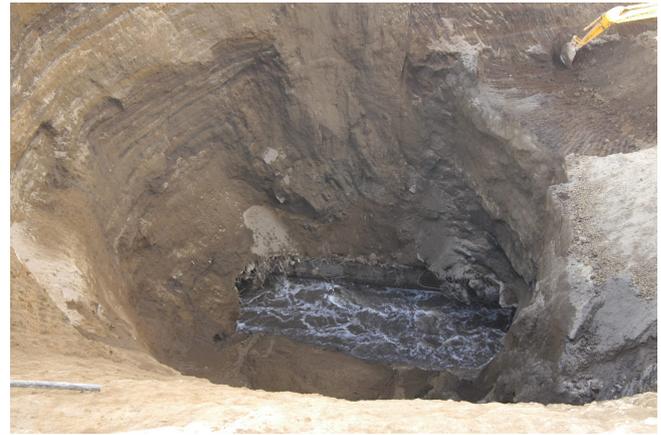
**Figure 4.** View into the sinkhole with the appearance of the Machángara River at its base.

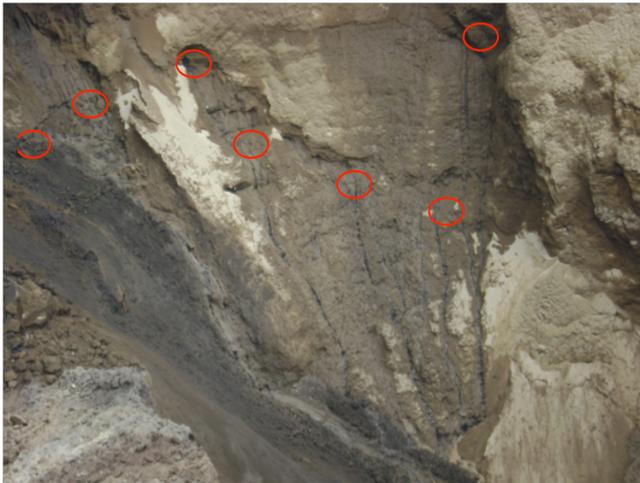
After sinking and collapse took place, groundwater emerged in the south and southwestern slopes at a depth of 20 m from the upper rim of the slope (Fig. 6). These water springs contributed with a total flow of around  $6 \text{ m}^3 \text{ s}^{-1}$ , which decreased 50 % due to drilling of pumping wells strategically located. These springs revealed the presence of a free aquifer located at the south side of the sinkhole. Indeed, the existence of the aquifer was determined after field observations followed by three drillings; the water table is located between 12 and 15 m deep. The aquifer is composed of granular materials within a silty-sandy matrix, with a thickness of around 18 m with a gradient from southwest to northeast, toward the Machángara River (Fig. 7). The aquifer recharge probably takes place in the Luluncoto gorge situated 2 km to the southwest.

**Figure 6.** Southern and southwestern side of the inner part of the sinkhole, where water flows.

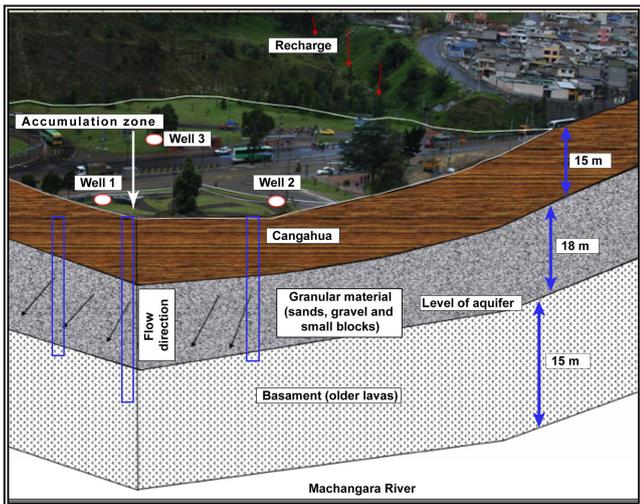
**Figure 7.** Conceptual model of the aquifer with the site of the wells and the flowing direction.

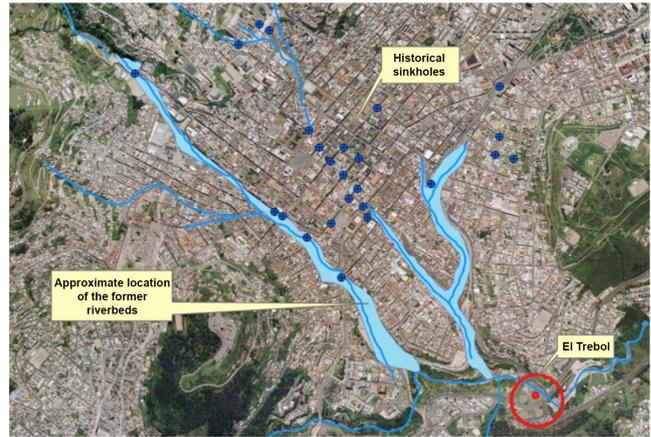
**Figure 8.** Historical sinkholes in the form of subsidence (blue circles) at Machángara River, including the El Trébol sector (marked with the red circle and red dot).

include 12 sinkholes (Table 2; Fig. 8) of different magnitudes, defined as “declines or collapses of roadway in the filler material streams, caused by faulty sewers”, as well as the filling, initially performed with debris and garbage, the age, type of construction and degree of deterioration of the physical work of the channels, sewers and collectors (Peltre, 1989). These former sinkholes are undoubtedly aligned along the earlier and now covered river channels on the old bed of the filled streams. Therefore, we can assume that they will continue to occur, especially in periods of daily rainfall above the historical average. In the area of El Trébol, the first serious collapse was registered 31 March 2008, 10 years after channels were made for the construction of the infrastructure to solve the problems of the traffic jams. Furthermore, there was a second sinkhole in almost the same spot but of less extension compared to the one in 2008 on 10 January 2014 (Fig. 9).

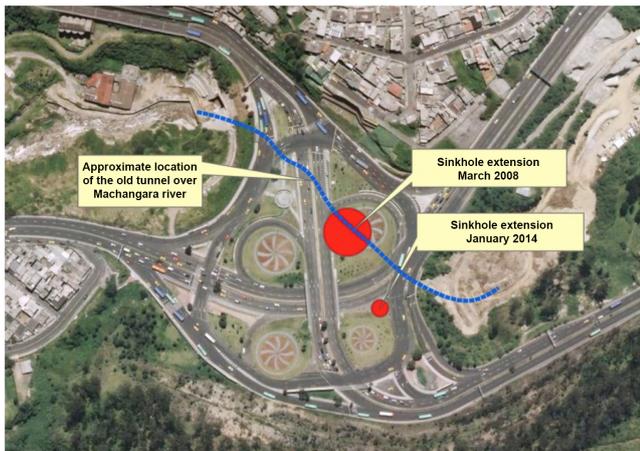
**Figure 9.** El Trébol sector with the flowing direction of the Machángara River including the sinkholes of 31 March 2008 (big red circle) and the recent but smaller one of 10 January 2014 (small red circle).

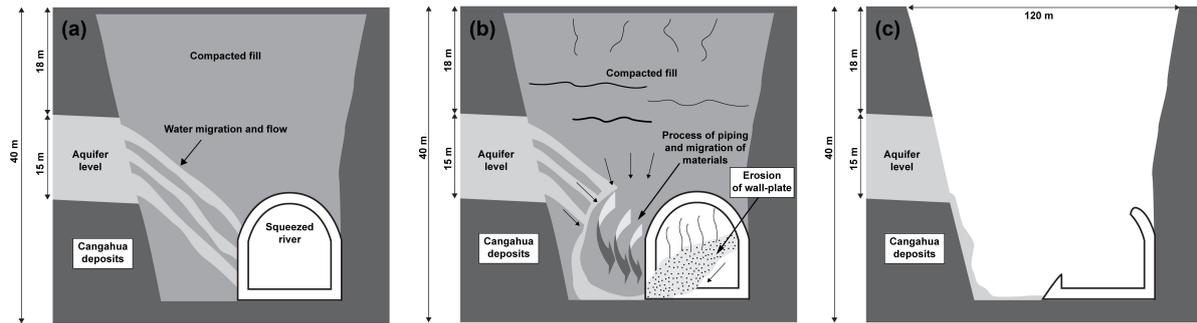
The water with the chemical conditions described above does not cause a significant effect on the elements of the collector at all. The potential alteration is rather directly related to the high speeds of the water and sediment carried by the river (large boulders, scrap wood, etc.), which collide with the structures producing weakening, fracturing and erosion, mainly at the floor (see Fig. 10a) (Arias Jiménez, 2008).

This hypothesis is based on the fact that, in the collapsed collector on the left margin of the channel, there are no vestiges of the floor. This is possible because the channel turns and the water collides in the union of the right gable with the floor, causing weakening and faulting. The water caused localized erosion leaving the right transept without support and initiated a process of dragging of sediments filling and covering the channel, causing the phenomenon known as piping, a process that is accelerated due to the presence of underground stream water (Arias Jiménez, 2008), as illustrated in Fig. 10a–c.

As a result of piping, a cavern formed and the material of the collapse was transported downstream. The soil lost sus-

tainability and collapse of the filling occurred, leading to the formation of the sinkhole in the form of a crater. As stated above at first the sinkhole had a diameter of 30 to 40 m, while a little later due to the constant landslides caused by the action of rain and the presence of groundwater, it finally reached a diameter of 120 to 140 m.

**Figure 10.** (a) Schematic view of the channelized river, the characteristics of the terrain and of the compacted fill; (b) alteration of the compacted fill, process of piping and migration of materials, initial stage of the collapse; (c) formation of sinkhole, material drags surroundings due to river activity.
