Post-event field survey of 28 September 2018 Sulawesi earthquake and tsunami

Wahyu Widiyanto^{1,2}, Purwanto B. Santoso², Shih-Chun Hsiao¹, and Rudy T. Imananta³

Abstract. An earthquake with a magnitude of $M_w = 7.5$ that occurred in Sulawesi, Indonesia, on 28 September 2018 triggered liquefaction and tsunamis that caused severe damage and many casualties. This paper reports the results of a post-tsunami field survey conducted by a team with members from Indonesia and Taiwan that began 13 d after the earthquake. The main purpose of this survey was to measure the run-up of tsunami waves and inundation and observe the damage caused by the tsunami. Measurements were made in 18 selected sites, most in Palu Bay. The survey results show that the run-up height and inundation distance reached 10.7 m in Tondo and 488 m in Layana. Inundation depths of 2 to 4 m were common at most sites and the highest was 8.4 m in Taipa. The arrival times of the tsunami waves were quite short and different for each site, typically about 3–8 min from the time of the main earthquake event. This study also describes the damage to buildings and infrastructure and coastal landslides.

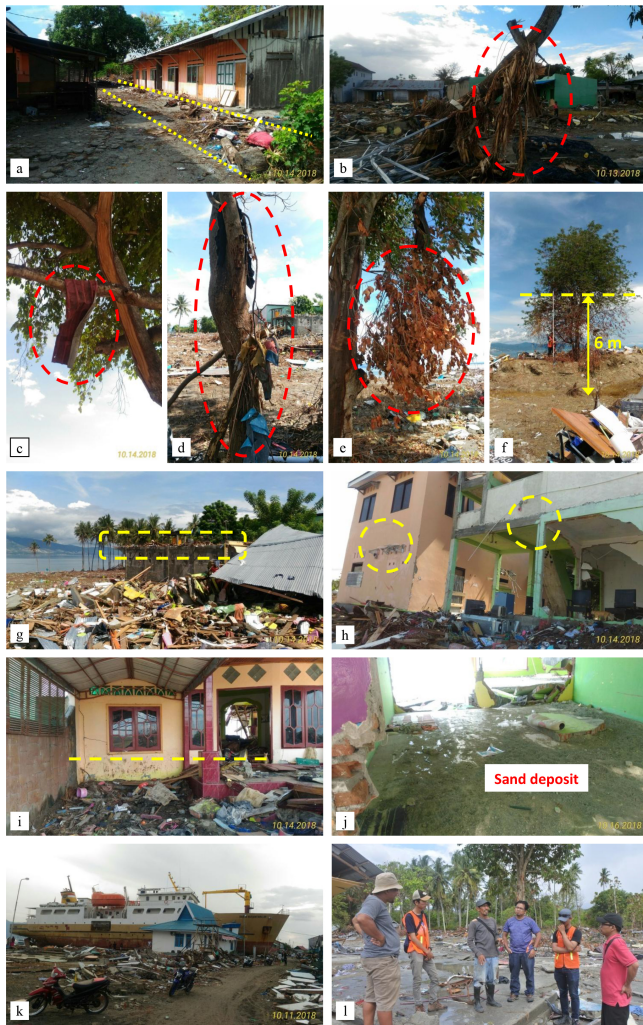
(f) brown leaves (submerged in saltwater during the tsunami event). Figure 2 shows some evidence of run-up and inundation traces.

Figure 2. Evidence of tsunami run-up and inundation. (a) Debris left behind in the residential area of Tondo, (b) debris caught in a tree in Mamboro, (c) and (d) debris stuck in a tree in Tondo, and (e) leaves turned brown due to being submerged in saltwater. (f) A tree had green leaves at the top and brown at the lower part, indicating the tsunami inundation height (flow depth) limit in Layana. (g) Debris lodged on top of a building, (h) broken house element showing tsunami water level, (i) watermark on a house wall in Lero Village, (j) sand deposit on building floor in Donggala City, (k) a 45 m long ship moved to land in Wani Harbor, and (l) interview with a survivor in Mamboro.

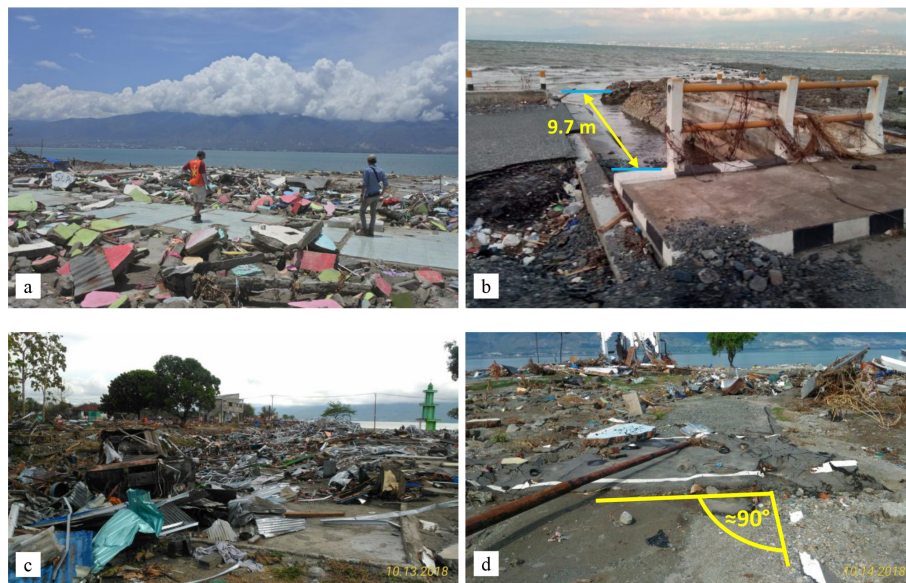
Figure 6. (a) Damage caused by the tsunami in Tondo, a residential complex where a lot of private boarding houses were inhabited by students at the University of Tadulako, (b) a reinforced concrete bridge on Cumi-cumi Road in Palu City was shifted by 9.7 m by the tsunami, (c) Mamboro Village with 90 % of houses destroyed, and (d) asphalt layer of small road turned 90° in Tondo.

Detailed measurements of a reinforced concrete bridge with simple support beams on Cumi-cumi Road, near Palu Grand Mall, Palu City (Fig. 6b) were taken. This bridge was shifted by as much as 9.7 m. It provided clues regarding the strength of the tsunamis. This bridge is made of reinforced

concrete with a bridge span of 5.0 m and a width of 19.1 m. It passed over an open channel, which had a width of 4.1 m and a depth of 1.6 m. It had 14 beam girders with dimensions of 0.25 m × 0.30 m and a girder distance of 1.35 m (its sketch is available in the Supplement). Its plate had a thickness of 0.20 m. Based on these dimensions, the surface area of the bridge was 244.7 m², the volume was 23.4 m³, and the mass was estimated to be around 56 t. The bridge was estimated to have been submerged by tsunami water as deep as 3.0–4.5 m based on the tsunami marks around it (Site 7, Lere). Debris caught in the bridge fence (Fig. 6b) provided evidence of the tsunami water soaking the bridge. The shift stopped because the bridge body was stuck in the wall of a building. Furthermore, we investigated this case with the help of Google Earth®, as shown in Fig. 7a and b, which show satellite images taken on 17 August and 2 October 2018, respectively. As shown, the asphalt layer of the road was broken and the bridge over the open channel was shifted away from the coast by the tsunami. The position of this bridge is at the end of Palu Bay (0.88123° S; 119.83907° E).

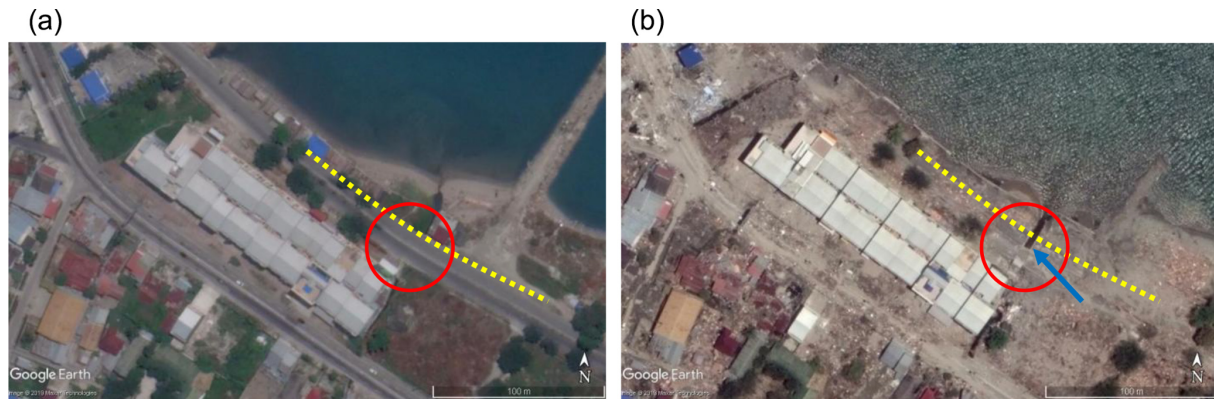
Figure 7. Satellite images taken on (a) 17 August and (b) 2 October 2018, showing the bridge shift (images source: Google Earth©).

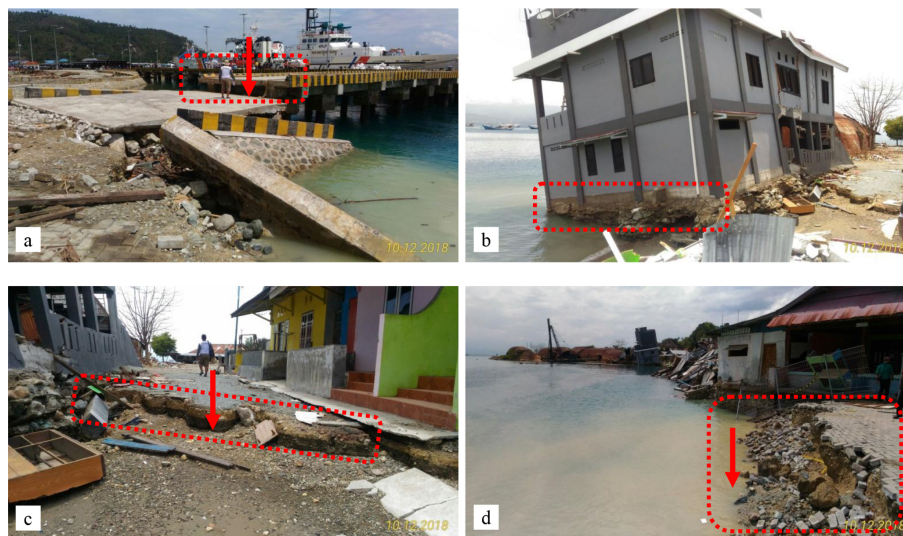
Figure 10. Landslide in Donggala City. (a) A trestle dropped 0.8 m in Donggala Port, (b) a building on the seaside slipped down significantly, (c) the surface of an alley in a settlement dropped 0.4 m, and (d) a layered courtyard with paving blocks dropped around 1.5 m.

Total coastal landslides in Palu Bay related to the 28 September 2018 event occurred at seven locations (Sassa and Takagawa, 2019), six locations (Arikawa, 2018), or 10 locations (Omira et al., 2019). Our team found two additional locations of coastal landslides. These are landslide locations not found by other survey teams. The two locations are around the river mouth in Donggala City (Figs. 10 and 11) and around the river mouth in Lero Village (Figs. 12 and 13). Landslides in Donggala were indicated by the loss of land around the Donggala River. Around 30 houses were reported to have suddenly sunk along with some of the residents. The wharf in the port of Donggala dropped by about 80 cm. The pile that was being installed for the foundation of a large building sank deep into the soil layer suddenly and was lost.

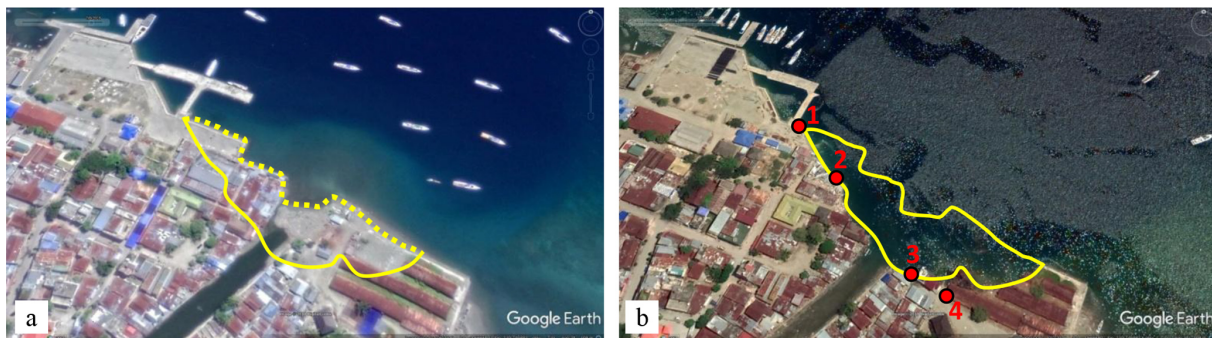
Figure 11. Possible landslide areas in Donggala (yellow dotted lines). Images were obtained from Google Earth©. Satellite images taken on (a) 6 July 2016 (more than a year before the earthquake) and (b) 2 October 2018 (4 d after the earthquake and tsunami). The yellow bounded area is around 10 068 m² or 1 ha. Numbers 1, 2, 3, and 4 in (b) correspond to Fig. 10a, b, c, and d.

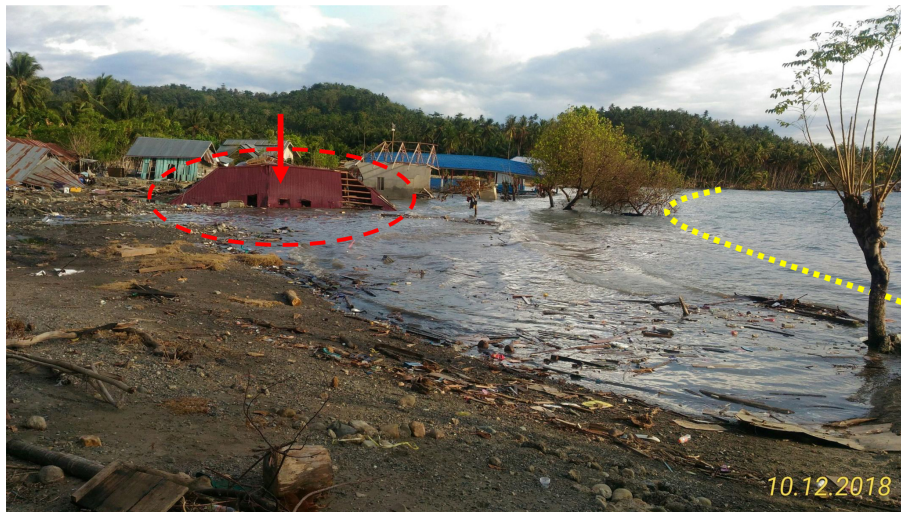
Figure 12. Quick land subsidence in Lero Village. Photograph taken 2 weeks after the event. Some houses dropped suddenly, around 3–4 m, when the earthquake occurred. Residents of these houses, especially those indicated by the oval, could not evacuate in time. The yellow dotted line is the former coastline.

In Lero Village, some houses and their inhabitants drowned when the tremor struck. Figure 12 shows a house going down, with the ceiling at the position of the original floor. A typical house in Indonesia has a ceiling height of 3 to 4 m. This indicates that the landslide in Lero Village lowered the land surface by 3 to 4 m. In addition, an eyewitness reported that the seabed around 10 m from the coastline changed from 1 m deep to a depth that made the seabed invisible to the naked eyes. He heard a roaring sound a minute after the main earthquake.

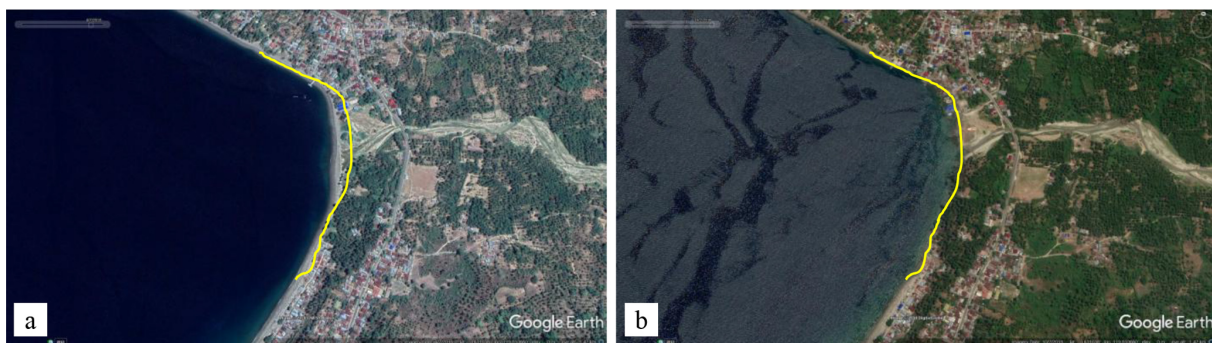
Figure 13. Quick land subsidence in Lero Village. Satellite images taken on (a) 7 April 2016 and (b) 2 October 2018, from Google Earth©, showing conditions after the earthquake and tsunami. The area of land that dropped is 22 971 m² or almost 2.3 ha.
