The 22 December 2018 Mount Anak Krakatau volcanogenic tsunami on Sunda Strait coasts, Indonesia: tsunami and damage characteristics

Syamsidik^{1,2}, Benazir^{1,2}, Mumtaz Luthfi^{1,3}, Anawat Suppasri⁴, and Louise K. Comfort⁵

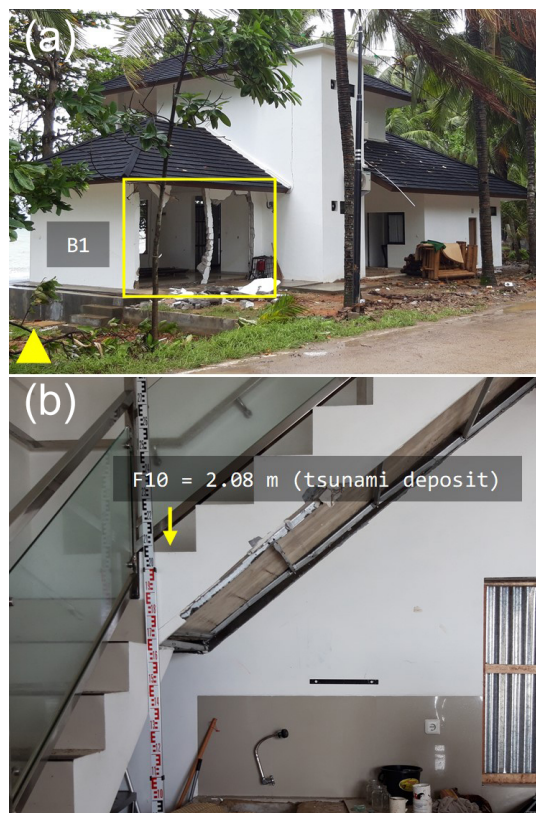
Figure 4. A villa's wall destroyed by tsunami on Bulakan Pondok beach (a) and a 2.08 m of flow depth recorded on the stair inside the villa (b). One-storey house had a major damage; meanwhile the two-storey house was moderate.

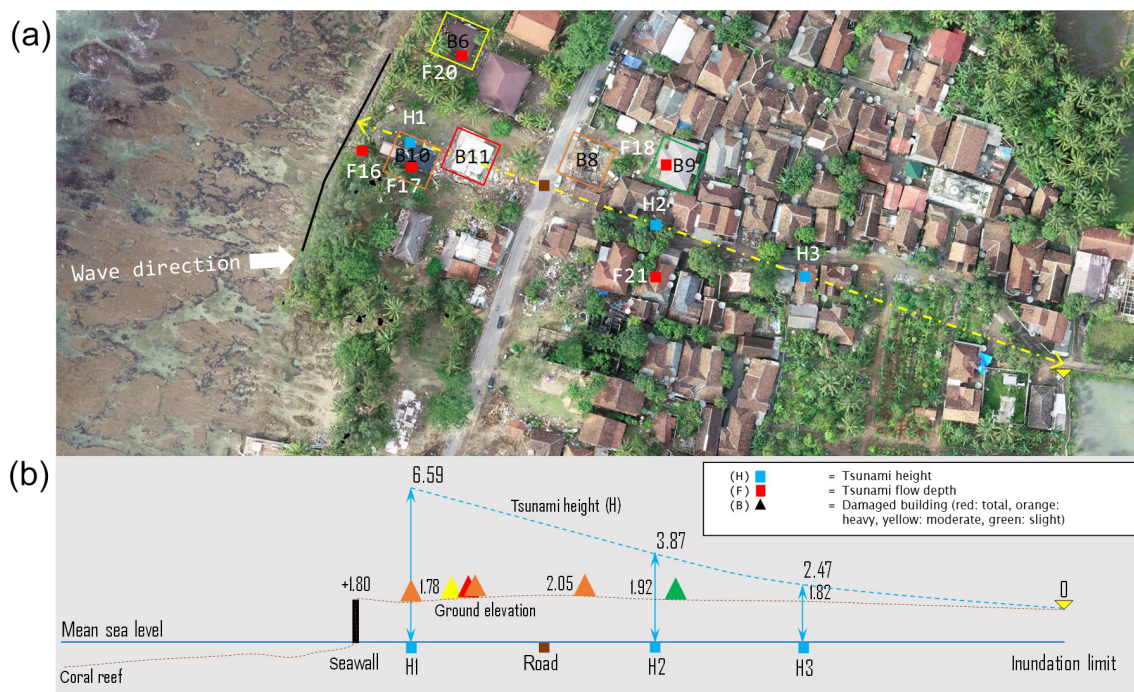
At this location, a transect was performed to measure tsunami height. Figure 5 also shows the profile of tsunami flow heights, ground elevations and house damage type. Height was calibrated with local tide data. Here, the tsunami flow's height was 6.59 m (H1). As the crown of a seawall along this coastline was 1.80 m a.s.l., the tsunami wave was considered large enough to destroy houses and other types of buildings in the area. The tsunami inundation distance reached 249 m, passing over a dense residential area.

Figure 5. A cross profile of tsunami height in Suka Ramai, Carita, Banten. Panel (a) is the location of the transect plotted on an aerial image captured on 28 December 2018.

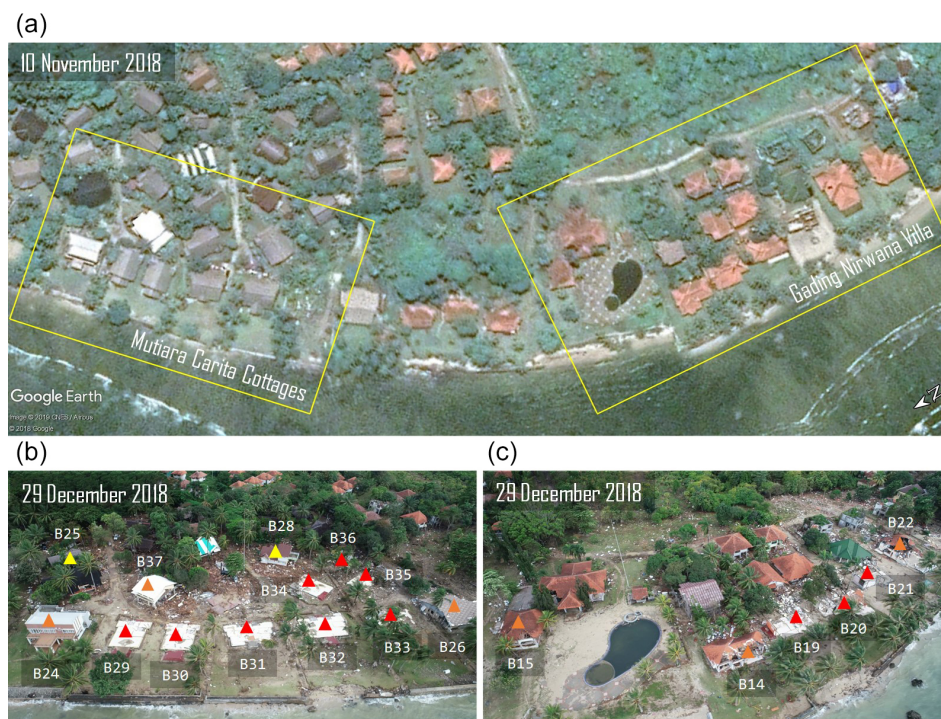
Further damage was identified in the Carita region of Pandeglang. The survey team investigated Mutiara Carita Cottage and Gading Nirwana Villa. The two resort complexes are situated close to the coastline, and some of the buildings directly face the sea. Most of the buildings in this area were located about 15 m from the coastline and apparently were not constructed for mitigating any waves coming from the strait. Most of the buildings were flattened by the tsunami wave, leaving only floors. Based on a wall clock found at an inundated house, the clock stopped at 21:45 local time (14:45 UTC). At Mutiara Carita, measured tsunami flow depth was 3.50 m, identified by a broken tree branch, and 3.34 m, which was identified from a broken roof element of the cottage. These are points F33 and F34 in data of this survey (Syamsidik et al., 2019b). A higher tsunami flow depth was found at Gading Nirwana Villa, which was 5.50 m (Syamsidik et al., 2019b). Flow depth was identified from a broken roof at the villa. An aerial view of the cottage captured on 25 December 2019 can be seen in Fig. 6.

Figure 6. Aerial view of land destruction at Mutiara Carita Cottages and Gading Nirwana Villa, Banten. Panel (a) was adapted from Google Earth.

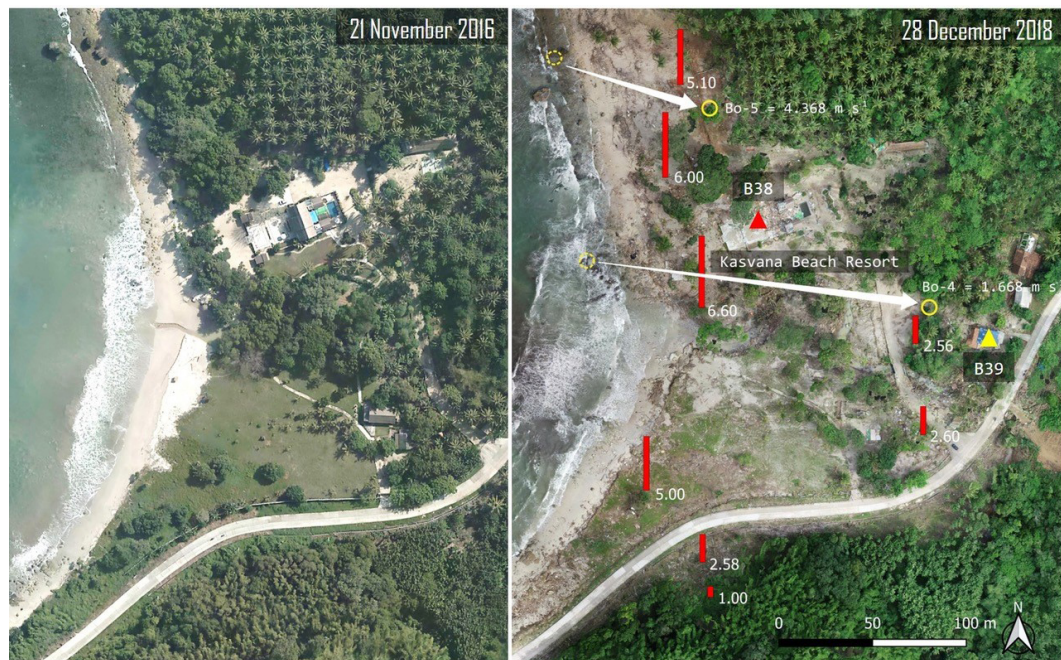
Figure 7 shows conditions at Cipeuyu Beach, located west of the Tanjung Lesung resort, comparing scenes before and after the tsunami. The figure also shows the distribution of tsunami flow depths. Although no significant residential area was found here, traces of the massive impacts of the tsunami could be identified at the Kasvana Beach Resort. Maximum flow depths around this resort were at 6.60 m (F47), identified from a broken branch of a *Pandanus odorifer* sp. tree. According to an interview with the resort staff, seven people died. They were guests and staff of the resort. Severe erosion was also seen along the coastline near the resort. The

Figure 7. The land destruction and flow depth distribution at Cipenyu Beach, Banten. Panel (a) is an image captured before the tsunami (from Google Earth). Panel (b) is an aerial view captured by drone on 29 December 2018.

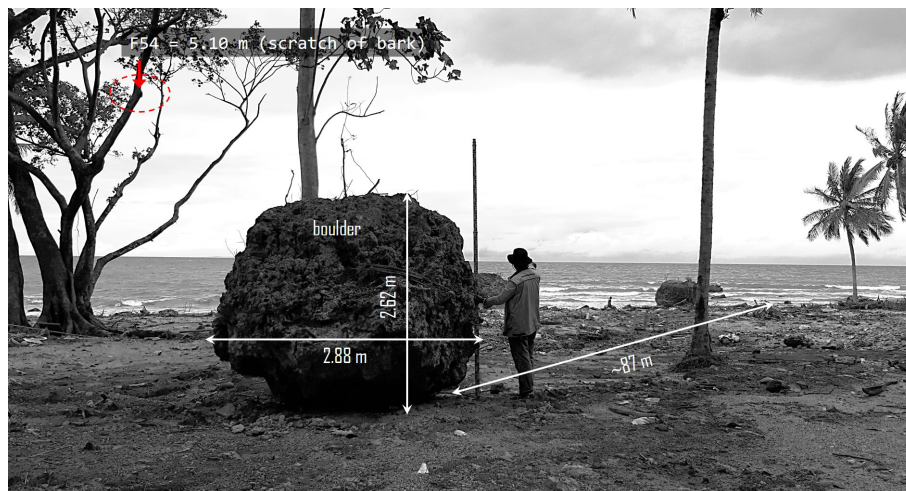
deadly force of the tsunami wave was also revealed by a large tsunami boulder (Bo-5), which was found around 87 m from its initial source (see Fig. 8). The boulder's origin was based on eyewitness interviews stating that the boulder was at the beach area close to the resort before the tsunami. Another tsunami flow depth mark close to the boulder was measured at 5.10 m (point F54 in Syamsidik et al., 2019b). The topography around the area was relatively flat. Based on Eq. (1), it is inferred that the minimum velocity that transported the boulder was about 4.37 m s^{-1} .

Figure 8. The largest boulder found in Cipenyu Beach of Banten was transported about 87 m from its original place. An arrow shows the estimated transport direction of the boulder with an estimated velocity of 4.37 m s^{-1} , captured on 28 December 2018.

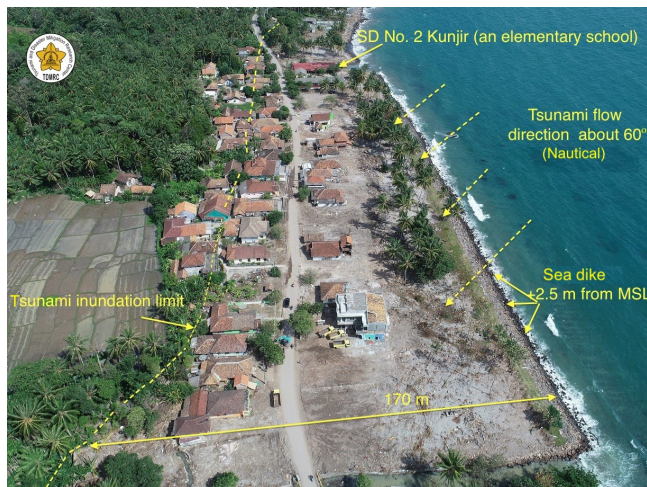
Figure 11 shows an aerial view of the damage caused by the tsunami in the villages of Batu Balak and Kunyir. At the hatchery plant, tsunami flow depth was measured at 3.82 m a.g.l. (point F88 in Syamsidik et al., 2019b). An elementary school in Kunyir located close to the coastline sustained massive damage. At this school, tsunami flow depth was measured at 3.33 m (point F91). The tsunami inundation limit was located 160 m from the coastline. Although Kunyir was protected by a revetment structure with a crown 2.5 m a.m.s.l. (metres above mean sea level), it could not protect the area from the tsunami. On the revetment, tsunami flow depth was at 2.10 m, based on a tree mistakenly located on top of the structure. In Waymuli, the highest tsunami flow depth was 3.92 m (point F105).

Figure 11. An aerial view from tsunami-affected area around the villages of Batu Balak and Kunjir, Lampung, captured on 31 December 2018 (MSL – mean sea level).

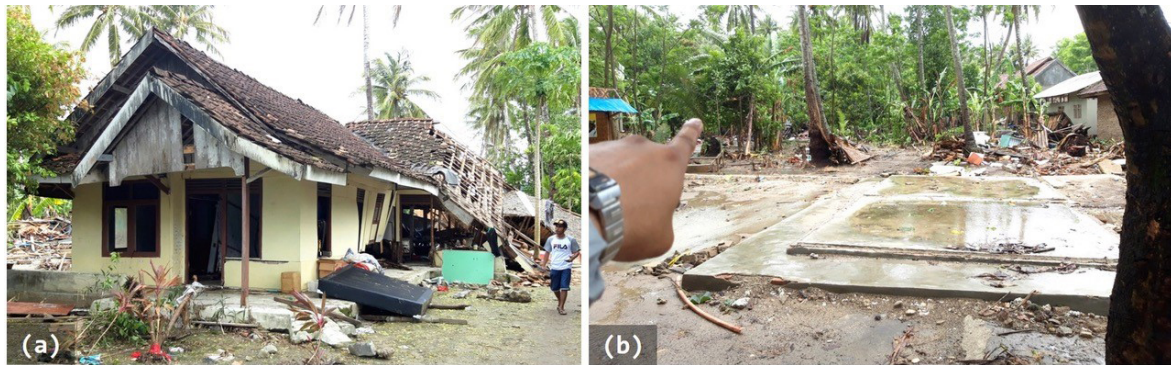
There were 25 wooden houses surveyed in the affected area. Due to the limited number of surveyed wooden houses, analysis of the damage was performed by classifying the damage as seen in Table 1. Only three classifications of damage could be identified, namely DS2, DS3 and DS4; 2 houses could be classified as DS2, 7 houses were DS3, and 19 houses were DS4. Examples of the damage found at wooden houses due to tsunami impacts can be seen in Fig. 13. Based on the number of surveyed wooden houses, it was found that a tsunami flow depth higher than 2.0 m could have completely washed away the houses, provided there was no debris in the flow. If the tsunami flow contained debris, the limit of the tsunami flow depth that could wash away a house was lower. In cases where the flow depths were lower than 2.0 m, damage was found to be due to failure of the bottom plates of the walls. Similar investigations of the impacts of tsunami bores on wooden walls were completed by Linton et al. (2013) and Wilson et al. (2009). They revealed that (1) the tsunami flow at the foundations beneath the walls could generate an uplifting force and (2) if the wave broke near the wooden structure, it also increased loading. Although the location of the tsunami breaking wave in the 2018 Mount Anak

Krakatau tsunami remains unknown, the pattern of damage to the lower parts of the wooden walls was similar to that in these studies.

Figure 13. Examples of damage at wooden houses: (a) major damage and (b) complete damage or washed away.
