## Brief communication: Monitoring a soft-rock coastal cliff using webcams and strain sensors

Diego Guenzi<sup>1</sup>, Danilo Godone<sup>1</sup>, Paolo Allasia<sup>1</sup>, Nunzio Luciano Fazio<sup>2</sup>, Michele Perrotti<sup>2</sup>, and Piernicola Lollino<sup>2</sup>

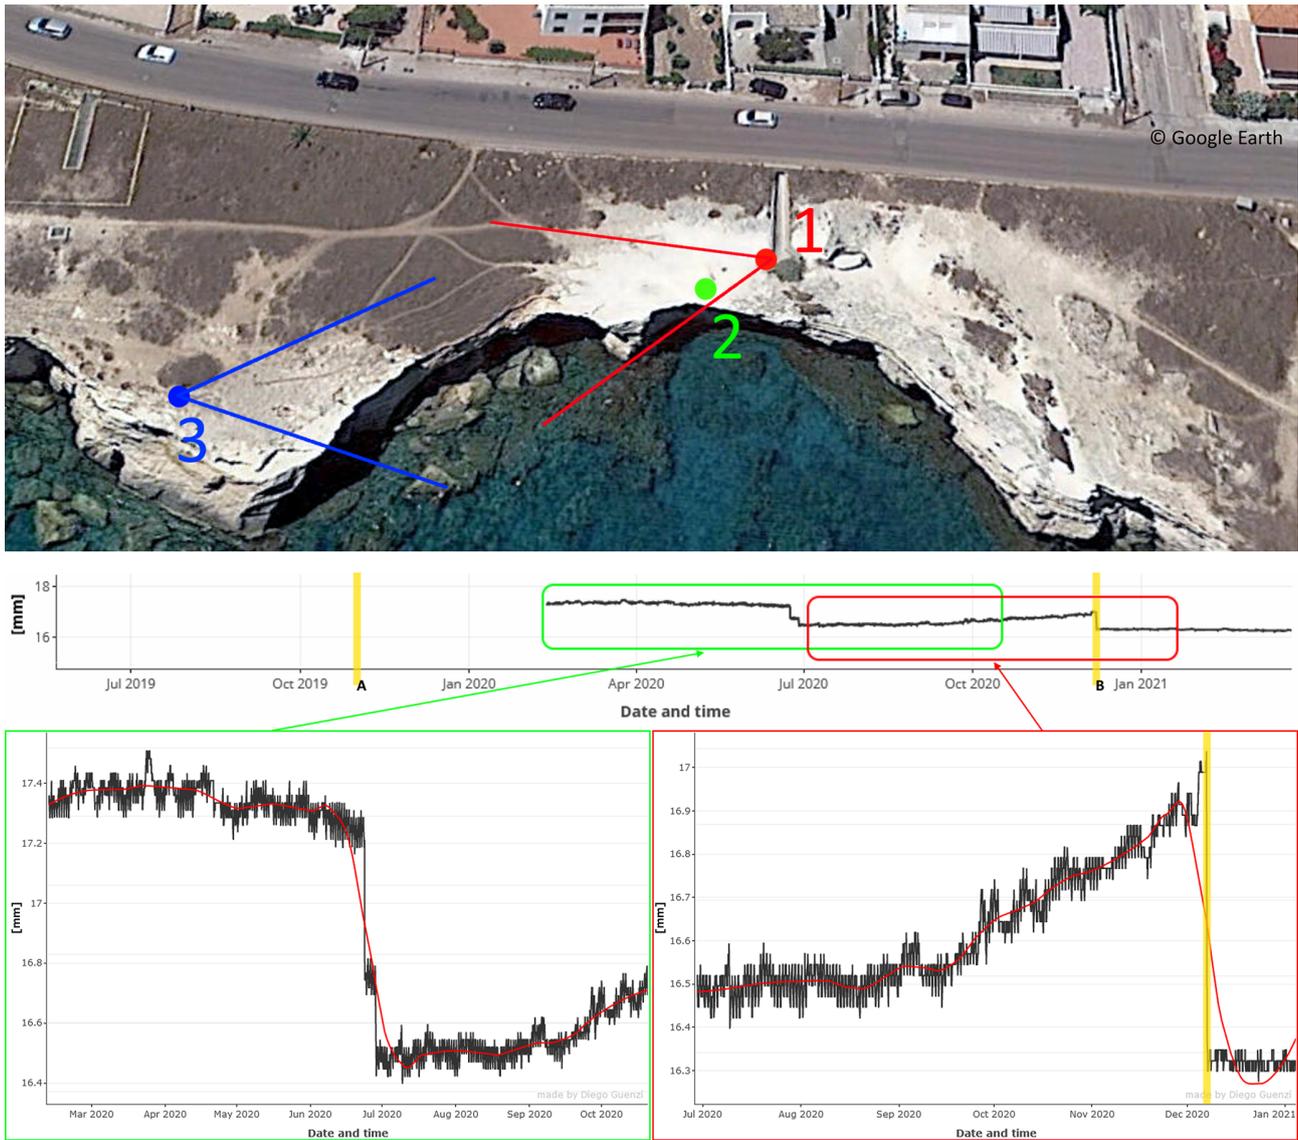
**Figure 1.** At the top, plan of the monitored cliff area (taken from © Google Earth) – in red (marked with “1”) the main camera position and the Raspberry Camera Module field of view; in blue (marked with “3”) the secondary camera; the green dot marked with “2” is the position of the crack meter. At the bottom, the crack-meter data – in the green box the first period of data obtained using the automatic crack meter (from 12 February 2020 up to 20 October 2020). In the red box the second period of data of the same crack meter (going from 29 June 2020 to 4 January 2021). Two main rockfalls have been noticed in this period and have been marked with the “A” and “B” yellow lines.

Two other rockfall events took place on 23 June 2020, around 17:05 (bottom of Fig. 1, green area), and on 28 June 2020, approximately between 09:00 and 11:00. In the latter event, the cameras, despite the area being under restricted access, also detected the presence of a passer-by; this anthropogenic disturbance interfered with the crack-meter measurements. This event confirmed that crack-meter devices alone cannot be used to monitor areas like the examined one, and an optical system is fundamental for having an additional control on the global factors acting on the site.

The last recorded event is related to the rockfall that occurred on 7 December 2020, 04:15. In this case, crack-meter data starting from July 2020 show a slight trend of the monitored fissure, which is seen to gradually enlarge up to the time of failure (bottom of Fig. 1, red area). Unfortunately, at that time, the optical instrumentation was off due to the lack of power caused by the adverse weather conditions: in the previous 96 h, a rather intense rainfall event occurred, which reached a peak of 24 h cumulative precipitation of 80 mm. Despite this issue, however, the images and videos obtained before and after the event are consistent with what was detected by the sudden deviation in the data of the crack meter. The fracture monitored by the instrument was not directly affected by the collapse, since the collapse involved a rock block not far from it, while the crack meter itself recorded, at the time of failure, a contraction of approximately 1 mm. In this case, following the same approach, it was possible to estimate the volume of the collapse, which resulted in being about  $20 \text{ m}^3 \pm 30 \%$ . Based on the data acquired by the secondary camera, we have also observed that the collapse itself occurred in two stages: the most conspicuous part, as already mentioned, collapsed around 04:15, while a second detachment, considerably smaller, occurred between 11:00 and 16:30 on the same day, without affecting the crack-meter measurements (see Fig. 3).

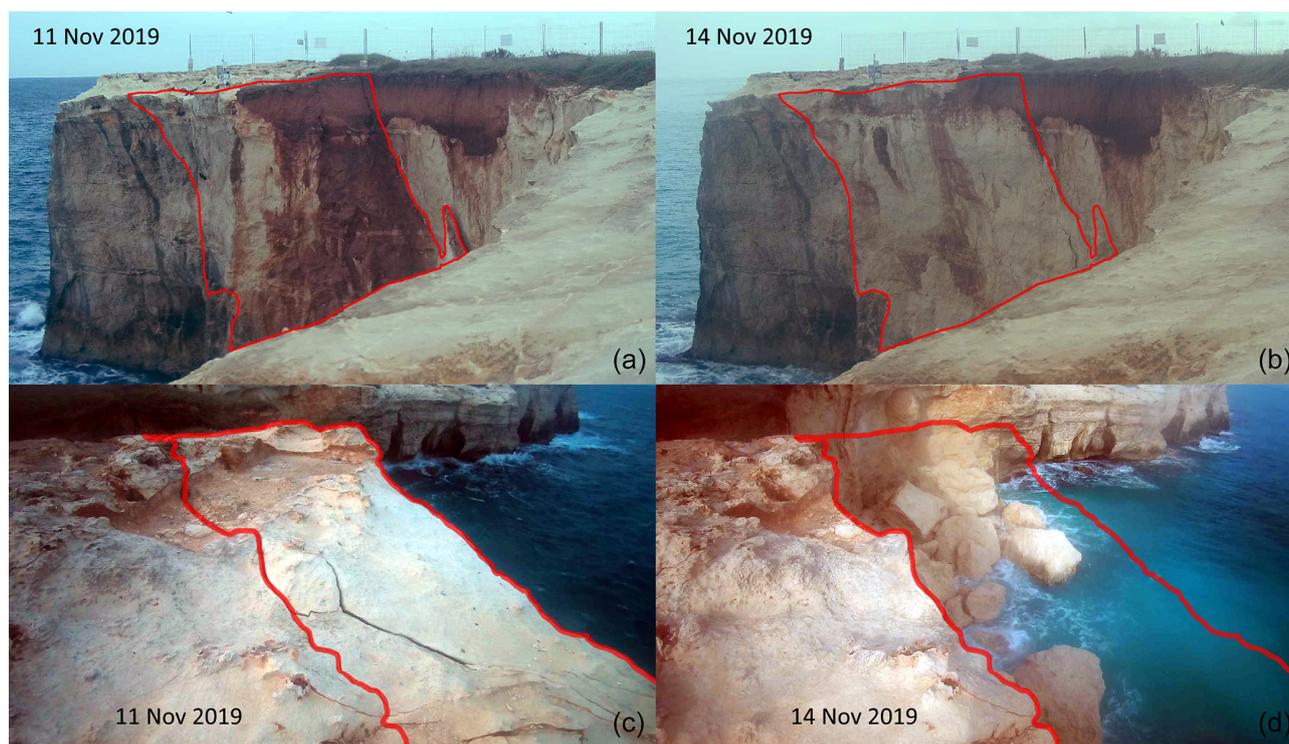
**Figure 2.** The first rockfall (marked with “A” in Fig. 1) – panel (a) shows the cliff as it was on 11 November 2019 and panel (b) shows it as it was 3 d later (both images are taken from the Raspberry Camera Module – see Fig. 1 for the position). Panels (c) and (d) show the same event but from a different point of view (the secondary camera – see Fig. 1 for the position): (c) a picture taken before the collapse and (d) a picture taken on 14 November 2019.

In these 2 years of activity, the monitoring system recorded several events. The first remarkable event occurred between 12 November 2019 (after 09:00 CET) and 14 November 2019 (before 08:30) when a collapse of a large part of the cliff took place (see Fig. 2). Unfortunately, when the failure occurred, the instrumentation was inactive due to the lack of energy caused by the severe rainstorm that struck the area for a few days; moreover, no crack meter was still available (see bottom of Fig. 1). Despite these issues, both images and videos just before and after the collapse were available. Based on such information and the application of image change detection techniques, we estimated a volume of the collapse equal to  $300 \text{ m}^3 \pm 30 \%$  following the methods described in Giordan et al. (2020).

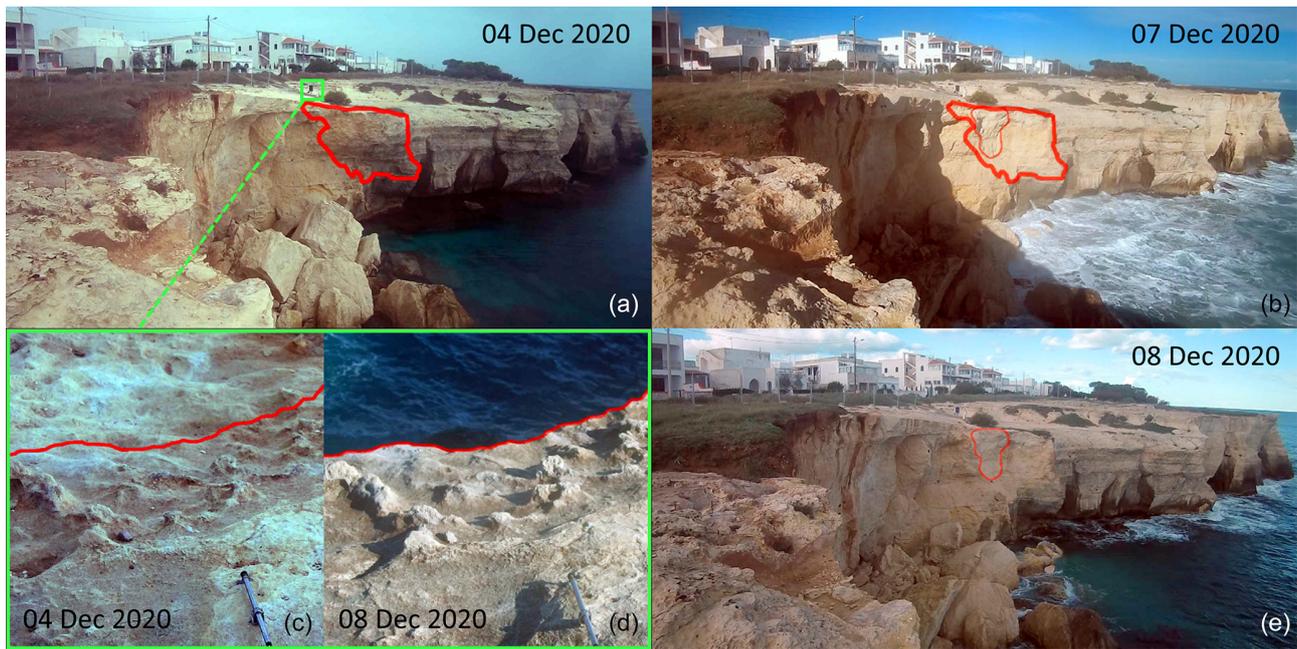
**Figure 3.** The second rockfall (marked with “B” in Fig. 1) – panel (a) shows the cliff as it was on 4 December 2020 and panel (b) shows it as it was on the morning of 7 December 2020, after the main collapse (marked by the thick red line). Panel (e) shows the cliff as it was on 8 December 2020, after a minor rockfall (marked by the thin red line). Those three images are taken from the secondary camera (see Fig. 1 for the position). In panels (c) and (d), two smaller images that show the collapse from another point of view (the main camera, which could also be seen in the top left image, highlighted in green – see Fig. 1 for the position) both before the rockfall (c) and after it (d). In those images, the newly installed automatic crack meter is also visible.
