Supplement of

Transformations in exposure to debris flows in post-earthquake Sichuan, China

Isabelle Utley et al.

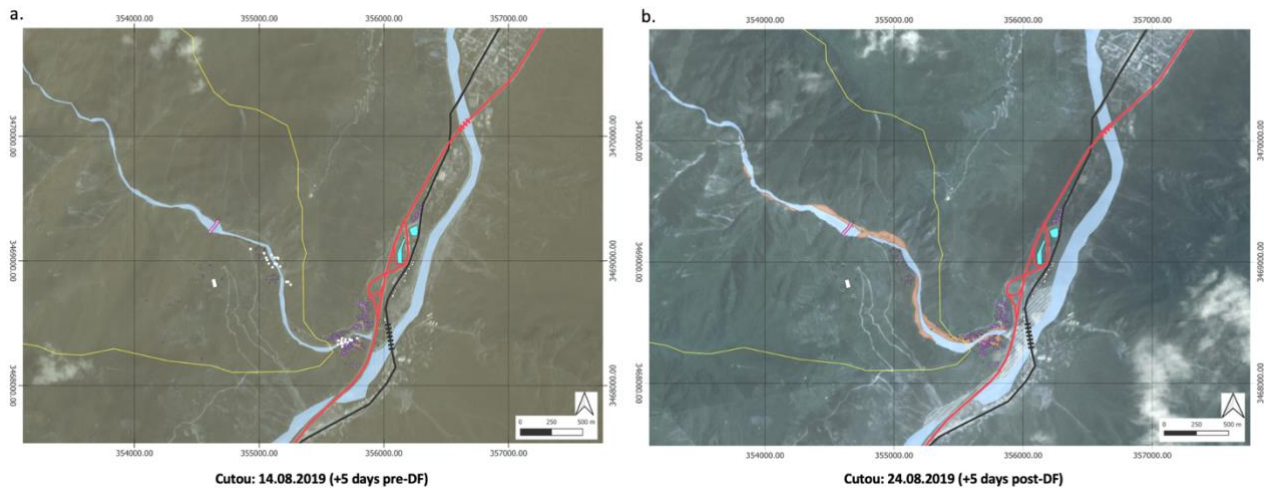
Figure S1. Pre- and post-debris flow event satellite imagery of Cutou Gully (© Google Earth 2019).

Satellite images showing the catchment area of Cutou Gully (i) before and (ii) after the debris flow event of 2019. Areas of debris flow inundation are highlighted in brown. Notable features include damage to built structures, scarring and erosion within the channel, and sediment deposition. Image interpretation supported the classification of affected areas as damaged, reconstructed, or newly developed, as outlined in the methodology and aided Figures 5 and 6 of manuscript. Satellite data sourced from Google Earth (2023).

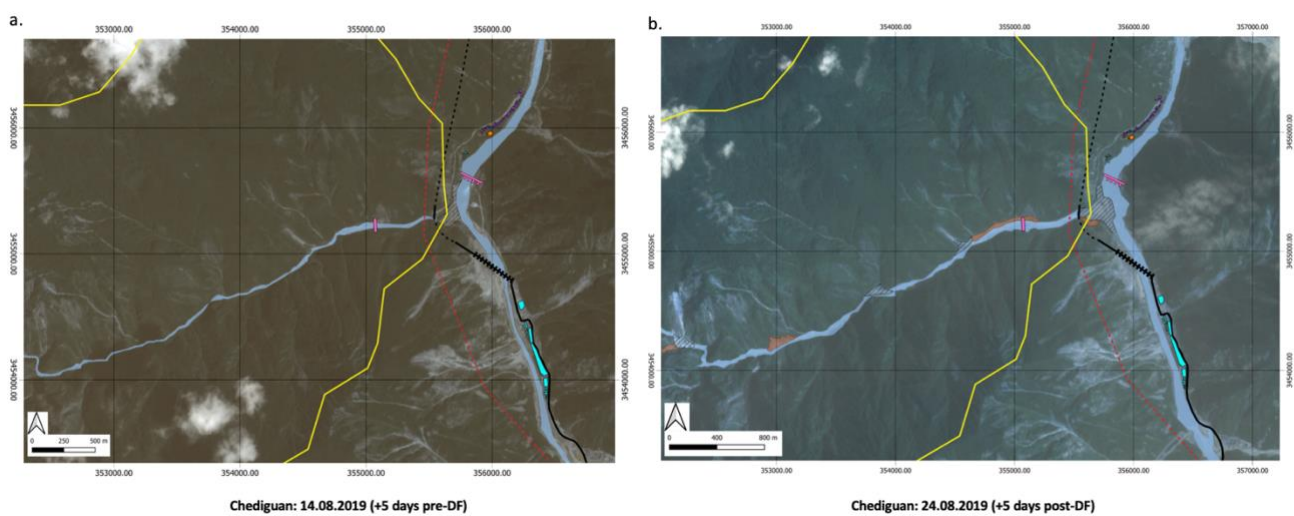
Figure S2. Pre- and post-debris flow event satellite imagery of Chediguan Gully (© Google Earth 2019).

Satellite images showing the catchment area of Chediguan Gully (i) before and (ii) after the debris flow event of 2019. Areas of debris flow inundation are highlighted in brown. Notable features include damage to built structures, scarring and erosion within the channel, and sediment deposition. Image interpretation supported the classification of affected areas as damaged, reconstructed, or newly developed, as outlined in the methodology and aided Figures 5 and 6 of manuscript. Satellite data sourced from Google Earth (2023).

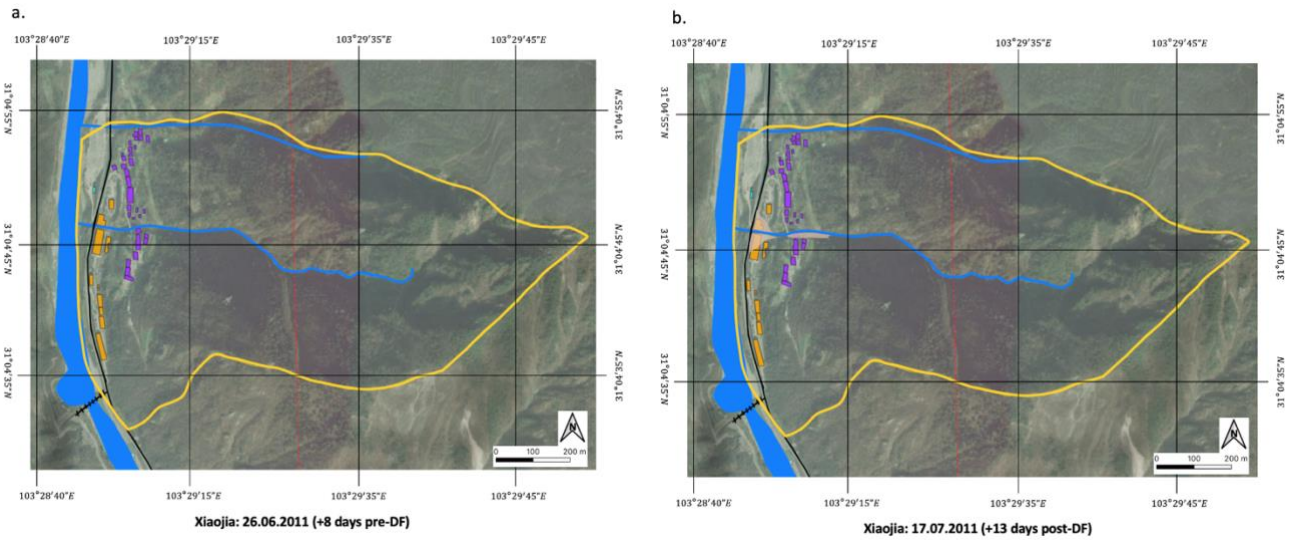
Figure S3. Pre- and post-debris flow event satellite imagery of Xiaojia Gully, (© Google Earth 2011).

Satellite images showing the catchment area of Xiaojia Gully (i) before and (ii) after the debris flow event of 2011. Areas of debris flow inundation are highlighted in brown. Notable features include damage to built structures, scarring and erosion within the channel, and sediment deposition. Image interpretation supported the classification of affected areas as damaged, reconstructed, or newly developed, as outlined in the methodology and aided Figures 5 and 6 of manuscript. Satellite data sourced from Google Earth (2023).
