Tsunami vulnerability of buildings and people in South Java – field observations after the July 2006 Java tsunami

S. Reese¹, W. J. Cousins², W. L. Power², N. G. Palmer², I. G. Tejakusuma³, and S. Nugrahadi³

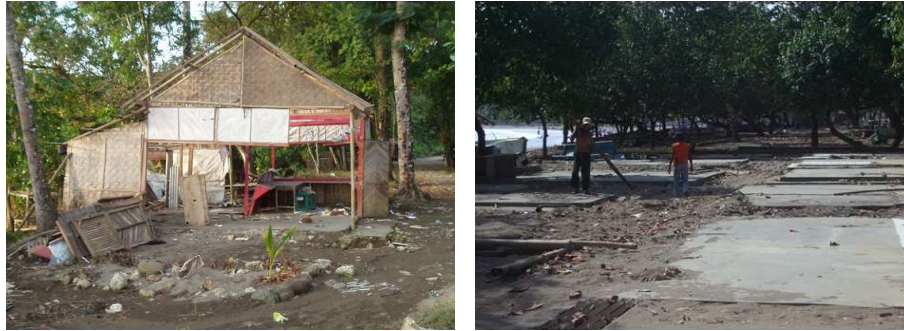
Performance of these structures was on average poor with a few exceptions, for instance where buildings were on strong piles. In nearly all cases a flood depth of less than a metre (above floor) caused light to moderate damage, 1.5 to 2 m resulted in roughly 70% destroyed and 30% lightly to heavily damaged but repairable, and a depth exceeding 2 m essentially caused total destruction (Fig. 11).

Fig. 11. Typical damage to semi-permanent wooden shops, after inundation to nearly 1 m depth (a) and to 3 m (b). Only the concrete floors remain in the right image, where prior to the tsunami there had been a row of more than 30 shops.

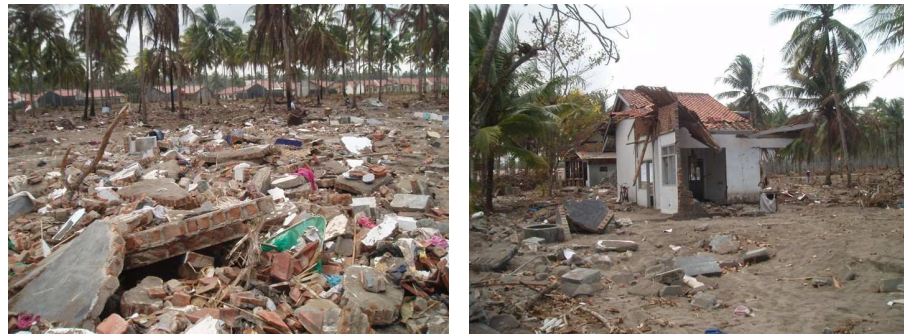
Many of the single story residential structures and shops were made of unreinforced brick walls on concrete foundations. The construction was weak, with single-skin brick walls, often plastered on both sides. The vast majority of roofs were covered with clay tiles, a few with corrugated steel sheets. The observed damage levels were not much different from the timber/bamboo ones (Fig. 12).

The main difference was that slightly more houses remained upright where the flood depth was greater than 2 m. But most of them seemed not repairable apart from the concrete floor which often remained intact.

Fig. 12. The remains of traditional brick houses after inundation to a depth of ca. 3 m (a). There were a few partially intact (b).

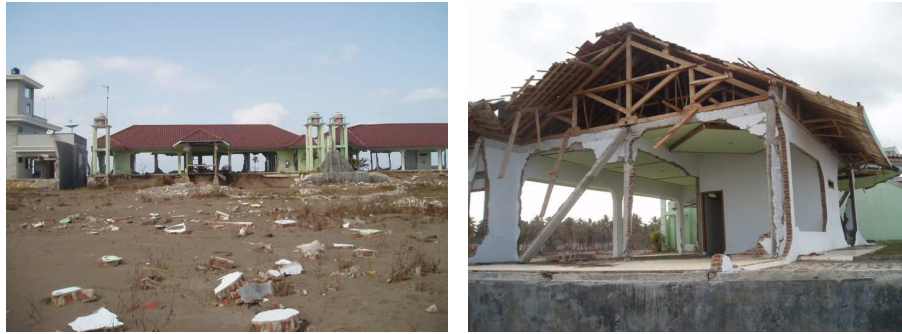
The non-engineered masonry structures had rudimentary reinforced concrete columns, and single-skin infill brick walls that were often plastered on both sides. Buildings typically had concrete floors and were one and two-storey houses and shops. Columns ranged from 100 mm × 100 mm with 4 wires of 3 mm diameter, to 200 mm × 200 mm with 4 smooth bars of 8 to 12 mm diameter at the four corners. The walls suffered punching shear failure, often with holes punched through multiple walls. Even though the reinforcement was rudimentary, it improved the performance significantly. The observed damage levels were

- <1 m of water – minor damage only,
- 1.5 to 2 m of water – light to moderate damage (repairable), and
- 3 to 4 m of water – serious damage, but buildings upright and probably repairable (Fig. 13).

Fig. 13. Two relatively well-made apartment complexes (a) with rudimentary reinforced concrete columns (b), after inundation to a depth of 3.8 m.

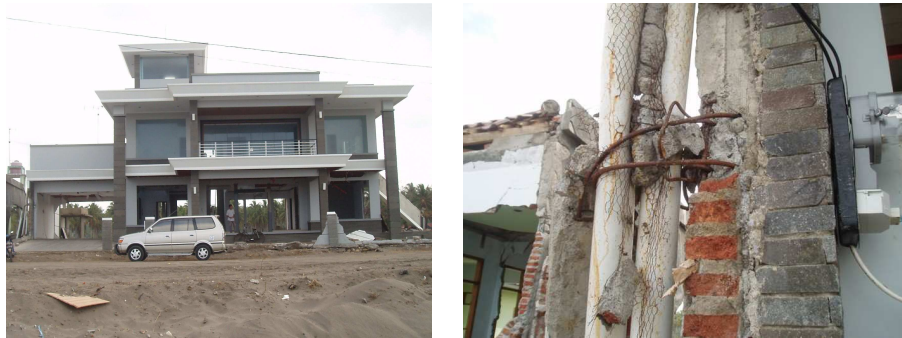
These robust constructions were the predominant structure type for hotels, but also some shops and houses. Often with two or more storeys, they had brick infill walls with plastering on both sides, reinforced concrete columns of at least 200 mm × 200 mm, at least 6 bars of 12 mm reinforcement, and concrete floors. These well-constructed and reinforced buildings survived the tsunami with minor damage only. Damage was often limited to broken windows and

doors or failed first floor walls which could be due to the effect of debris. Observed damage levels were:

- <1 m of water – zero to light damage to ground floor,
- 1.5 to 2 m of water – light to moderate damage to ground floor (repairable), and
- 3 to 4 m of water – moderate damage to ground floor (holes punched through 1 or more walls), but building upright and repairable (Fig. 14).

Fig. 14. Well engineered beachfront villa after inundation to a depth of 3.8 m (a). Reinforcement detail is shown at right (b).
