**Survey of the 2013
Super Typhoon
Haiyan**

Field survey report and satellite image interpretation of the 2013 Super Typhoon Haiyan in the Philippines

International Research Institute of Disaster Science (IRIDeS), Tohoku University, Japan

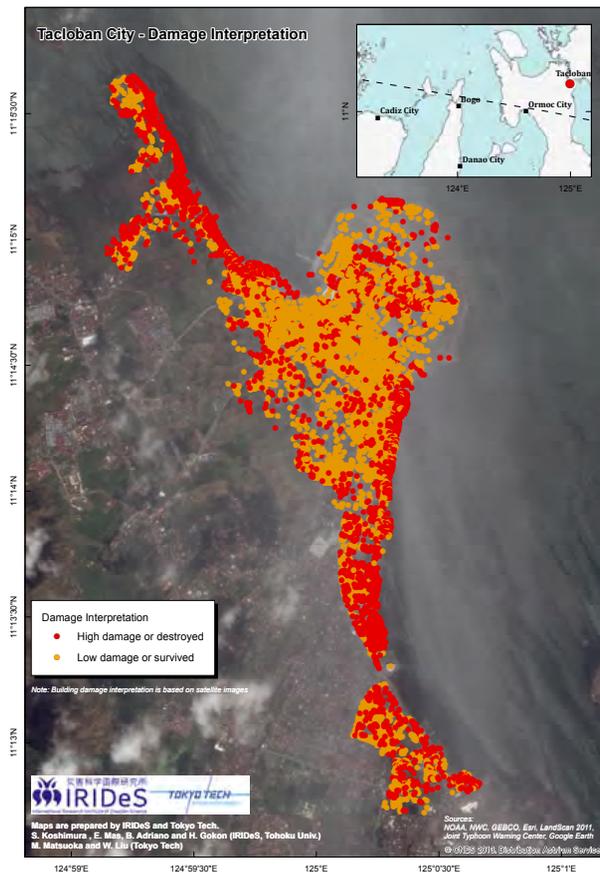
The results of this assessment are shown in Fig. 3. Significant damage was interpreted in the coasts to the north and south of downtown Tacloban. During our field survey, we visually confirmed the extensive damage in these areas. The verification of our interpretation is, at this moment, qualitative due to the difficulties experienced during the field survey in gathering detailed information at a house-by-house resolution (Fig. 4). The extensive damage interpreted to the north and south of the downtown was confirmed to be due to the high vulnerability of the structures in these areas and to the presence of stranded ships, which caused most of the damage near the Anibong area (Fig. 5).

Figure 3. The results of the visual damage assessment using pre- and post-event satellite images and two classification criteria. (i) High damage or destruction in red and (ii) low damage or survival in orange.

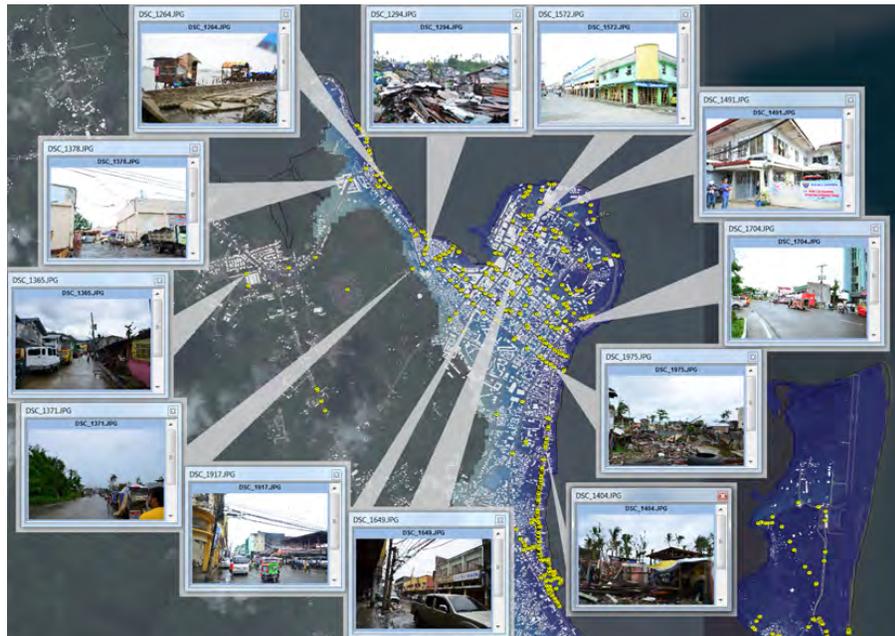
Figure 4. Photos taken during the field survey at the areas assessed through visual inspection of satellite images. The damage conditions and distribution confirm the interpretation that higher damages existed to the north and south of the downtown area in Tacloban city, the Philippines.

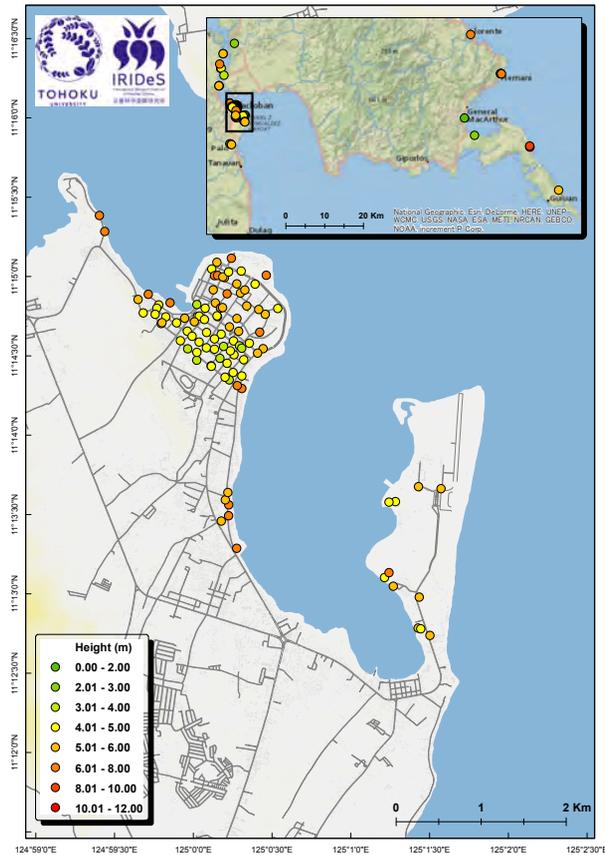
Figure 7. Level of storm surge inundation (Leyte Is. and West Samar Is.) and surface wave heights (East Samar Is.) with respect to the local mean sea level.

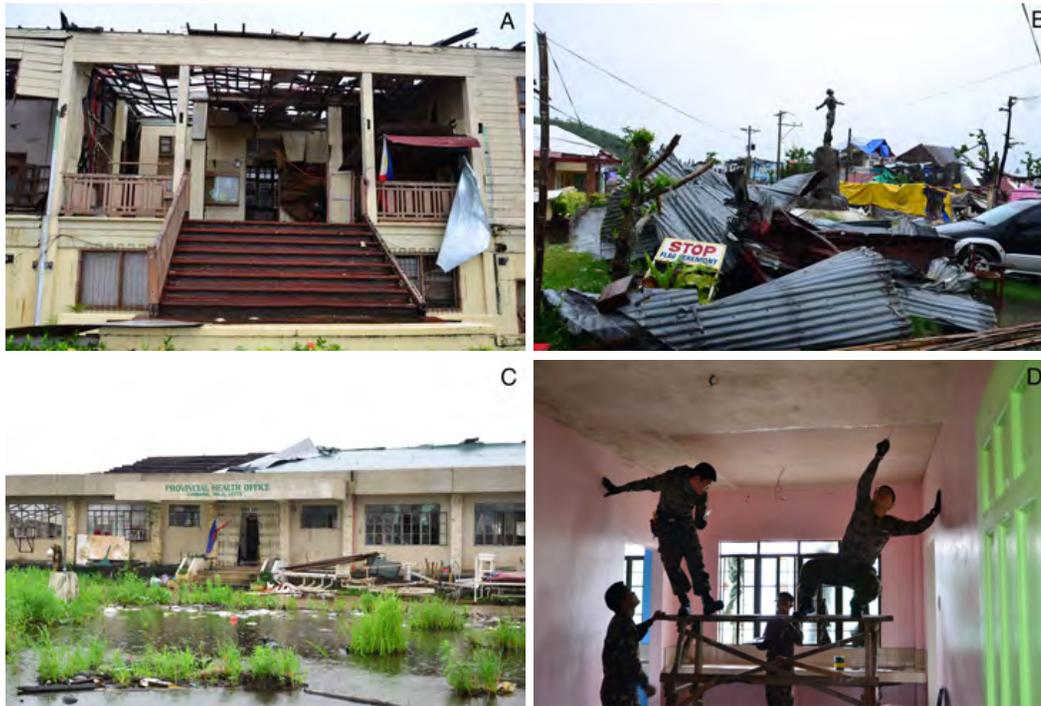
Figure 8. (A, B) Damage observed at the School of Health Science at the University of the Philippines, Manila. (C) Damage to the Provincial Health Office building in Palo. (D) The South Korean army helping with the restoration of a local hospital in Palo.

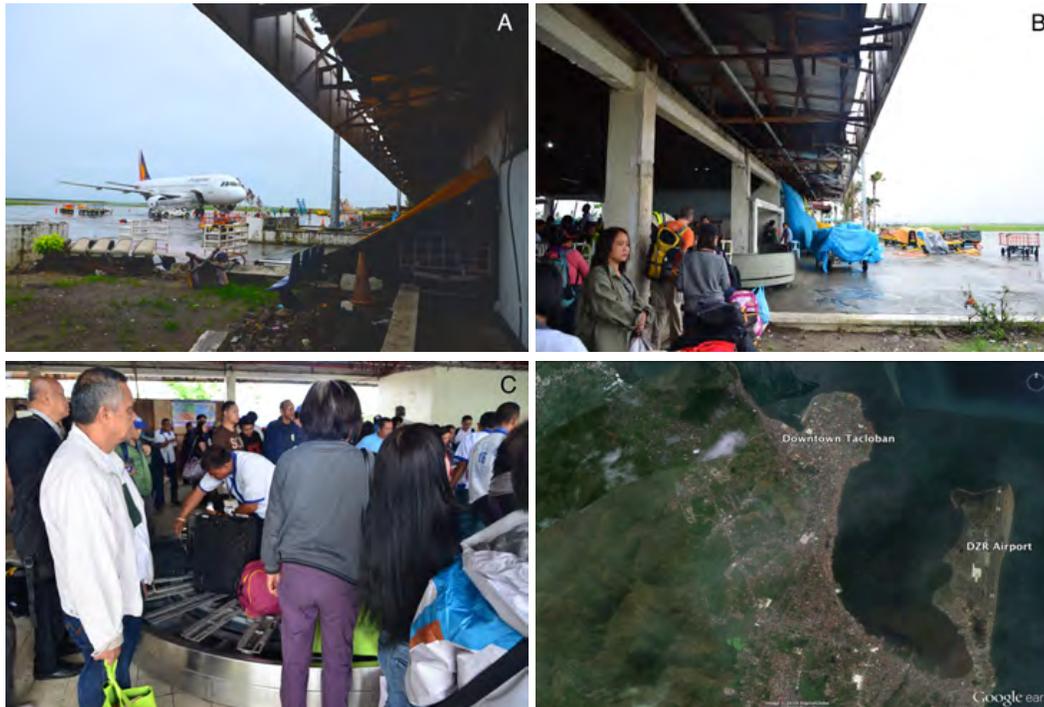
Figure 9. (A, B) Damage to the walls and roof of a gate to the side of the runway. (C) Passengers arriving and baggage claim belt out of service due to damage.

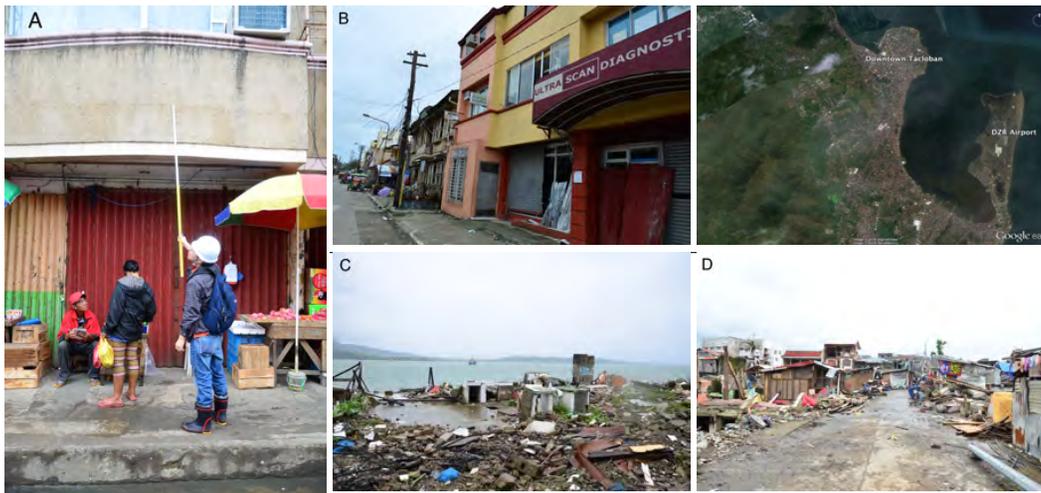
Figure 10. (A) Watermark in the inland downtown area, where no structural damage was observed. (B) Inland downtown, damage to doors due to flooding. (C, D) Extensive damage at the coastline near downtown Tacloban.

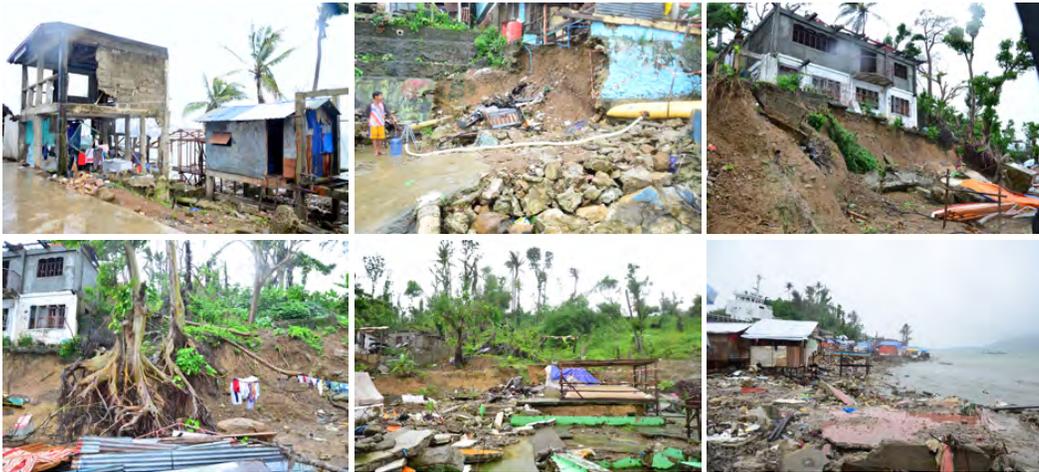
The Anibong area is located immediately to the north of downtown Tacloban, in the coastal area of the Panalaron bay. The Anibong and neighboring barangays (villages) were intensely damaged by the storm surge, the winds and the waves. Ships stranded here were the main cause of damage in the area (Fig. 5). Behind Anibong, a steep hill functioned as a barrier to the surge; however, the hill remains unstable due to the erosion of its slopes. Figure 11 shows the damage to frame concrete structures; a local landslide and soil erosion were deep enough to uncover house foundations and tree roots. Pile dwellings, or palafittes, are the main type of house found in this area. Due to these houses' lightweight building materials and their wooden piles not being deep enough in the sandy soil, this was one of the most vulnerable places in the Tacloban city area.

Figure 11. Damage observed at the Anibong area, north of downtown Tacloban. Destruction of wooden pile dwellings, erosion and local instability of slopes.

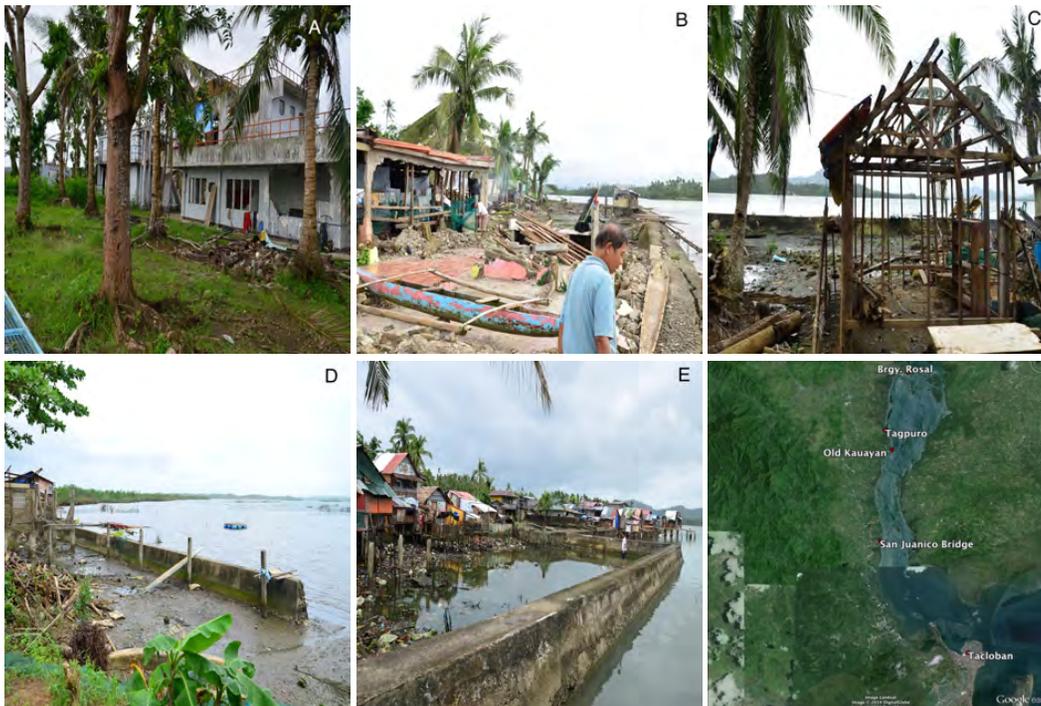
to 5 m. Significant damage was observed to pile dwellings located behind a 3 m-high seawall, which was overtopped by the storm surge, and roofs were ripped off by the winds. The storm surge mainly affected the west side of the San Juanico strait, from the bridge up to the north (Fig. 12).

Figure 12. Damage at the northern part of Leyte Island. **(A)** Structure near the San Juanico Bridge. Inundation height was measured at 5.9 m. **(B, C)** Coastal village of Old Kauayan, a small sea wall was overtopped and damaged. Surge flooding of 4.4 m was measured here. **(D)** Sea wall damage at Tagpuro. The runup height was 6.9 m. **(E)** Barangay Rosal area with a 5.0 m storm surge inundation and damage to houses behind the 3.0 m sea wall.

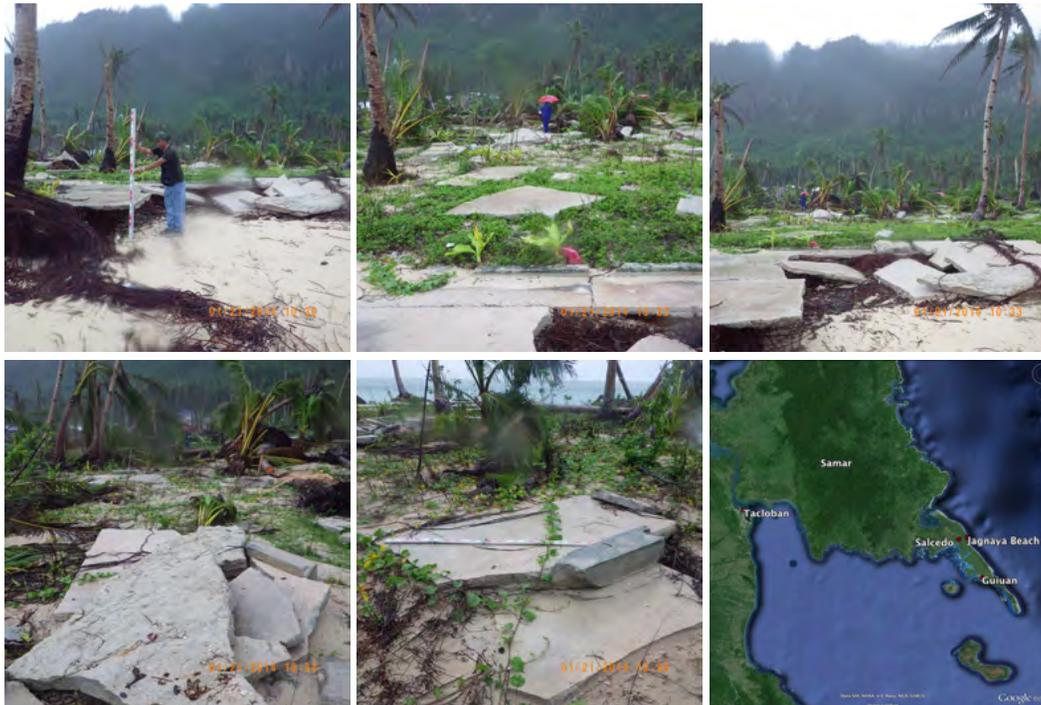
Figure 13. Guiuan village, one of the areas most affected by surface waves. Sand erosion, vegetation damage and concrete structures destroyed.

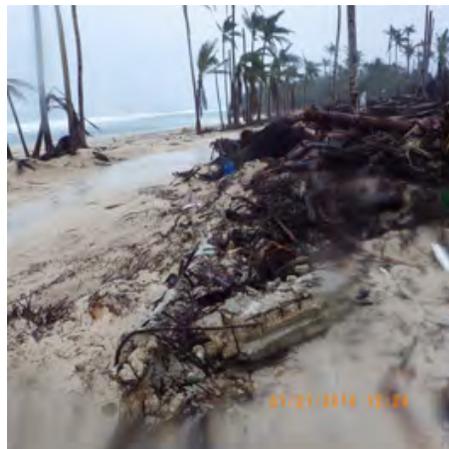
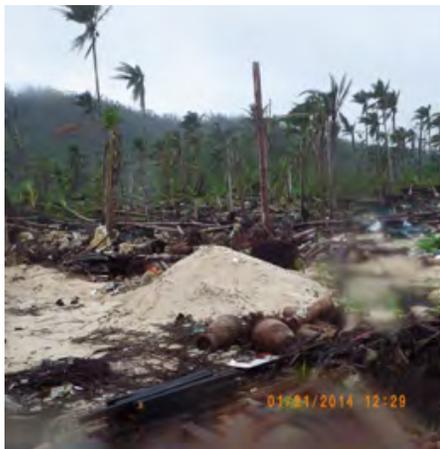
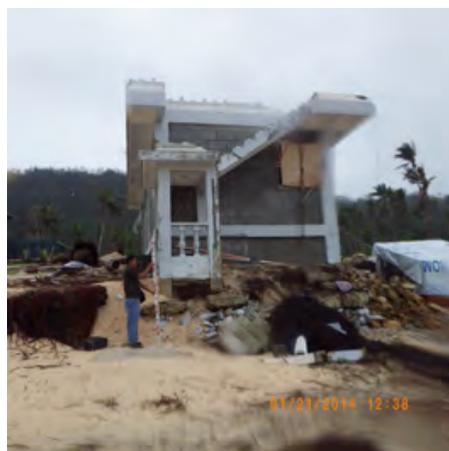
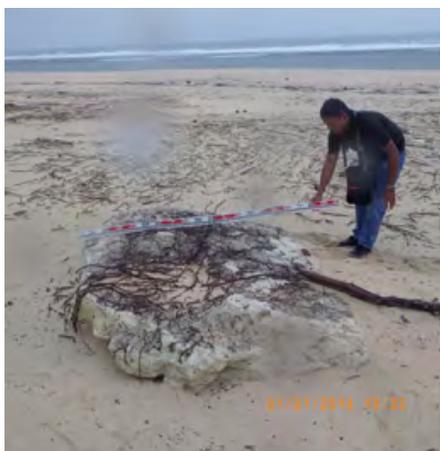
Figure 14. Jagnaya Beach area, east of Salcedo village. Extensive sand erosion and deposition to inland was observed. In addition, coral boulders were observed on the beach, which were possibly carried inland by the waves.
