Nat. Hazards Earth Syst. Sci. Discuss., 2, 4299–4330, 2014 www.nat-hazards-earth-syst-sci-discuss.net/2/4299/2014/ doi:10.5194/nhessd-2-4299-2014 © Author(s) 2014. CC Attribution 3.0 License.

Rockslides on limestone cliffs with sub-horizontal bedding in the southwestern calcareous area, China

Z. Feng¹, B. Li¹, Y. P. Yin², and K. He³

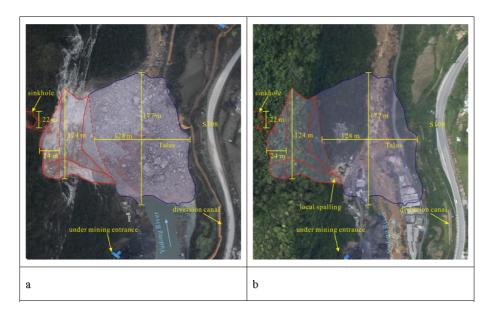
- area, including sinkholes, karst tunnels, and dissolution fissures. A remote sensing image taken the day after the rock collapse shows a sinkhole at the crest with a diameter of 2.2 m immediately behind the fall. The pipe flow and induced groundwater dynamics acted on the unstable rock block and changed the instability. However, because of abundant vegetation, the sinkhole is not visible in a previous image that was taken in

Figure 3. Aerial photos of Rock Slide Itaken in summer 2012 (a) and on 19 February 2013 (b). The zoning of the depleted mass and talus is projected in picture (a) prior to the catastrophe. The abundant vegetation and steep terrain make it difficult to distinguish the potential failure. However, there were signs of local spalling at the toe of the cliff face (a). A 22 m-diameter sinkhole was exposed in winter, which connected with the main back scar of the rock slide (b).
