The 27 May 1937 catastrophic flow failure of gold tailings at Tlalpujahua, Michoacán, México

J. L. Macías¹, P. Corona-Chávez², J. M. Sánchez-Núñez³, M. Martínez-Medina^{4,5}, V. H. Garduño-Monroy², F. García-Tenorio¹, and G. Cisneros-Máximo¹

Received: 16 June 2014 – Accepted: 6 July 2014 – Published: 20 August 2014

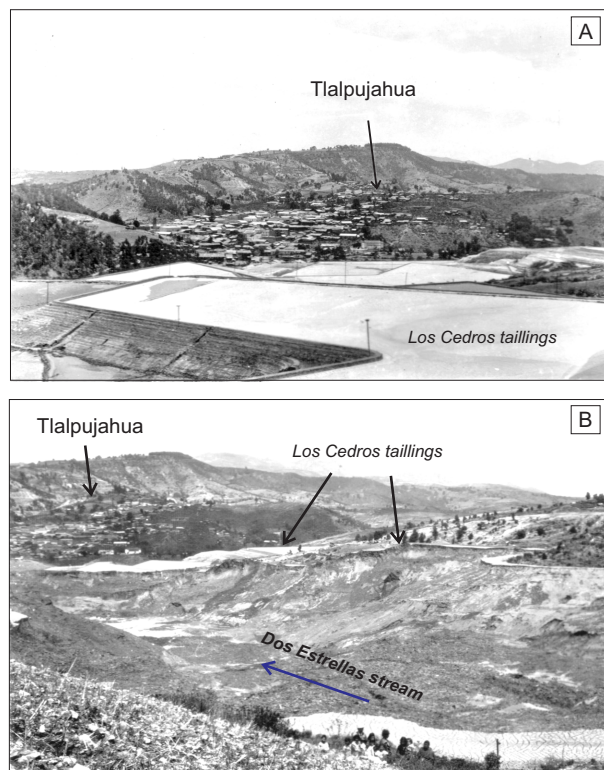
performed. The thickness of the tailings increased rapidly (ca. 35 m thick) to an approximated elevation up to 2875 m and acquired a platform-like form (Fig. 4). From 1908 to 1936, the dam had an approximated volume of 14.7 million t of mine waste (Uribe Salas, 2009; Corona Chávez et al., 2010; Table 1). In 1934, the mine had its largest production (820 603 t, ~ 2 thousand t day⁻¹). By 1935, the mining company was projecting the construction of a new dam, suggesting that Los Cedros dam was already at or near its capacity. However, this new project of the company never materialized.

Figure 4. Panoramic views in 1937 from the southeast that show **(A)** Los Cedros tailings dam with a platform-like form prior to the collapse; and **(B)** the tailings and the Dos Estrellas Stream scoured by the flood after the collapse. See people standing on the hill in the foreground.

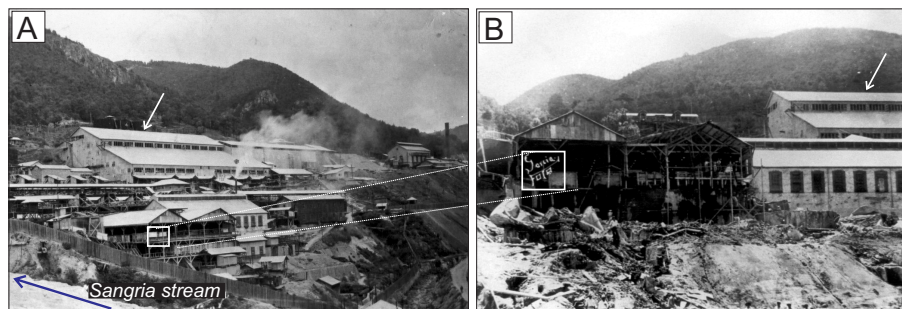
Los Cedros metallurgical plant (Fig. 5a and b) and then the Trigueros hill. Inhabitants felt the ground shaking caused by the flood impact.

Figure 5. Panoramic view of Los Cedros metallurgical plant of “Las Dos Estrellas” mining company at the Sangria stream, **(A)** before and **(B)** after the collapse. The white squares show the same location in both images, and an undisturbed roof of the Metallurgical plant (white arrows).

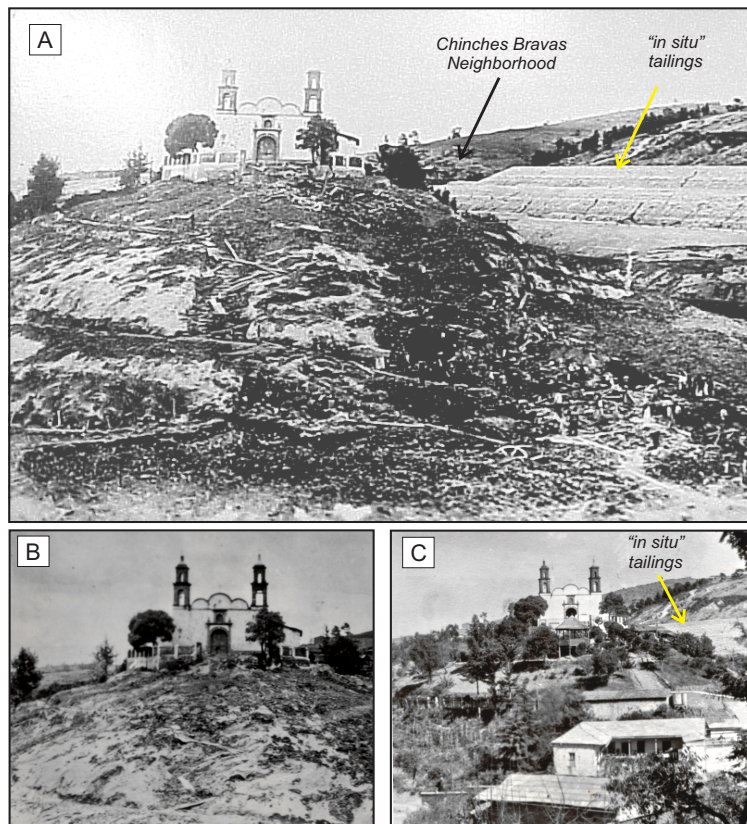
Proximal exposures of the TFD (or Las Lamas) deposit occur around the San Jesus del Monte hill. At the top of this hill stands the San Jesus del Monte church (Fig. 6), which withstood the worst part of the 1937 flood. Today, this hill and church lie within the Tlalpujahua village limits. Proximal outcrops of Las Lamas flood are found on the San Jesus del Monte hill at minimum and maximum elevations of 2500 m and 2540 m, respectively. From this site on, the deposit can be traced downstream along the Tlalpujahua River (Fig. 7a). The deposit appears either as flat terraces (1–2 m thick) or as an overbank layer (20–40 cm thick) resting on top of older alluvial deposits and local basement rocks (andesites, schists, and paleosols). On the other hand, distal deposits occur as far as 9 km from San Jesus del Monte hill, at site 23 and at an elevation of 2350 m (Fig. 8), where it is 45 cm thick. Here, an eyewitness described that the flood travelled more than 1 km from this location where it was still able to carry meter-size boulders. The most distal locations are further north at elevations of 2270 m along the Venta de Bravo Valley and close to the Federal Highway 15 where it connects to the cities of Maravatio and Atlacomulco. By considering a minimum extent of 11 km for the deposit and the present exposures, we estimate the deposit to cover a minimum area of about 982 000 m². If we assume an average thickness of 1 m for the deposit, we would obtain a minimum volume of 982 000 m³ of material (0.00098 km³). By using the contour lines and thicknesses and the Spatial Analyst software of ArcGIS we obtained a volume of 1 492 000 m³ (0.00149 km³). As described below, the flood moved with sediment-water concentrations of ~ 50 %, therefore, if we assume such concentrations

Figure 6. (A) Panoramic and (B) close-up view from the southwest of San Jesus del Monte hill and Church after the 27 May 1937 flood with rubble, and wood planks dispersed on the surface and the striped slopes of the hill. (C) View of the same hill prior to the flood that shows houses on its southern slope.

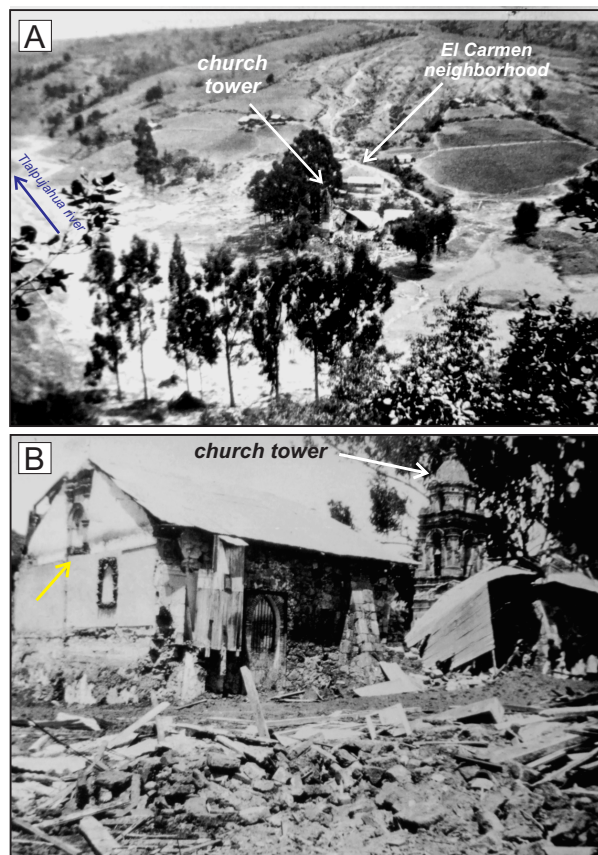
Figure 7. Different views of El Carmen Church after the 1937 flood and extent of the deposit along the Tlalpujahua river (a), and rubble and high-mud marks (yellow arrow) (b).

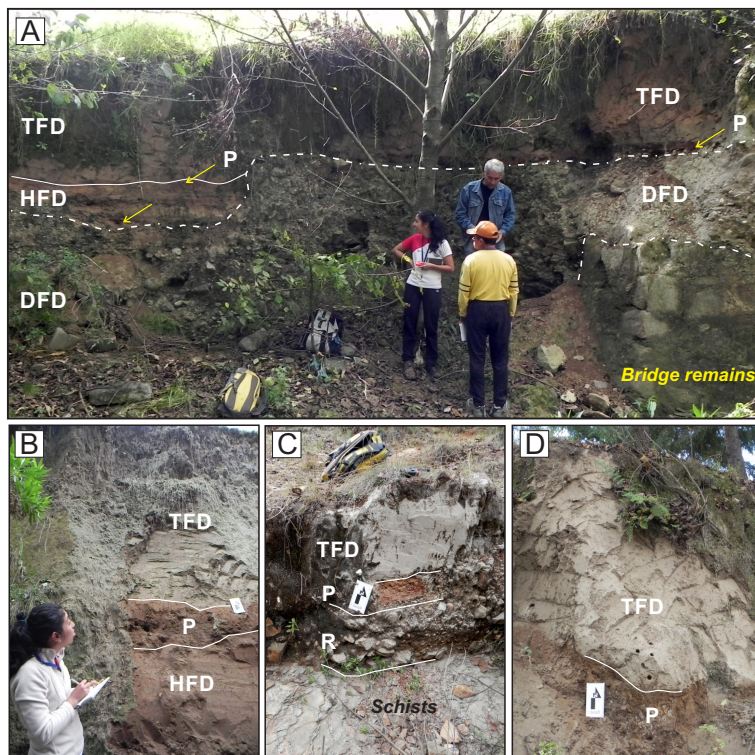
Figure 10. Aspects of the Tailings Flood Deposit (TFD) at three different sections. **(A)** At section TL-14, the TDF rests over a paleosol, a thin hyperconcentrated flood deposit (HFD), another paleosol, and a basal debris flood deposit (DFD) that contains pieces of bottle glass. The DFD forms a paleo-channel that stands against the remains of an old stone bridge. **(B)** View of the TFD at Sect. 17 overlying a paleosol and the lower brown hyperconcentrated flood deposit (HFD) rich in sand-size particles. **(C)** At section TL-18 the TFD overlies a poorly developed paleosol, a reworked bed with gravel-sized fragments and schists from the local basement. **(D)** At section TL-19 the deposits rests directly on top of a thicker paleosol.

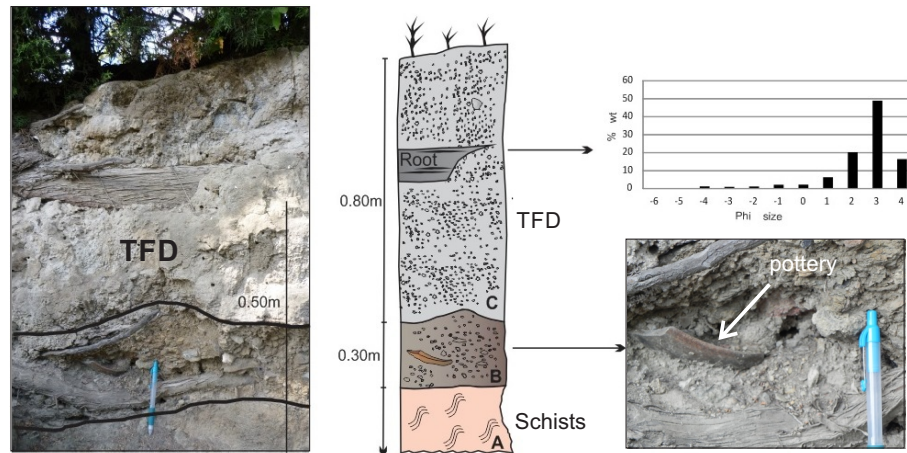
At site TL13, along the steps of the San Jesus del Monte church, the TFD varies in thickness from 80 cm to 40 cm. It overlies an anthropogenic layer rich in pottery shards, charcoal and other remains, and older debris flow and the basement green schists (Fig. 11).

Figure 11. View of section TL13 looking to the west at the steps of San Jesus del Monte Hill. The section shows from the base schists, a debris flow deposit that turns into a pottery rich soil, and the whitish TFD atop grading into the modern soil cover with trees.

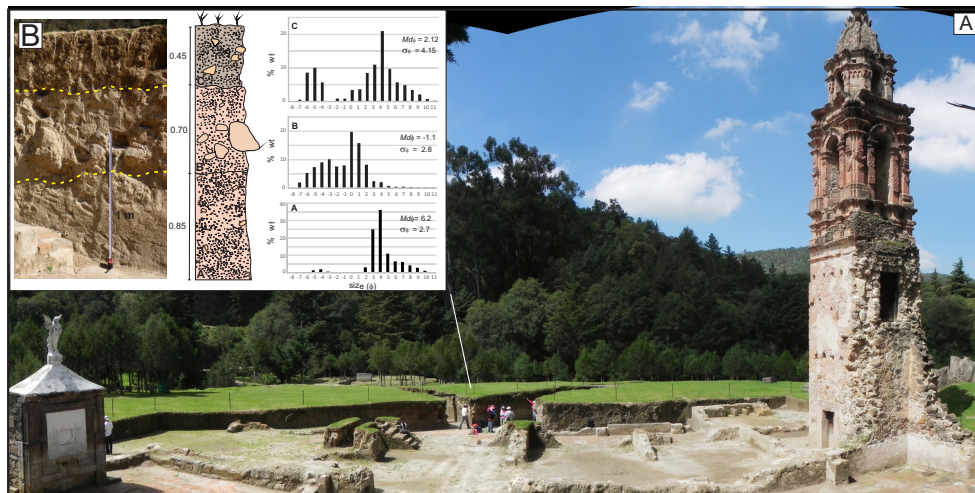
Figure 12. (A) Panoramic view from the east of the remains of El Carmen church buried by the Tailings Flood Deposit (section TL-01). The excavation of the church remains exposed the ancient floor of the sanctuary also observed in insets. (B) Stratigraphic column showing three beds separated by dashed yellow lines and their granulometric bimodal distributions.

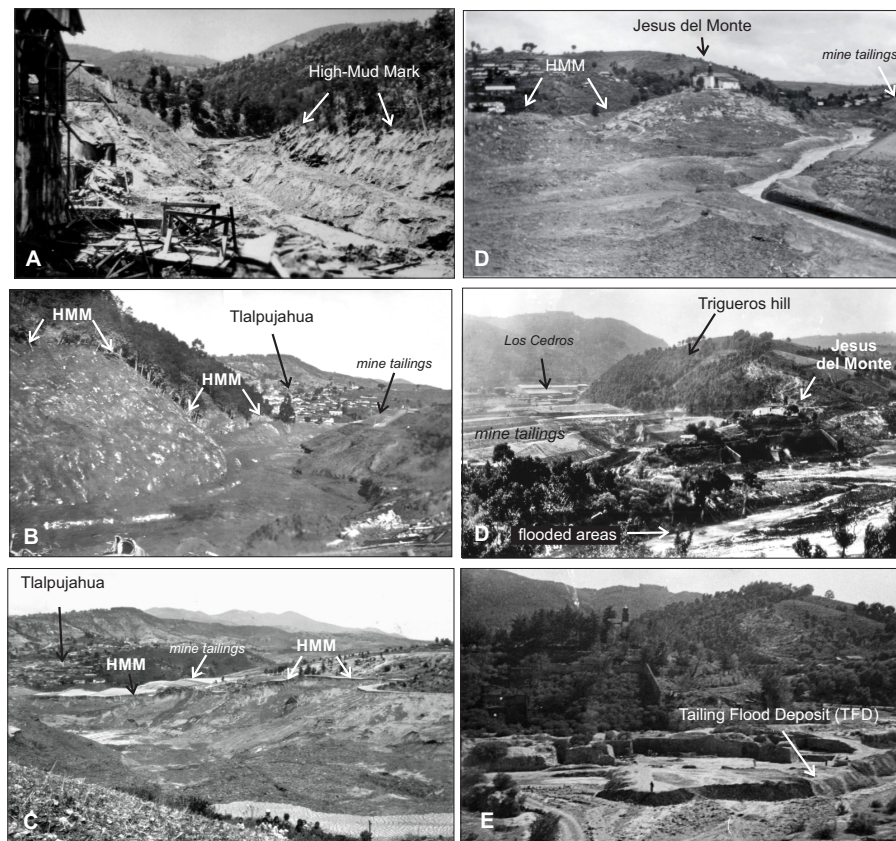
Velocities of the flow were estimated from runup obstacles aligned perpendicular to the flow by using the simple relationship $v = \sqrt{2gh}$ in which h is the runup height and g is the acceleration due to gravity (Sheridan et al., 2005). High mud marks observed in photographs were about 30 m high, suggesting flow speeds of 25 m s^{-1} . As emphasized by Sheridan et al. (2005) these estimates are considered minimum velocities because this equation does not account for friction. The impact of the flood against Trigueros hill caused its split into a short-lived, less powerful upstream surge that only advanced a few hundred meters and the huge sustained flow wave that rushed downstream towards the village of Talpujahua, scouring the old road, trees and tailings from the retaining wall of the dam (Fig. 14b). Unfortunately, several neighborhoods stood downstream and were completely devastated by the flood (Fig. 14c). Pictures of the places and remains of these neighborhoods show the maximum thickness of deposits and the high-water marks suggesting that the wave was moving as an hyperconcentrated flow (ca. 50 % sediment concentration). Downstream, the Talpujahua river carved a gully between the outskirts of the Talpujahua village and the Jesus del Monte hill that was surrounded by several neighborhoods, including La Cuadrilla, at its base.

Figure 14. Views of damage caused by the Tailings flood in 1937 at different locations of this study: los Cedros metallurgical plant (A), Trigueros Hill (B), the Dos Estrellas stream between Trigueros and Jesus del Monte (C), and Jesus del Monte (D–F). HMM = High Mud Marks.
