1 **Rockslides on limestone cliffs with sub-horizontal bedding in the southwestern calcareous**
2 **area, China**

11 **Abstract:** Calcareous mountainous areas are highly prone to geohazards, and rockslides play an
12 important role in cliff retreat. This study presents three examples of failures of limestone cliffs
13 with sub-horizontal bedding in the southwestern calcareous area of China. Field observations and
14 numerical modeling of Yudong Escarpment, Zengzi Cliff, and Wangxia Cliff showed that
15 pre-existing vertical joints passing through thick limestone and the alternation of competent and
16 incompetent layers are the most significant features for rockslides. A “hard on soft” cliff made of
17 hard rocks superimposed of soft rocks is prone to rock slump, characterized by shearing through
18 the underlying weak strata along a curved surface and backward tilting. When a slope contains
19 weak interlayers rather than a soft basal layers, a rock collapse could occur from the compression
20 fracture and tensile split of the rock mass near the interfaces. A rock slide might shear through a

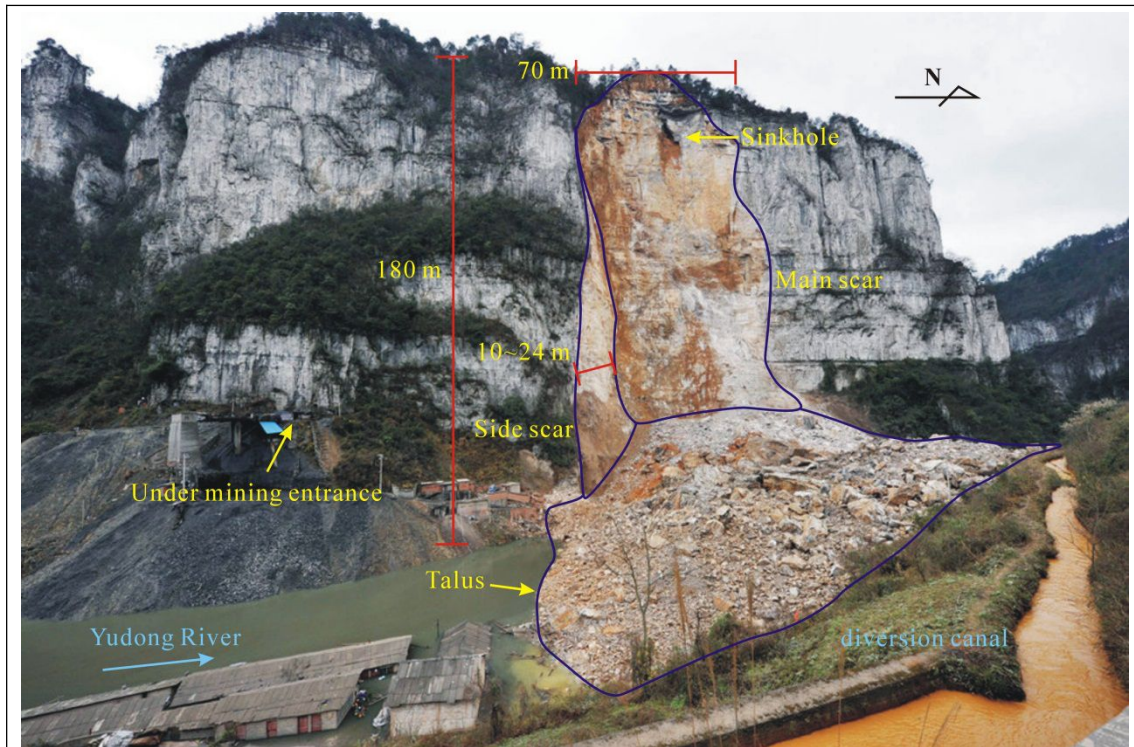
115 On February 18, 2013, a rock slide occurred in Longchang County, Guizhou Province. The

Fig. 2 Photograph showing an overview of Yudong rock slide I.

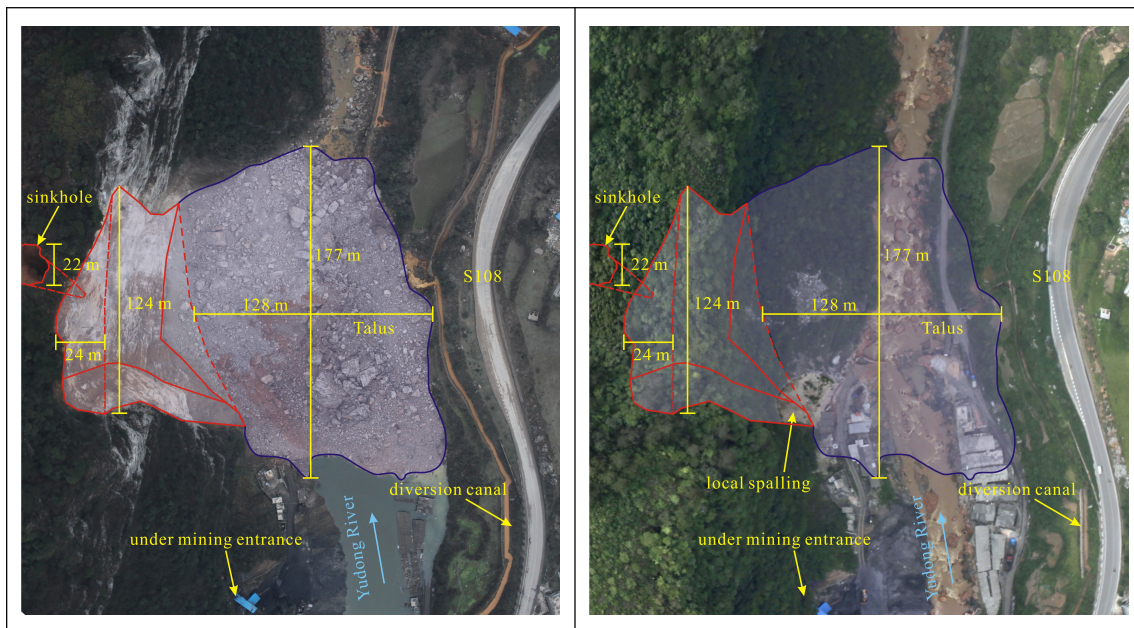
137 been observed on the vertical scar. The selective karst widens and connects the pre-existing steep
138 joints so that the area of the rock bridge covers less than 30% of the main scar (Huang, 2013). The
139 directed scratches indicate the brittle failure of the rock bridges and consequent fall of the rock
140 mass. The rock slide left two scars originate from joints. The main scar is nearly parallel to the
141 cliff face and about 80 m wide. The upper part of the main scar is a sub-vertical plane, and the
142 lower parts are planar and dip out of the cliff. The conjugate side scar is about 24 m wide and
143 perpendicular to the cliff face (Fig.2).

Fig. 3 Aerial photos of Rock Slide Itaken in summer 2012 (a) and on February 19 2013 (b). The zoning of the depleted mass and talus is projected in picture (a) prior to the catastrophe. The abundant vegetation and steep terrain make it difficult to distinguish the potential failure. However, there were signs of local spalling at the toe of the cliff face (a). A 22-m-diameter sinkhole was exposed in winter, which connected with the main back scar of the rock slide (b).

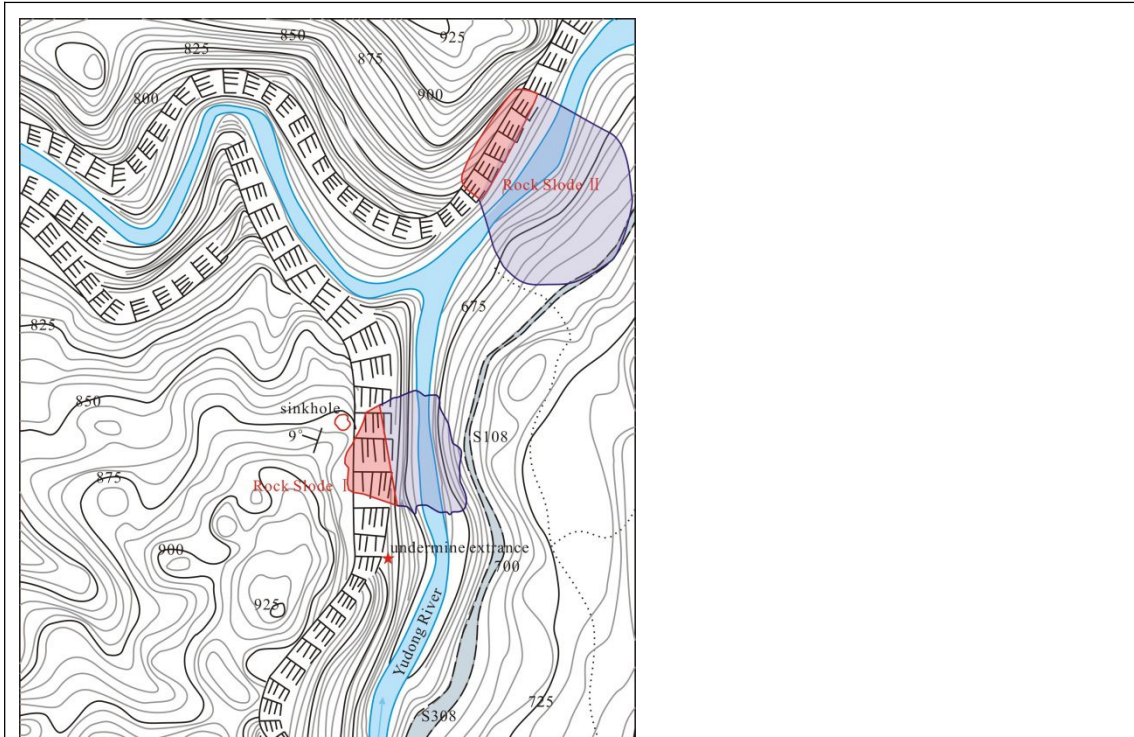
145 Another massive rock slide (II) (Fig. 4) occurred on April 16, 2013, about 100 m away from the
 146 February 18 rock slide (I). The morphology of the vertical scar of rock slide II is similar to that of
 147 rock slide I. The lower rupture surface forms a steep and irregular scar (Fig. 5). These two rock
 148 slides have the same failure mechanism of a steep back scar separating the unstable block from the
 149 escarpment and the block breaking through the toe leading to free fall of the rock mass. The
 150 rupture surface implies a plane slide involving shear failure through the rock mass. There is little
 151 or no shear displacement along the rupture surface, and the velocity is very high. The brittle
 152 failure of the rock mass in the toe area can be explained by the brittle failure of the rock mass

Fig. 4 Rock slide II is located north of rock slide I and has the same geological conditions, except for undermining. The volume of the talus of rock slide II is $30 \times 10^4 \text{ m}^3$. It blocked the Yudong River and covered 80 m of the S308 road.

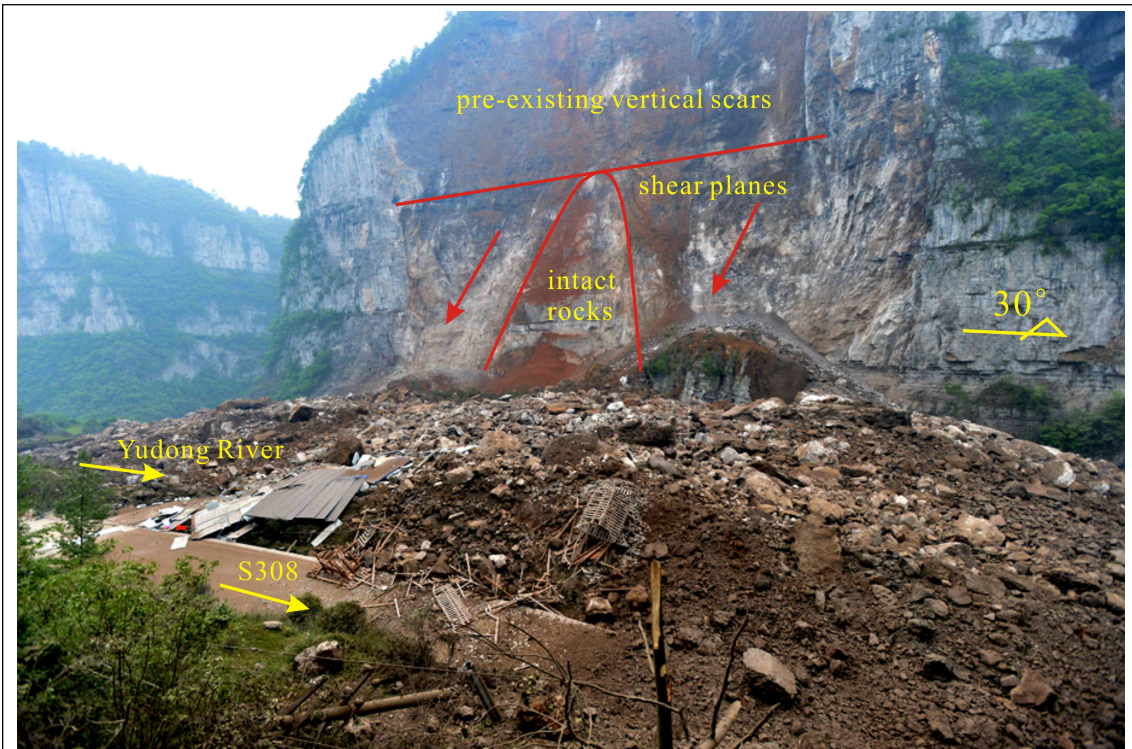
Fig. 5 Photograph showing rock slide II at Yudong. The pre-existing vertical scars are coated with karst of a yellowish-brown color, while the rupture surfaces are white and gray, indicating brittle failure and planar sliding through the limestone.

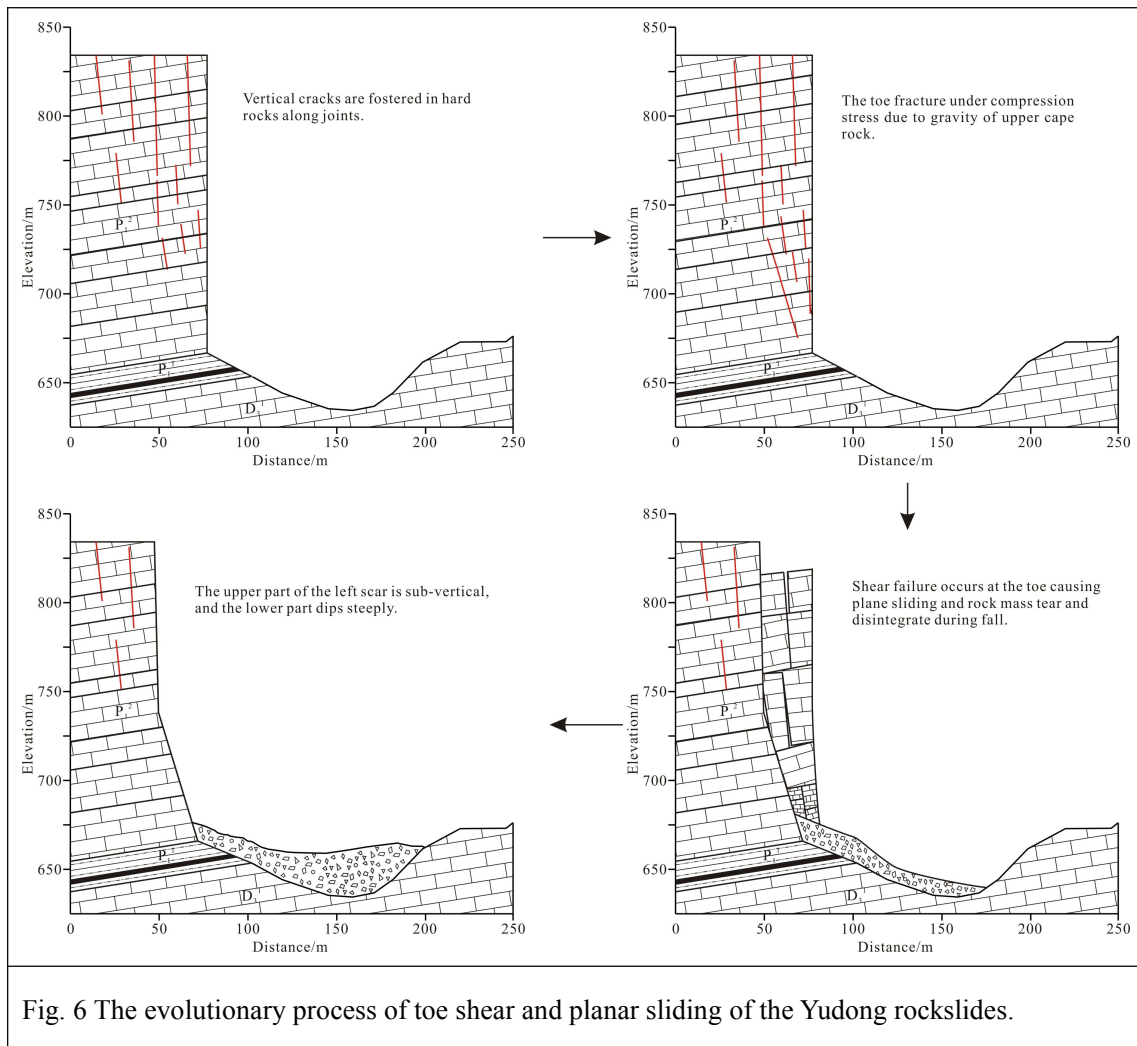
153 under uniaxial compression tests. In other words, it is largely dependent on the mechanical
154 properties of the rock mass at the toe. The toe is sheared along random discontinuities of limited
155 persistence traced by the rupture surface (Fig. 6).

Fig. 6 The evolutionary process of toe shear and planar sliding of the Yudong rockslides.

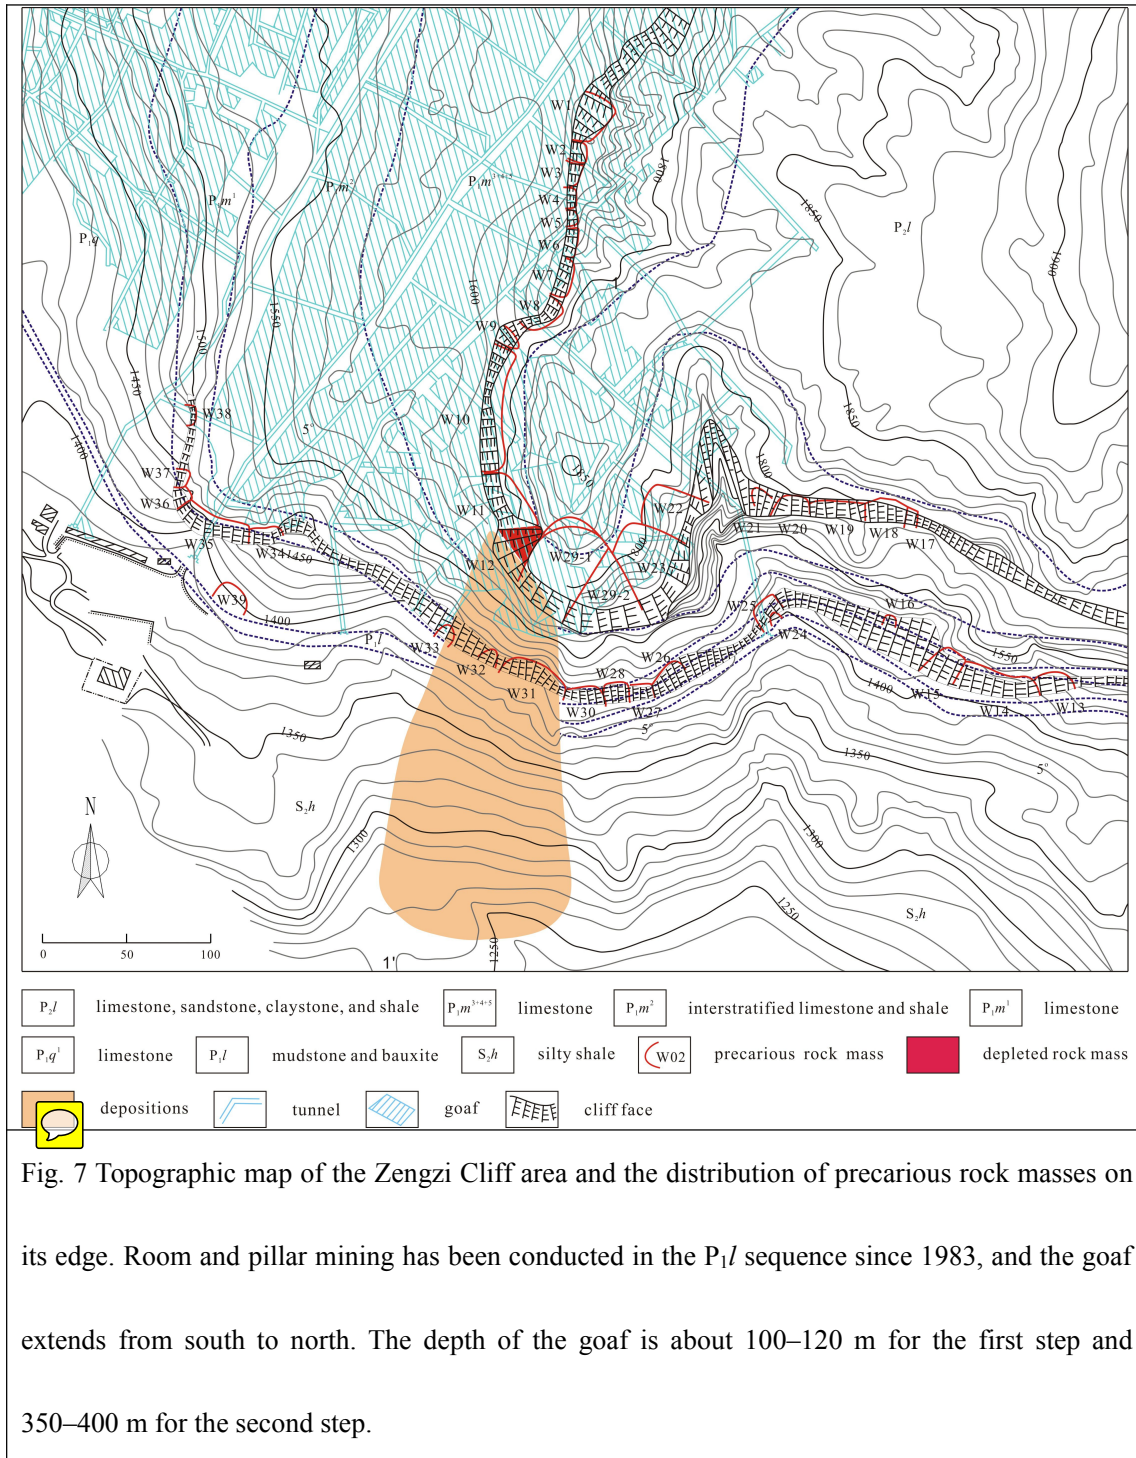
Fig. 7 Topographic map of the Zengzi Cliff area and the distribution of precarious rock masses on its edge. Room and pillar mining has been conducted in the P_1l sequence since 1983, and the goaf extends from south to north. The depth of the goaf is about 100–120 m for the first step and 350–400 m for the second step.

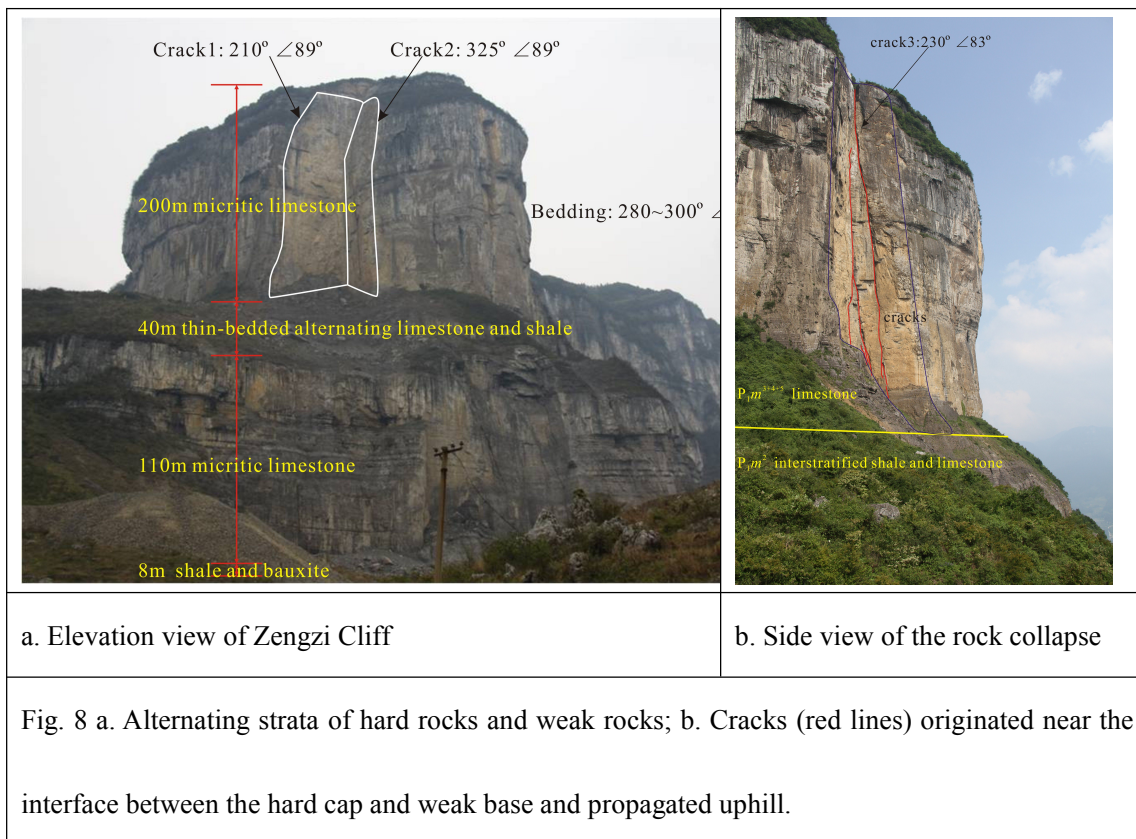
168 Rocks frequently fall in the Zengzi Cliff area. On August 12, 2004, a massive rock collapse
 169 occurred in the upper platform, which is about 200 m high (Fig. 8). The depleted mass is a prism
 170 block shaped by sub-vertical joints and bedding. Two vertical back scars and a groove surface in

171 the underlain soft strata are exposed after the collapse. Large areas of the scars are coated with
 172 karst argillaceous fillings and yellowish-orange calcite, while the rock bridge failure scars are
 173 fresh. Field investigations showed that the head scars are wide open prior to the massive collapse.
 174 Seepage forces and frost from percolating water acted on the prism block over a long time and
 175 influenced the stability; however, only karst could alter the conditions in the rock adjoining the
 176 slope by increasing the connectivity of back scars. The underlying soft strata consist of alternating
 177 beds of thin-bedded shale and medium-bedded limestone, and as a result of weathering, form a
 178 40-m-high slope.

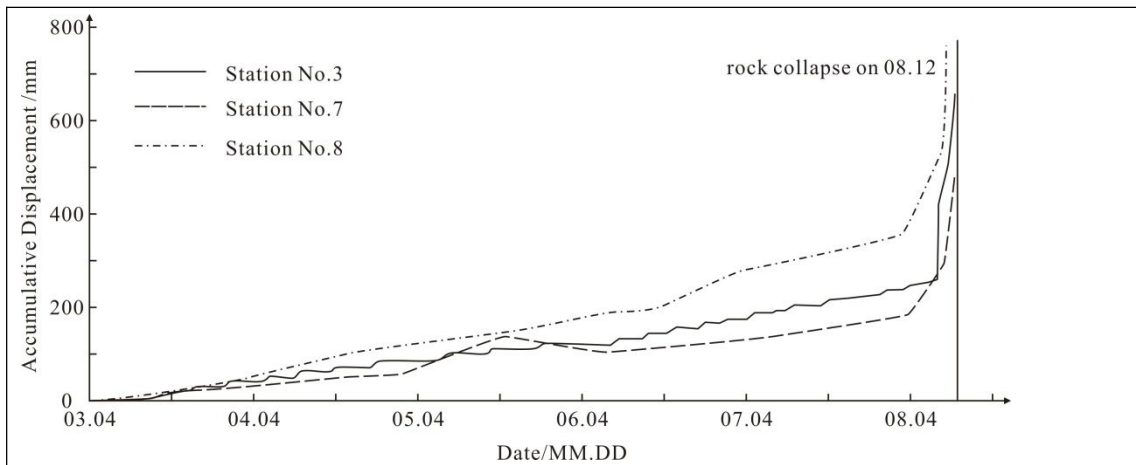
182 to 4–15 mm/10 d in the period between April and July 2004 (Fig. 9), and signs of pre-collapse,

Fig. 9 Cumulative displacement of monitoring stations at the crest of Zengzi Cliff in 2004 (Ren, 2005).

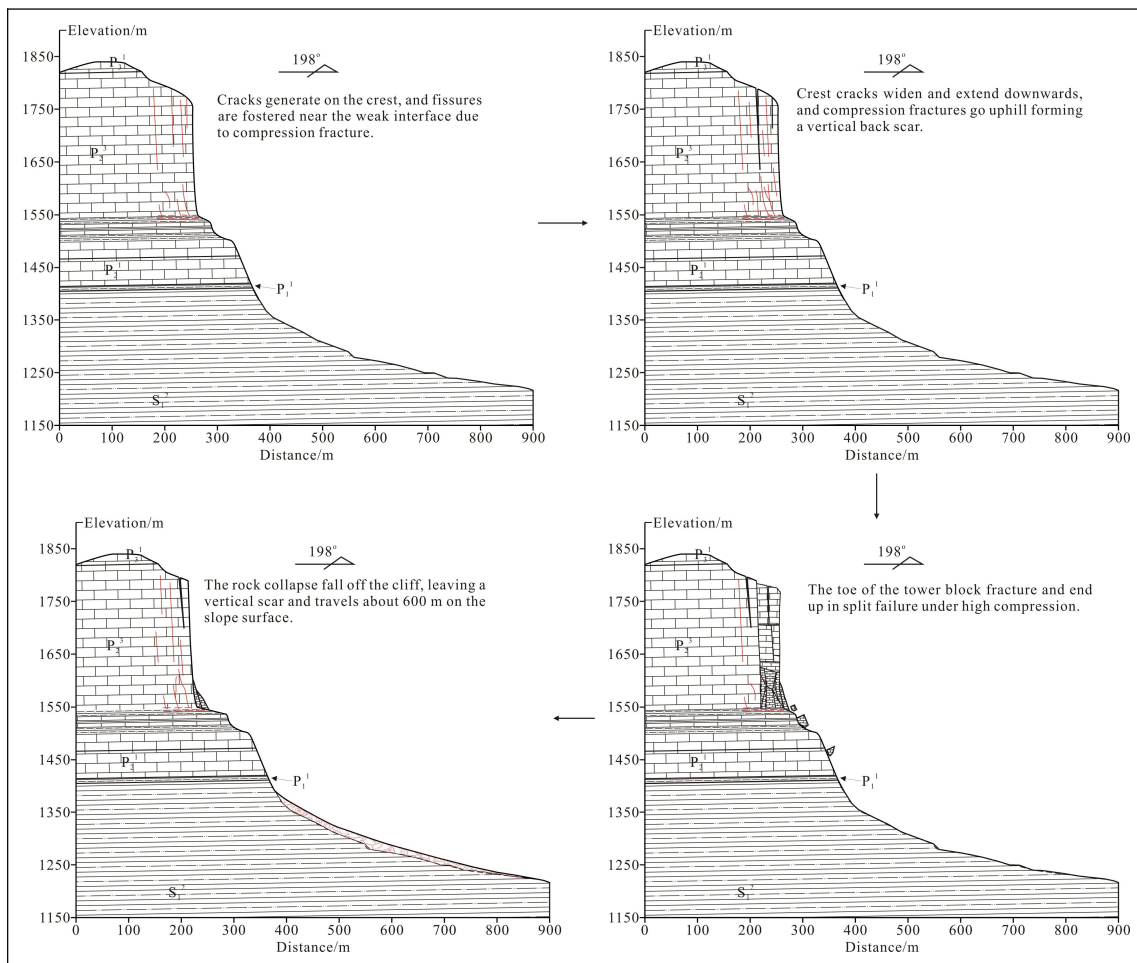
198 Furthermore, the soft strata are not sufficiently weak. These strata consist of interbedded thin
 199 layers of shale (0.1–0.2 m) and medium-thick limestone. The tower block could easily shear
 200 through the shale but not the intercalated limestone. Under these circumstances, tensile split
 201 failure of the tower bottom is a reasonable failure mechanism, involving compression fracturing
 202 and horizontal shearing in the shale beds (Fig. 10). Field studies and deformability tests on rock
 203 masses all around the world have demonstrated that folded and flat-lying rock masses are prone to
 204 tensile splitting near thin weak planes. Compression fracturing and tensile splitting are important
 205 failure mechanisms for sub-horizontally bedded slopes. The Zengzi cliff collapse exposed back
 206 scars in the nearby deformable rock mass, which propagated uphill (Fig. 8b), and a fractured rock

Fig. 10 Failure process of the Zengzi rock collapse, involving toe splitting and tensile failure.

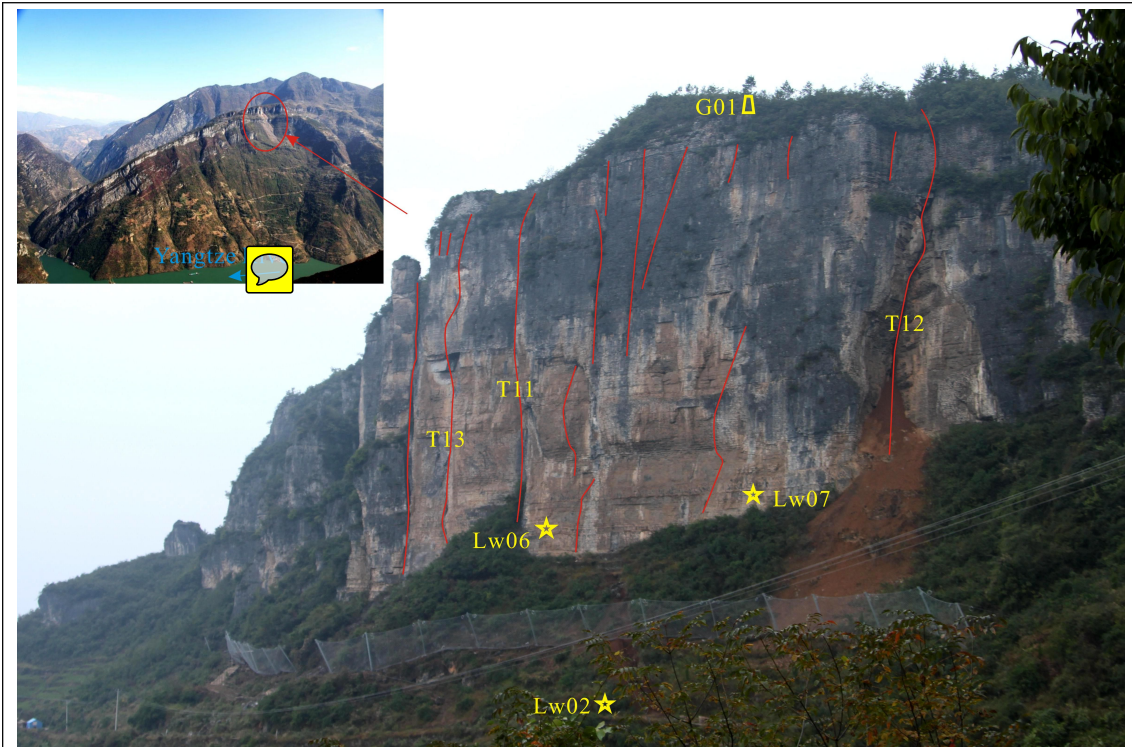
Fig. 11 Overview of Wangxia Cliff prior to the catastrophic rock slump. G01 represents a GPS station, and Lw02–Lw07 indicate the displacement monitoring stations. The rock slump of October 21, 2010 was controlled by vertical scars T11 and T12. The red lines represent fissures in the rock mass.

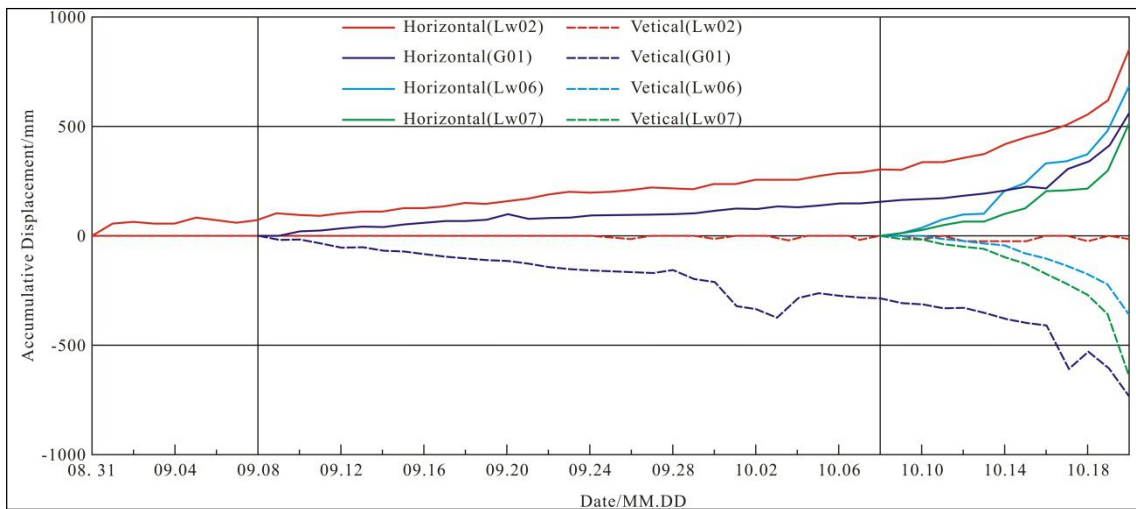
Fig. 12 Cumulative displacement at monitoring stations at the Wangxia rock slump (Le, et al., 2011).

239 It is worth mentioning that there is a good correlation between the acceleration of displacement
 240 and concentrated rainfall. Because of cracks and fissures in the limestone, water could easily and
 241 rapidly percolate into the weak strata. The unconfined compressive strength (UCS) of the shale
 242 shows a substantial decrease when saturated, and the softening factor is about 0.62. However,
 243 there is a 2–4 day time lag between concentrated rainfall and acceleration of displacement,

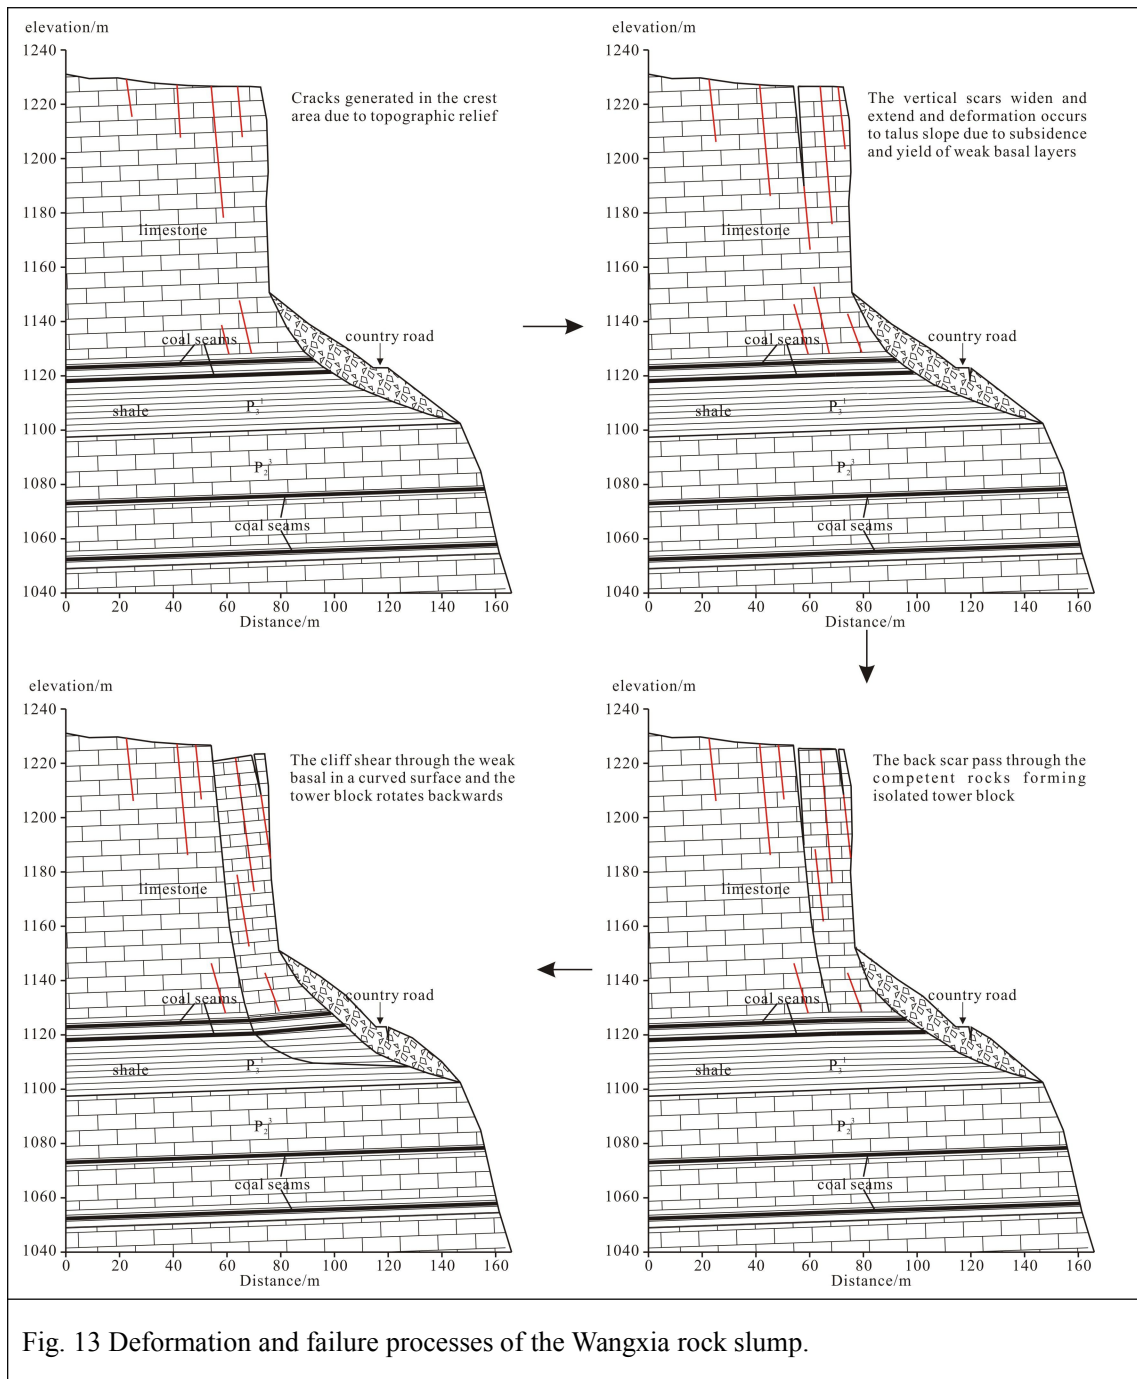
230 more obvious both in volume and frequency. Finally, a massive rock slump occurred on October
231 21, in which the isolated prism slid downhill, breaking through the toe and leaning against the
232 back scars. The underlying weak rocks were squeezed out and scattered over the slope surface.
233 Displacement monitoring showed that the crest was dominated by subsidence, while the horizontal
234 and vertical displacements were about the same at the base. The incompetent base showed
235 horizontal movement and little subsidence. These phenomena were caused by ductile yielding and
236 rotational shearing in the incompetent base (Fig. 13). The squeezing out contributed to the uphill
237 propagation of cracks and disintegration of the mountain into slab- and prism-like blocks.

Fig. 13 Deformation and failure processes of the Wangxia rock slump.

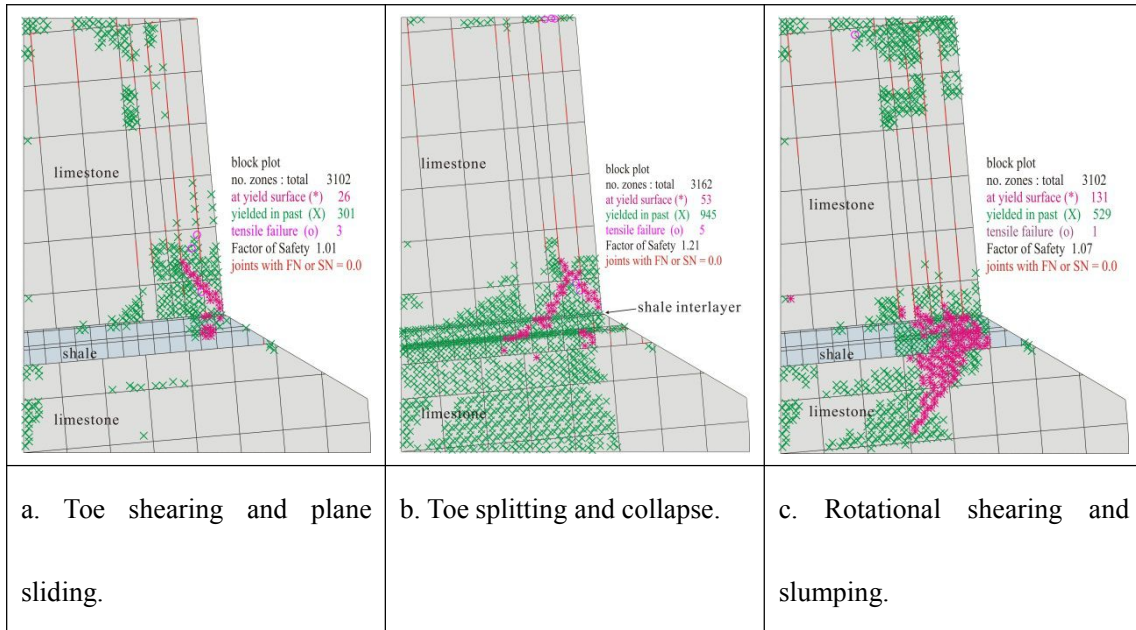
Fig. 14 Plastic state and joint opening for rockslide initiation in cliff slopes.

257 A yielding curved surface gradually emerges in the basal layers under long-term gravitational
258 compression of the upper cap rock. A large plastic zone is present in the weak basal layers and
259 nearby hard rock mass (Fig. 14c). The horizontal movement of the weak stratum is prominent.

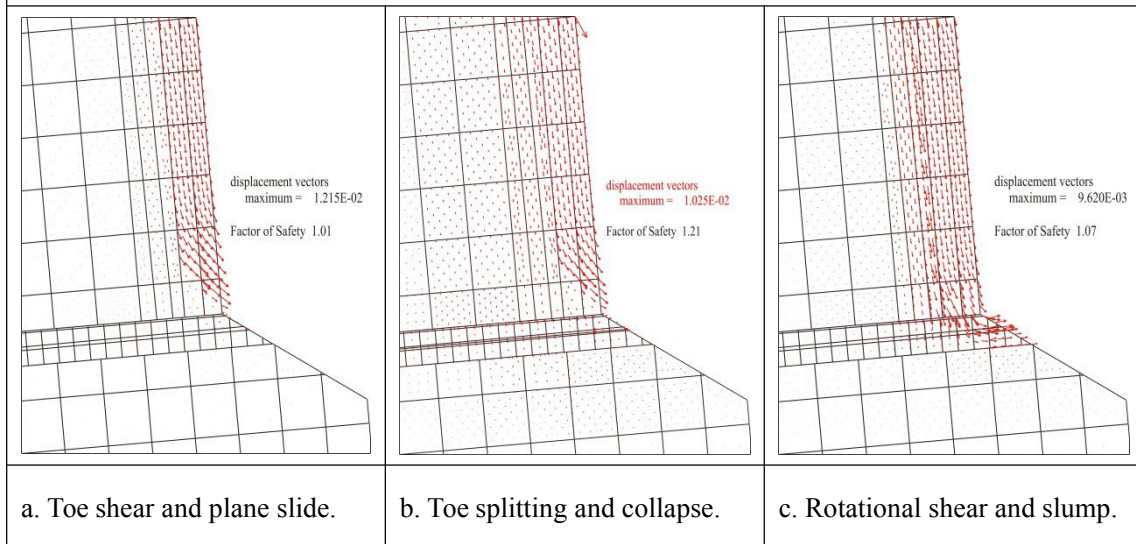
Fig. 15 Displacement vectors of the initial failures of cliff slopes.

260 Pre-existing joints in the hard rock mass widen upward and slip with the ductile flow of the basal
261 layers. The movement of the massive unstable rock mass is dominated by subsidence in the crest
262 area and back tilting at the toe (Fig. 15c).

263 When the weak basal is a thin interlayer, rotational slide through the toe is unlikely to occur. The
264 horizontal shear stress determines the possibility of shear failure in the beds. For a sub-horizontal
265 bedded slope with gentle tectonic disturbance during geologic evolution, the horizontal to vertical
266 stress ratio is generally less than 1 (Zhang, et al., 1994). This indicates that it is possible for a
267 weak interlayer with a frictional angle less than 45° to shear horizontally. Under these
268 circumstances, the plastic zone ranges over the interlayer as well as the overlying competent rocks.
269 The rock mass at the toe is in a plastic state as a result of compression fractures. Two yield
270 surfaces dipping in opposite directions are formed (Fig. 14b), similar to tensile failure behavior for
271 some brittle rock samples. The displacement prior to collapse is limited, and remarkable squeezing

272 out is unlikely to be observed in the toe area (Fig. 15b).

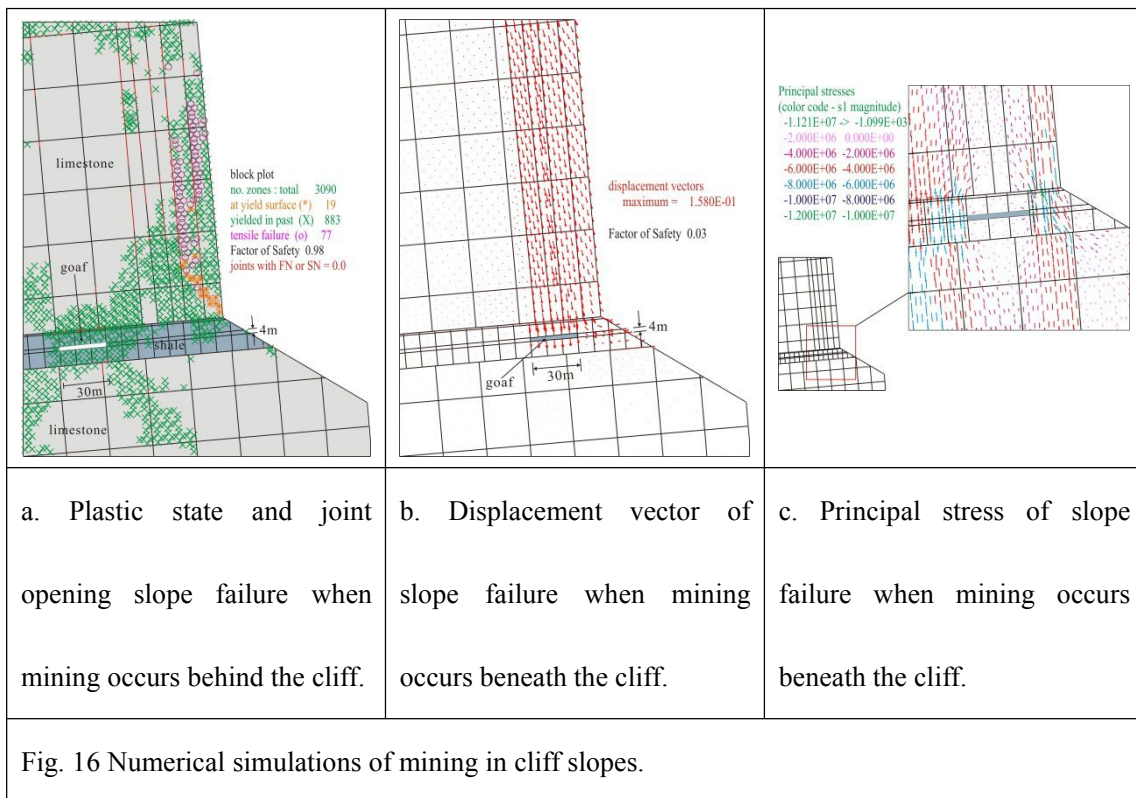
283 The failures at the three locations described above are related to large areas of mining out. Pells
 284 (2008) used a continuum 2D model to assess macro-scale movements of cliff faces caused by total
 285 extraction and proved that the steep slope tends to tilt outwards when mining occurs beneath the
 286 cliff, and extraction well behind the cliff face causes back tilt. Our similar simulations are shown
 287 in Fig. 16. The rock slide model in Fig. 14a was adopted. The roof tends to collapse, and the
 288 surrounding rocks gradually fracture. The undermining-induced subsidence of the crest causes the
 289 dilation and tensile failure of the rock mass (Fig. 16a). The FOS decreases from 1.01 to 0.98 when
 290 the underground mining is located behind the cliff face. When the extraction is directly beneath
 291 the cliff, the rock mass is subjected to a small constraint; hence, cliff failure break-out through the

292 fractured rock mass between the goaf and open face is feasible (Fig. 16b). The maximum principal
 293 stress on both sides of the goaf increases while that of the overlying rocks decreases (Fig. 16c).
