Nat. Hazards Earth Syst. Sci. Discuss., 2, 4299–4330, 2014 www.nat-hazards-earth-syst-sci-discuss.net/2/4299/2014/ doi:10.5194/nhessd-2-4299-2014 © Author(s) 2014. CC Attribution 3.0 License.

Rockslides on limestone cliffs with sub-horizontal bedding in the southwestern calcareous area, China

Z. Feng¹, B. Li¹, Y. P. Yin², and K. He³

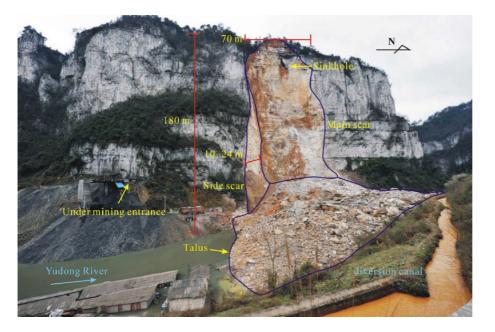
bridges and consequent fall of the rock mass. The rock slide left two scars originate from joints. The main scar is nearly parallel to the cliff face and about 80 m wide. The upper part of the main scar is a sub-vertical plane, and the lower parts are planar and dip out of the cliff. The conjugate side scar is about 24 m wide and perpendicular to the sciff face (Fig. 2).

Figure 2. Photograph showing an overview of Yudong rock slide I.

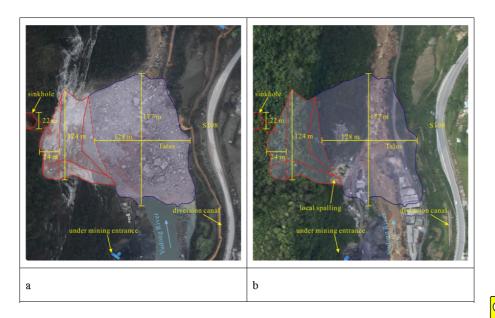
- area, including sinkholes, karst tunnels, and dissolution fissures. A remote sensing image taken the day after the rock collapse shows a sinkhole at the crest with a diameter of 2.2 m immediately behind the fall. The pipe flow and induced groundwater dynamics acted on the unstable rock block and changed the instability. However, because of abundant vegetation, the sinkhole is not visible in a previous image that was taken in

- the summer of 2012 (Fig. 3). The intense karstic erosion of a yellowish-orange color has been observed on the vertical scar. The selective karst widens and connects the pre-existing steep joints so that the area of the rock bridge covers less than 30 % of the main scar (Huang, 2013). The directed scratches indicate the brittle failure of the rock

Figure 3. Aerial photos of Rock Slide Itaken in summer 2012 (a) and on 19 February 2013 (b). The zoning of the depleted mass and talus is projected in picture (a) prior to the catastrophe. The abundant vegetation and steep terrain make it difficult to distinguish the potential failure. However, there were signs of local spalling at the toe of the cliff face (a). A 22 m-diameter sinkhole was exposed in winter, which connected with the main back scar of the rock slide (b).

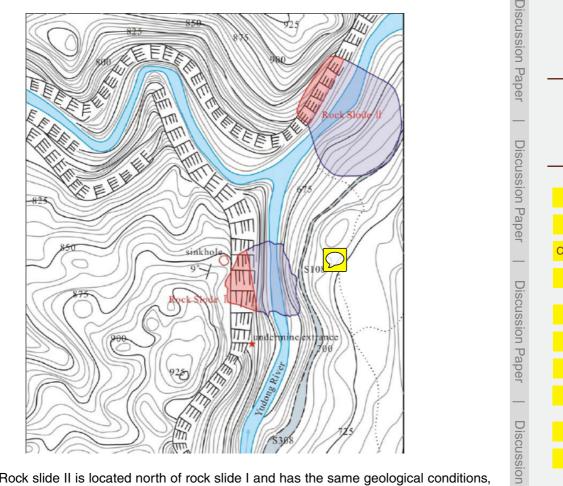
Another massive rock slide (II) (Fig. 4) occurred on 16 April 2013, about 100 m away from the 18 February rock slide (I). The morphology of the vertical scar of rock slide II is similar to that of rock slide I. The lower rupture surface forms a steep and irregular scar (Fig. 5). These two rock slides have the same failure mechanism of a steep back scar separating the unstable block from the escarpment and the block breaking through the toe leading to free fall of the rock mass. The rupture surface implies a plane slide involving shear failure through the rock mass. There is little or no shear displacement along the rupture surface, and the velocity is very high. The brittle failure of the rock mass in the toe area can be explained by the brittle failure of the rock mass under uniaxial compression tests. In other words, it is largely dependent on the mechanical properties of the rock mass at the toe. The toe is sheared along random discontinuities of limited persistence traced by the rupture surface (Fig. 6).

Figure 4. Rock slide II is located north of rock slide I and has the same geological conditions, except for undermining. The volume of the talus of rock slide II is 30×10^4 m³. It blocked the Yudong River and covered 80 m of the S308 road.

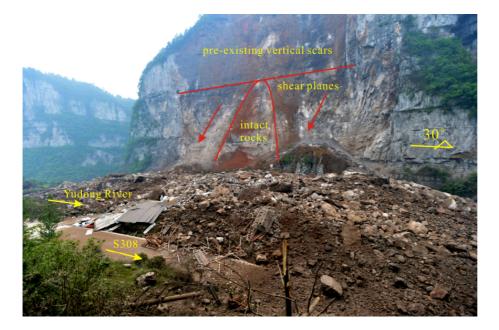
Figure 5. Photograph showing rock slide II at Yudong. The pre-existing vertical scars are coated with karst of a yellowish-brown color, while the rupture surfaces are white and gray, indicating brittle failure and planar sliding through the limestone.

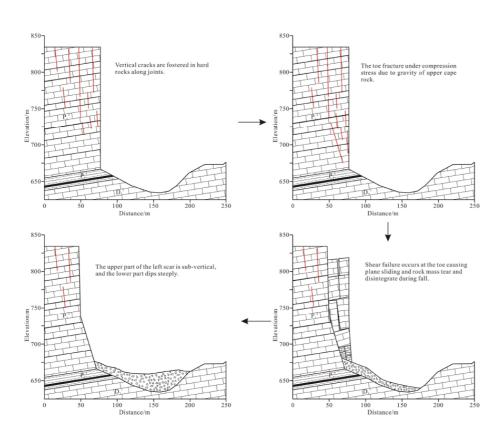
Figure 6. The evolutionary process of toe shear and planar sliding of the Yudong rockslides.

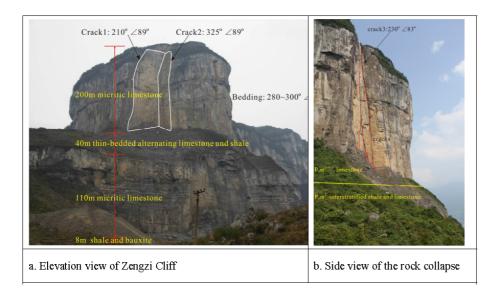
Rocks frequently fall in the Zengzi Cliff area. On 12 August 2004, a massive rock collapse occurred in the upper platform, which is about 200 m high (Fig. 8). The depleted mass is a prism block shaped by sub-vertical joints and bedding. Two vertical back scars and a groove surface in the underlain soft strata are exposed after the collapse.

Figure 8. (a) Alternating strata of hard rocks and weak rocks; (b) Cracks (red lines) originated near the interface between the hard cap and weak base and propagated uphill.

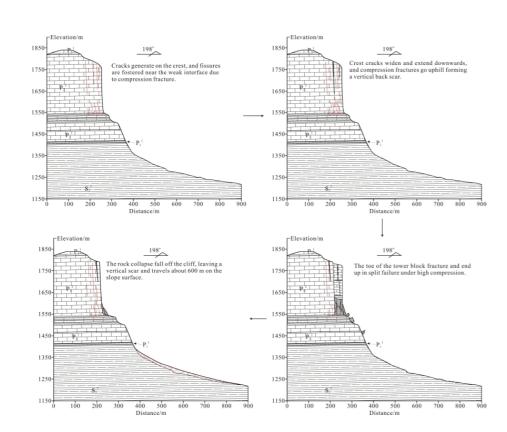
Figure 10. Failure process of the Zengzi rock collapse, involving toe splitting and tensile failure.

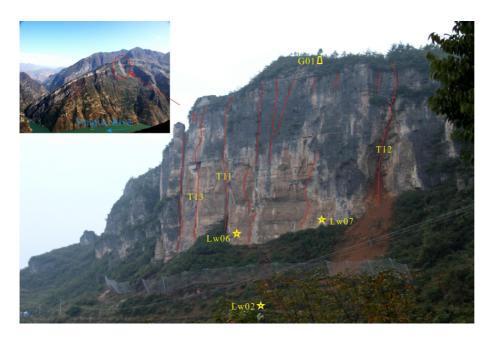
- ¹⁵ When the base is sufficiently weak, and there is a steep fracture separating the column from the slope in the cap area, a rock slump with back-tilting mechanism is likely to occur. The Wangxia Cliff failure slump mechanism involved isolated limestone block breaking through shale at the toe, with rotational movement. The Wangxia Cliff is situated at the top of the right bank of the Yangtze River in Wushan County of Chongqing, about 1000 m above the water level (Fig. 11). Located in the flat core of the Hengshixi

Figure 11. Overview of Wangxia Cliff prior to the catastrophic rock slump. G01 represents a GPS station, and Lw02–Lw07 indicate the displacement monitoring stations. The rock slump of 21 October 2010 was controlled by vertical scars T11 and T12. The red lines represent fissures in the rock mass.

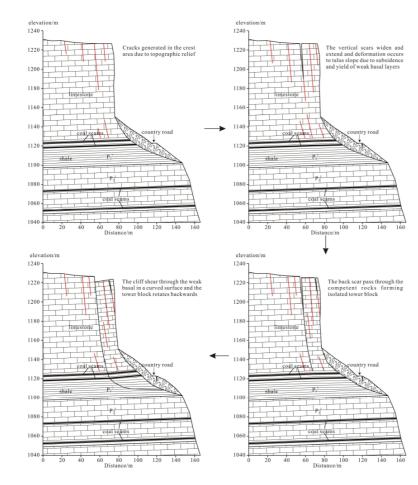
- toe and leaning against the back scars. The underlying weak rocks were squeezed out and scattered over the slope surface. Displacement monitoring showed that the crest was dominated by subsidence, while the horizontal and vertical displacements were about the same at the base. The incompetent base showed horizontal movement and little subsidence. These phenomena were caused by ductile yielding and rotational shearing in the incompetent base (Fig. 13). The squeezing out contributed to the up-

Figure 13. Deformation and failure processes of the Wangxia rock slump.
