J. L. Macías et al.

The 27 May 1937 catastrophic flow failure of gold tailings at Tlalpujahua, Michoacán, México

Received: 16 June 2014 – Accepted: 6 July 2014 – Published: 20 August 2014

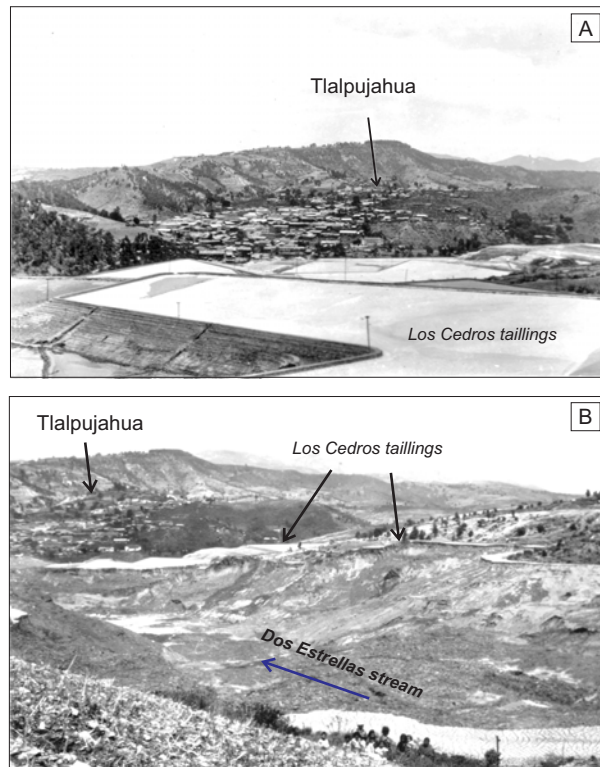
performed. The thickness of the tailings increased rapidly (ca. 35 m thick) to an approximated elevation up to 2875 m and acquired a platform-like form (Fig. 4). From 1908 to 1936, the dam had an approximated volume of 14.7 million t of mine waste (Uribe Salas, 2009; Corona Chávez et al., 2010; Table 1). In 1934, the mine had its largest production (820 603 t, ~ 2 thousand t day⁻¹). By 1935, the mining company was projecting the construction of a new dam, suggesting that Los Cedros dam was already at or near its capacity. However, this new project of the company never materialized.

Figure 4. Panoramic views in 1937 from the southeast that show **(A)** Los Cedros tailings dam with a platform-like form prior to the collapse; and **(B)** the tailings and the Dos Estrellas Stream scoured by the flood after the collapse. See people standing on the hill in the foreground.

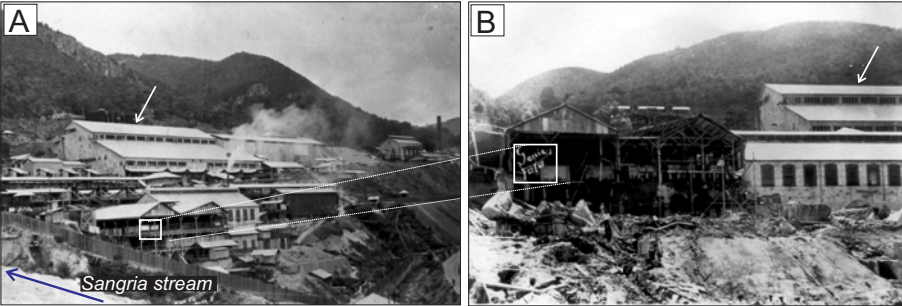
Los Cedros metallurgical plant (Fig. 5a and b) and then the Trigueros hill. Inhabitants felt the ground shaking caused by the flood impact.

Figure 5. Panoramic view of Los Cedros metallurgical plant of “Las Dos Estrellas” mining company at the Sangria stream, (A) before and (B) after the collapse. The white squares show the same location in both images, and an undisturbed roof of the Metallurgical plant (white arrows).

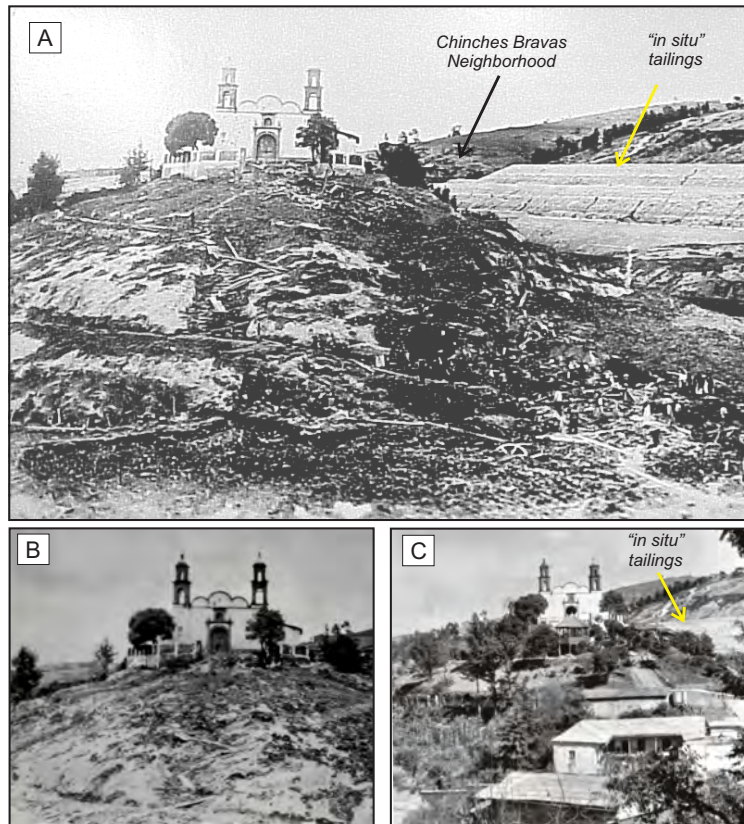
Figure 6. (A) Panoramic and (B) close-up view from the southwest of San Jesus del Monte hill and Church after the 27 May 1937 flood with rubble, and wood planks dispersed on the surface and the striped slopes of the hill. (C) View of the same hill prior to the flood that shows houses on its southern slope.

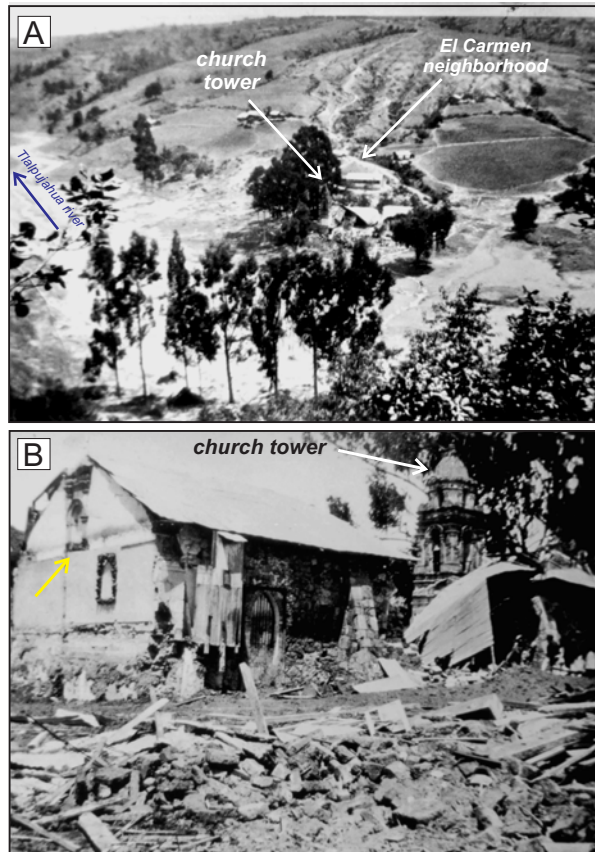
Figure 7. Different views of El Carmen Church after the 1937 flood and extent of the deposit along the Tlalpujahua river (a), and rubble and high-mud marks (yellow arrow) (b).

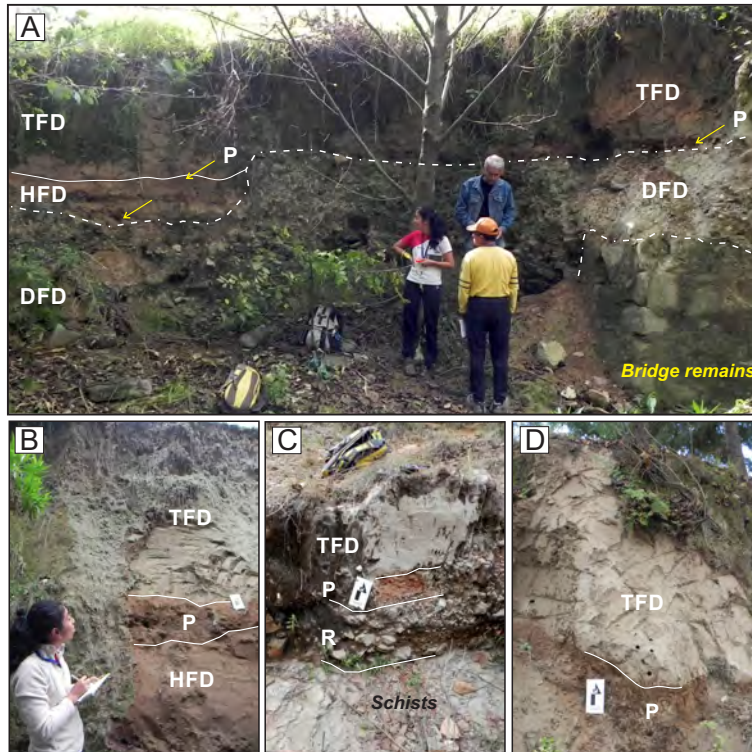
Figure 10. Aspects of the Tailings Flood Deposit (TFD) at three different sections. **(A)** At section TL-14, the TDF rests over a paleosol, a thin hyperconcentrated flood deposit (HFD), another paleosol, and a basal debris flood deposit (DFD) that contains pieces of bottle glass. The DFD forms a paleo-channel that stands against the remains of an old stone bridge. **(B)** View of the TFD at Sect. 17 overlying a paleosol and the lower brown hyperconcentrated flood deposit (HFD) rich in sand-size particles. **(C)** At section TL-18 the TFD overlies a poorly developed paleosol, a reworked bed with gravel-sized fragments and schists from the local basement. **(D)** At section TL-19 the deposits rests directly on top of a thicker paleosol.

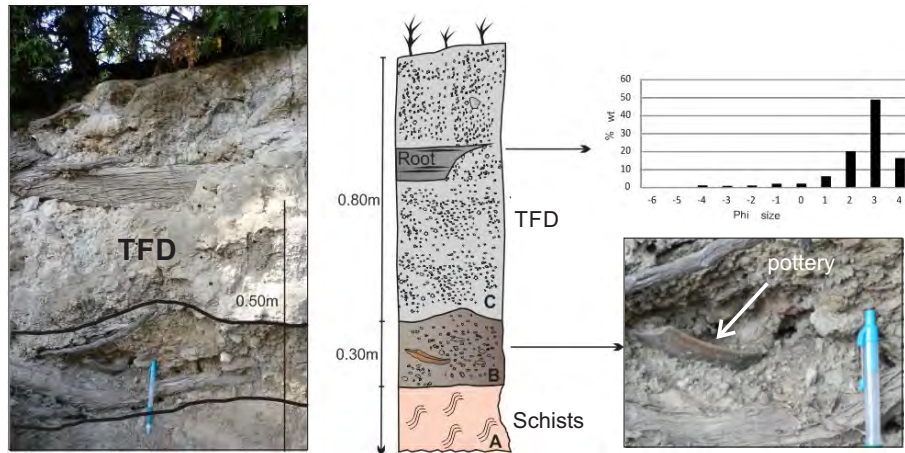
Figure 11. View of section TL13 looking to the west at the steps of San Jesus del Monte Hill. The section shows from the base schists, a debris flow deposit that turns into a pottery rich soil, and the whitish TFD atop grading into the modern soil cover with trees.

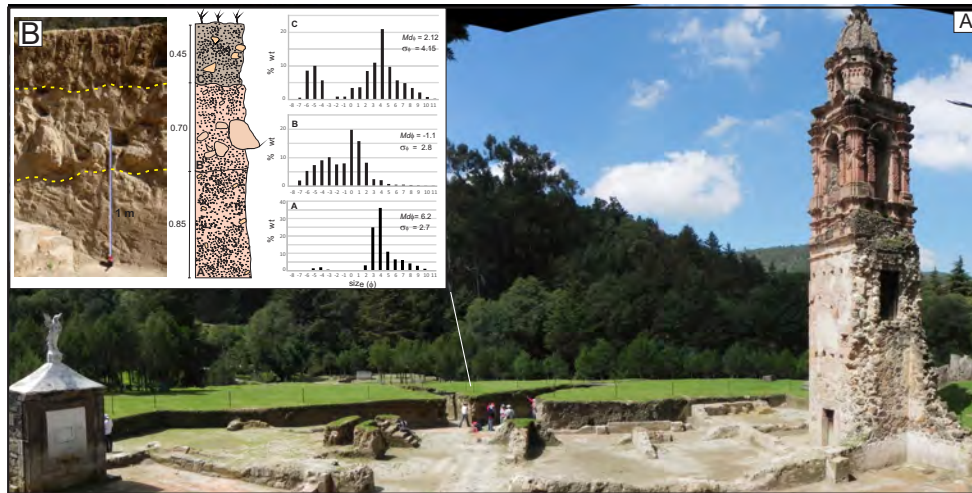
Figure 12. (A) Panoramic view from the east of the remains of El Carmen church buried by the Tailings Flood Deposit (section TL-01). The excavation of the church remains exposed the ancient floor of the sanctuary also observed in insets. (B) Stratigraphic column showing three beds separated by dashed yellow lines and their granulometric bimodal distributions.

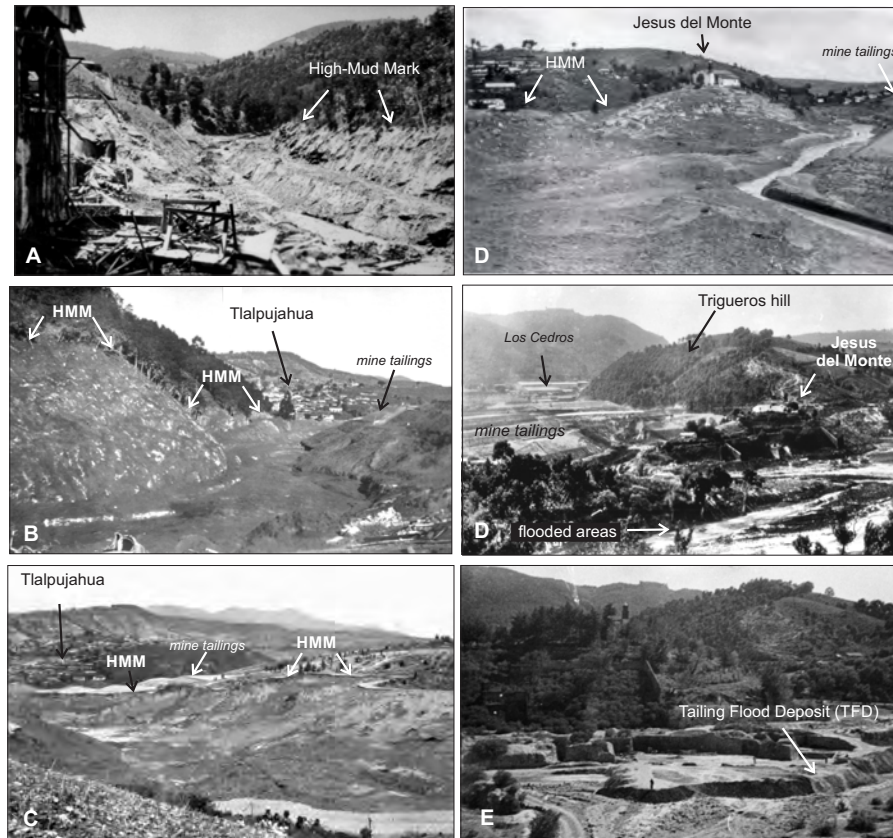
Figure 14. Views of damage caused by the Tailings flood in 1937 at different locations of this study: los Cedros metallurgical plant (A), Trigueros Hill (B), the Dos Estrellas stream between Trigueros and Jesus del Monte (C), and Jesus del Monte (D–F). HMM = High Mud Marks.
