Building and design defects observed in the residential sector and the types of damage observed in recent earthquakes in Turkey

M. Tolga Çöğürçü

Selcuk University, Engineering Faculty, Department of Civil Engineering, Konya, Turkey

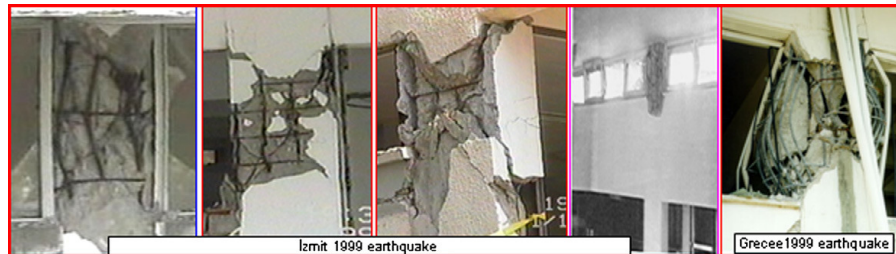
If there is a difference between the lengths of columns on the same floor, it will cause a negative damage mechanism during an earthquake (Picture 3). Ribbon windows that are made from column to column in the halls of structures such as schools and hospitals and the presence of which are not considered in static projects can cause brittle fractures in columns.

Picture 3. Several short column failures observed after earthquakes (Isik, 2006).

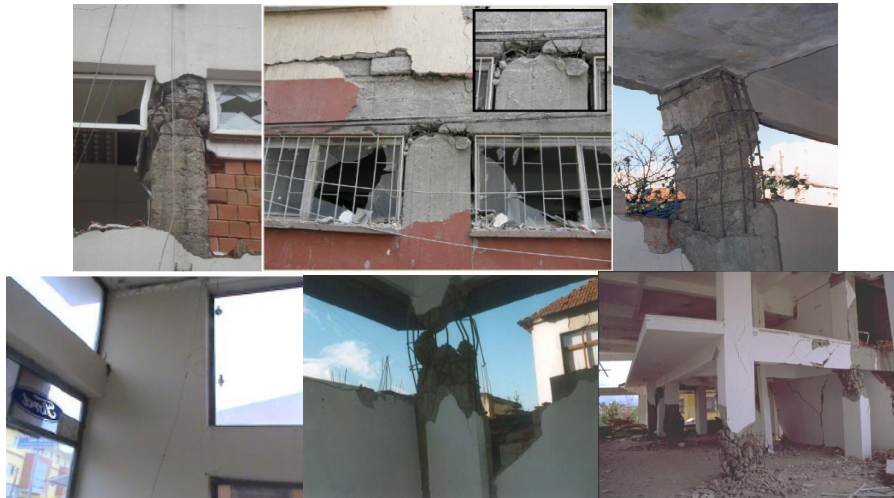
Examples of damage that occurred in reinforced concrete buildings due to window bays left in infilled walls and column edges are shown in Picture 4 and Picture 5.

Picture 4. Examples of damage caused by the formation of short columns (Middle East Technical University, 2011).

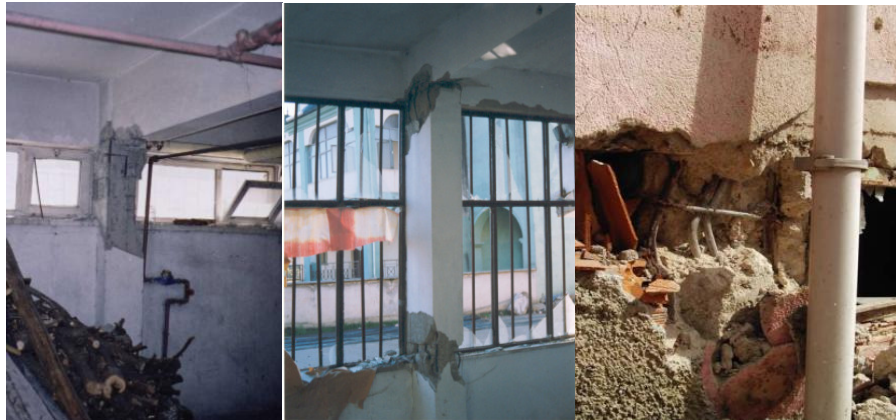
Picture 5. Short column formation caused by ribbon windows (Middle East Technical University, 2011).

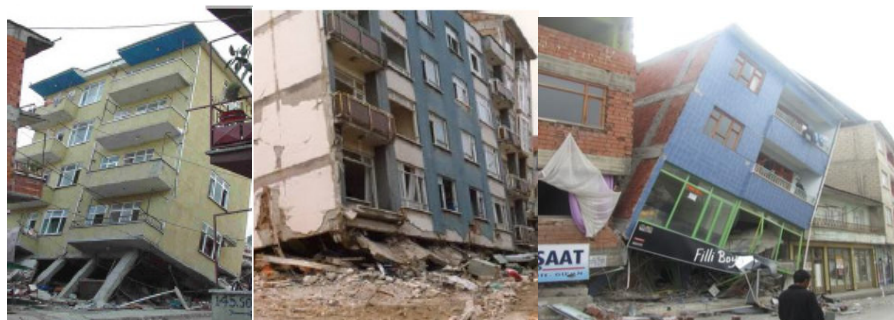
In Picture 6, many examples are shown of soft story and weak story damages observed in the 2011 Van earthquake.

Picture 6. Examples of damage related to soft-story and weak story irregularities (source: Ahmet Topçu).

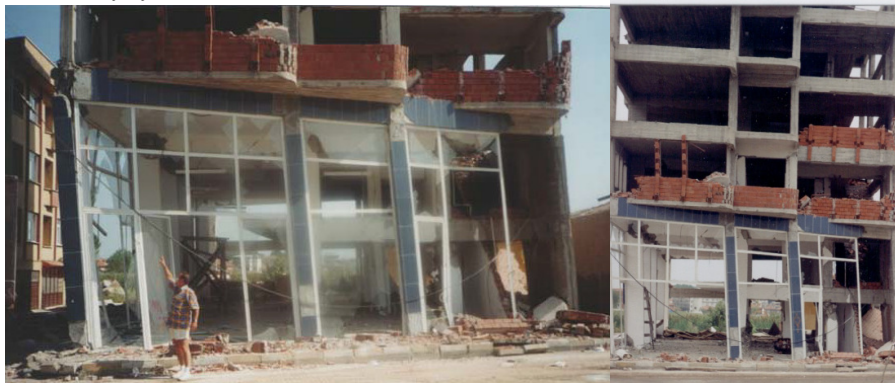
Many buildings were heavily damaged in the 17 August 1999, Kocaeli earthquake. Those buildings did not have masonry-infilled walls on their ground floors in order to leave space for commercial uses on Izmit and Golcuk Street and especially on AdapazarıInonu and Cark Street ($M = 7.4$). The upper floors of the incomplete five-floor building shown in Picture 7 were designed as residential floors, and the ground floor was designed for shops. This building, in which the ground floor was quite high and lacked masonry-infilled walls, was heavily damaged and collapsed due to weak story syndrome.

According to the η_c – weak story and η_k – soft story criteria in the TEC-2007, weak story and soft story irregularities were not found in this building. Instead, the building collapsed due to the weakness and softness of the ground floor. In this case, the TEC-2007 could not identify a weak or soft story in the building. Thus, the design engineer and the assignors were misled as to the threat to human life because the building was shown through rose-colored glasses.

Picture 7. Heavy damage in the weak story of a five-floor building in Adapazari (17 August 1999, Kocaeli Earthquake, $M = 7.4$) (Isik, 2006).

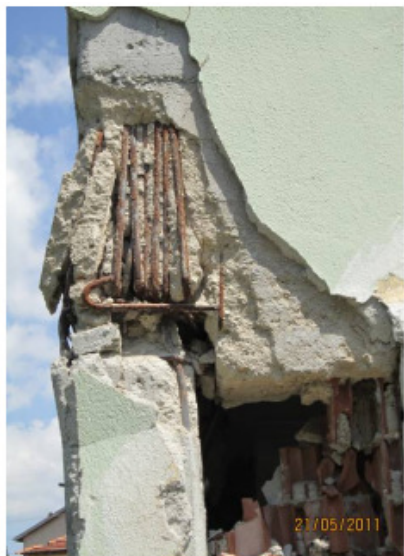
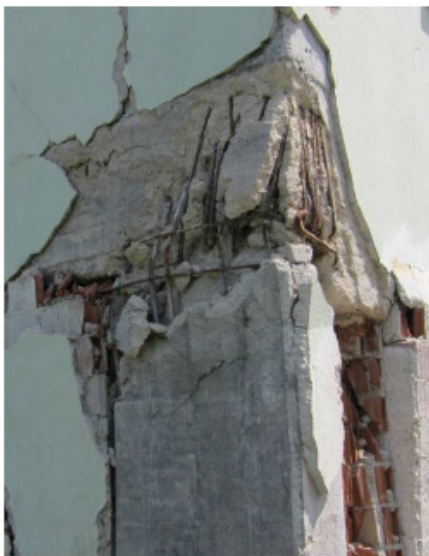
Picture 8. A reinforced concrete structure that was heavily damaged at the integration region during the 19 May 2011, Simav Earthquake (Cayci, 2012).

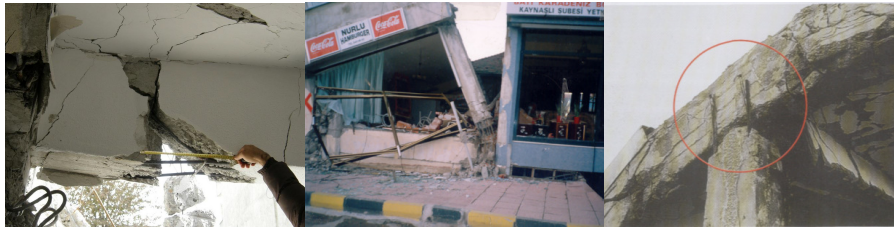
Picture 9. Pulling away of longitudinal reinforcements.

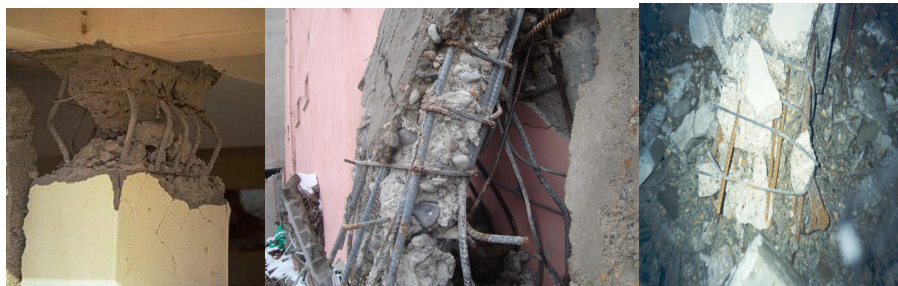
Reinforcement detailing errors were frequently encountered in structures, especially those constructed before the establishment of the 1998 Earthquake Code. After the 2011-Van earthquake, typical reinforcement defects were observed in most of the heavily damaged buildings. Discontinuities in column lateral reinforcements in the joint re-

gion and inadequate length of the reinforcement interlocking sections were the most common detailing errors.

Picture 10. Damage caused by reinforcement detailing errors (source: Erdal Camcı).

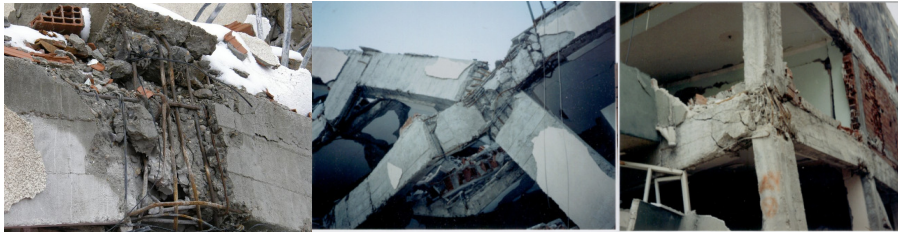
**Picture 12.** Damage to column-beam integration zones (İKÜ-CE-2011/01, 2011).

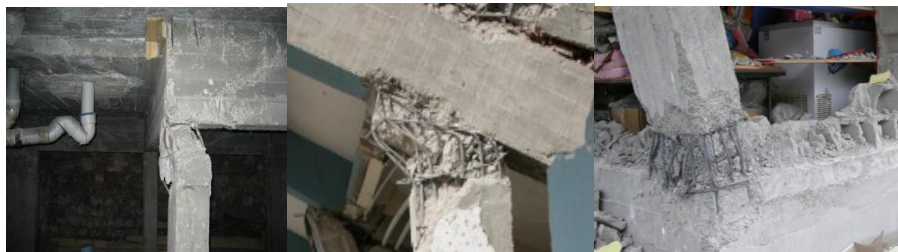
Although it was stated in the earthquake code that columns should be stronger than beams and that hinging occurred in columns investigated after earthquakes, it was observed that the damage to beams was limited and that in some cases there was no damage. Several examples of this type of damage, which is called strong beam-weak column damage, are given in Picture 13. As the damage becomes progressively worse, hinges occurred in the columns, decreasing the horizontal stability and causing the collapse of building in the way that floors collapse one after another, which is called a

Picture 13. Examples of strong beam-weak column damage.

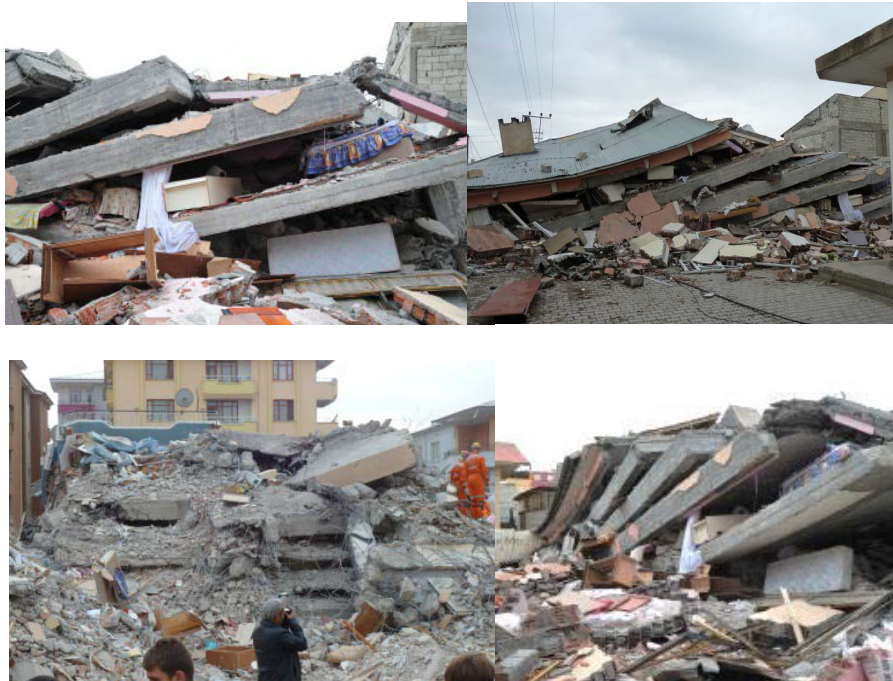
Picture 14. Full collapse of a building as a result of plastic hinges in the bottom and top zones of columns in a reinforced concrete structure in Van-Ercis (Onen et al., 2011).

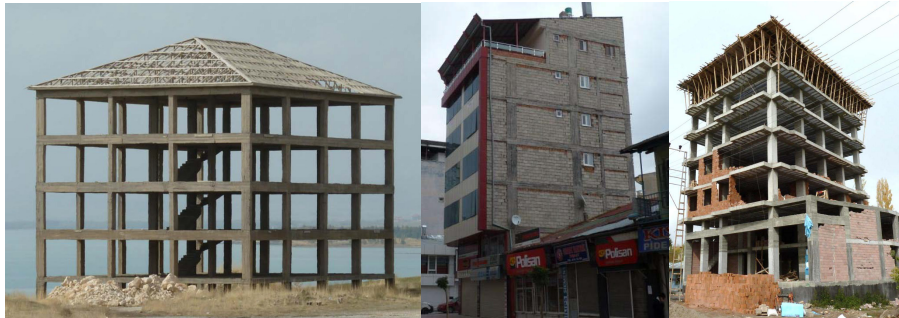
One of the most commonly encountered problems in damage investigations after earthquakes is that the buildings do not have adequate lateral rigidity or an adequate layout of shear walls. Ductile behavior is desired in a structure under earthquake loads, and all structure systems should have adequate rigidity. More horizontal translation will cause damage to elements such as non-load bearing partition walls, and this will increase the economic losses. Moreover, second-degree forces will cause more movement of the elements. For these reasons, the TEC 2007 imposes restrictions on the horizontal displacements that occur in floors under horizontal loads.

Picture 15. Buildings that do not have adequate shearwalls.

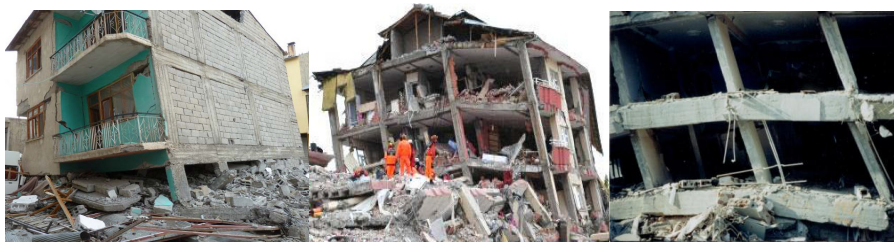
Picture 16 shows examples of earthquake damage and collapse observed in reinforced concrete buildings with insufficient lateral rigidity.

Picture 16. Damage observed in buildings with insufficient lateral rigidity.

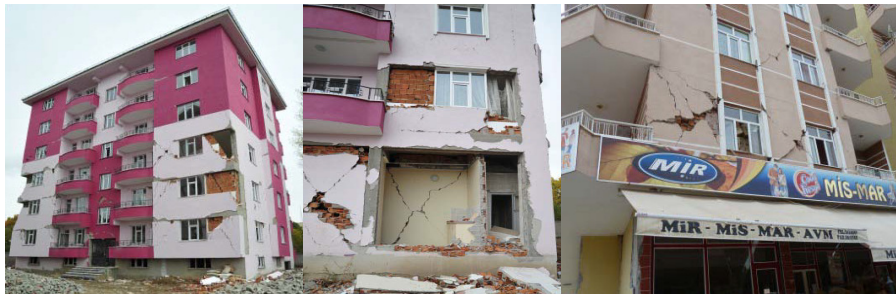
Picture 17 shows examples of damage in non-bearing brick-infilled walls as a result of excess translation of buildings.

Picture 17. Damage observed in non-bearing brick-infilled walls.

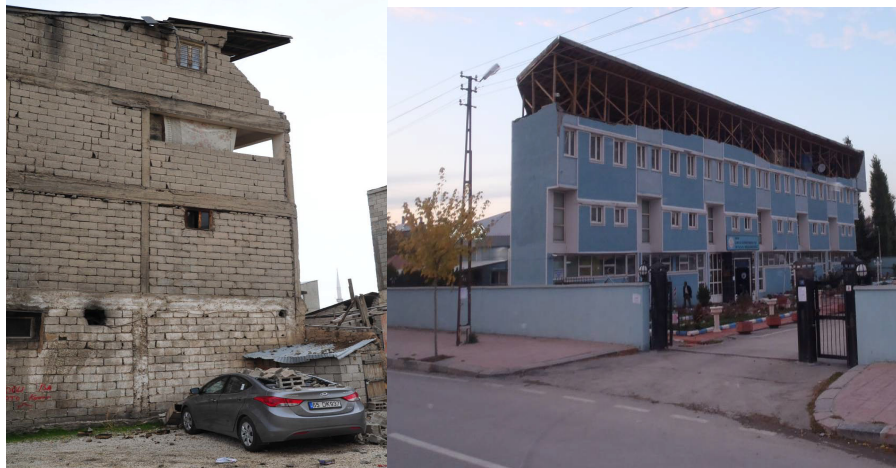
Picture 18. Gable wall damage (www.dramaistanbul.com.tr).

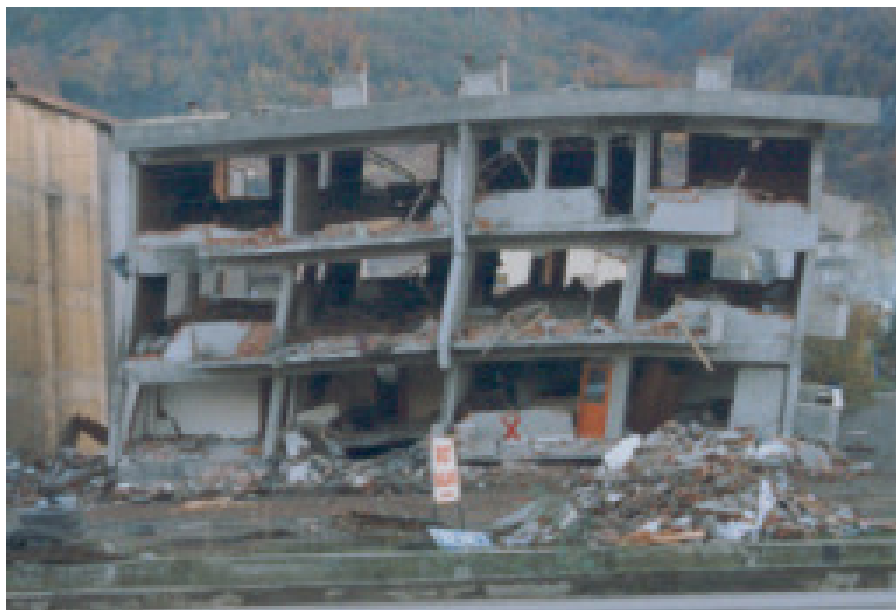
Picture 19. Earthquake damage in a building with columns placed in the same direction.

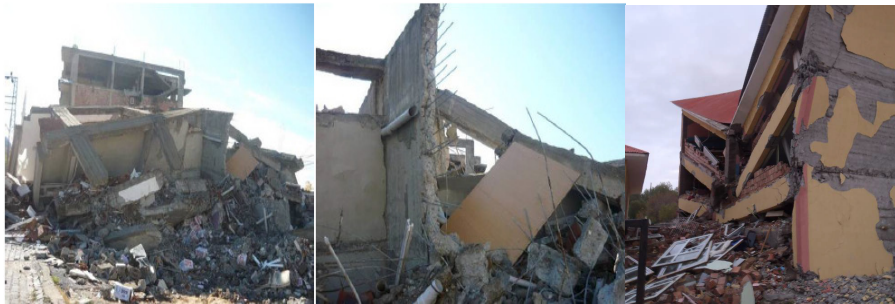
Picture 20 shows examples of damage that occurred during earthquakes due to the placement of partitions in the plan.

Picture 20. A building that collapsed due to contributions of lateral translation and torsion (Anonymous, 2013).

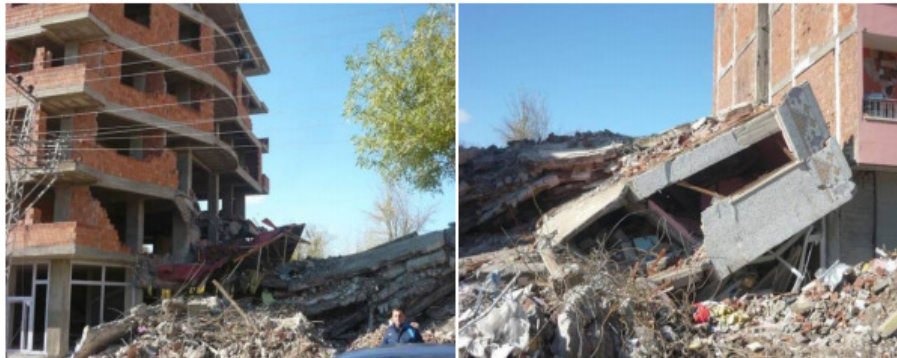
Many building bylaws allow adjoined constructions (attached). These attached constructions are not well-protected against earthquakes. They transfer earthquake force to each other, and they collide as a result of oscillation. The last type of construction, called a street corner, is generally damaged very heavily (Turk, 2011).

Picture 21. Reinforced concrete multi-story building that collapsed by colliding with adjacent buildings due to a daubing effect (Inel et al., 2011).

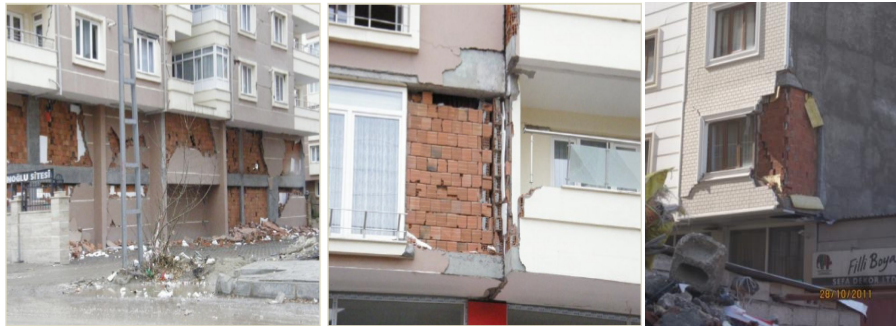
Picture 22. Damage in the outer walls of a reinforced concrete building in Van city due to separations in the walls (Celebi et al., 2011).

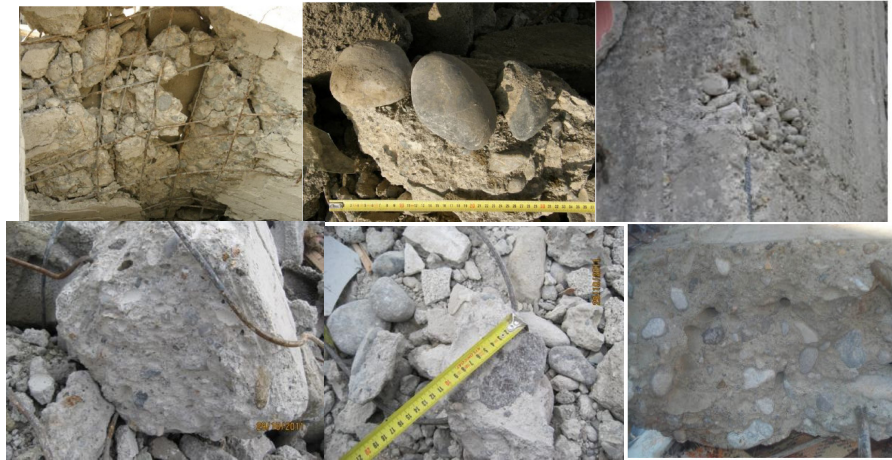
Picture 23. Concrete and aggregate samples in a single-story reinforced concrete building that collapsed in the Van Organized Industrial Site (İKÜ-CE-2011/01, 2011), and a concrete cross-section displayed in the wreckage (Kızılkanaat et al., 2011).
