CONSTRUCTION AND DESIGN DEFECTS IN THE RESIDENTIAL BUILDINGS AND OBSERVED EARTHQUAKE DAMAGE TYPES IN TURKEY

M. Tolga ÇÖĞÜRCÜ

Selcuk University, Engineering Faculty, Department of Civil Engineering, Konya.

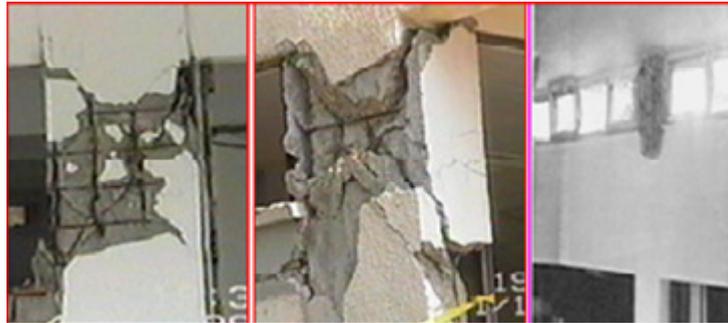
If there is a difference between the lengths of columns on the same floor, it will cause a negative damage mechanism during an earthquake (Figure 9). Ribbon windows that are made from column to column in the halls of structures such as schools and hospitals and the presence of which are not considered in static projects can cause brittle fractures in columns.

Figure 9. Several short column failures observed after earthquakes [5].

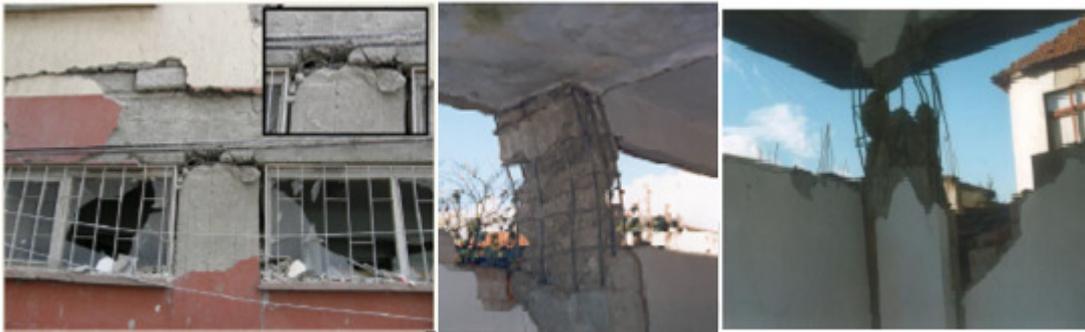
Examples of damage that occurred in reinforced concrete buildings due to window bays left in infilled walls and column edges are shown in Figure 10 and Figure 11.

Figure 10. Examples of damage caused by the formation of short columns [8].

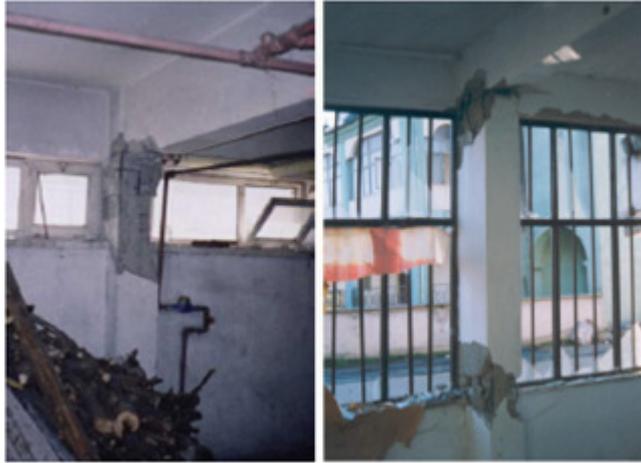
Figure 11. Short column formation caused by ribbon windows [8].

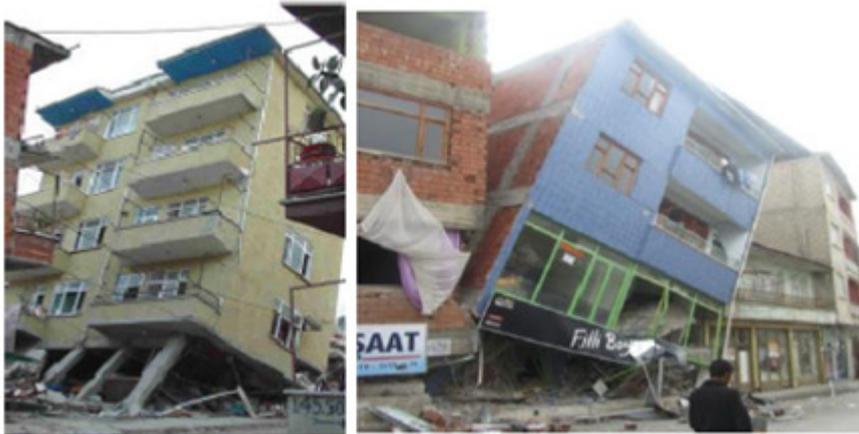
In Figure 12, many examples are shown of soft story and weak story damages observed in the 2011 Van earthquake.

Figure 12. Examples of damage related to soft-story and weak story irregularities (Source: Ahmet Topçu).

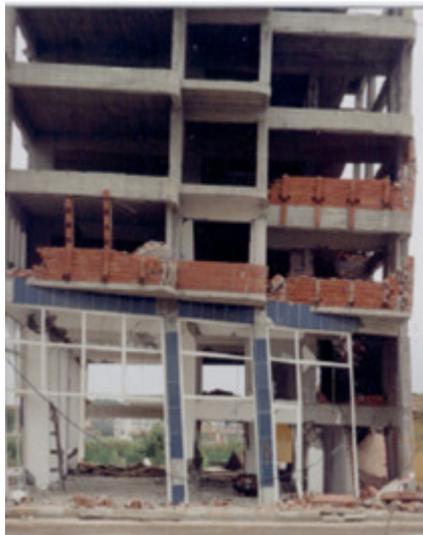
Many buildings were heavily damaged in the August 17, 1999, Kocaeli earthquake. Those buildings did not have masonry-infilled walls on their ground floors in order to leave space for commercial uses on Izmit and Golcuk Street and especially on Adapazarı Inonu and Cark Street (M= 7.4). The upper floors of the incomplete five-floor building shown in Figure 13 were designed as residential floors, and the ground floor was designed for shops. This building, in which the ground floor was quite high and lacked masonry-infilled walls, was heavily damaged and collapsed due to weak story syndrome.

According to the η_c – weak story and η_k –soft story criteria in the TEC-2007, weak story and soft story irregularities were not found in this building. Instead, the building collapsed due to the weakness and softness of the ground floor. In this case, the TEC-2007 could not identify a weak or soft story in the building. Thus, the design engineer and the assignors were misled as to the threat to human life because the building was shown through rose-colored glasses.

Figure 13. Heavy damage in the weak story of a five-floor building in Adapazari (August 17, 1999, Kocaeli Earthquake, $M = 7.4$) [5].

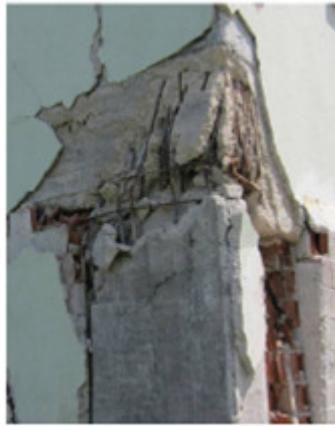
It was observed that hooks were attached to the ends of the longitudinal reinforcements in old reinforced concrete structures. In Figure 14, a heavily damaged column element can be seen. The building, which was used as a primary school, contained many negative application and detailing defects. Beam lateral reinforcements were applied adjacent to the end region, and they were not integrated with concrete. Hooks were attached to the ends of the beam longitudinal reinforcements and continued at the end region, except for the lateral reinforcement. Column lateral reinforcements did not continue at the integration region of the column and beam. Moreover, the interlocking length of the column longitudinal reinforcement was inadequate. For these reasons, the reinforcements were pulled away from the integration region [10].

Figure 14. A reinforced concrete structure that was heavily damaged at the integration region during the May 19, 2011, Simav Earthquake [10].

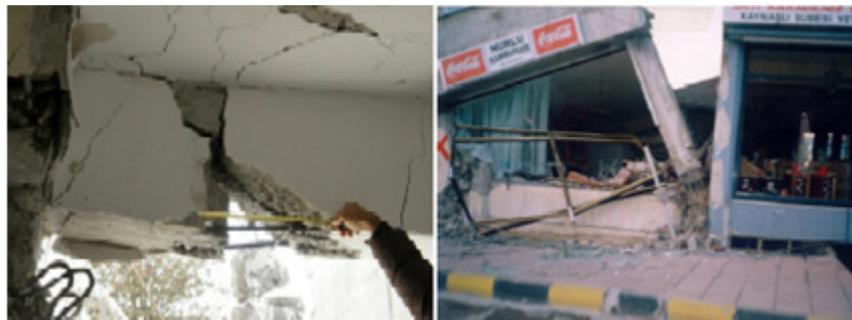
Figure 15. Pulling away of longitudinal reinforcements.

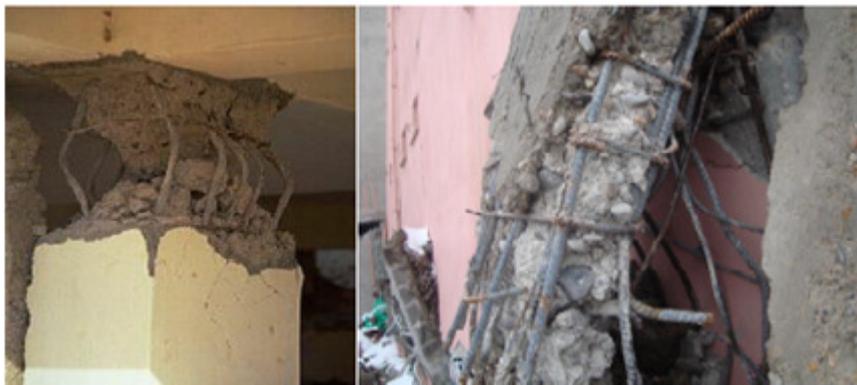
Figure 16. Damage caused by reinforcement detailing mistakes (Source: Erdal Camcı).

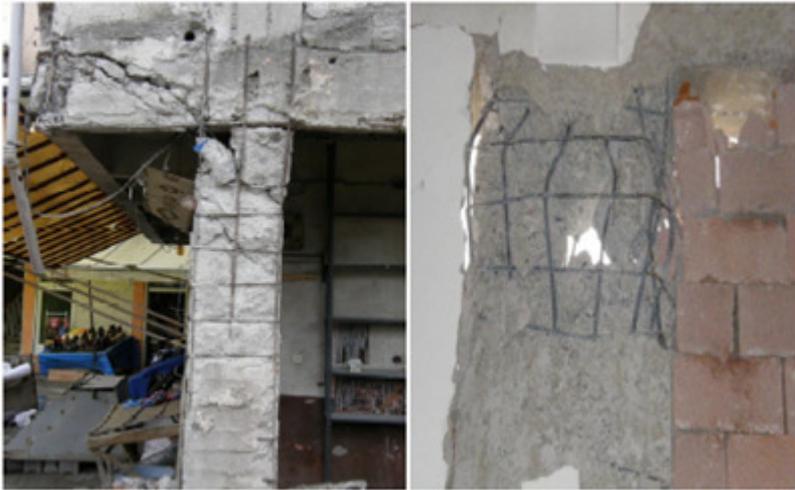
In the TEC-2007, although confinement zones are defined at the end points of columns and beams and although it was determined that the stirrup frequency in the confinement zones should not be less than 10 cm, it was observed that such confinement zones were not formed in reinforced concrete elements damaged in the earthquake (Figure 6). It was observed that the stirrup frequency at the end zones of the columns and beams was approximately 20-30 cm. Plastic hinges are formed at the column ends due to strong beam-weak column formation under reversible loads. Because of the infrequent stirrups under excess spinings caused by the ductility request and because hooks with 90° adequate ductility were not obtained, correspondingly heavy damage was observed in many of the buildings. Inadequate concrete quality also contributed to these failures. In Figure 17, examples of column damage and stirrup frequency are given.

Figure 17. Damage caused by excess stirrup intervals in the confinement zones of columns [20].

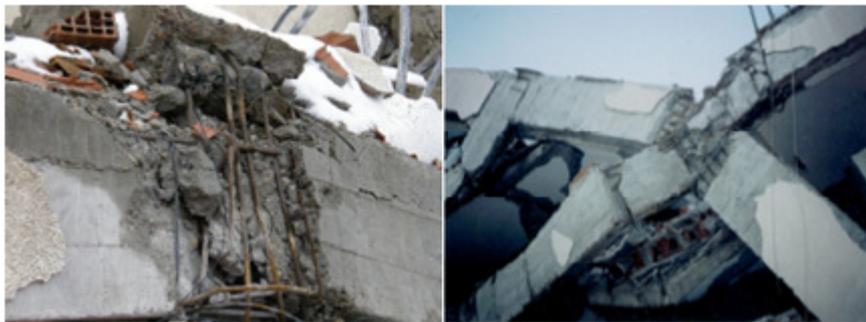
Figure 18. Damage to column-beam joint region [20].

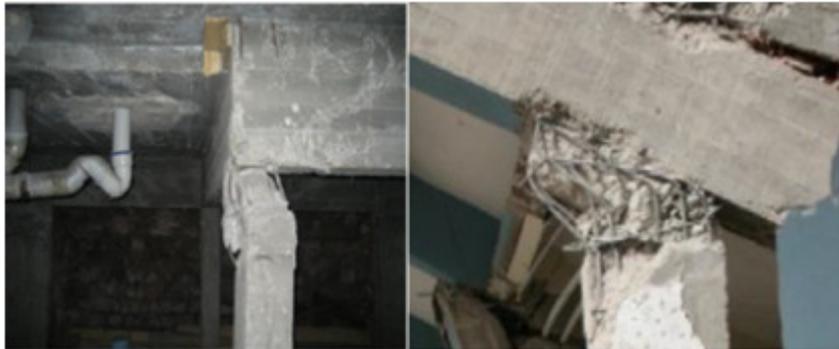
Figure 19. Examples of strong beam-weak column damage.

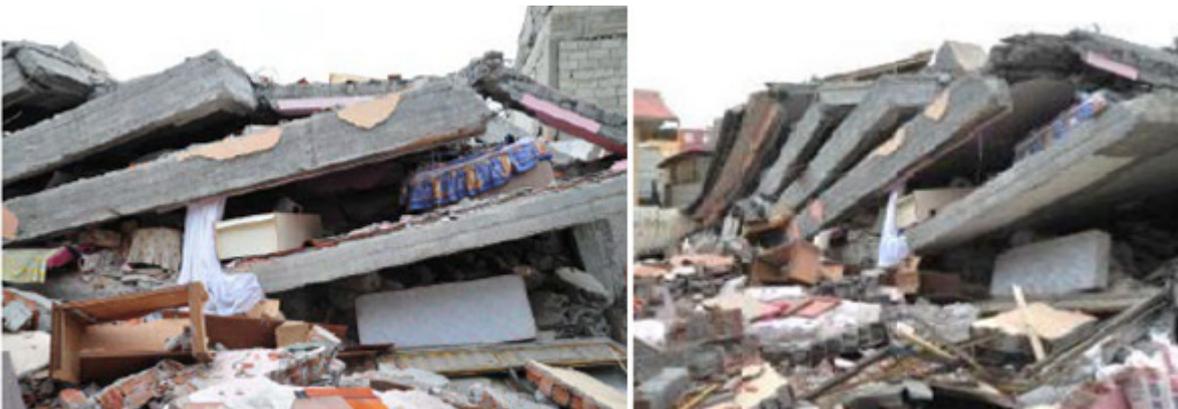
Although it was stated in the earthquake code that columns should be stronger than beams and that hinging occurred in columns investigated after earthquakes, it was observed that the damage to beams was limited and that in some cases there was no damage. Several examples of this type of damage, which is called strong beam-weak column damage, are given in Figure 19. As the damage becomes progressively worse, hinges occurred in the columns, decreasing the horizontal stability and causing the collapse of building in the way that floors collapse one after another, which is called a "pancake" collapse. Pancake collapses are the most common type of collapse (Figure 20).

Figure 20. Full collapse of a building as a result of plastic hinges in the bottom and top zones of columns in a reinforced concrete structure in Van-Ercis [1].

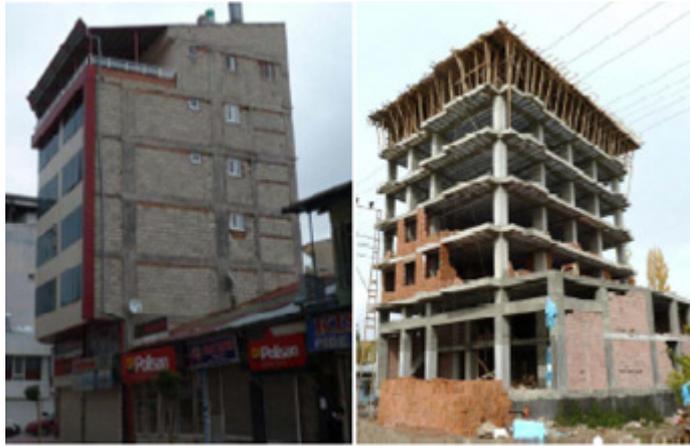
Figure 21. Buildings that do not have adequate shearwalls.

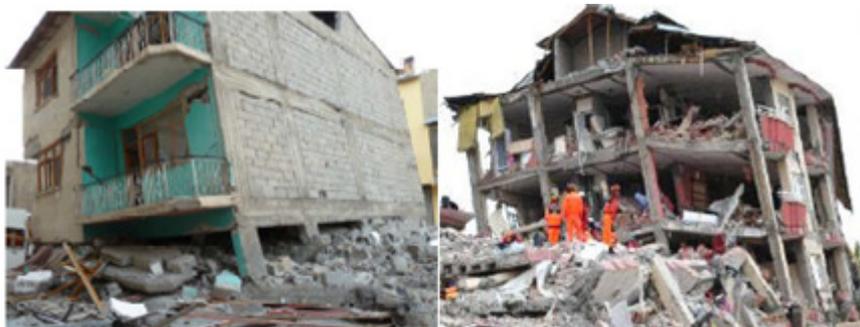
Figure 22 shows examples of earthquake damage and collapse observed in reinforced concrete buildings with insufficient lateral rigidity.

Figure 22. Damage observed in buildings with insufficient lateral rigidity.

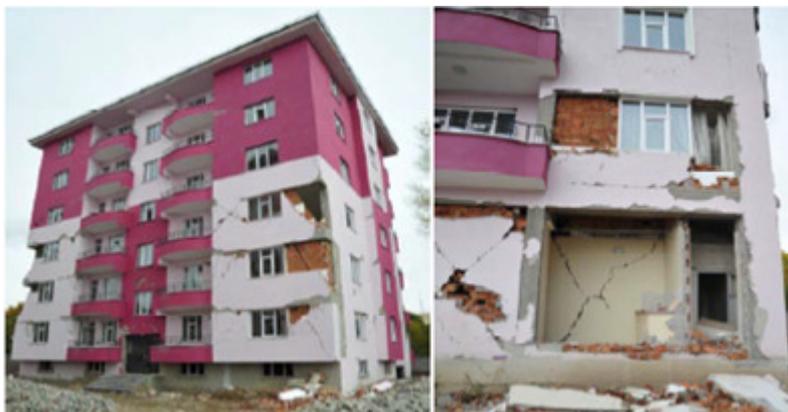
Figure 23 shows examples of damage in non-bearing brick-infilled walls as a result of excess translation of buildings.

Figure 23. Damage observed in non-bearing brick-infilled walls.

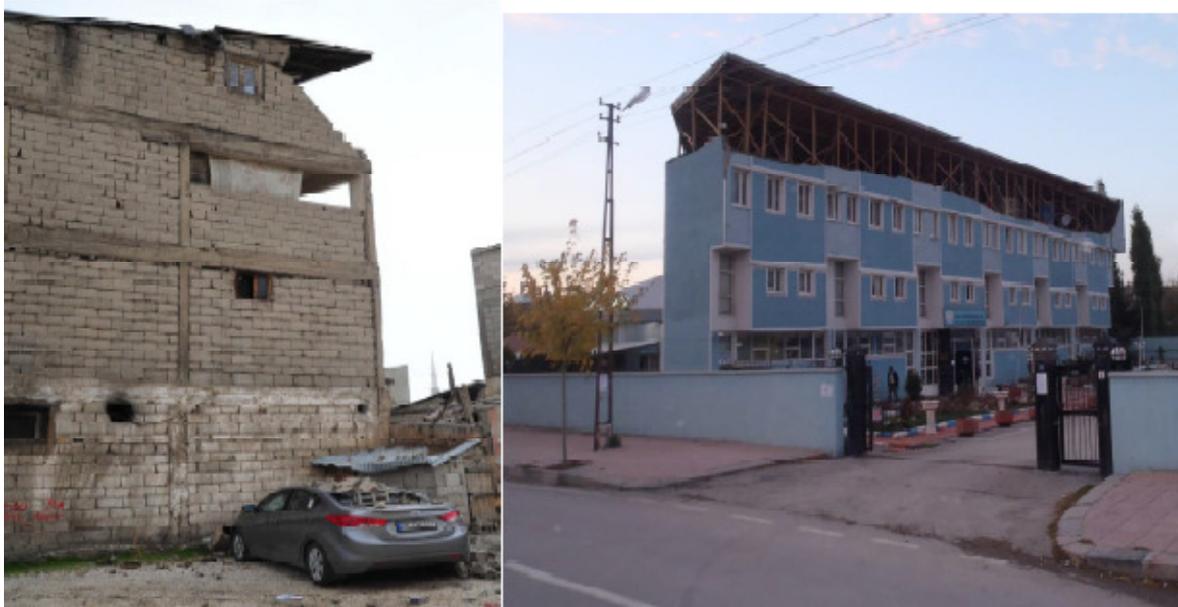
Walls with upper sides that are clear and supported at the bottom, such as vertical corbels or garden walls, frequently collapse under horizontal loads because the gable walls are not combined with overhead beams in garrets. The collapse of these walls does not pose a problem in terms of the veering of the building. However, the collapse of these walls on the street or in other buildings might put people in danger. Figure 24 shows examples of gable wall damage.

Figure 24. Gable wall damage (www.dramaistanbul.com.tr).

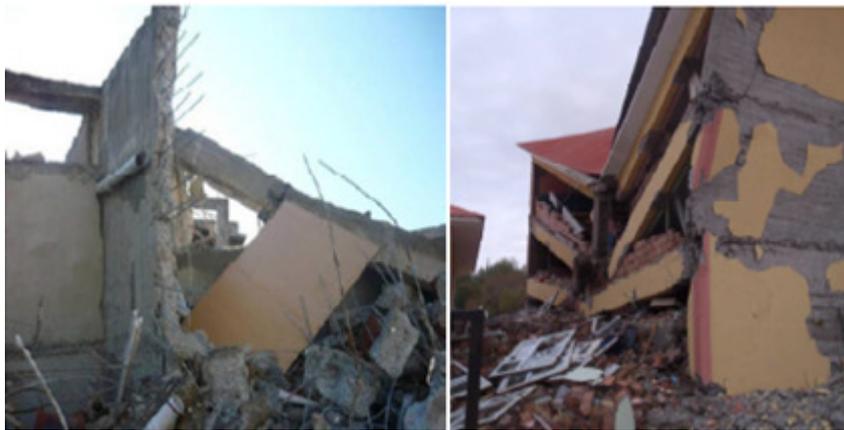
Figure 25 shows examples of damage that occurred during earthquakes due to the placement of partitions in the plan.

Figure 25. A building that collapsed due to contributions of lateral translation and torsion [3].

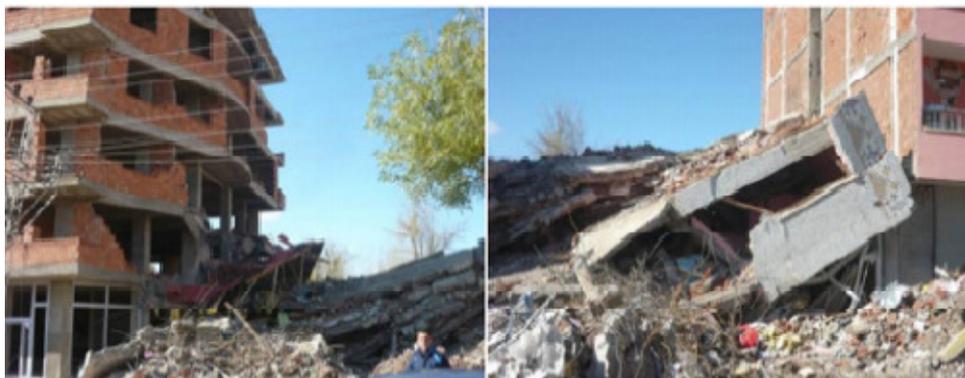
Figure 26 shows examples of the types of damage that occur when there is not an adequate earthquake joint between attached buildings.

Figure 26. Reinforced concrete multi-story building that collapsed by colliding with adjacent buildings due to a daubling effect [15].

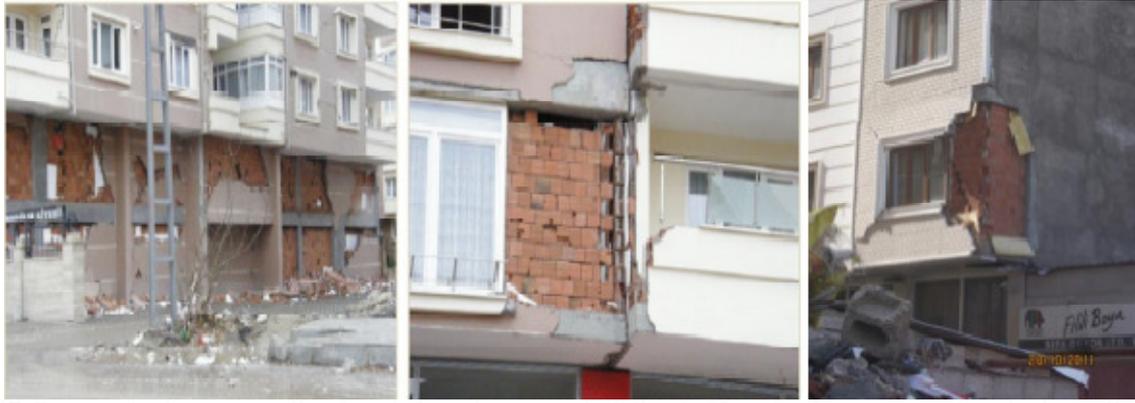
In two-row brick walls that are not connected to each other mechanically throughout the wall gaps, diagonal cracks and big out-of-plane motions have been observed. For this reason, there have been many cases of buildings with no damage in load-bearing components but with severe loss of life and property due to wall damage (Figure 27)[16].

Figure 27. Damage in the outer walls of a reinforced concrete building in Van city due to separations in the walls [16].

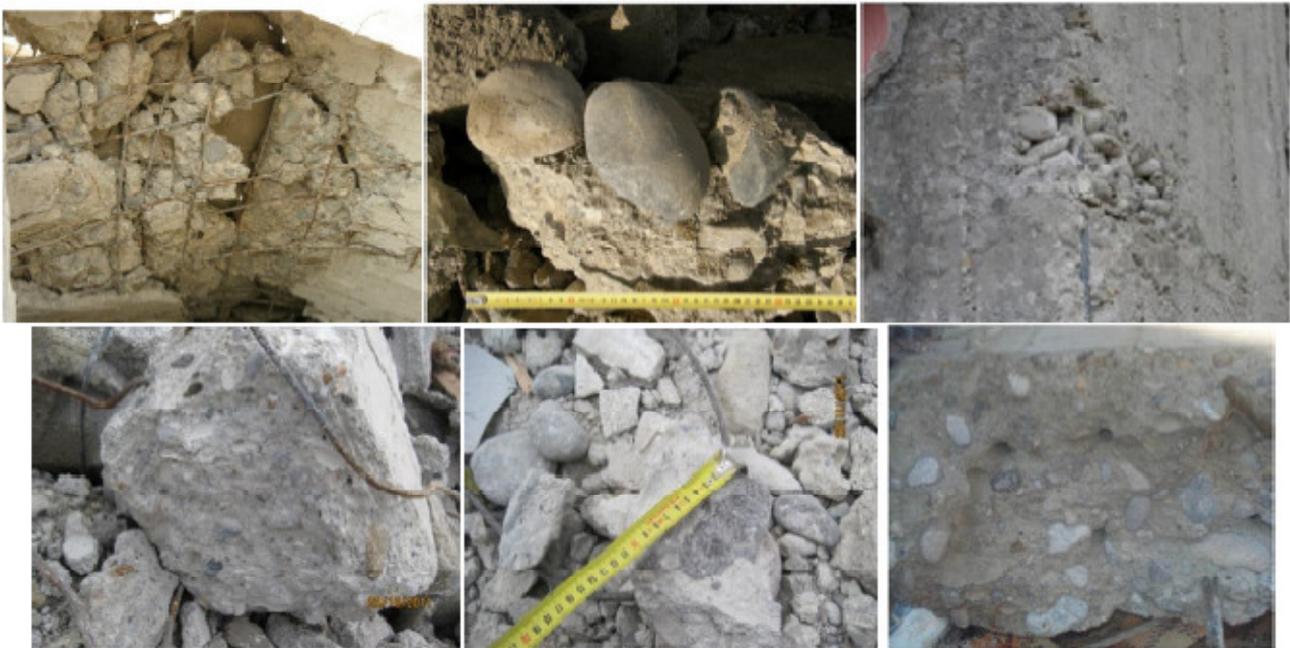
In the concrete that is generally used for construction, segregations and reinforcement placement defects are observed. Such defects were observed in all investigated buildings (Figure 28).

Figure 28. Concrete and aggregate samples in a single-story reinforced concrete building that collapsed in the Van Organized Industrial Site [20], and a concrete cross-section displayed in the wreckage [17].
