1 **Causes and consequences of the Sinkhole at “El Trebol” of Quito,**
2 **Ecuador - Implications to economic damage and risk assessment**

28 **Abstract**

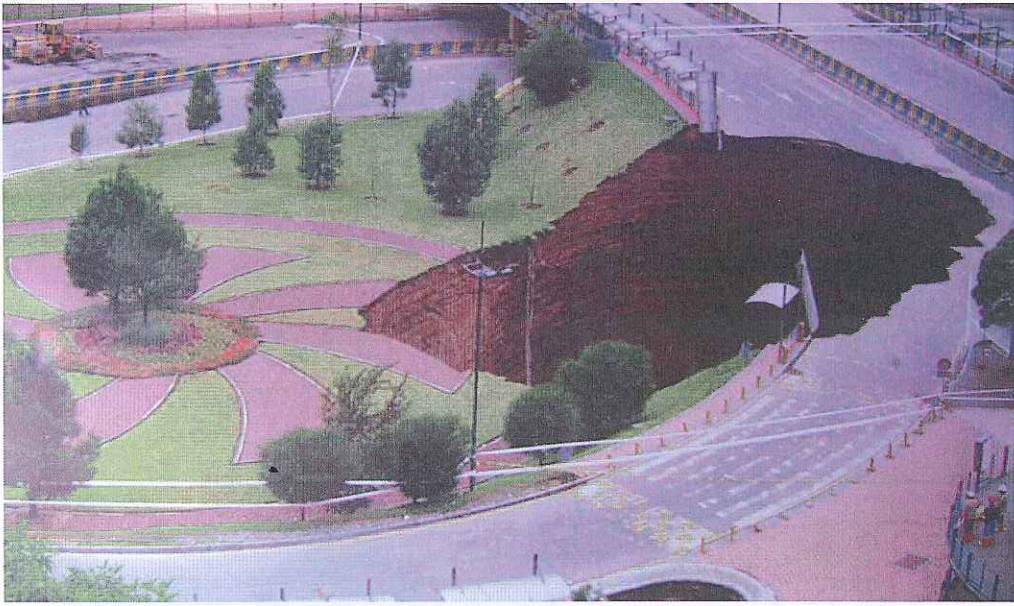
67 Considering this context, on the 31st of March 2008, during a regular working day, a
68 heavy rainfall took place within an already extremely wet season, and around 2 p.m.,
69 a sinkhole of great proportions was observed in the Trébol traffic hub. In the first few
70 minutes, the sinkhole started to be generated in the form of a crater with a diameter of
71 30 meters. The collapse continued to grow in the following days until the final
72 dimensions of this almost round sinkhole reached approximately 120 meters in
73 diameter and some 40 meters of depth, revealing ^{THE} base of the sinkhole, and the
74 Machángara river.

577 Figure 2: Initial stage of sinkhole at "El Trebol".

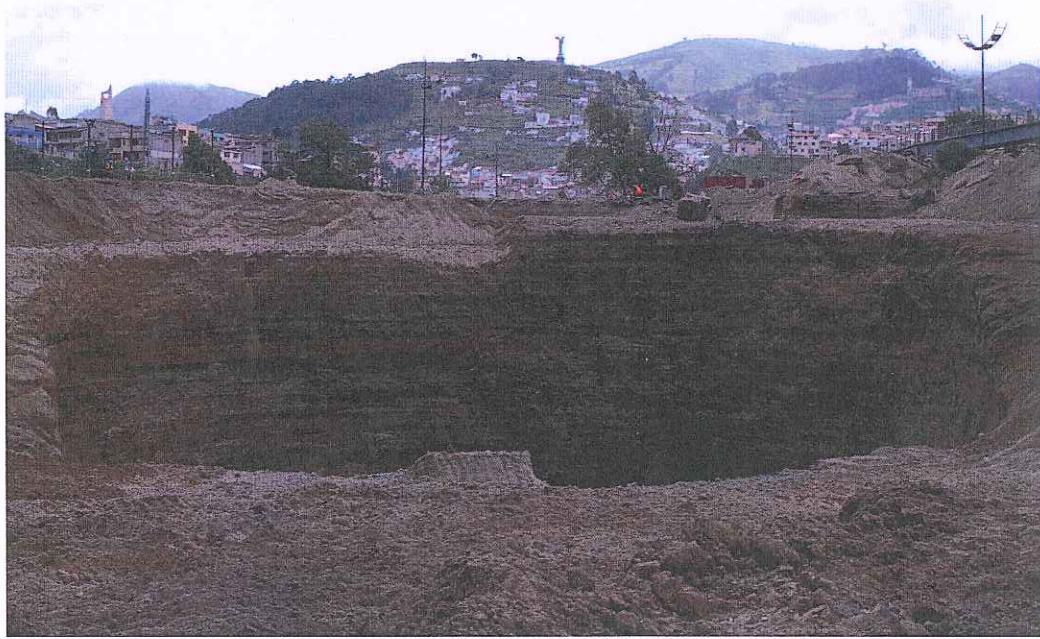
579 Figure 3: Panoramic view of the final stage of the sinkhole at "El Trebol". On the background the Panecillo
580 volcanic dome.

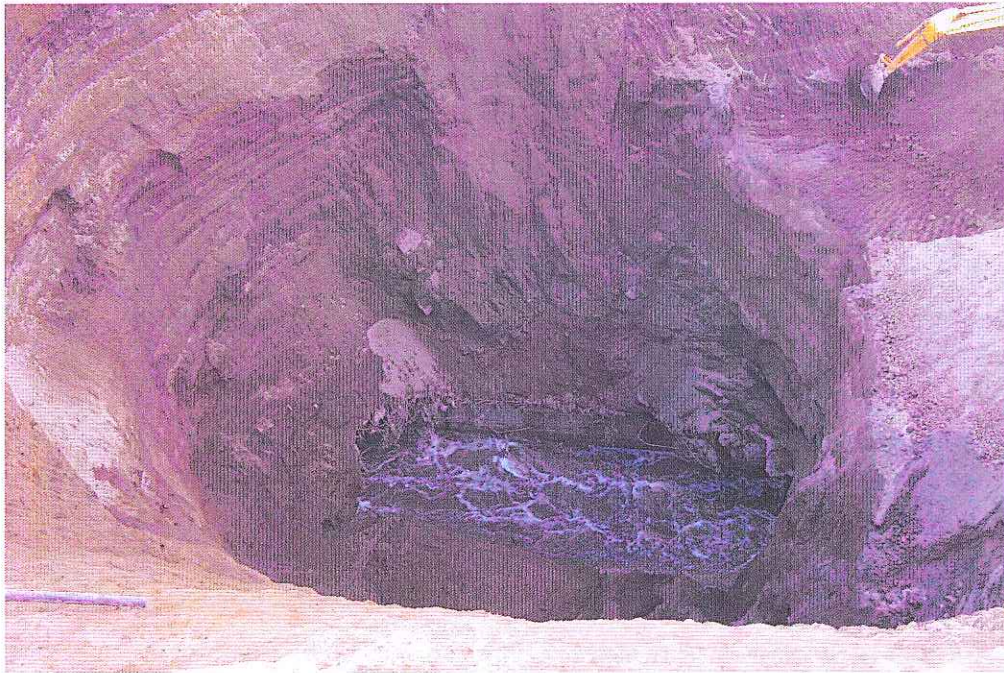
Figure 4: View into the sinkhole with the appearance of the Machángara river at its base.

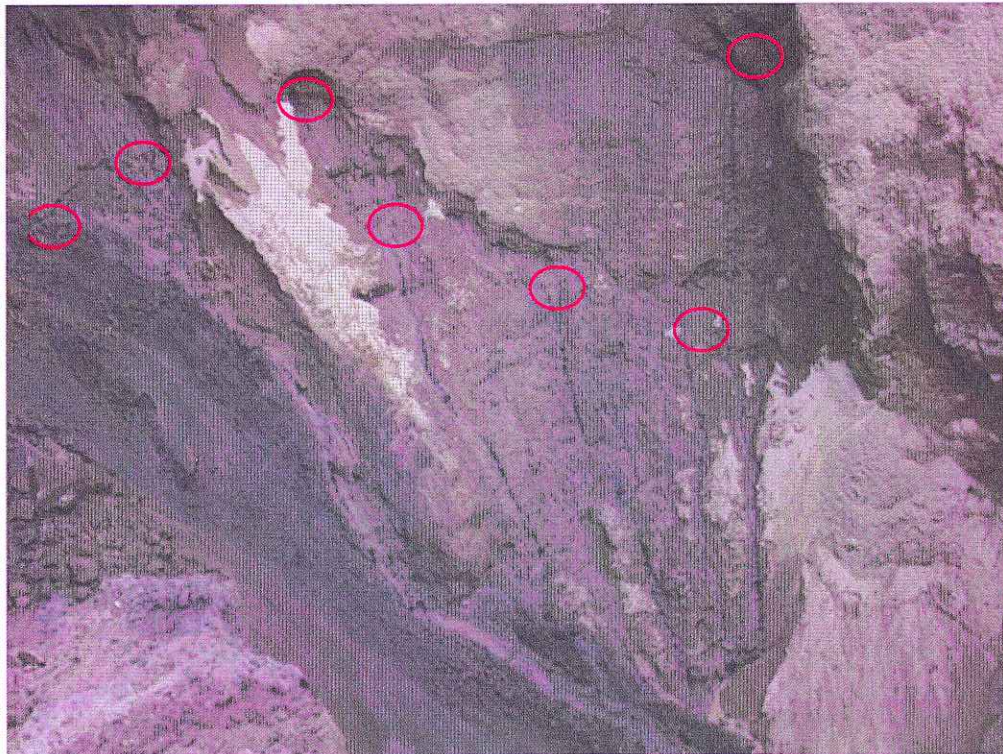
188 After the subsidence and collapse took place, groundwater emerged in the south and
189 southwestern slopes at a depth of 20 meters from the upper rim of the slope (Fig. 6),

190 These water springs contributed with a total flow of around 6 l/s, which decreased
191 50% due to drilling of pumping wells strategically located. These springs revealed the
192 presence of a free aquifer located in the south side of the sinkhole. Indeed, the

Figure 6: Southern and southwestern side of the inner part of the sinkhole, where water flows.

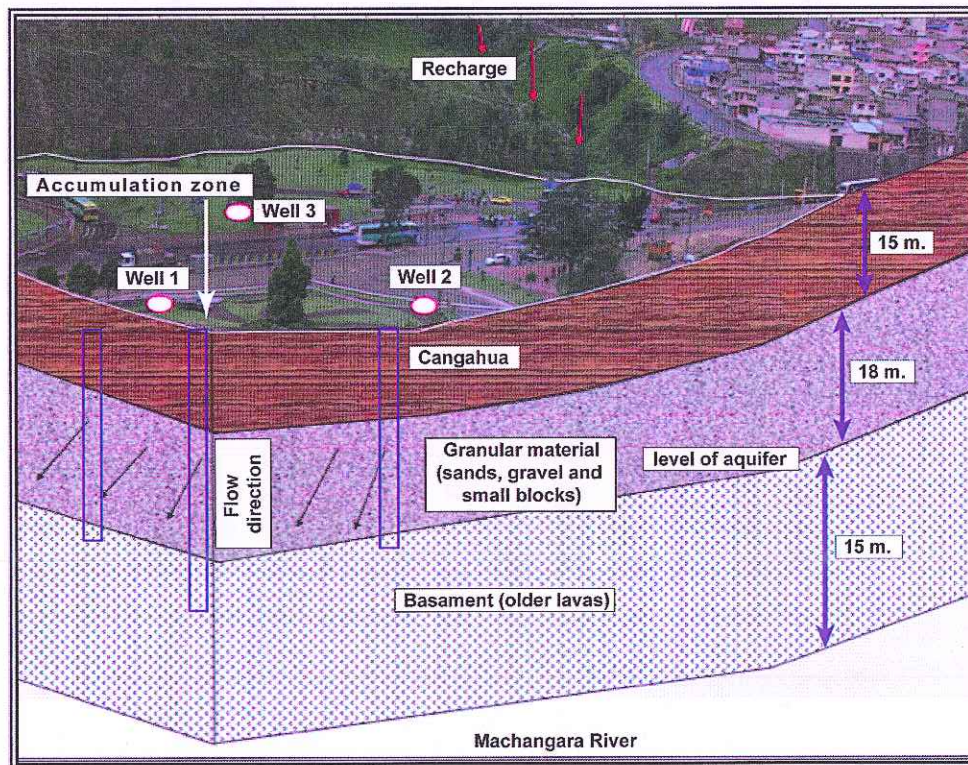
193 existence of the aquifer was determined after field observations followed by three
194 drillings; the water table is located between 12 and 15 meters deep. The aquifer is
195 composed by granular materials within a silty-sandy matrix, with a thickness of

196 around 18 m with a gradient from southwest to northeast, ~~the direction to the~~
197 Machángara River (Fig. 7). The aquifer recharge probably takes place in the
198 Luluncoto gorge situated 2 km to ^{THE} the southwestern.

Figure 7: Conceptual model of the aquifer with the site of the wells and the flowing direction.

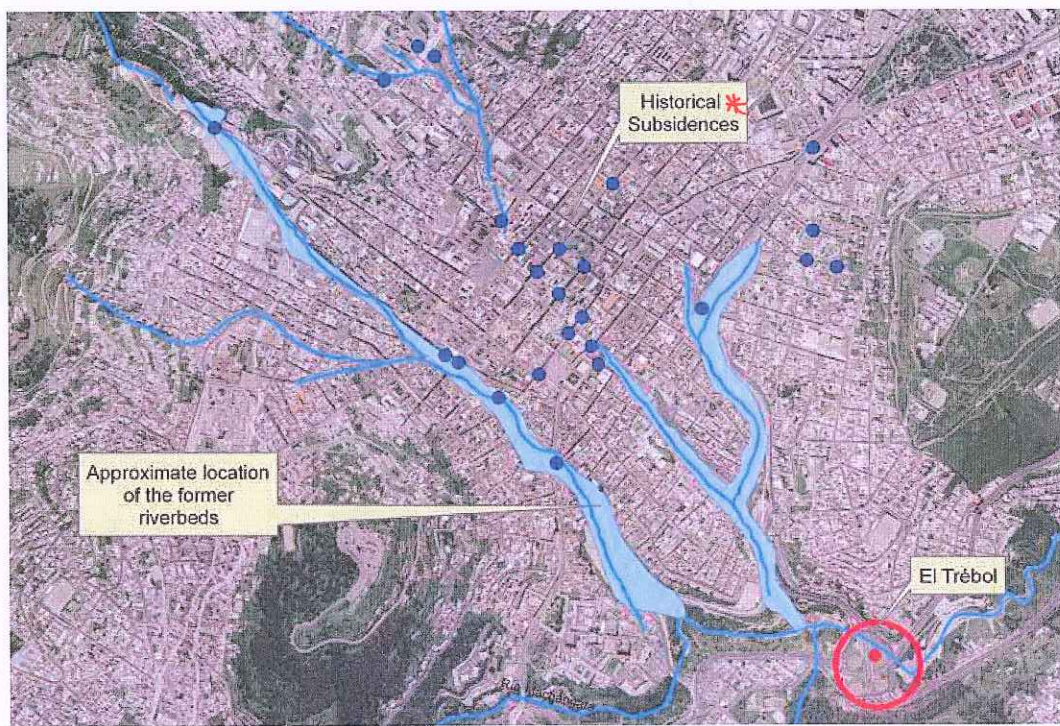
216 Historical records include 12 ~~sinking holes~~ ^{SINKHOLES} (Table 2; Fig. 8) of different magnitudes,
217 defined as "~~X~~ declines or collapses of roadway in the filler material streams, caused
218 by faulty sewers"^{*)} as well as the filling, initially performed with debris and garbage,
219 the age, type of construction and degree of deterioration of the physical work of the
220 channels, sewers and collectors (Pewter, 1986). ^{THIS IS IMPORTANT TO UNDERSTAND POSSIBLE SIMILARITIES WITH EL TREBOL SINKHOLE}

594 Figure 8: Historical subsidences at Machángara river, including the El Trébol sector (marked with the red
595 circle).

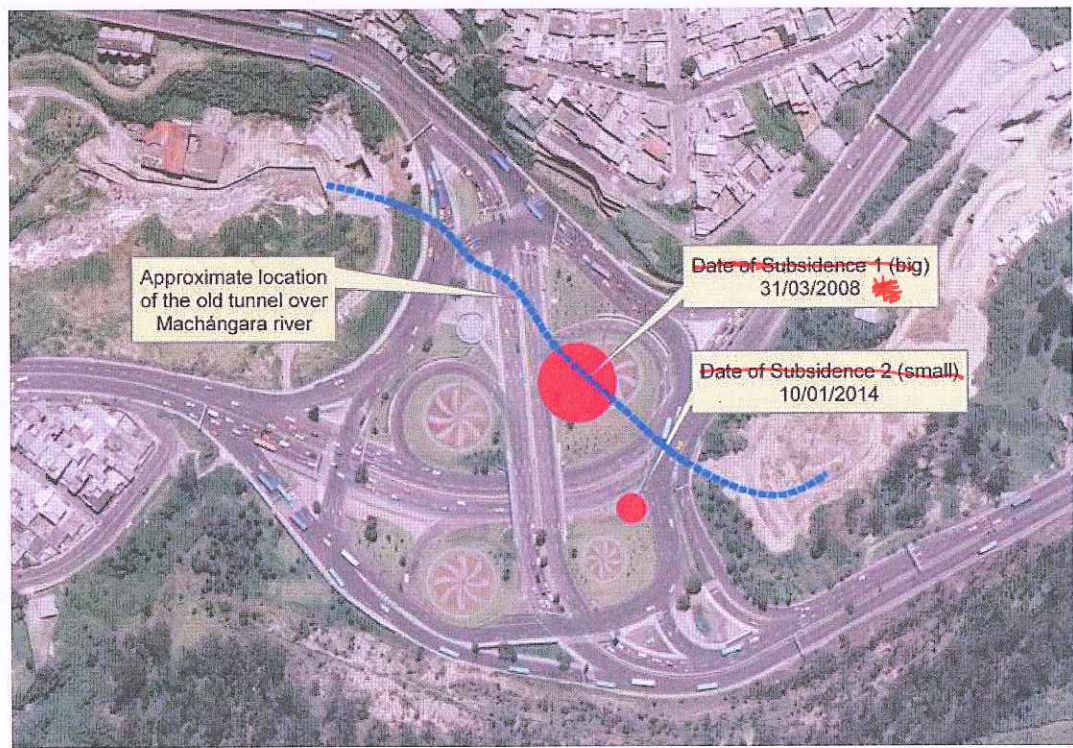
221 The former sinkholes were located on the old bed of the filled streams, so we can
222 assume that ~~it~~ ^{THEY} will continue to occur, especially in periods of daily rainfall above the
223 historical average. In the area of El Trébol, the first serious collapse was registered the
224 31st of March 2008, 10 years after channels were made for the construction of the
225 infrastructure to solve the problems of the traffic jams. Furthermore, there was a
226 second sinkhole of lower rate ^{*} on 10 January 2014 (Fig. 9). ^{* WHAT DO YOU MEAN BY "LOWER RATE"? "SMALLER"? WHAT CAUSED IT?}

597 Fig. 9: El Trébol sector with the flowing direction of the Machángara river including the sinkholes of ^{31/03/2008} ~~2008~~
598 (big red circle) and the ^{SMALLER ONE OF 10/01/2014} ~~recent in 2014~~ (small red circle).
599

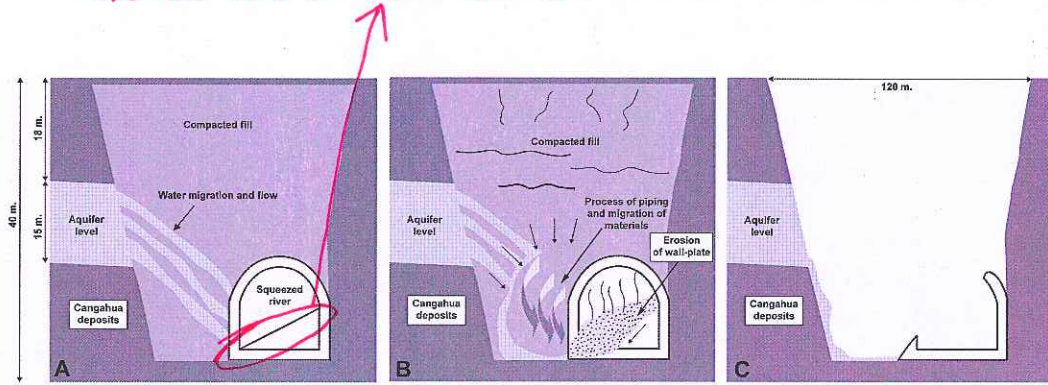
284 The water with the chemical conditions described above, does not cause a significant
285 effect on the elements of the collector at all. The potential alteration is rather directly
286 related to the high speeds of the water and sediment carried by the river (boulders
287 ~~large~~, scrap wood, etc), which ~~colliding~~ ^{COLLIDE} with the structures ~~produce~~ ^{PRODUCING} ~~weakening~~,
288 fracturing and erosion, mainly at the floor (see figure 10a) (Arias Jiménez, 2008).

293 This hypothesis is based on the fact that in the collapsed collector on the left margin
294 of the channel there are no vestiges of the floor. It would have a higher weight
295 considering that the channel on that site makes a small break and the force of the
296 water colliding directly in the union of the right gable with the floor, causing
297 weakening and faulting. The water caused floor erosion, leaving the right transept
298 without support and initiated a process of dragging of sediments filling and covering
299 the channel, causing the phenomenon known as piping, a process that accelerated due
300 to the presence of underground streams water (Arias Jiménez, 2008), as illustrated in

301 Figures 10a-c.

601 Figure 10: a) Schematic view of the channelized river, the characteristics of the terrain and of the compacted
