1       **Causes and consequences of the Sinkhole at “El Trebol” of Quito,**  
2       **Ecuador - Implications to economic damage and risk assessment**

29 The so-called “El Trébol” is a critical road interchange in Quito connecting the north  
30 and south regions of the city. In addition, it connects Quito with the highly populated  
31 “Los Chillos” valley, one of the most traveled zones in the Ecuadorian capital. El  
32 Trébol was constructed in the late sixties in order to resolve the traffic jams of the  
33 capital city and for that purpose the Machángara river was rerouted through a concrete  
34 box tunnel. In March 2008, the tunnel contained a high amount of trash furniture that  
35 had been impacting the top portion of the tunnel, compromising the structural  
36 integrity. On the 31st of March 2008 after a heavy rainfall a sinkhole of great  
37 proportions was formed in the Trébol traffic hub. In the first few minutes, with an  
38 initial diameter of 30 meters. The collapse continued to grow in the following days  
39 until the final dimensions of 120 meters in diameter and some 40 meters of depth,

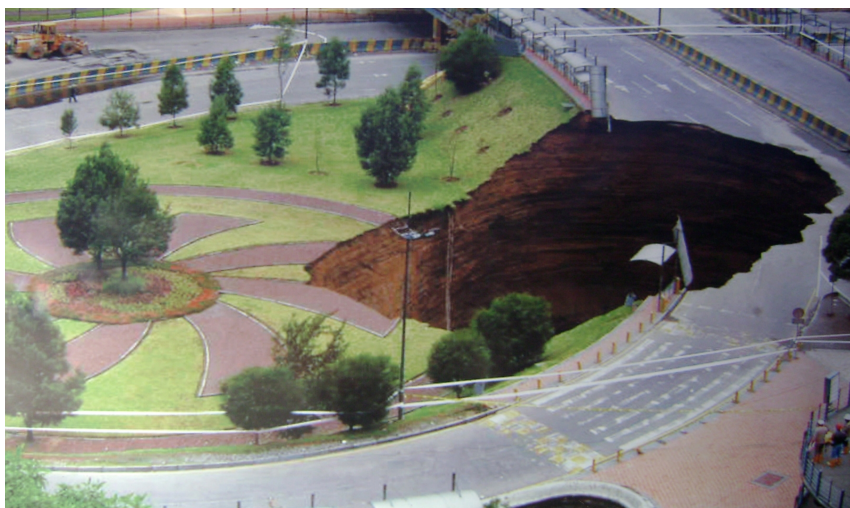
67 Considering this context, on the 31st of March 2008, during a regular working day, a  
68 heavy rainfall took place within an already extremely wet season, and around 2 p.m.,  
69 a sinkhole of great proportions was observed in the Trébol traffic hub. In the first few  
70 minutes, the sinkhole started to be generated in the form of a crater with a diameter of  
71 30 meters. The collapse continued to grow in the following days until the final  
72 dimensions of this almost round sinkhole reached approximately 120 meters in  
73 diameter and some 40 meters of depth, revealing base of the sinkhole, and the  
74 Machángara river.

577 Figure 2: Initial stage of sinkhole at "El Trebol".

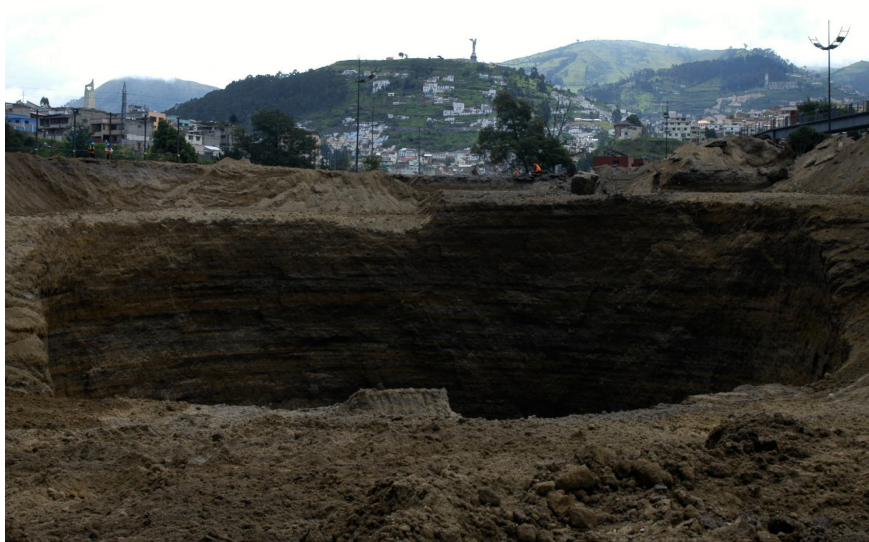
579 Figure 3: Panoramic view of the final stage of the sinkhole at "El Trebol". On the background the Panecillo  
580 volcanic dome.

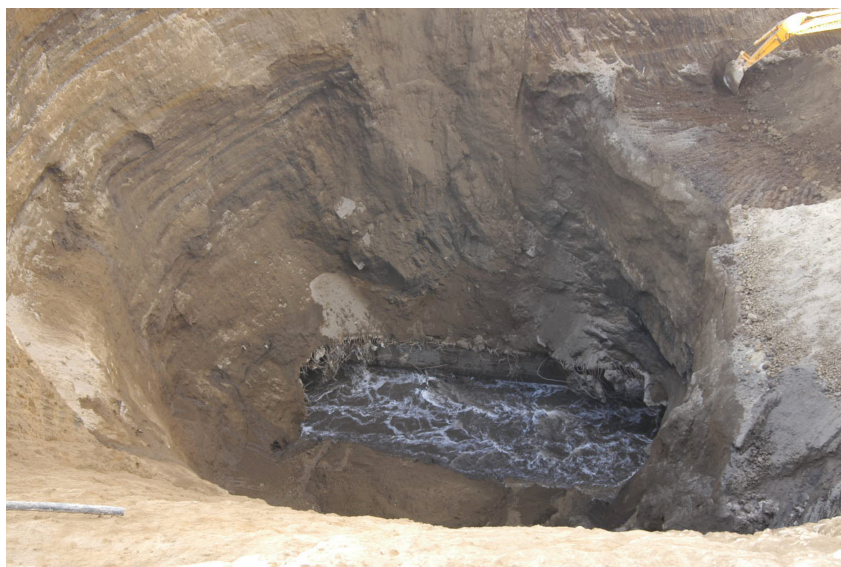
239 covered river. That river was detected after the visible collapse of the squeezed river  
240 concrete channel of the river Machángara for a distance of some 20 m. The result of  
241 this subsidence led to a traffic collapse and the declaration of the state of emergency  
242 of the Municipality of Quito. This analysis intend to identify the causes of this  
243 subsidence and afterwards to search for further areas with similar problems and  
244 vulnerabilities in order to avoid future disasters where potentially people could be  
245 involved.

582 Figure 4: View into the sinkhole with the appearance of the Machángara river at its base.

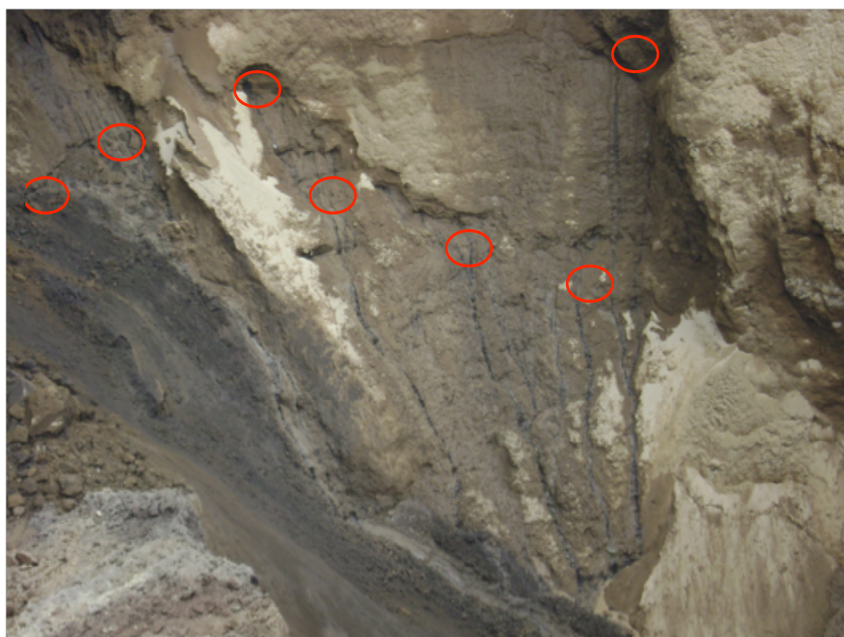
188 After the subsidence and collapse took place, groundwater emerged in the south and  
189 southwestern slopes at a depth of 20 meters from the upper rim of the slope (Fig. 6),  
190 These water springs contributed with a total flow of around 6 l/s, which decreased  
191 50% due to drilling of pumping wells strategically located. These springs revealed the  
192 presence of a free aquifer located in the south side of the sinkhole. Indeed, the  
193 existence of the aquifer was determined after field observations followed by three  
194 drillings, the water table is located between 12 and 15 meters deep. The aquifer is  
195 composed by granular materials within a silty sandy matrix, with a thickness of  
196 around 18 m with a gradient from southwest to northeast, the direction to the  
197 Machángara River (Fig. 7). The aquifer recharge probably takes place in the  
198 Luluncoto gorge situated 2 km to the southwestern.

590 Figure 6: Southern and southwestern side of the inner part of the sinkhole, where water flows.

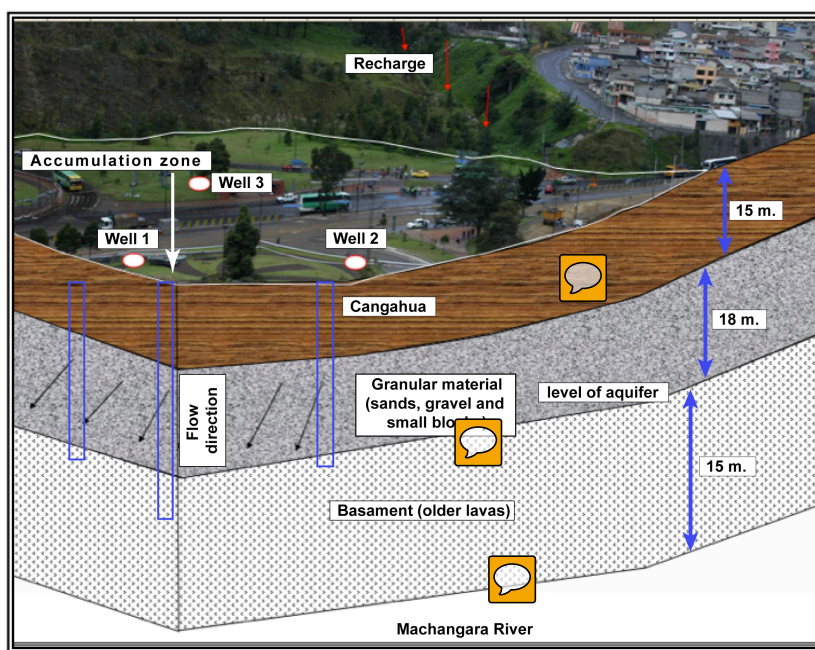
199 A flow of around 10 l/s was obtained from the aquifer considering two sources: (1)  
200 the continuous pumping from the wells and (2) the water springs from the south slope  
201 of the sinkhole. Despite this 10 l/s flow that was permanently extracted, the aquifer  
202 kept on flowing, suggesting that its recharge must have been higher than 10 l/s.  
203 Therefore, this flow should be taken into account when performing any reconstruction

592 Figure 7: Conceptual model of the aquifer with the site of the wells and the flowing direction.

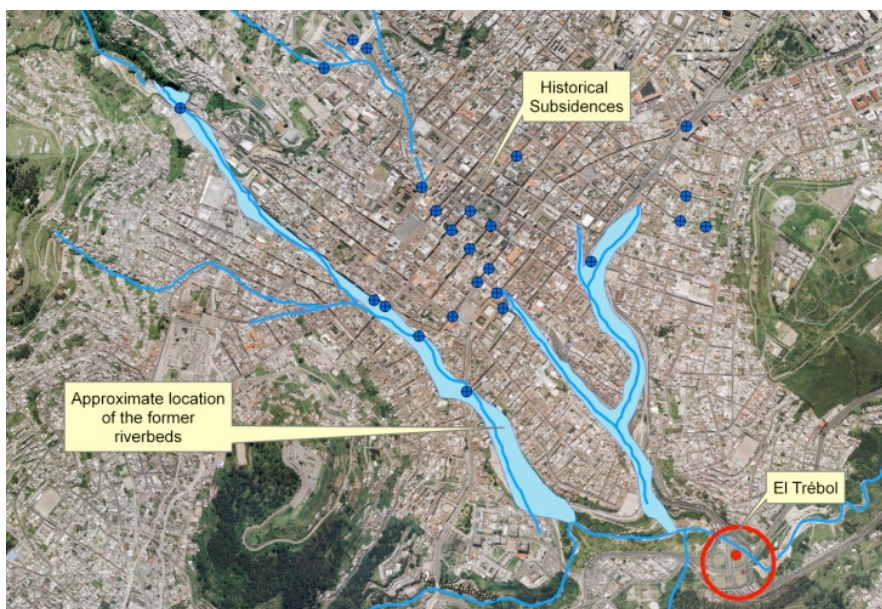
214 As a result of uncontrolled growth of the city, this natural drainage system was  
215 conducted on sewer channels below the construction of roads for vehicular traffic. ,  
216 Historical records include 12 sinking holes (Table 2; Fig. 8) of different magnitudes,  
217 defined as "... declines or collapses of roadway in the filler material streams, caused  
218 by faulty sewers"; as well as the filling, initially performed with debris and garbage,  
219 the age, type of construction and degree of deterioration of the physical work of the  
220 channels, sewers and collectors (Pewter, 1986).

221 The former sinkholes were located on the old bed of the filled streams, so we can  
222 assume that it will continue to occur, especially in periods of daily rainfall above the  
223 historical average. In the area of El Trébol, the first serious collapse was registered the  
224 31<sup>st</sup> of March 2008, 10 years after channels were made for the construction of the  
225 infrastructure to solve the problems of the traffic jams. Furthermore, there was a  
226 second sinkhole of lower rate on 10 January 2014 (Fig. 9).

594 Figure 8: Historical subsidences at Machángara river, including the El Trébol sector (marked with the red  
595 circle).

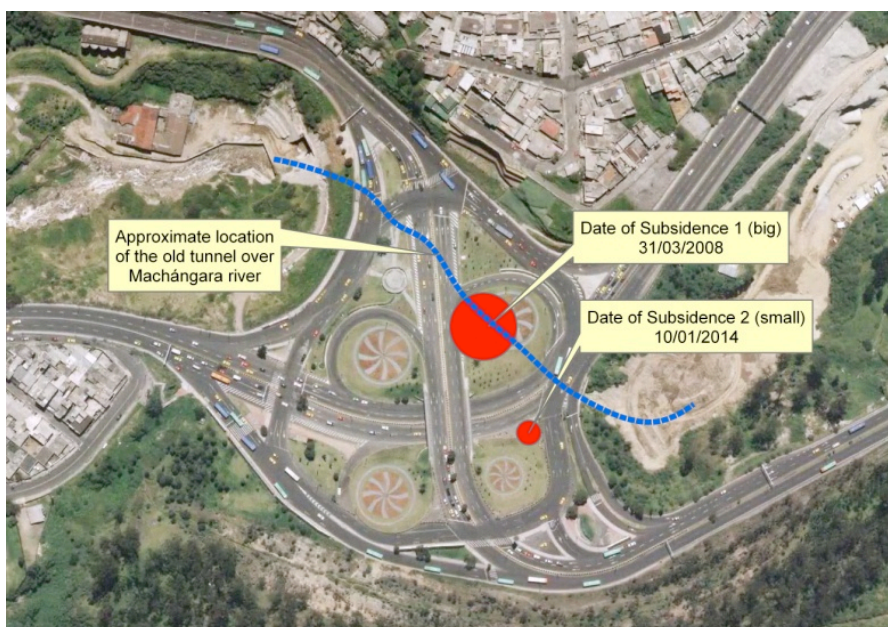
597 Fig. 9: El Trébol sector with the flowing direction of the Machángara river including the sinkholes of 2008  
598 (big red circle) and the recent in 2014 (small red circle).

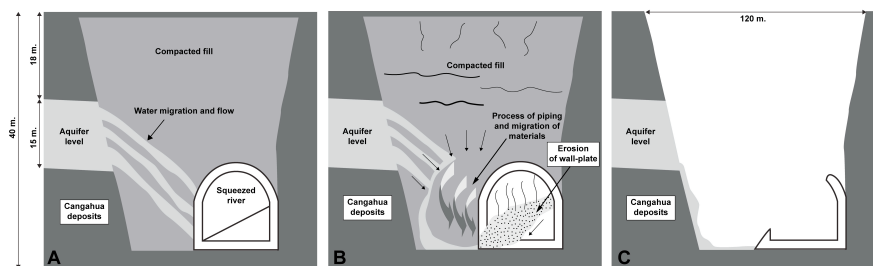
284 ~~The water with the chemical conditions described above, does not cause a significant~~  
285 ~~effect on the elements of the collector at all.~~ The potential alteration is rather directly  
286 related to the high speeds of the water and sediment carried by the river (boulders  
287 large, scrap wood, etc), which colliding with the structures produce weakening,  
288 fracturing and erosion, mainly at the floor (see figure 10a) (Arias Jiménez, 2008).

that the collapse of the channel was caused by a systematic alteration of  
291 structural elements by the erosion produced by big sediments and to a very less extend  
292 by the chemical action of the waters.

293 This hypothesis is based on the fact that in the collapsed collector on the left margin  
294 of the channel there are no vestiges of the floor. It would have a higher weight  
295 considering that the channel on that site makes a small break and the force of the  
296 water colliding directly in the union of the right gable with the floor, causing  
297 weakening and faulting. The water caused floor erosion, leaving the right transept  
298 without support and initiated a process of dragging of sediments filling and covering  
299 the channel, causing the phenomenon known as piping, a process that accelerated due  
300 to the presence of underground streams water (Arias Jiménez, 2008), as illustrated in  
301 Figures 10a-c.

302 As a result of piping a cavern was formed,

the soil lost sustainability and collapse of  
303 the filling occurred leading to the formation of the sinkhole in form of a crater. As  
304 stated above at first the sinkhole had a diameter of 30 to 40m, while a little later due

601 Figure 10: a) Schematic view of the channelized river, the characteristics of the terrain and of the compacted  
602 fill; b) Alteration of the compacted fill, process of piping and migration of materials, initial stage of the  
603 collapse; c) Formation of sinkhole, material drags surroundings due to river activity.
