1 The catastrophic landfill flowslide at Hongao dumpsite on December 20, 2015 in Shenzhen, China

6 **Abstract** A catastrophic flowslide occurred at Hongao dumpsite on Dec 20, 2015 in the Guangming New
7 District of Shenzhen, China. The flowslide caused 69 casualties with 8 missing and damaged 33 buildings.
8 In the absence of extreme weather condition and seismic activity, the cause(s) of the failure was analyzed
9 on the basis of multi-temporal remote sensing images, site investigation, *in-situ* tests, laboratory tests, and
10 numerical analyses. The preliminary results showed that the volume of the flowslide deposit was 2.32×10^6
11 m^3 and the volume of dumpsite filling was $6.27 \times 10^6 \text{ m}^3$ at the time of the event, which is three times larger
12 than the design capacity. The flowslide has the characteristics of high travel velocity and long run-out
13 distance. The displaced material was primarily silty soil in mixture of construction and demolition waste at
14 high moisture content. The primary causes of the failure were concluded as follow: (1) The dumpsite

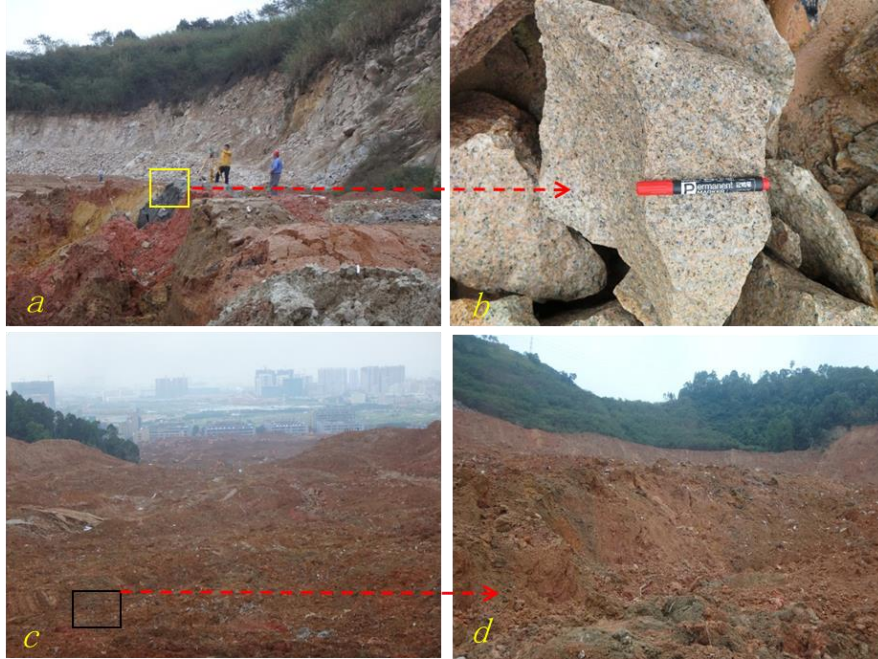
113 Fig. 2 Photos of the rock and soil specimen collected from the displaced material. **a** Exposed granite rock
 114 near the flowslide scarp; **b** Close view of the granite rocks; **c** Displaced material in the zone of depletion;
 115 **d** Materials in the flowslide source area.

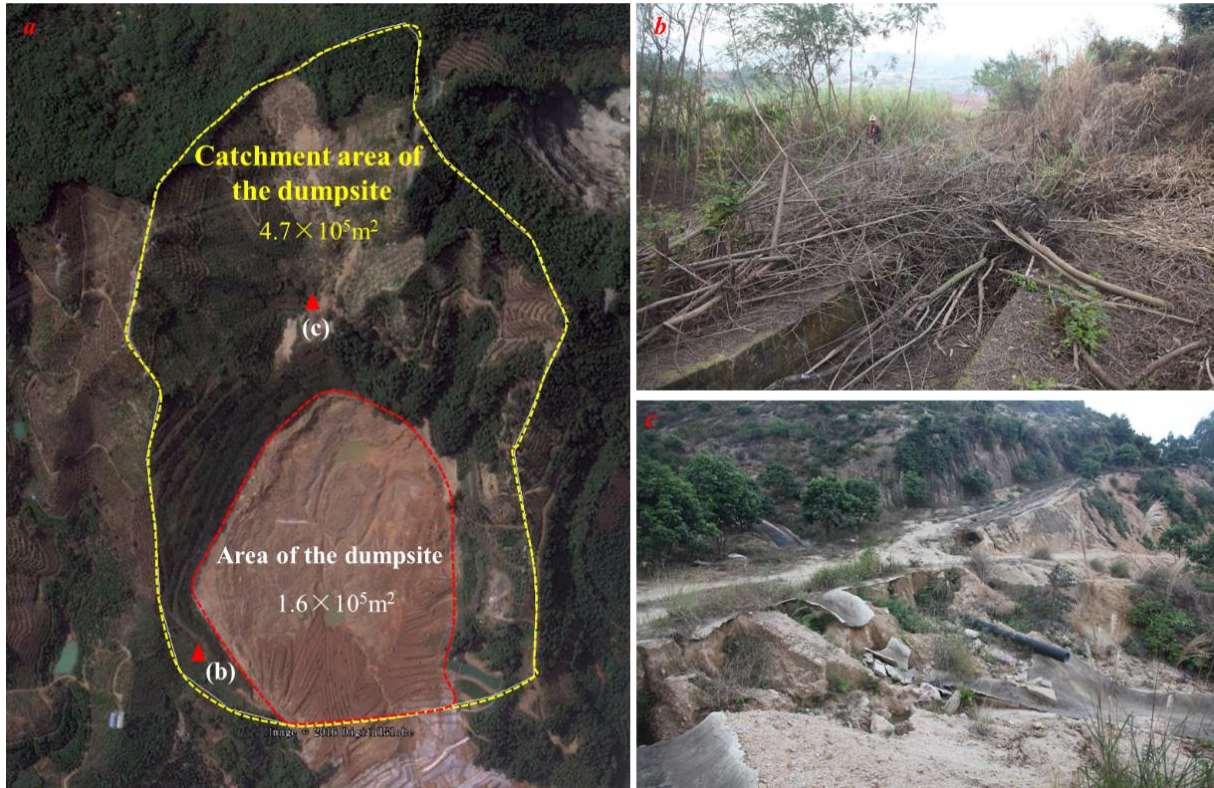
106 drainage system was abandoned (Fig. 5b and 5c), possibly in the lack of maintenance. With the inadequate
 107 drainage, the ingress of rainwater in the dumpsite was permitted (Fig. 6c), in addition to the concentration
 108 of surface run-off and groundwater into the dumpsite. Field test estimated that the permeability of the waste
 109 filling was $5.26 \times 10^{-6} \text{ cm/s}$. Low permeability and inadequate drainage resulted in the high moisture content
 110 and high pore water pressure in the dumpsite. The groundwater in the area were mainly bedrock fissure
 111 water and Quaternary pore water (Fig. 6).

121
 122 Fig. 5 **a** An overview of the catchment area (Google Earth image); **b** The surrounding peripheral drainage
 123 channel of the dumpsite was abandoned; **c** Damaged drainage pipes were not repaired and failed to divert
 124 surface run-off into the peripheral drainage channel. Surface run-off concentrated in the waste filling.

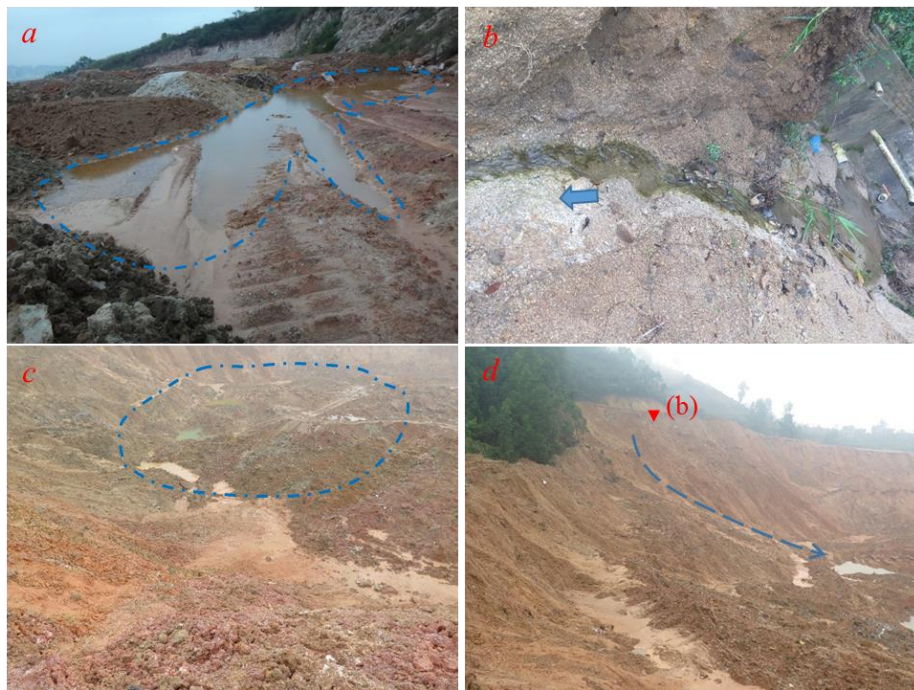
125
 126 Fig. 6 **a** Groundwater overflow in the rock fissures near the flowslide crown; **b** Water accumulation in the
 127 flowslide crown; **c** Water accumulation in the source area; **d** Surface run-off and infiltration contributed to
 128 groundwater seepage.

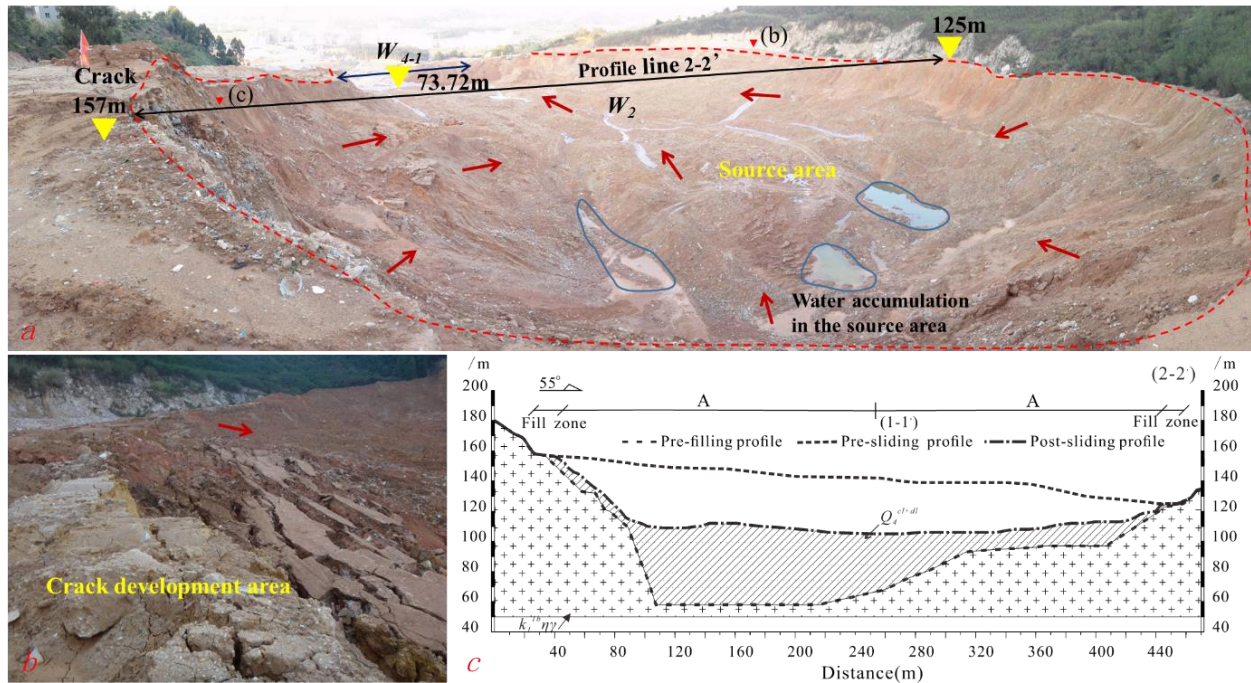
200 Fig. 12 **a** An overview of the source area (image taken at the flowslide crown facing north). A large opening
 201 (W_{4-1}) formed due to the failure of the retaining slope (the exit of the original quarry pit), which provided
 202 passage for the flowslide and permitted rapid release of kinematic energy; **b** Surface cracks were developed
 203 due to unloading near the crest and the flanks of the flowslide; **c** The geological cross section (profile line
 204 2-2') of the source area.
 205

206 With the ingress of rainwater and groundwater in the dumpsite, pore water pressure increases due to low
 207 permeability of the underlying granite. The lack of drainage resulted in waste filling saturation in the basal
 208 zone of the dumpsite which appeared as the final sliding bed of the flowslide (Fig. 12a).

209 A large amount of silty soil were observed in the source area. The material on both sides of the source area
 210 were mobilized due to the debuttressing effect as the waste filling in the lower portion of the dumpsite slid
 211 into the downstream industrial park, and in consequence, caused further collapse of the dumpsite. Step-like
 212 steep scarp was formed on the west of the main scarp with tensile cracks developed on the rear edge as well
 213 as both sides of the scarp.

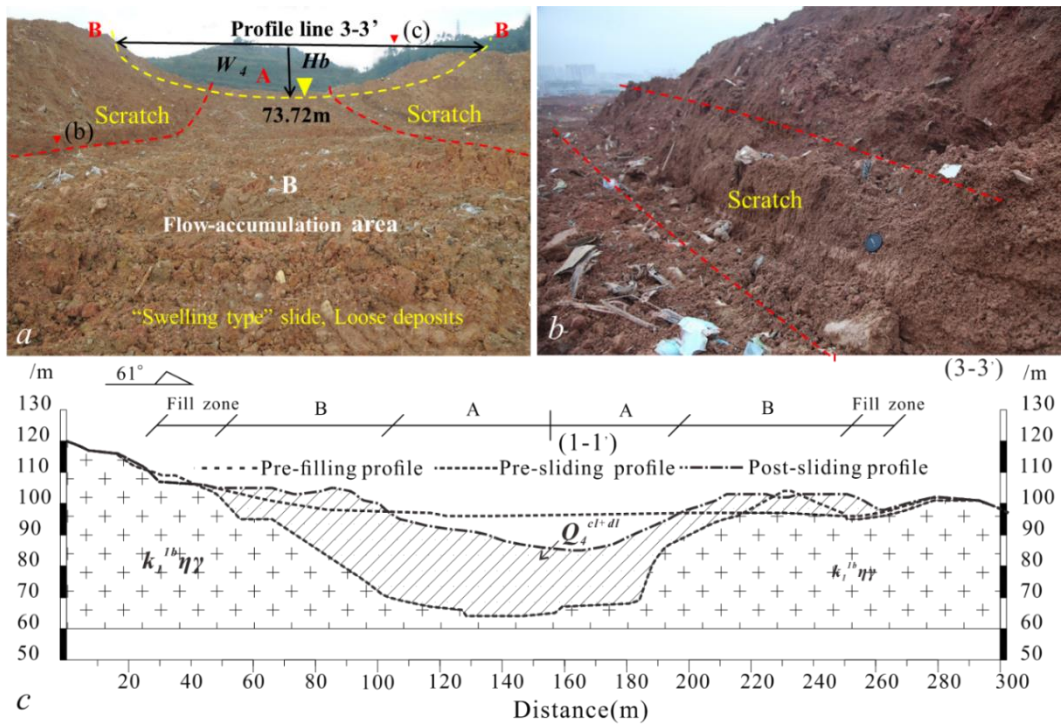
214 The presence of the aforementioned rock hills formed unfavorable topography for retaining slope stability
 215 by promoting a narrow gully for groundwater flow (Fig. 7c and Fig. 9). As a result of the retaining slope
 216 failure, a large opening was formed at the elevation of 73.7 m (between the front edge of the steep scarp
 217 and the rear edge of the flow-accumulation area) as shown in Fig. 9, Fig. 10, and Fig. 12a. The displaced
 218 material was stratified in the middle part of the flow-accumulation area during the high-speed sliding. The

219 shape of the failed retaining slope was half-elliptic-like with a width (W_{4-1}) of 217.7 m and a height (H_b) of
 220 27.5 m (Fig. 13a and 13c).

221
 222 Fig. 13 **a** The half-elliptic-like opening of the failed retaining slope; **b** Details on the scratch caused by the
 223 mass movement; **c** Geological cross section (profile line 3-3') of the failed retaining slope located at the
 224 original quarry pit between the two rock hills.

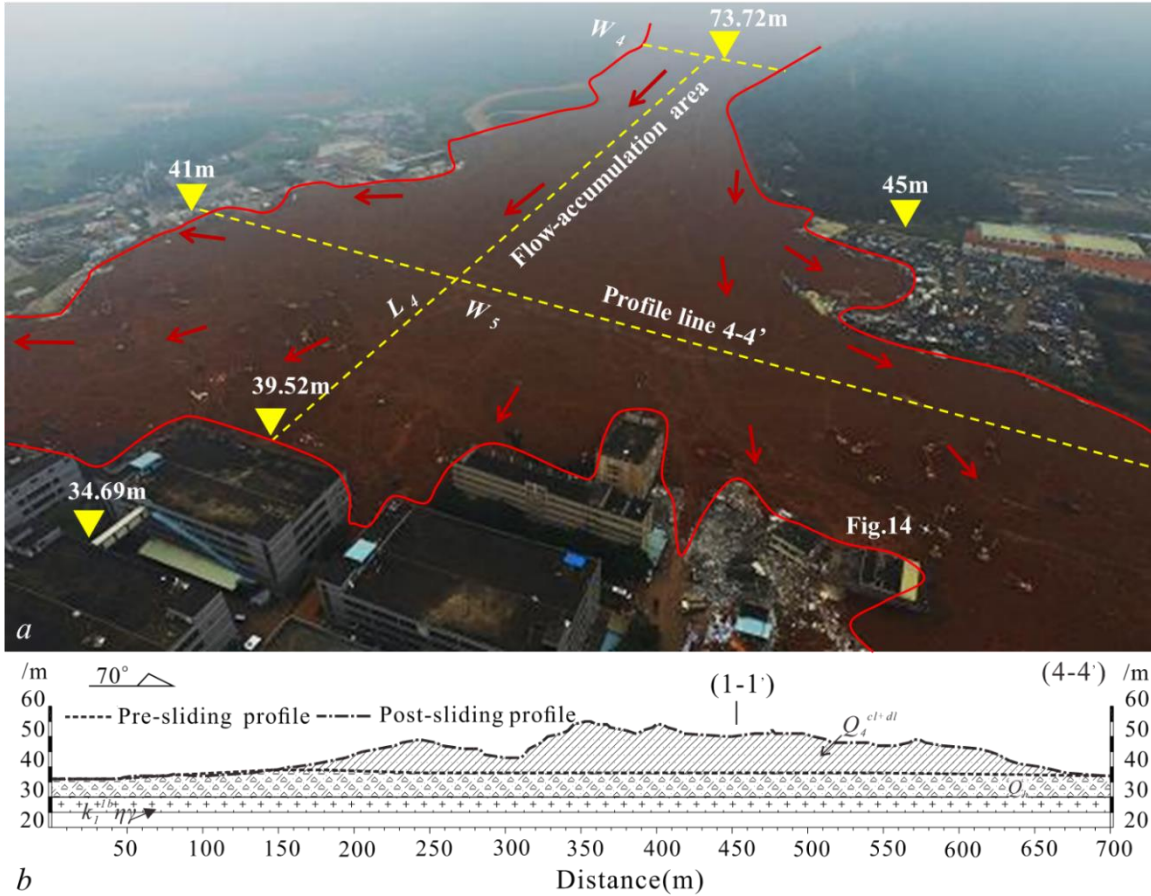
226 The fan-shaped flow-accumulation area mantled the retaining slope of the dumpsite and a large part of the
 227 industrial park as shown in Fig. 12a. The original slope gradient of the industrial park (Φ) was 1.36° along
 228 the profile line 1-1' as shown in Fig. 12 and Table 1. The area located immediately downstream of the
 229 dumpsite was relatively flat with no major construction except a pond (area approx. 3600 m^2) and a channel
 230 (width: 7 m and length: 130 m). Most of the industrial structures were constructed on east, west, and north
 231 side of the pond as shown in Fig. 9, and thus created a ideal flow channel for the flowslide. The failure of
 232 the rock retaining slope resulted in an opening for the waste fill movement which subsequently destroyed
 233 downstream buildings (Fig. 14 and 15).

Fig. 14 **a** The overview of the flow-accumulation area with elevations (China News Agency); **b** Geological cross section (profile line 4-4') of the flow-accumulation area. The length (L_4) was 664.4 m and the width (W_3) was 218.3 m with the width of the front edge (W_5) of 592.3 m. The area of the flow-accumulation area is $28.51 \times 10^4 \text{ m}^2$, and the elevation difference (H_4) was 35.7 m with an apparent dip (Φ_6) of 3.08° . The average thickness in the flow-accumulation area was 8.21 m with the maximum thickness of 18.82 m (Fig. 12c, Table 1, and Table 3).

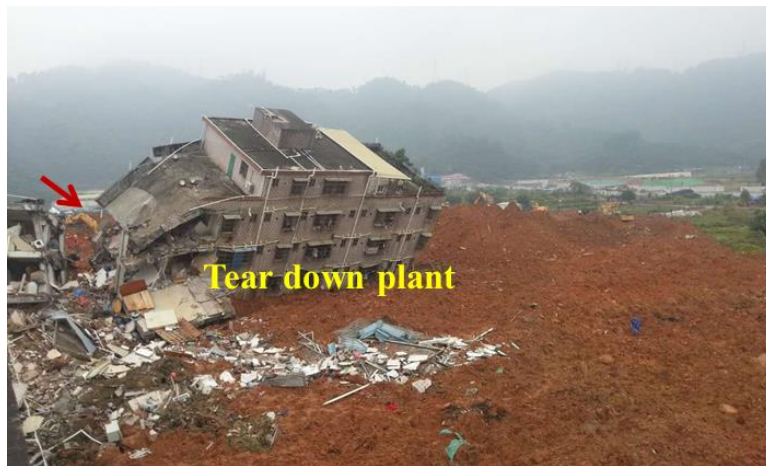
Fig. 15 The damage of buildings in the industrial park (China News Agency)

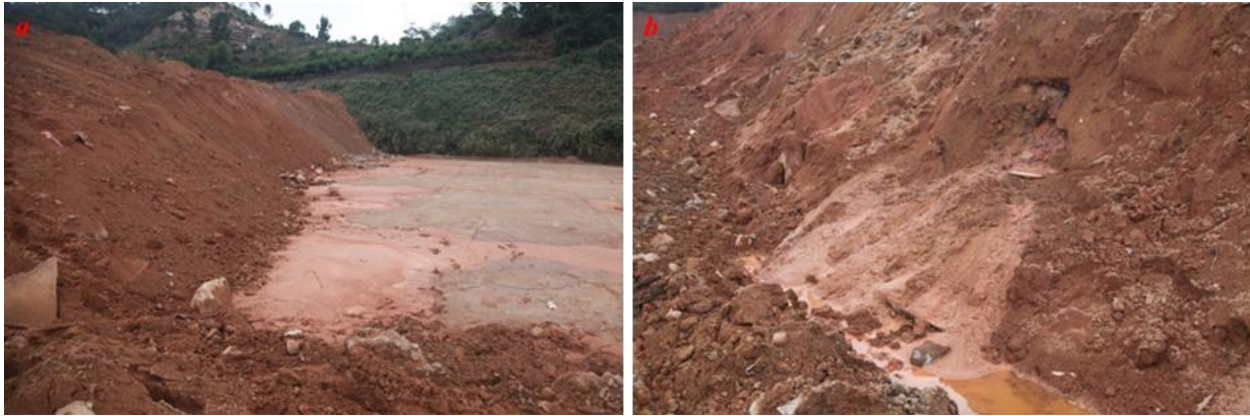
245 The high sliding velocity and long-runout distance of the flowslide may be related to a more diffuse failure
246 due to liquefaction near the base of the slope. Evidences of localized liquefaction can be found at several
247 locations (Fig. 16). Empirical correlation was used to back-calculate the flowslide travel velocity on the
248 basis of its geometrical characteristics. To better understand the failure mechanism, laboratory tests and
249 numerical analyses were performed.

Fig. 16 Evidences of liquefaction near the opening of the failed slope.
