1 The catastrophic landfill flowslide at Hongao dumpsite on December 20, 2015 in Shenzhen, China

6 **Abstract** A catastrophic flowslide occurred at Hongao dumpsite on Dec 20, 2015 in the Guangming New
7 District of Shenzhen, China. The flowslide caused 73 casualties with 4 missing and damaged 33 buildings.
8 In the absence of extreme weather condition and seismic activity, the causes of the failure were analyzed
9 on the basis of multi-temporal remote sensing images, site investigation, *in-situ* tests, laboratory tests, and
10 numerical analyses. Site investigations showed that the volume of the flowslide deposit was $2.32 \times 10^6 \text{ m}^3$
11 and the volume of dumpsite filling was $6.27 \times 10^6 \text{ m}^3$ at the time of the event, which is 3 times greater than
12 the design capacity. The flowslide was characterized by high travel velocity and long runout distance. The
13 displaced material was primarily silty soil in mixture of construction and demolition waste at high water

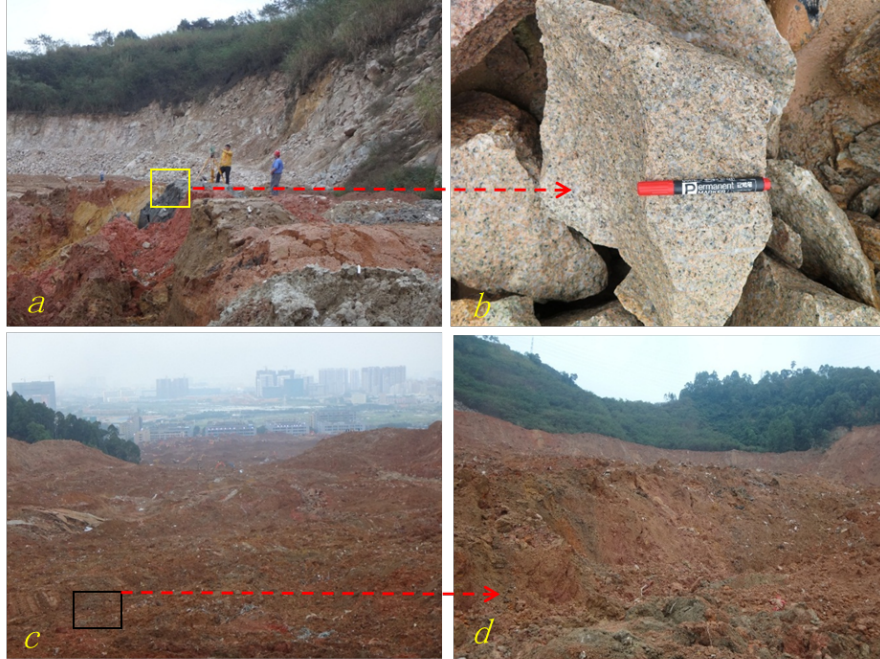
111 Fig. 2 Photos of the rock and soil specimen collected from the displaced material. **a** Exposed granite rock
 112 near the flowslide scarp; **b** Close view of the granite rocks; **c** Displaced material in the zone of depletion;
 113 **d** Materials in the flowslide source area.

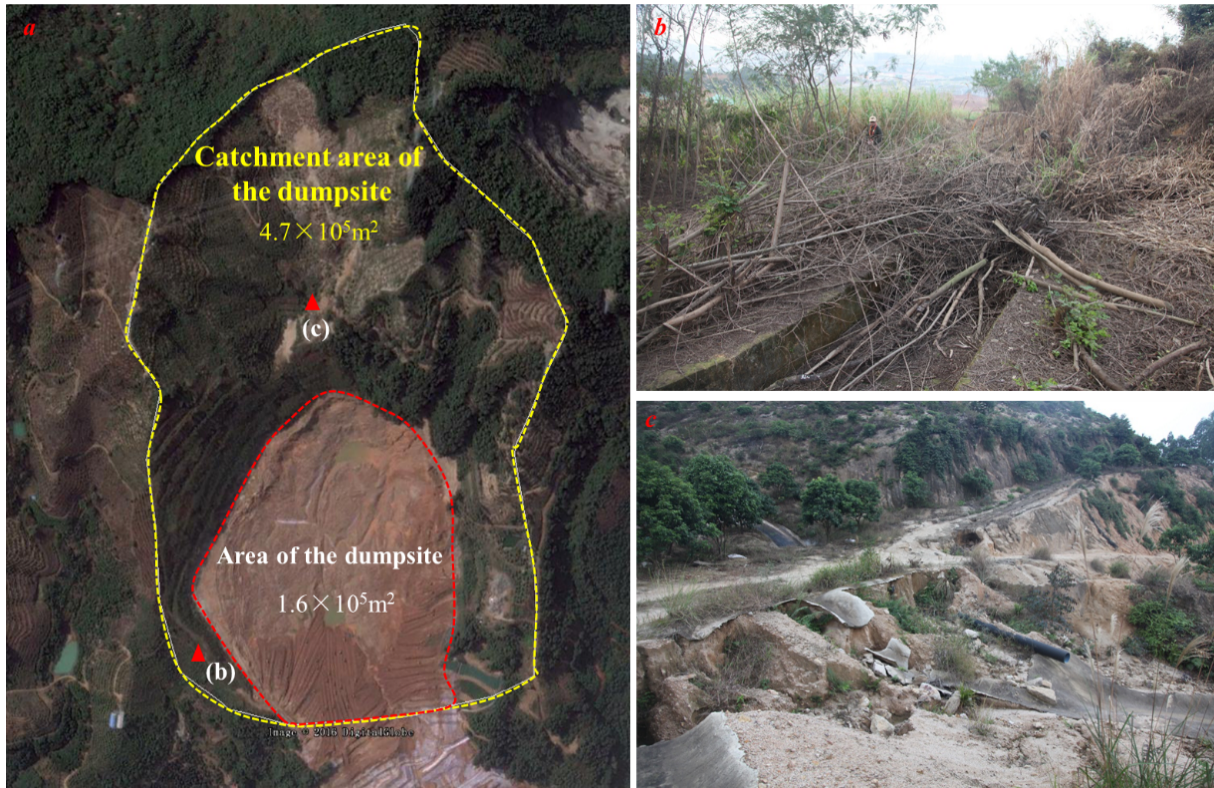
96 The study area belongs to the zone of subtropical monsoon climate with an average temperature of 22° and
 97 an average annual precipitation of 1500 mm concentrating between April and September (> 85 % of the
 98 annual rainfall) (Zhang et al., 2006). Based on the rainfall data from the nearby Tangjia Rainfall Station
 99 (Jan 1, 2013 - Dec 20, 2015) as shown in Fig. 4, a heavy rainfall occurred on Dec 9, 2015 with accumulated
 100 precipitation of 67.8 mm. The area of catchment (Fig. 5a) was estimated as $4.7 \times 10^5 \text{ m}^2$, which was nearly
 101 3 times greater than the area of the dumpsite ($1.6 \times 10^5 \text{ m}^2$). Drainage system was implemented to collect
 102 surface run-off by the drainage pipes installed at a higher elevation above the dumpsite and diverted into
 103 the peripheral drainage channels. Field evidences suggested that the drainage system was abandoned,
 104 possibly due to the lack of maintenance (Fig. 5b and 5c). With the inadequate drainage, ingress of rainwater

Fig. 5 **a** An overview of the catchment area (Google Earth image); **b** The surrounding peripheral drainage channel of the dumpsite was abandoned; **c** Damaged drainage pipes were not repaired and failed to divert surface run-off into the peripheral drainage channel. Surface run-off concentrated in the waste filling.

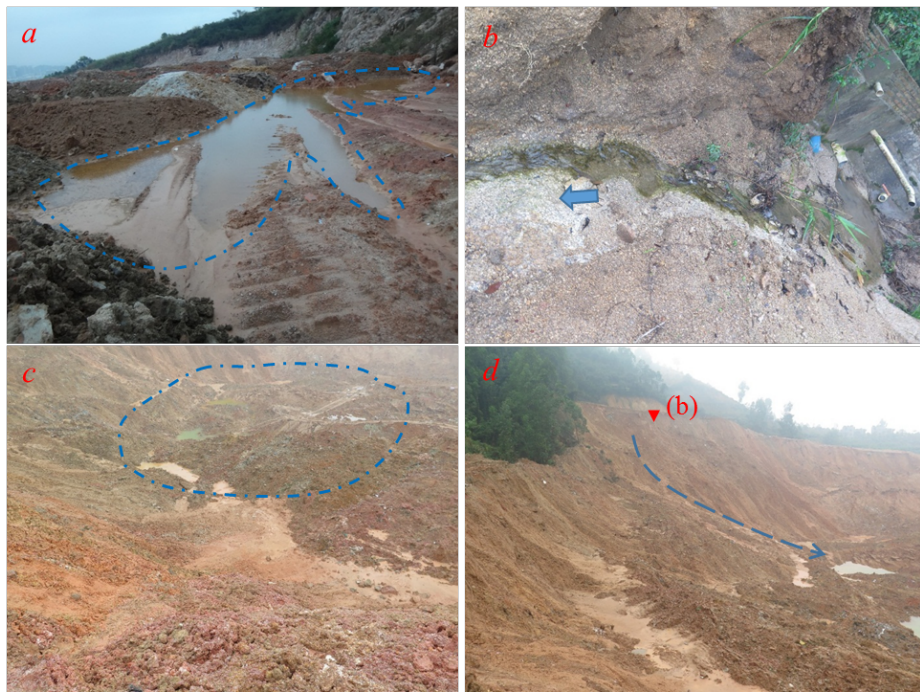
105 in the dumpsite was permitted (Fig. 6c), in addition to the concentration of surface run-off and groundwater
 106 into the dumpsite. The infiltration rate of the waste filling was estimated as $5.26 \times 10^{-6} \text{ cm/s}$ by field double
 107 ring infiltrometer. Low permeability and inadequate drainage resulted in high water content and high pore
 108 water pressure in the dumpsite. The groundwater in the study area were mainly bedrock fissure water and
 109 Quaternary pore water (Fig. 6).

Fig. 6 **a** Groundwater overflow in the rock fissures near the flowslide crown; **b** Water accumulation in the flowslide crown; **c** Water accumulation in the source area; **d** Surface run-off and infiltration contributed to groundwater seepage.

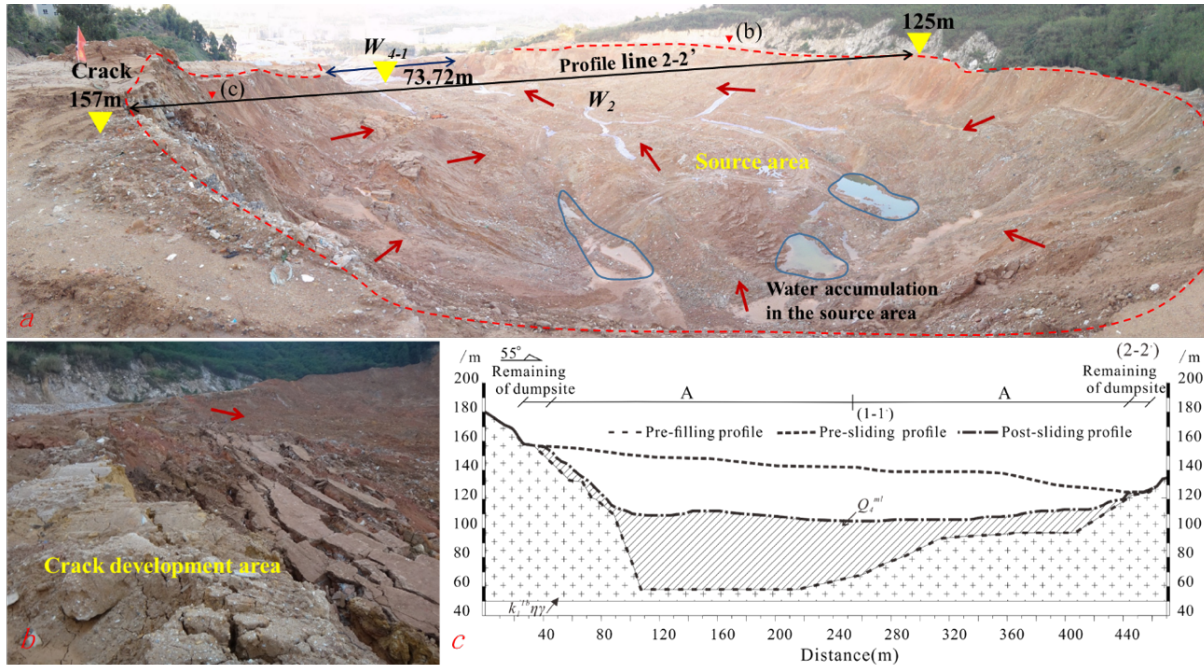
199 Fig. 12 **a** An overview of the source area (image taken at the flowslide crown facing north). A large opening
 200 (W_{4-1}) formed due to the failure of the retaining slope (the exit of the original quarry pit), which provided
 201 passage for the flowslide and permitted rapid release of kinematic energy; **b** Surface cracks were developed
 202 due to unloading near the crest and the flanks of the flowslide; **c** The geological cross section (profile line
 203 2-2') of the source area.
 204

205 Pore water pressure increases as rainwater and groundwater ingress in the dumpsite. The lack of drainage
 206 resulted in waste filling saturation in the basal zone of the dumpsite which appeared as the final sliding bed
 207 of the flowslide (Fig. 12a). A large amount of silty soil was observed in the source area. The water content
 208 of the remaining materials in the source area is 17.3%-42.4% (6 sampling locations). The materials on both
 209 sides of the source area were mobilized due to the debutting effect as the waste filling in the lower
 210 portion of the dumpsite slid into the downstream industrial park, and in consequence, caused collapse of
 211 the dumpsite. Step-like steep scarp was formed on the west of the main scarp with tensile cracks developed
 212 on the rear edge as well as both sides of the scarp.

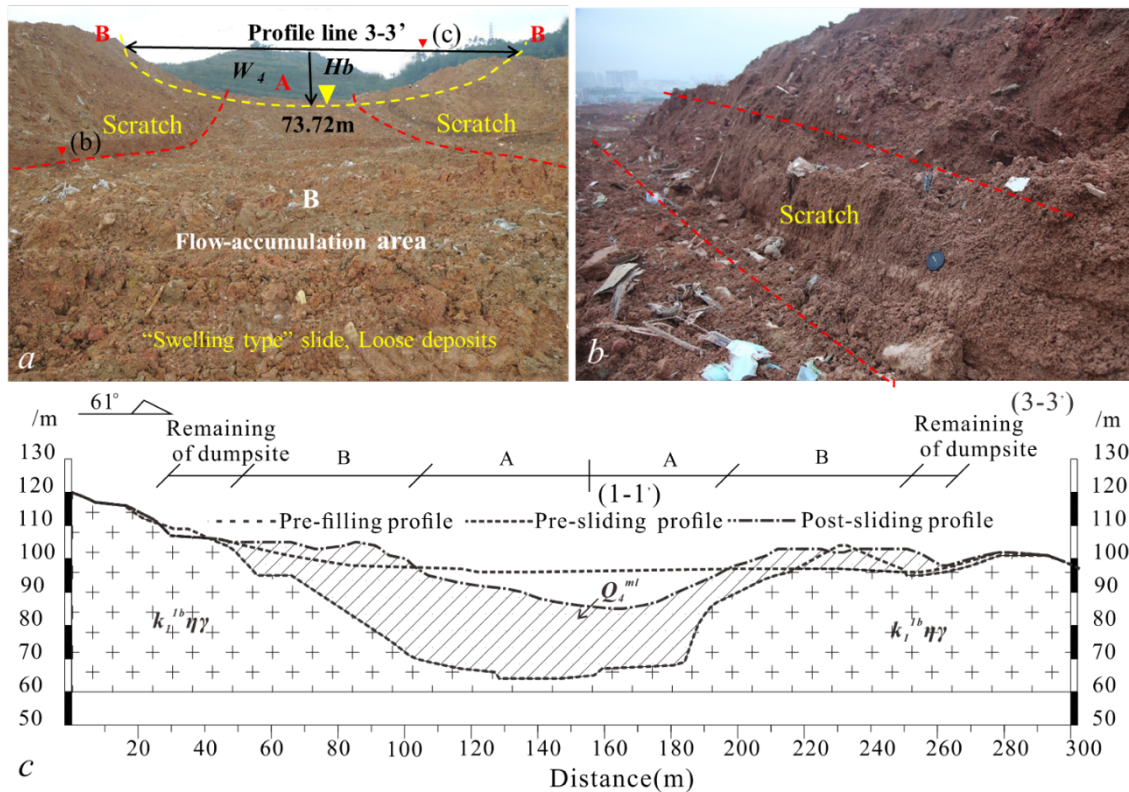
213 The presence of the aforementioned rock ridges formed unfavorable topography for the stability of the
 214 retaining slope as it promoted a narrow gully for groundwater flow (Fig. 7c and Fig. 9). As a result of the
 215 retaining slope failure, a large opening was formed at the elevation of 73.7 m (between the front edge of
 216 the steep scarp and the rear edge of the flow-accumulation area) as shown in Fig. 9, Fig. 10, and Fig. 12a.
 217 The displaced material was stratified in the middle part of the flow-accumulation area during the high-speed
 218 sliding. The shape of the failed retaining slope was half-elliptic-like with a width (W_{4-1}) of 217.7 m and a

221 Fig. 13 **a** The half-elliptic-like opening of the failed retaining slope; **b** Details on the scratch caused by the
 222 mass movement; **c** Geological cross section (profile line 3-3') of the failed retaining slope located at the
 223 original quarry pit between the two rock hills.

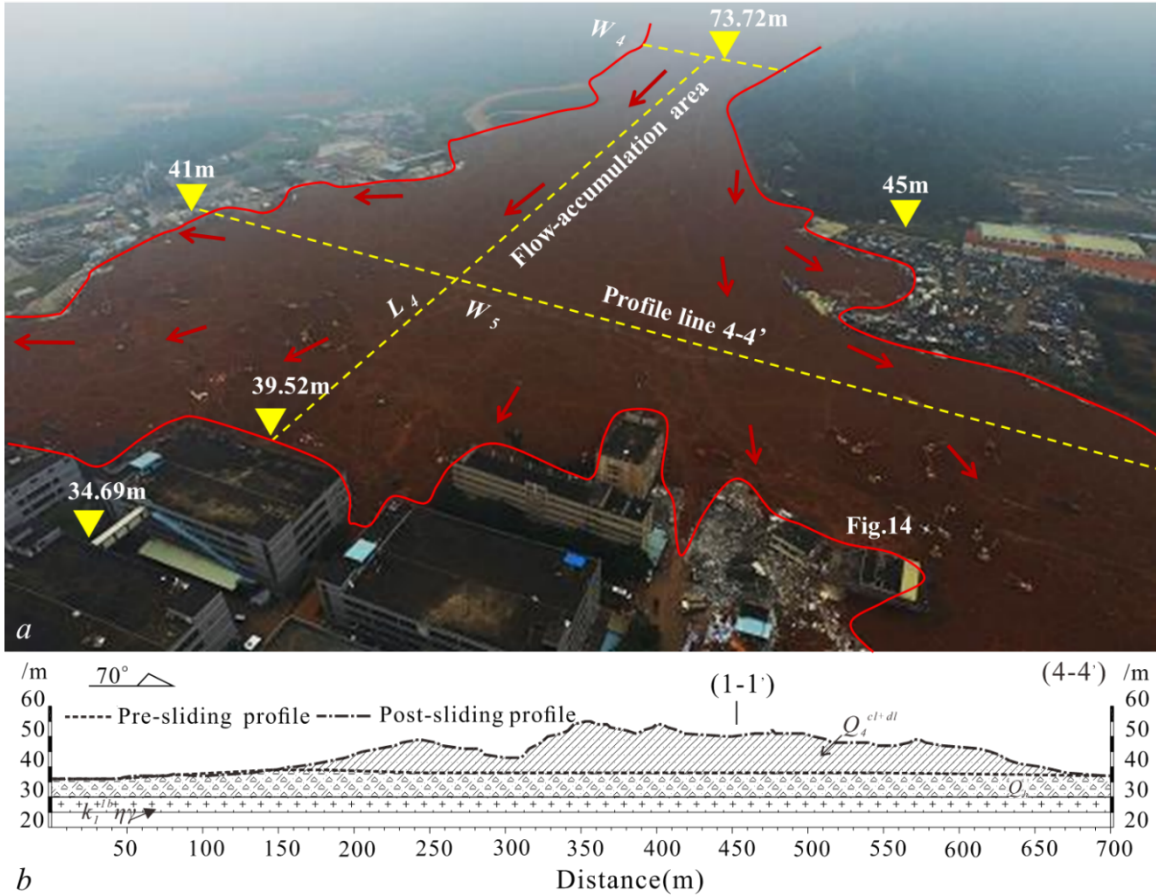
225 The fan-shaped flow-accumulation area mantled the retaining slope of the dumpsite as well as a large part
 226 of the industrial park as shown in Fig. 12a. The water content of the displaced material was 32.1%-37.2%
 227 (3 sampling locations). The original slope gradient of the industrial park (Φ) was 1.36° along the profile
 228 line 1-1' as shown in Fig. 12 and Table 1. The area located immediately downstream of the dumpsite was
 229 relatively flat with no major construction except a pond (area approx. 3600 m^2) and a channel (width: 7 m
 230 and length: 130 m). Most of the industrial structures were located on the east, west, and north side of the
 231 pond as shown in Fig. 9, and thus created an ideal flow channel for the flowslide. The failure of the rock
 232 retaining slope resulted in an opening for the waste fill movement which subsequently destroyed
 233 downstream buildings (Fig. 14 and 15).

Fig. 14 **a** The overview of the flow-accumulation area with elevations (China News Agency); **b** Geological cross section (profile line 4-4') of the flow-accumulation area. The length (L_4) was 664.4 m and the width (W_3) was 218.3 m with the width of the front edge (W_5) of 592.3 m. The area of the flow-accumulation area is $28.51 \times 10^4 \text{ m}^2$, and the elevation difference (H_4) was 35.7 m with an apparent dip (Φ_6) of 3.08° . The average thickness in the flow-accumulation area was 8.21 m with the maximum thickness of 18.82 m (Fig. 12c, Table 1, and Table 3).

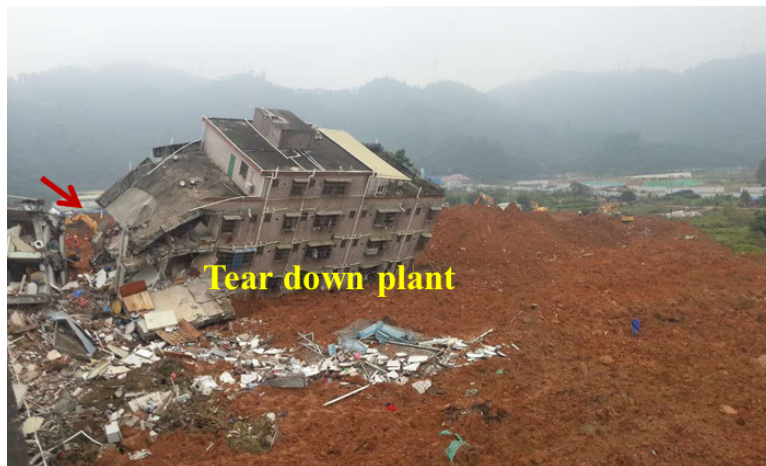
Fig. 15 The damage of buildings in the industrial park (China News Agency)

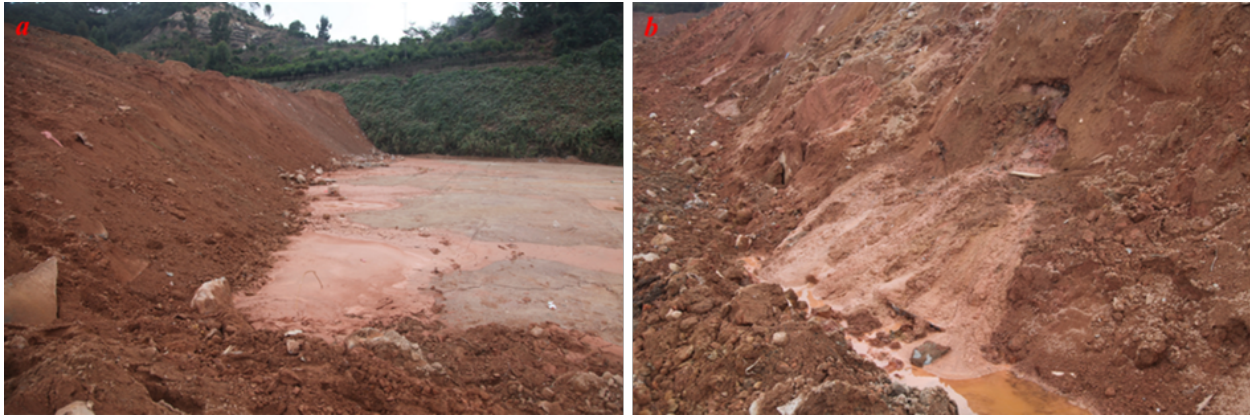
245 The high sliding velocity and long-runout distance of the flowslide may be related to a more diffuse failure
246 due to liquefaction near the base of the slope. Evidences of localized liquefaction can be found at several
247 locations (Fig. 16). Empirical correlation was used to back-calculate the flowslide travel velocity on the
248 basis of its geometrical characteristics. Laboratory tests and numerical analyses were performed to better
249 understand the failure process.

250
251 Fig. 16 Evidences of liquefaction near the opening of the failed slope.
