# 1 The catastrophic landfill flowslide at Hongao dumpsite on December 20, 2015 in Shenzhen, China

2 Qiang Xu<sup>1</sup>, Dalei Peng<sup>1</sup>, Weile Li<sup>1</sup>, Xiujun Dong<sup>1</sup>, Wei Hu<sup>1</sup>, Minggao Tang<sup>1</sup>, Fangzhou Liu<sup>2\*</sup>

6 **Abstract** A catastrophic flowslide occurred at Hongao dumpsite at approximately 11:40 AM on Dec 20,  
7 2015, in Guangming New District of Shenzhen, China. The flowslide damaged 33 buildings and caused  
8 total death toll of ~~69 and 8 missing~~, with the absence of extreme weather condition and seismic activity.  
9 The slope failure was analyzed on the basis of multi-temporal remote sensing images, site investigation, *in-*  
10 *situ* tests, laboratory experiment, and numerical analysis. The preliminary results showed that the volume  
11 of the flowslide deposit was ~~2.32×10<sup>6</sup> m<sup>3</sup>~~ and the volume of dumpsite filling was ~~6.27×10<sup>6</sup> m<sup>3</sup>~~ at the time  
12 of the event, ~~which is three times larger than the maximum design capacity~~. The flowslide had the  
13 characteristics of high travel speed and long run-out distance, of which the displaced material was primarily

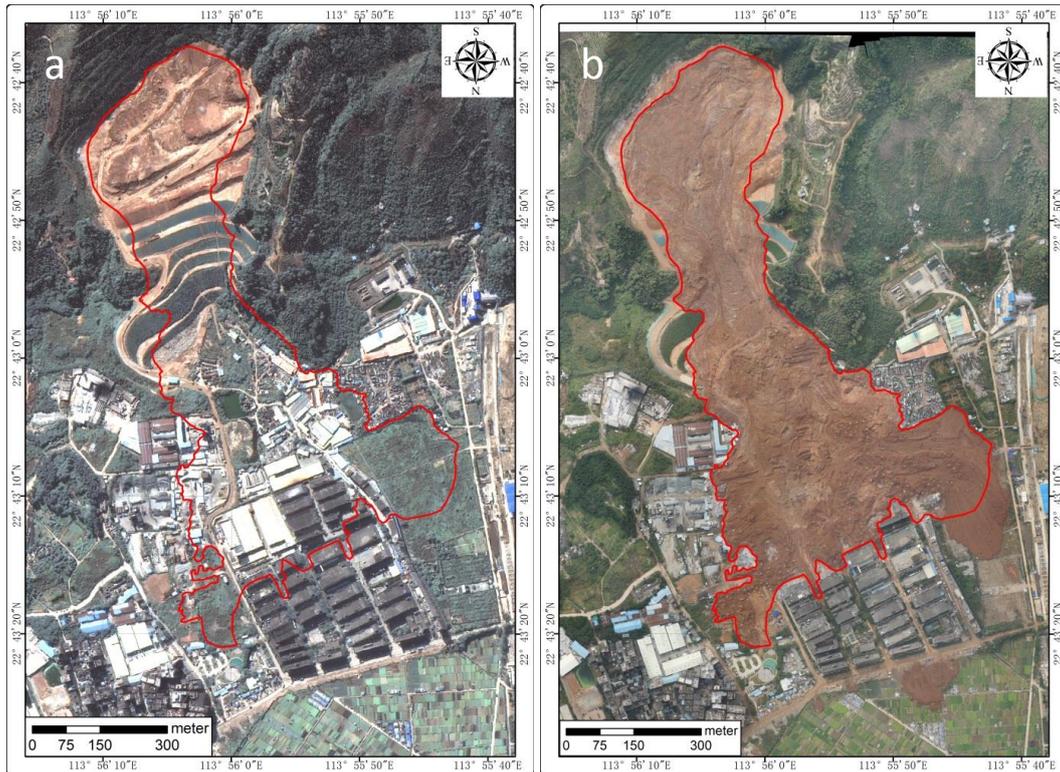
95 Fig. 1 Images for the Pre- and Post-sliding dumpsite. The boundary of the flowslide is indicated by the red  
96 line. **a** Pleiades satellite image (Dec 18, 2015); **b** Aerial photo (Dec 23, 2015).

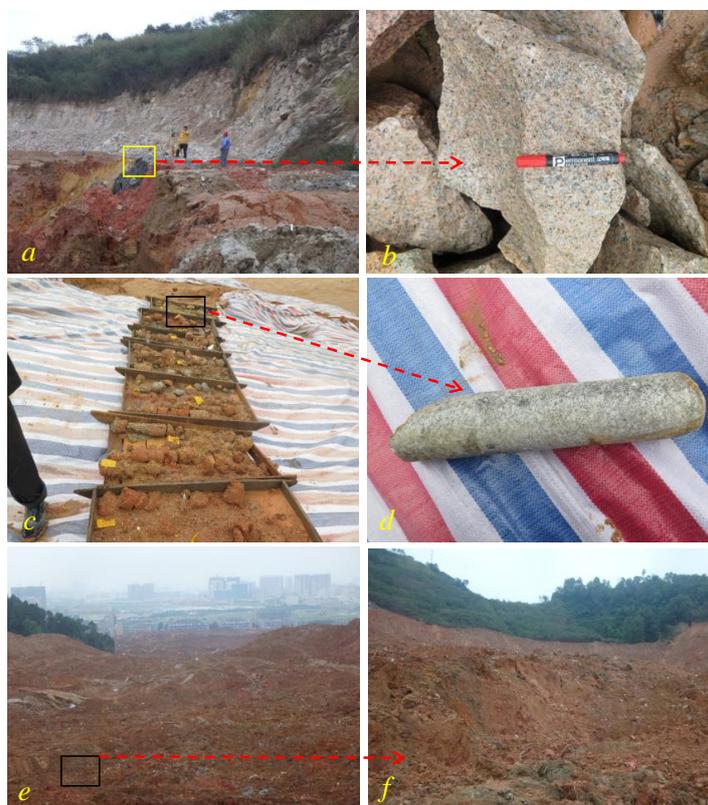
121 Fig. 3 Photos of the rock and soil specimen collected from the displaced material. **a** Exposed granite rock  
122 near the scarp of the landslide; **b** Close view of the granite rocks; **c** Drilling core samples; **d** Close view of  
123 the granite rock sample; **e** Displaced material in the zone of depletion; **f** Soils in the flowslide source area.

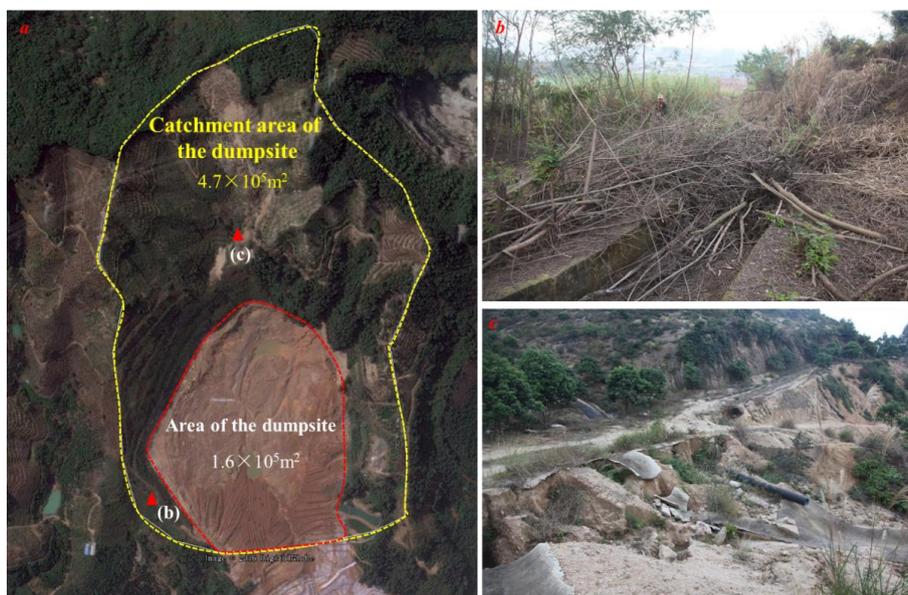
111 designed to be collected by the drainage pipes installed at a higher elevation than the dumpsite and divert  
112 into the peripheral drainage channel. However, the drainage system failed to operate due to the absence of  
113 maintenance, and led to the concentration of surface run-off and groundwater into the dumpsite. Field test  
114 estimated that the permeability of the waste filling was  $5.26 \times 10^{-6} \text{ cm/s}$ . Low permeability resulted in high  
115 moisture content and excess pore water pressure in the dumpsite. The groundwater in the study area were  
116 mainly bedrock fissure water and Quaternary pore water (Fig. 7).

Fig. 6 **a** An overview of the catchment area (Google Earth image); **b** The surrounding peripheral drainage channel of the dumpsite was abandoned; **c** Damaged drainage pipes were not repaired and failed to divert surface run-off into the peripheral drainage channel. Surface run-off concentrated in the waste filling.

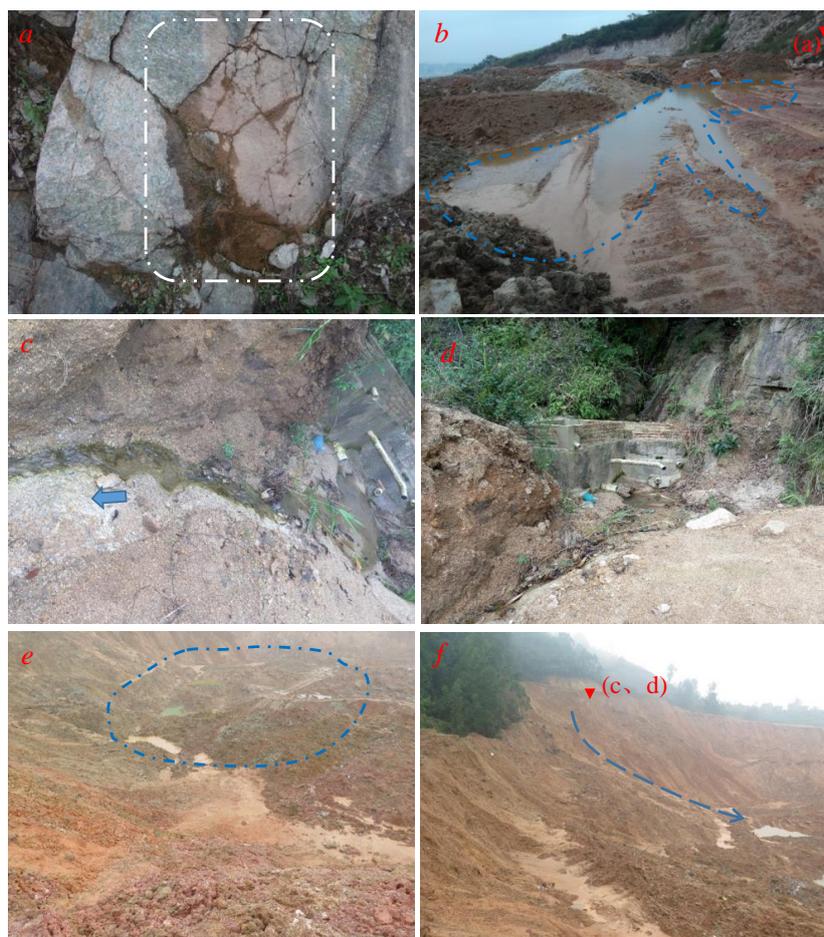
133 Fig. 7 **a** Groundwater overflow in the rock fissures near the flowslide crown; **b** Water accumulation in the  
134 flowslide crown; **c** Surface run-off near the flowslide source area during rainfall event; **d** Eroded channel  
135 in dry condition; **e** Water accumulation in the source area; **f** Surface run-off and infiltration contributed to  
136 groundwater seepage.

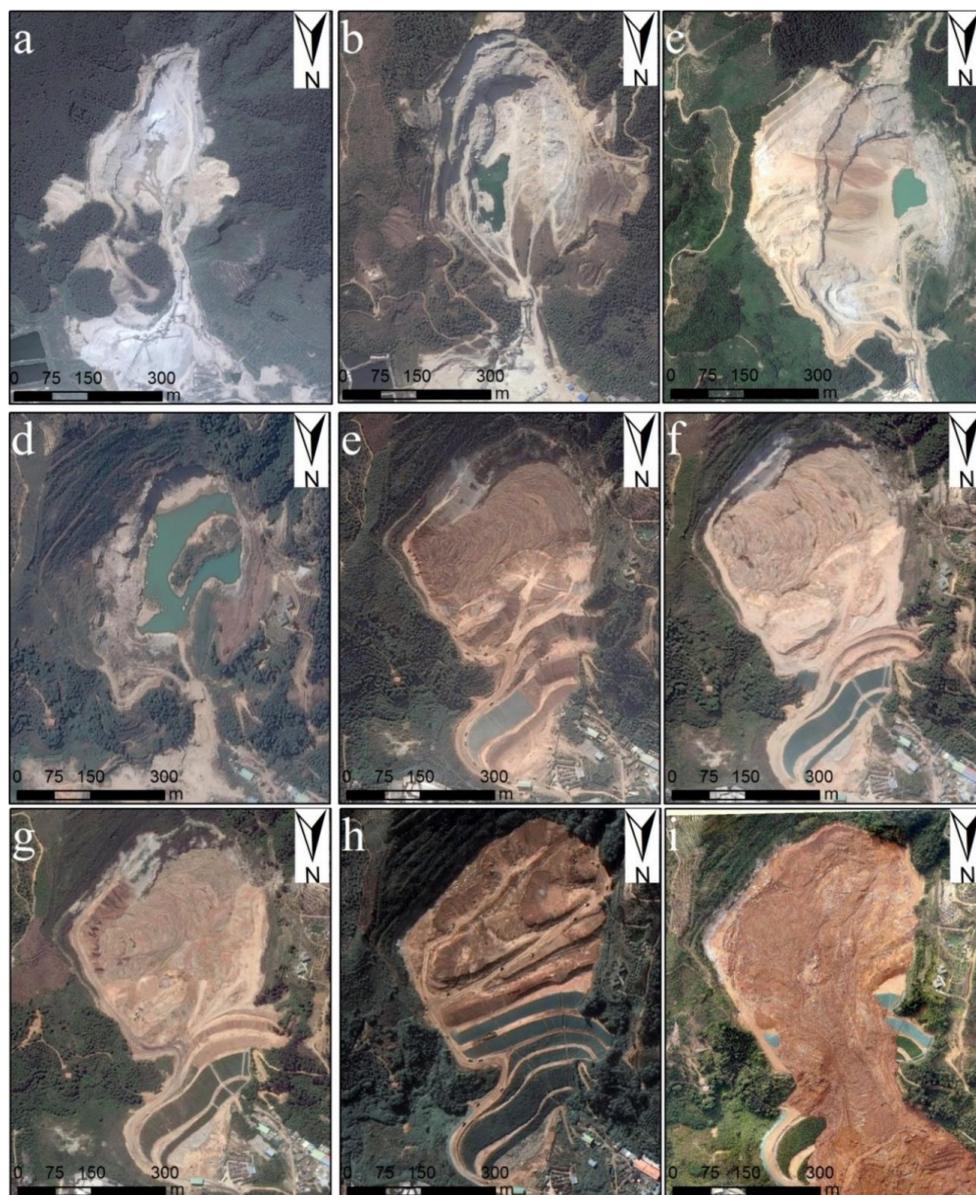
155  
156 Fig. 8 Multi-temporal remote sensing images of the study area. **a** 08/31/2002; **b** 02/20/2008; **c** 08/30/2010;  
157 **d** 11/25/2013; **e** 11/17/2014; **f** 01/23/2015; **g** 04/14/2015; **h** Pleiades (12/18/2015); **i** Aerial (12/23/2015).  
158 Image **a** to **g** were obtained from Google Earth. A service road was excavated at the exit of the quarry with  
159 a width of nearly 70 m (see image **a**, **b**, **c**, and **d**).

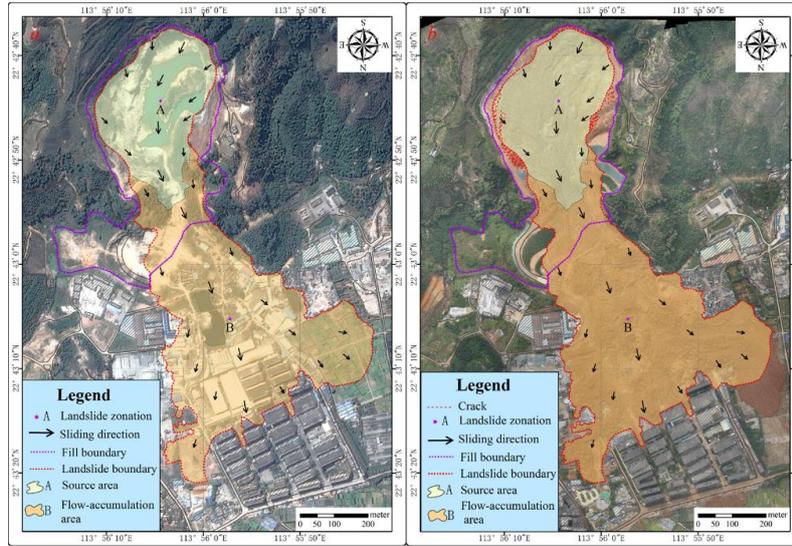
Fig.10 The direction of flowslide and distribution of the displaced material. **a** Flowslide overlying the pre-sliding industrial park showing the impact area and flow direction; **b** Aerial view of the flowslide.

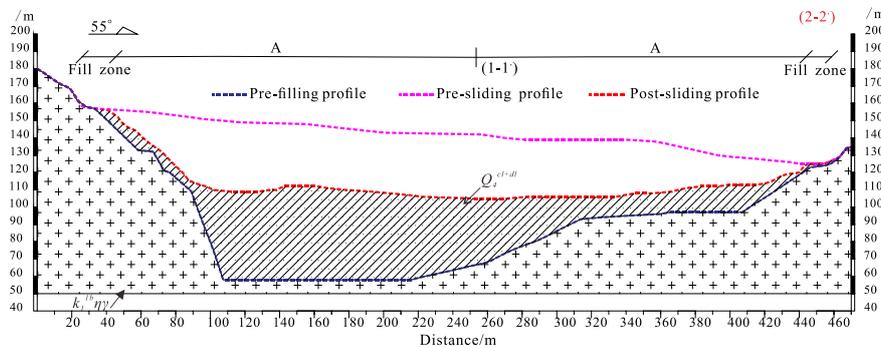
215 Fig.14 The geological cross section (profile line 2-2') of the source area.

216 With the ingress of rainwater and groundwater in the dumpsite, pore water pressure increases due to the  
 217 low permeability of the underlying granite in the Cretaceous system. It is appeared that the lack of drainage  
 218 resulted in waste filling saturation in the lower portion of the dumpsite, which in turn formed the sliding  
 219 bed of the flowslide (Fig. 15 and Fig. 16).

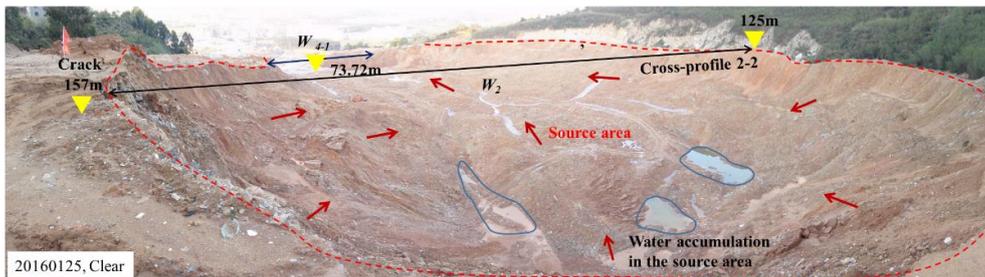
221 Fig.15 An overview of the source area (image taken at the flowslide crown facing north). A large opening  
 222 ( $W_{4.1}$ ) formed due to the failure of the retaining slope (the exit of the original quarry pit), which provided  
 223 passage for the flowslide and permitted rapid release of kinematic energy.

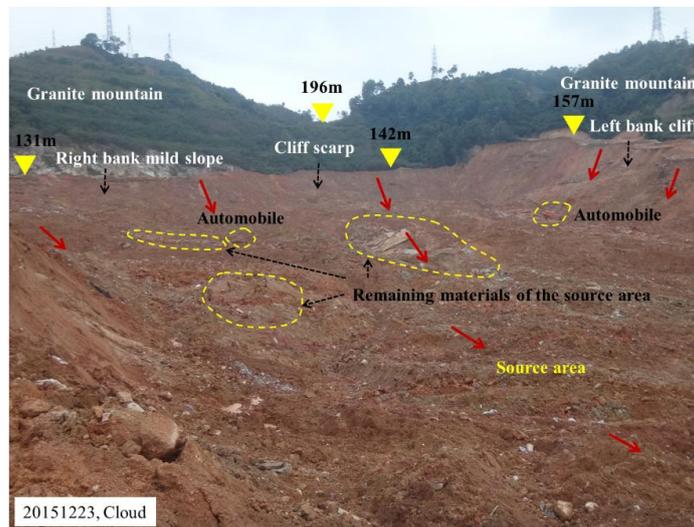
224 A large amount of silty soil were observed in the source area (Fig. 16). It is postulated that the material on  
 225 both sides of the source area were mobilized due to the debuttressing effect as the waste filling in the lower  
 226 portion of the dumpsite slid into the downstream industrial park, and in consequence, resulted in the collapse  
 227 of the dumpsite. Step-like steep scarp was formed on the west part of the main scarp area (Fig. 17c and  
 228 17d), with tensile cracks developed on the rear edge as well as both sides of the scarp.

229  
 230 Fig.16 An overview of the remaining material in the source area (image taken near the quarry pit exit facing  
 231 south). Several service vehicles parked in the rear edge of the dumpsite were dragged into the source area  
 232 as waste filling slide into the industrial park. Blocky rock fragments were found in the source area.

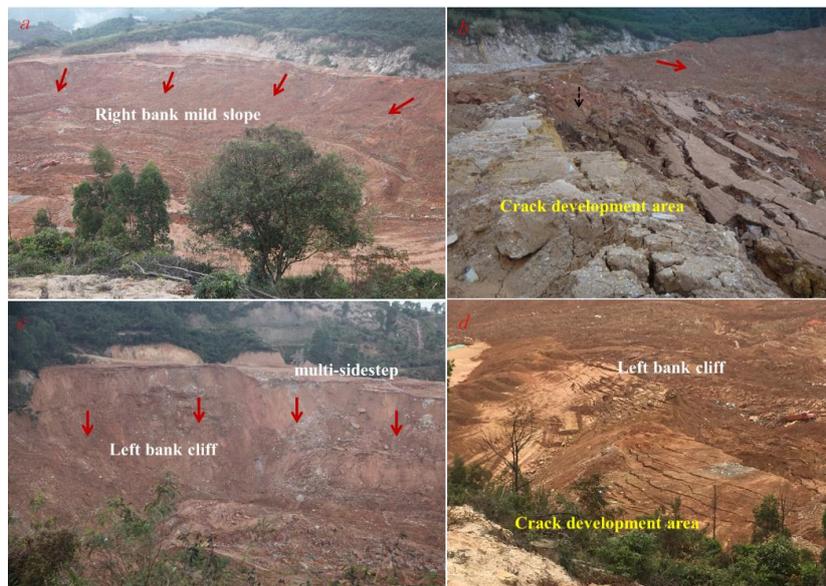
233  
 234 Fig.17 Characteristics of the remaining material in the source area. **a** Mild scarp on the east part of the main  
 235 scarp area; **b** Cracks were developed in the west boundary of the flowslide; **c** Step-like steep scarp on the  
 236 west part of the main scarp area; **d** An overview of the west part of the flowslide crown.

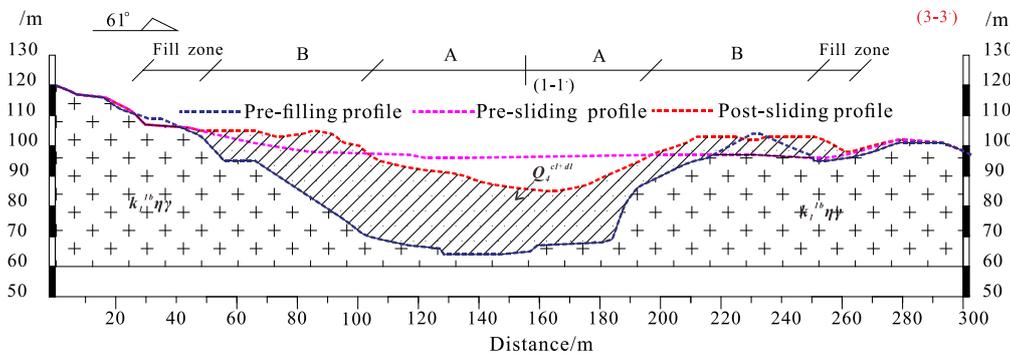
237 The presence of the aforementioned rock hills formed unfavorable topography for retaining slope stability  
 238 by promoting a narrow gully for groundwater flow (Fig. 8c and Fig. 10b). As a result of the retaining slope  
 239 failure, a large opening was formed at the elevation of 73.7 m between the front edge of the steep scarp and  
 240 the rear edge of the flow-accumulation area as shown in Fig. 11, Fig. 12, and Fig. 15. The displaced material  
 241 was stratified in the middle part of the flow-accumulation area during the high speed sliding process. The  
 242 shape of the failed retaining slope was half-elliptic-like with a width ( $W_{4-1}$ ) of 217.7 m and a height ( $H_b$ ) of  
 243 27.5 m (Fig. 18 and Fig. 19).

244  
 245 Fig. 18 Geological cross section (profile line 3-3') of the failed retaining slope located at the original quarry  
 246 between the two rock hills.

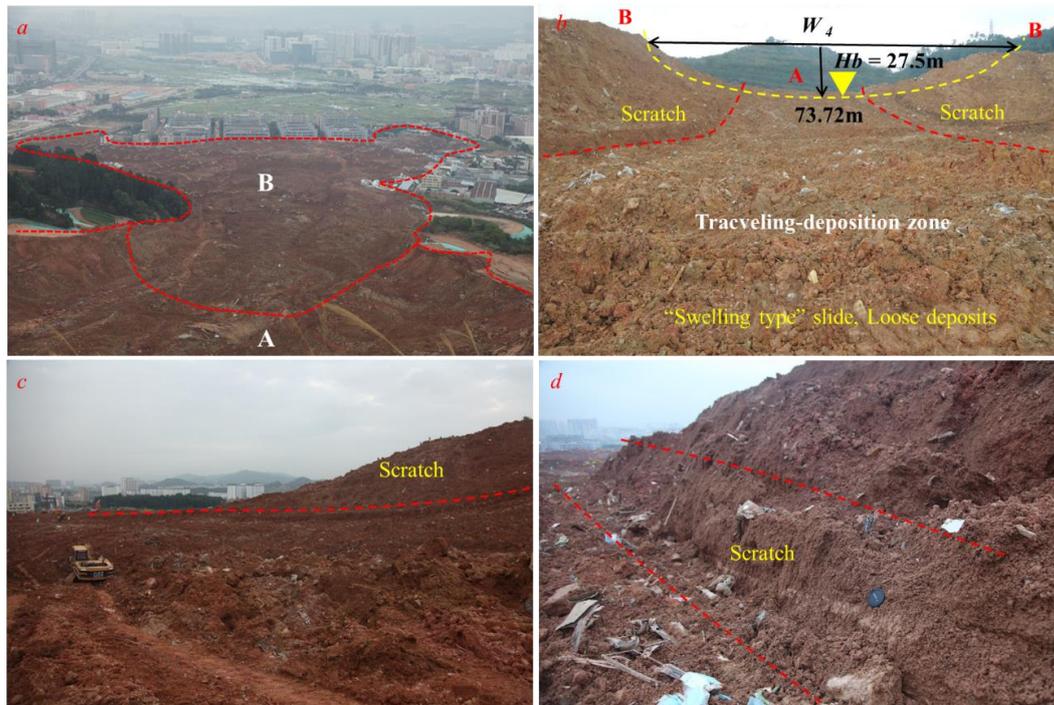
247  
 248 Fig. 19 **a** An overview of the exit of the flowslide between the source and flow-accumulation area (Photo  
 249 courtesy of China News Agency); **b** The half-elliptic-like opening of the failed retaining slope; **c** East side  
 250 of flow-accumulation area adjacent to the opening showing scratch caused by the flowslide; **d** Details on  
 251 the scratches.

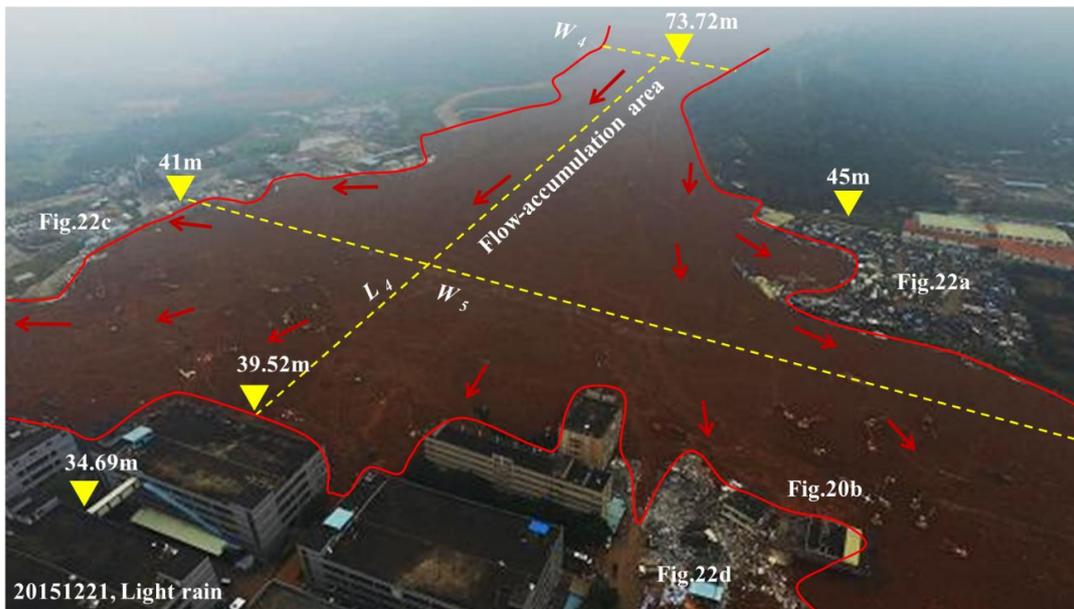
253 The fan-shaped flow-accumulation area mantled the retaining slope of the dumpsite and a large part of the  
 254 industrial park as shown in Fig. 20. The original slope gradient of the industrial park ( $\Phi$ ) was  $1.36^\circ$  along  
 255 the profile line 1-1' as shown in Fig. 14 and Table 1. The area immediately downstream of the landfill was  
 256 relatively flat with no major construction except a pond (approx.  $3600 \text{ m}^2$ ) and a channel (width: 7 m and  
 257 length: 130 m). Most of the industrial structures were constructed on east, west, and north side of the pond  
 258 as shown in Fig. 10a, and therefore, created a ideal flow channel for the mass movement. The failure of the  
 259 rock retaining slope resulted in an opening for the waste fill flow and destroyed downstream buildings (Fig.  
 260 20 and Fig. 21).

261  
 262 Fig. 20 The overview of the flow-accumulation area with elevations (Photo courtesy of China News Agency)

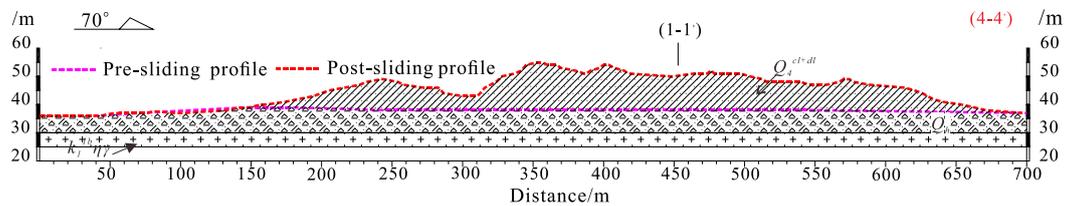
263  
 264 Fig. 21 Geological cross section (profile line 4-4') of the flow-accumulation area. The length ( $L_4$ ) was 664.4  
 265 m and the width ( $W_3$ ) was 218.3 m with the width of the front edge ( $W_5$ ) of 592.3 m. The area of the flow-  
 266 accumulation area is  $28.51 \times 10^4 \text{ m}^2$  and the elevation difference ( $H_4$ ) was 35.7 m with the apparent dip ( $\Phi_6$ )  
 267 of  $3.08^\circ$ . The average thickness in the flow-accumulation area was 8.21 m with the maximum thickness of  
 268 18.82 m (Fig. 14, Table 1, and Table 3).

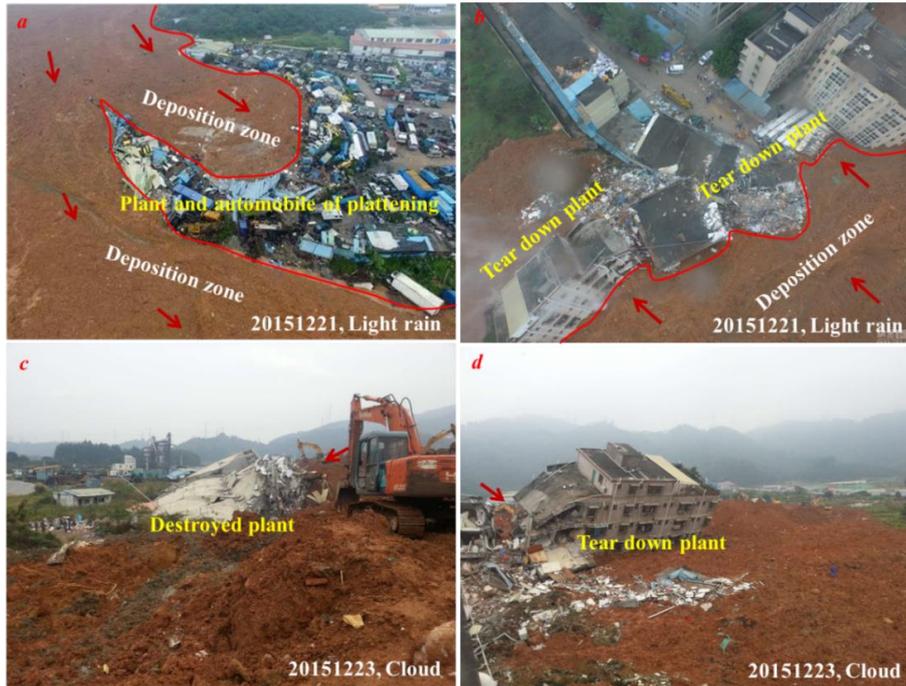
Fig. 22 The damage of buildings in the industrial park (Photo courtesy of China News Agency).

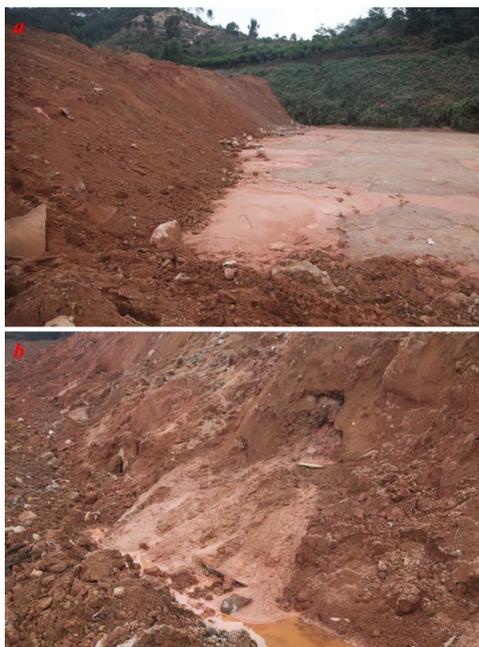
Since the parameters obtained by the inversion analysis were largely different from the experimental results, it is postulated that the deformation and failure of the landfill was ascribed to the excess pore water pressure in the waste filling. The sharp increase of the pore water pressure causes significant destruction and results in liquefaction. Localized liquefactions were found at several locations on the study area (Fig. 27). The exact reason for the surge in the pore water pressure remains unclear at this point, however, it may involve: (1) rapid surcharge loading in the dumpsite while pore water pressure cannot dissipate immediately; (2) the waste filling was loosely packed with large pores in the microstructure, and the collapse of particle structure lead to the shrinkage of pores, and in turn building excess pore water pressure.

Fig. 27 Evidence of liquefaction near the opening of the failed retaining slope.
