Damages during February, 6-24 2017 Çanakkale earthquake swarm

Abstract. On February 6, 2017 a swarm of earthquakes began at the western end of the Turkey. This has been the first recorded swarm at Çanakkale region since continuous seismic monitoring began in 1970. The number of located earthquakes increased during the next ten days. This paper describes the output of a survey carried out in the earthquake prone towns of Ayvacık, Çanakkale, Turkey, in February 2017 after the earthquakes. Observations collected on site regard traditional buildings at the rural area of Ayvacık. A description of the main structural features and their effects on the most frequently viewed damage modes are related in plane, out of plane behaviour of the wall regarding construction practice, connection type etc. It was found that there were no convenient connection details like cavity-ties or sufficient mortar strength resulting in decreased and/or lack of lateral load bearing capacity of the wall.

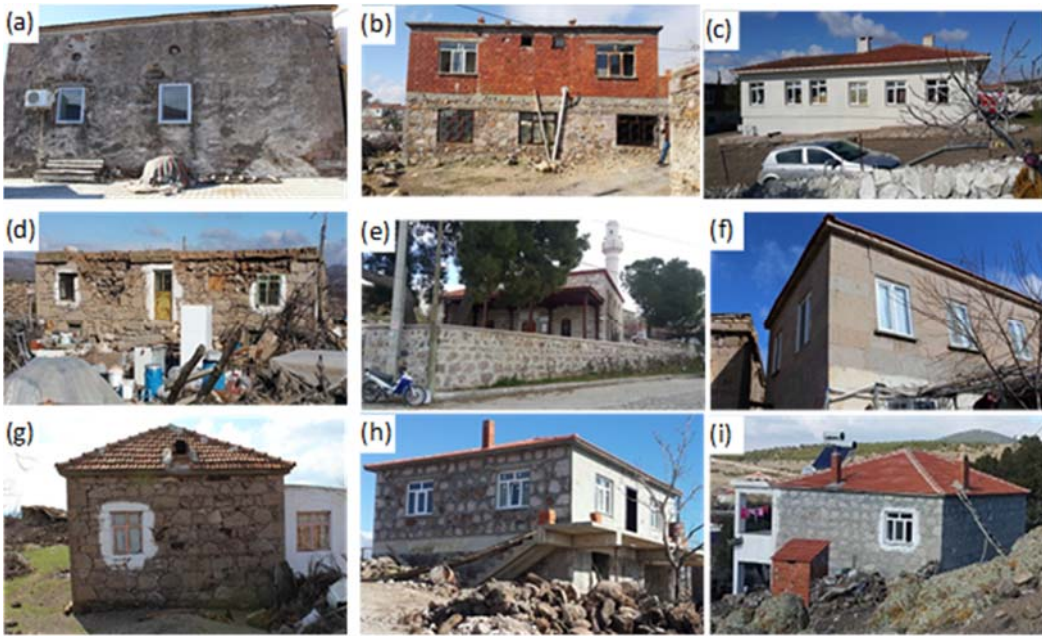
In the reconnaissance area, observations showed that the construction materials and skills are extremely deficient. Modern materials and techniques are just used in a small part of the observed region. Moreover, cement mortar between stone was not used for almost 50% of the wall. There are a few of building in which reinforced concrete element partly or fully used in the reconnaissance area. Curing of concrete is still not practiced as an integral part of the concreting process. The concrete blocks are of poor quality because of the poor quality of the concrete, a lack of compaction and very little or no curing. The existing building types in the area are shown in Fig. 4.

Figure 4 Existing building types in reconnaissance area: a) hatıl dwelling b) stone and brick in cement mortar, c) engineered RC building d) hatıl building with heavy roof, e) historical masonry with cut stone, f) cut stone without mortar, g) stone without mortar, h), i) stone in cement mortar with reinforced concrete.

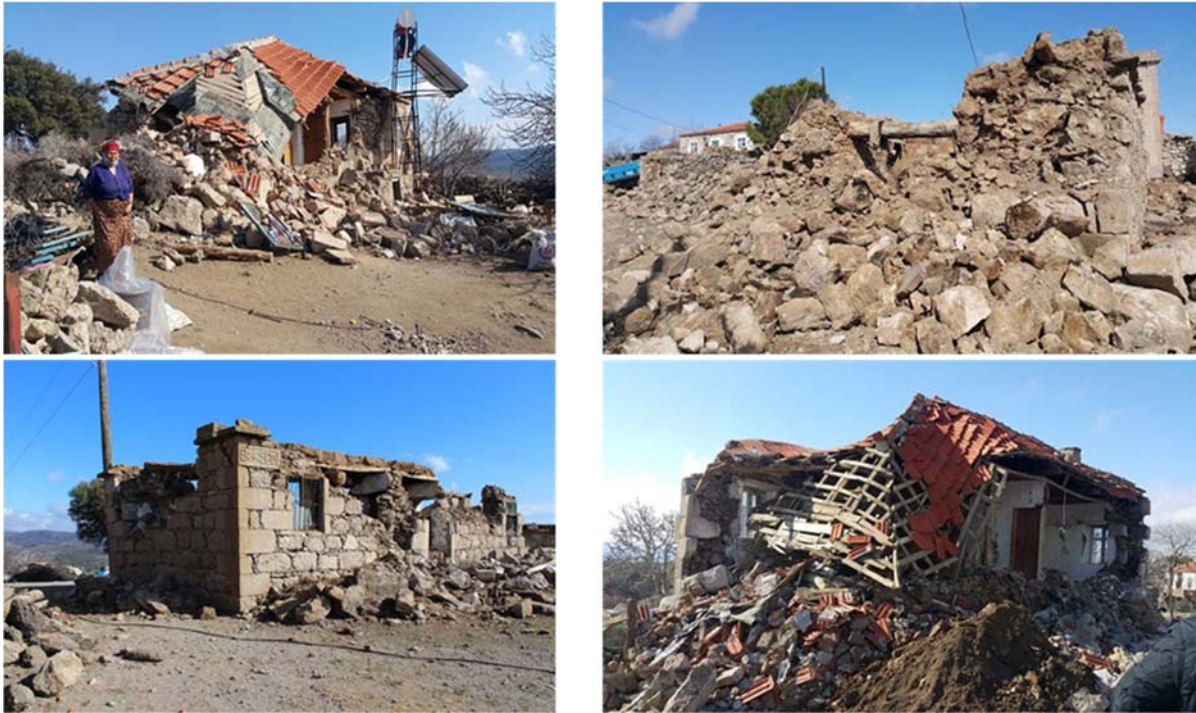
collapses occur in out-of-plane flexure mode. In addition to the general failure mode above mentioned, the technical reasons for damages and collapse observed reconnaissance may be summarized in detail as follows.

5 **Figure 15 Totally collapsed examples from Ayvacık, Çanakkale 2017 earthquakes swarm**

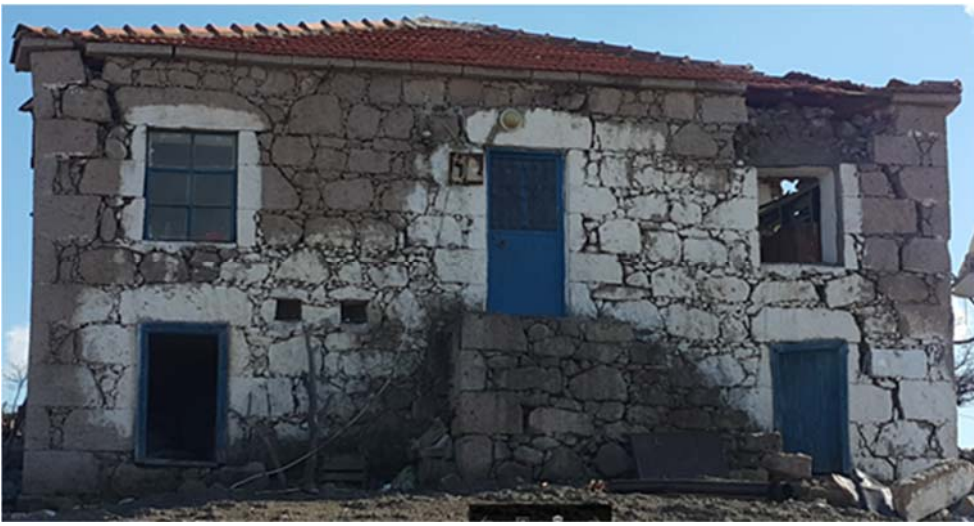
In the rural area of Turkey, the construction of dwelling is by the owner –occupier with aid of craftsmen who live in the locality but who are not full-time builders. These builders are usually taught their trade as a result of apprenticeship. Consequently, they have their own tools without any scientific rule and in the site the construction technique is still alive and building technique is so similar among the dwelling. For example, during the observation it is apparently shown that even thick mortar or mud was not used as binding agent between stone or masonry unit for almost all damaged dwellings. The Fig. 16 is a conspicuous example that heavy damages during the earthquakes were taken place for lack of mortar between stones. At the end of several moderate earthquakes this masonry dwelling became unstable.

Figure 16 An example of damaged dwelling due to inadequate interlocking

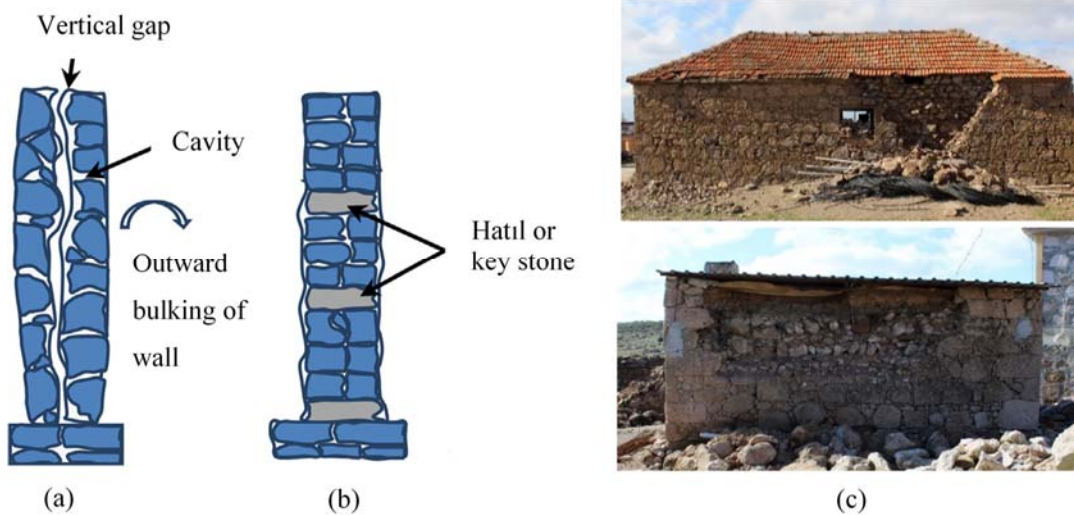
Another damage type observed in the region is outward bulking of wall which caused by interlocking deficiency. The reason of this deficiency is vertical gap between stones creating wall thickness as shown in Fig. 17. In order to prevent this damage, horizontal elements such as hatil or key stone, which provide integrity to masonry wall, can be used in specific intervals vertically. The key stones or hatils can provide limited resistance to lateral seismic loads and thus probably prevent the out-of-plan failure on some part of masonry walls.

Figure 17 Schematics of a conventional wall section without through stone, b wall section with through stones (Sharma, 2016) c observed damages in the region.

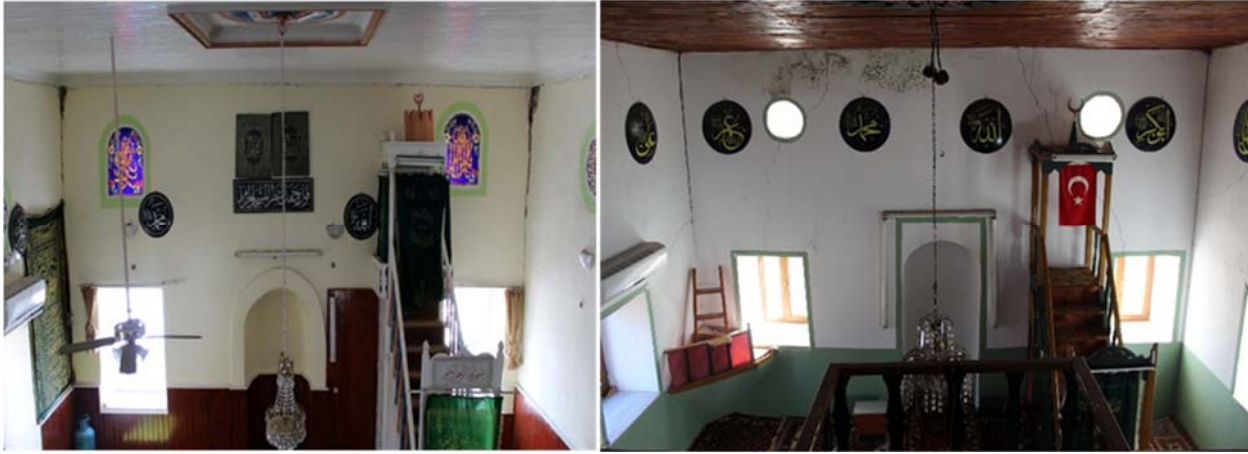
An additional interlocking damage type is observed at the intersection of perpendicular walls (Fig. 18). One of the walls acts out of plane while other remains very stiff in plane resulting in inevitable cracks. Damages in this type can either result in gaps developing between the in-plane and the out of plane wall or vertical cracks may occur in the out of plane wall (Tolles et al. 1996). Further phase of this damage may result in out of plane failure of gable-end wall. To avoid intersection damage, interlocking between perpendicular walls in the corners should be appropriately designed against lateral earthquake forces.

Figure 18 Observed damages at intersection of perpendicular walls

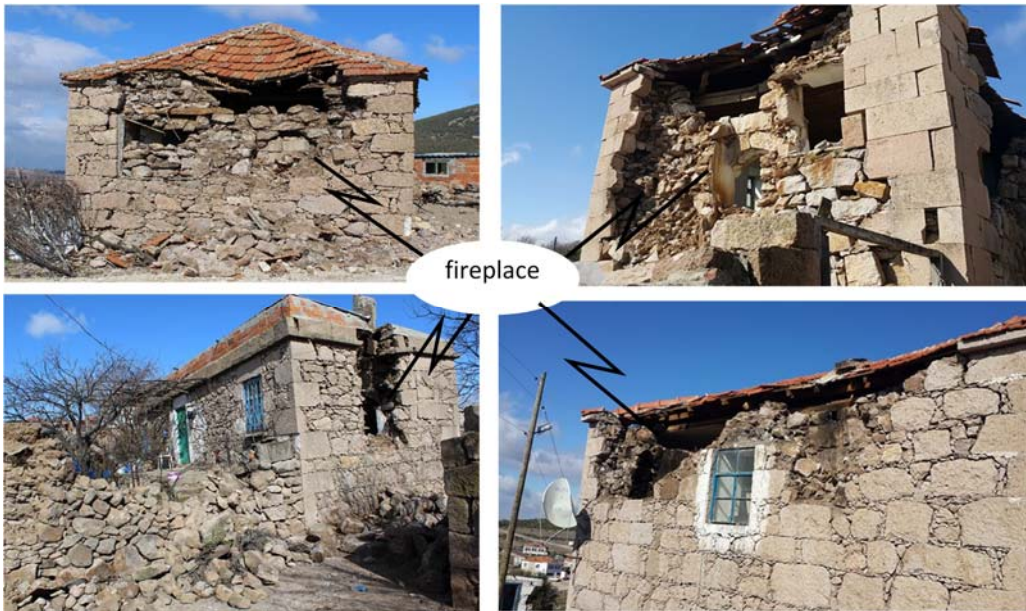
The design process of the masonry buildings needs to regularity more than other supporting system, because lateral load resisting system must have continuity to meet shear force stemming from earthquake. In the rural area, however, traditional fireplace was used in the buildings and it is built within the wall by decreasing the wall thickness or curving the wall outward. In such a case irretrievable damage is occurred on the wall because of the decreasing shear resistance (Fig. 19). This damage type was observed for different masonry structures in the site. For example, it can be seen from Fig. 19 that there were different examples like cut stone masonry, stone with plaster and stone without mortar. The common damage type is most likely stemming from the lack of skill of craftsman or traditional habits.

Figure 19 Examples of out of plane collapse due to wall cavity

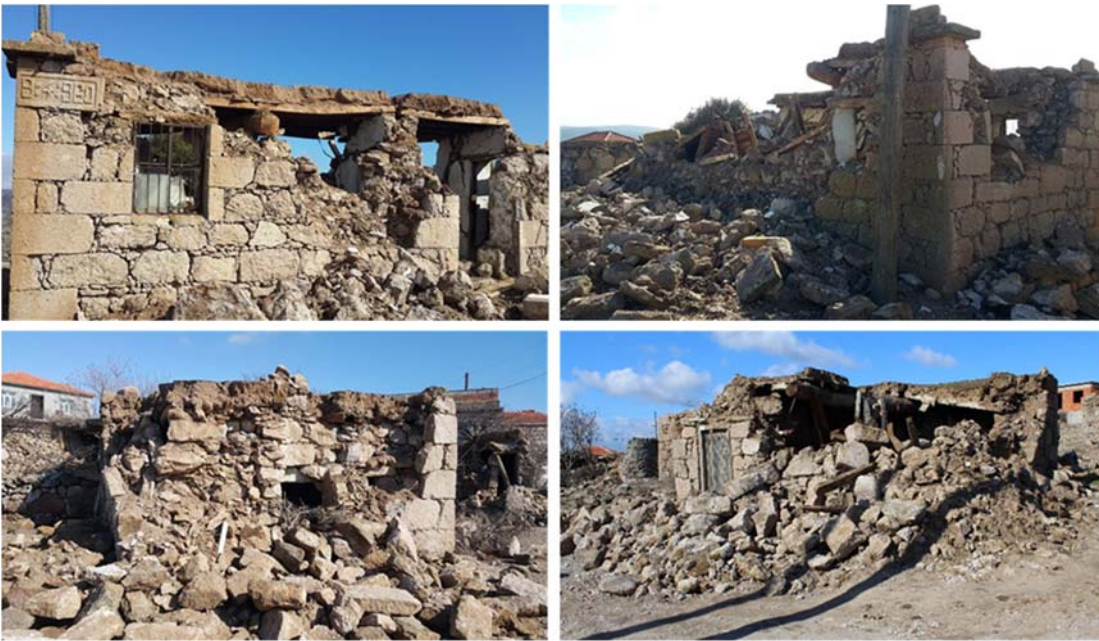
Another important reason that causes damage is the roof made from a thick and heavy layer of mud spread upon wooden logs (Fig. 20). This technique is widely used in some part of Anatolian region where timber is increasingly scarce. These heavy earth roofs are generally made hardening spreading soil with a cylindrical stone. To make the earth roof more durable against water leakage need to be thickened more and more over the years. Consequently, heavier earth roof cause bigger shear force during the earthquake. In general, the roof either supported by the beam and indirectly by the wall or inner structures beams and columns were round or sub-round in section, the trunk without its bark. This made connections and good bearing surfaces between them virtually impossible. Such beams were prone to roll off the other during the earthquake induced motions. Also, the round beam-ends point loaded (to an excessive degree) the supporting walls beneath and then collapse of the earth roof or wall is inevitable.

Figure 20 Examples of heavy earth wall collapse

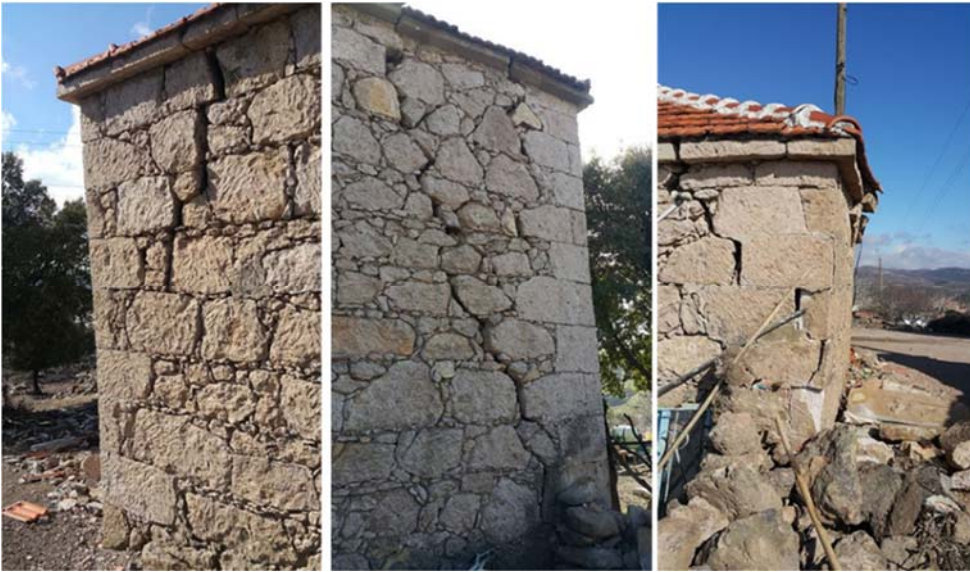
Many weak masonry walls without mortar had diagonal or inclined shear cracking as a result of cyclic shear forces applied during the earthquakes (Fig. 22). But this diagonal shear cracking does not necessarily lead to total collapse in general. However, collapse may be inevitable if the triangular wall blocks on each side of a full diagonal crack become unstable by substantially losing their interlock or friction resistance along the cracks (Fig. 23). Similar failures were previously reported
5 around the world (Ural et al., 2012; Klingner, 2006).

Figure 22 Examples of diagonal shear cracking

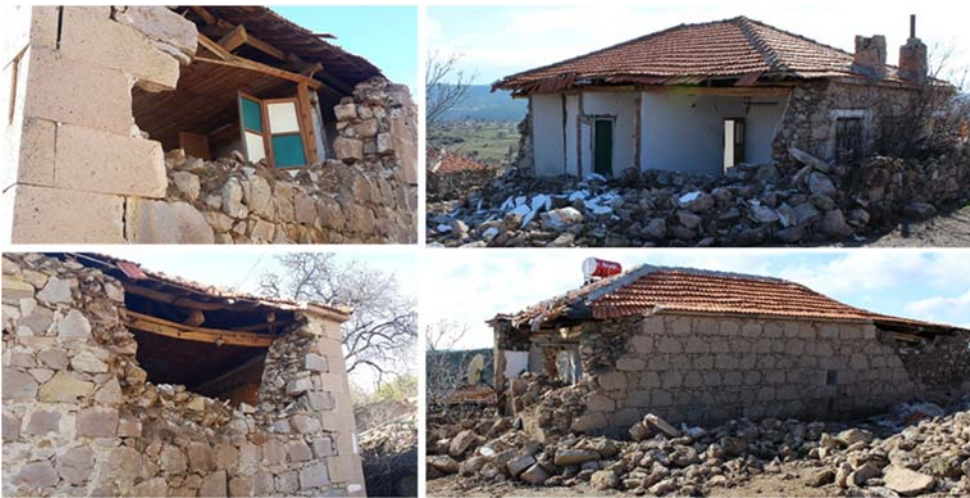
10 **Figure 23 Out of plane failures depending on improper wall thickness and/or height-length ratio**
