Response to Dr. Molinari:

Damages during February, 6-24 2017 Çanakkale earthquake swarm

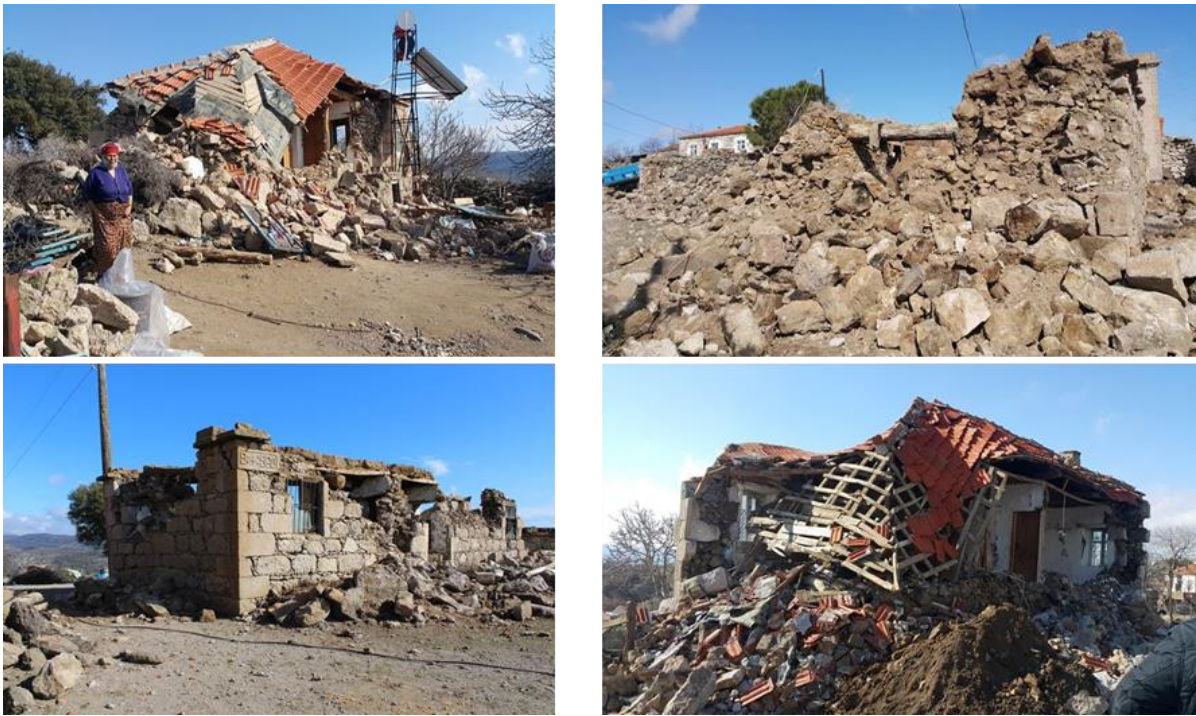
15 damage along the wall due to workmanship defects. Furthermore, when the wall is not designed with any engineering rule in mind, catastrophic and rapid collapse occurs in out-of-plane bending mode. In addition to the general failure mode mentioned above, the technical causes of damage and crashes observed in the reconnaissance area can be summarized as follows.~~In this case shear failure is inevitable in plane forming of diagonal cracks or similar cracks wherever is suitable to damage through the wall because of defects due to workmanship. Furthermore, when the wall did not design considering any~~
20 ~~engineered rule, the catastrophic and rapid collapses occur in out of plane flexure mode. In addition to the general failure mode above mentioned, the technical reasons for damages and collapse observed in reconnaissance area may be summarized in detail as follows.~~

Figure 16:5 Examples of Totally totally collapsed examples-structures from Ayvacık, Çanakkale 2017 earthquakes swarm

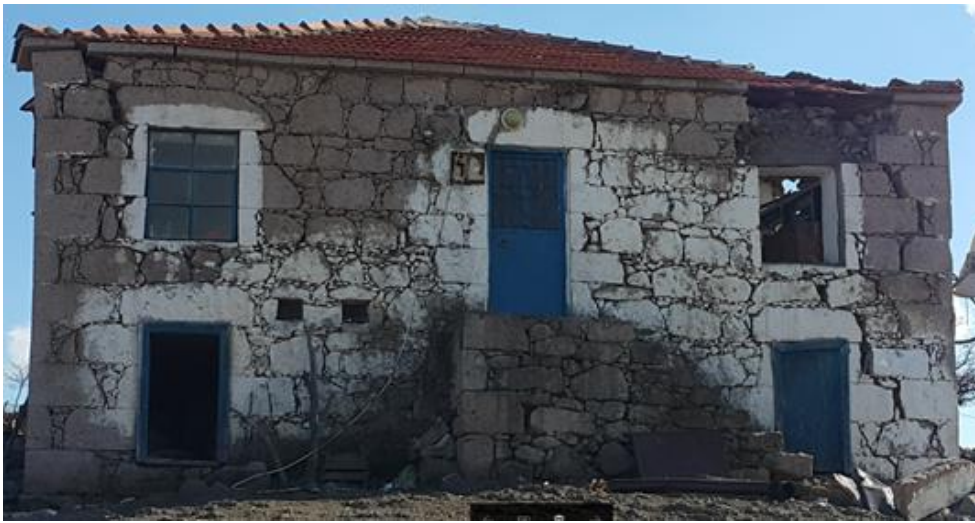
- Inadequate interlocking among the stone

Figure 17617: An example of a damaged dwelling due to inadequate interlocking

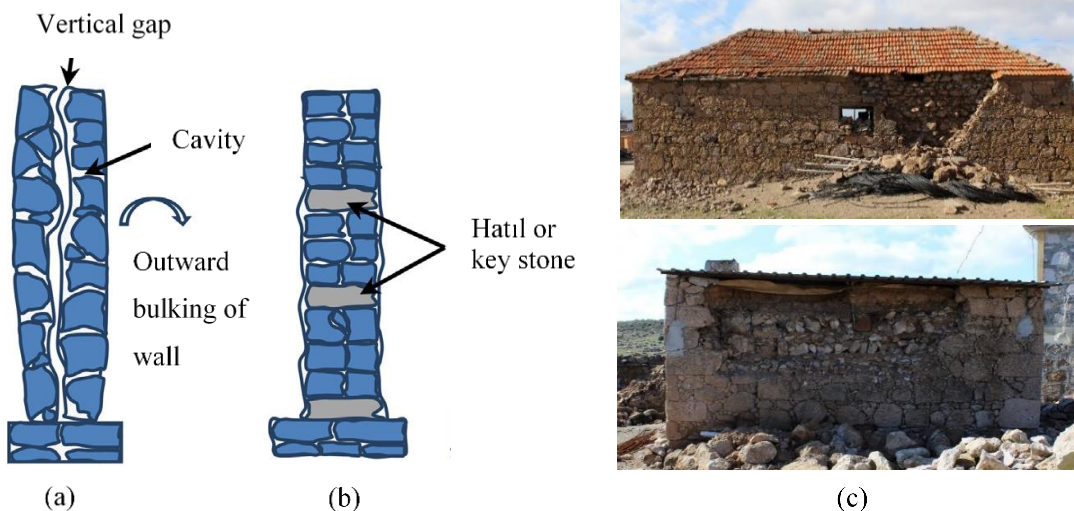
Another damage type observed in the region is outward bulking of walls, which is caused by ~~interlocking deficiency~~interlocking deficiency. The reason of this deficiency is the vertical gap between stones creating wall thickness as shown in Fig. 187. In order to prevent this damage, horizontal elements such as 'hatıl' or key stone, which provide integrity to masonry walls, can be vertically used in specific intervals ~~vertically~~. The key stones or 'hatıl's can provide limited resistance to lateral seismic loads, and thus probably prevent the out-of-plan failure on some part of masonry walls.

Figure 18718: Schematics of (a) conventional wall section without through stone, (b) wall section with through-key stones (Sharma, 2016), (c) observed damages observed in the region.

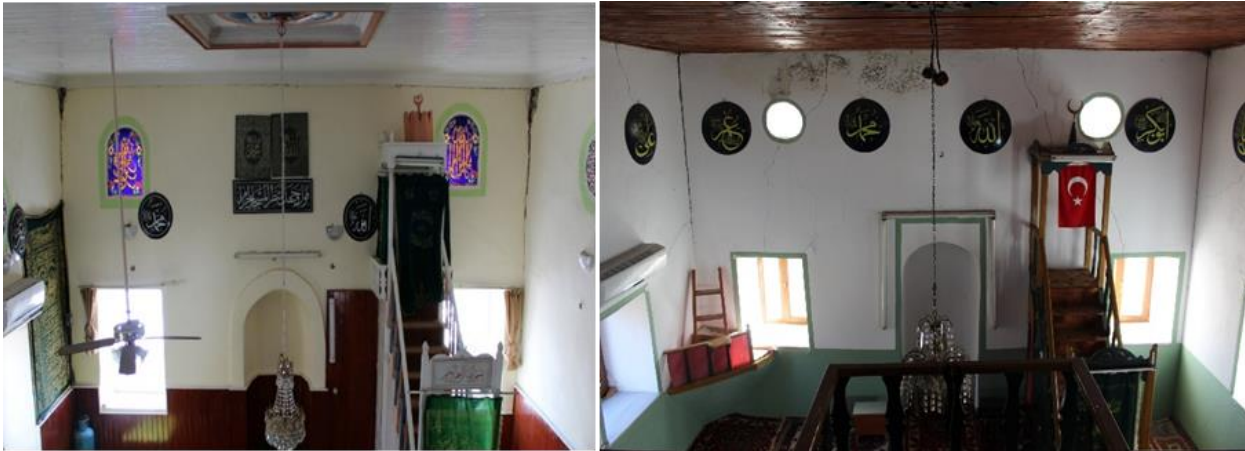
Another ~~additional~~ interlocking damage type is observed at the intersection of perpendicular walls (Fig. 198). One of the walls acts out of plane while ~~the~~ other remains very stiff in plane, resulting in inevitable cracks. ~~Damages in this type~~ This type of damage can either result in gaps developing between the in-plane and ~~the~~ out-of-plane wall or vertical cracks may occur in the out-of-plane wall (Tolles et al. 1996). Further phase stages of this damage may result in out-of-plane failure of gable-end wall. To avoid intersection damage, ~~the~~ interlocking in the corners between perpendicular walls ~~in the corners~~ should be appropriately properly designed against lateral earthquake forces.

10 **Figure 198-19:: Observed damages at intersection of perpendicular walls**

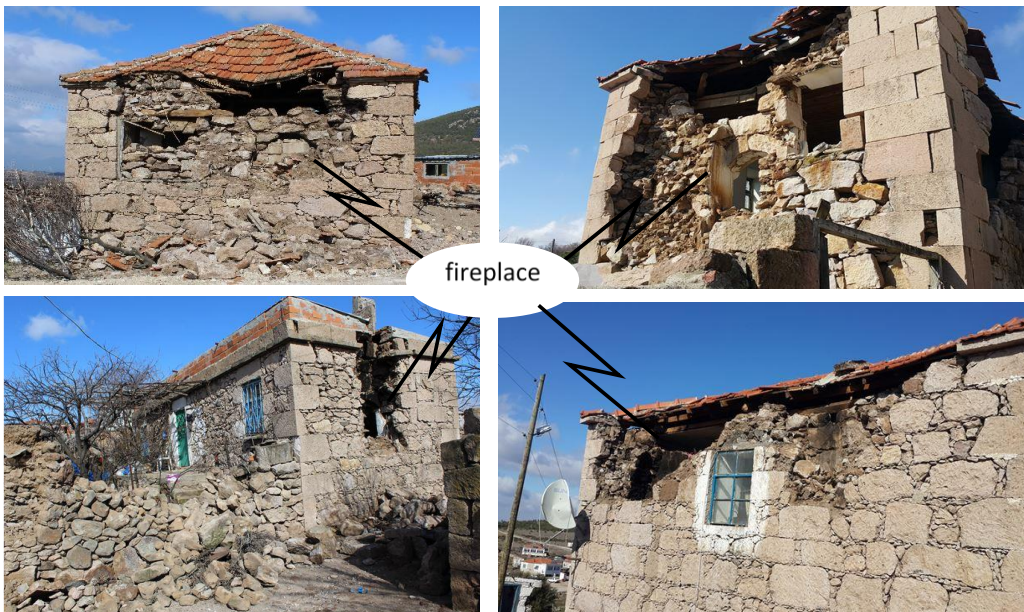
The design process of ~~the~~ masonry buildings needs ~~to more~~ regularity ~~more than compared to~~ other supporting systems, because ~~the system resisting~~ lateral loads ~~resisting system~~ must have continuity and regularity in order to meet shear forces ~~stemming from created by the~~ earthquake. In ~~the~~ rural areas, however, traditional fireplaces ~~was have been~~ used in ~~the~~ buildings, and ~~it is they are~~ built within the wall by decreasing the wall thickness or curving the wall outward. In such a case, irretrievable damage is ~~occurred-inflicted~~ on the wall because of ~~the~~ decreasing shear resistance (Fig. 2049). This damage type was observed ~~for in~~ different masonry structures in the site. ~~For example, it can be seen from Fig. 2019 that there were different examples like~~ Different cases such as cut stone masonry, stone with plaster, and stone without mortar can be seen in Fig. 20. The common damage type is most likely ~~stemming from caused by~~ the lack of ~~skill of craftsman~~ craftsmanship or traditional habits.

Figure 201920.: Examples of out of plane collapse due to wall cavity

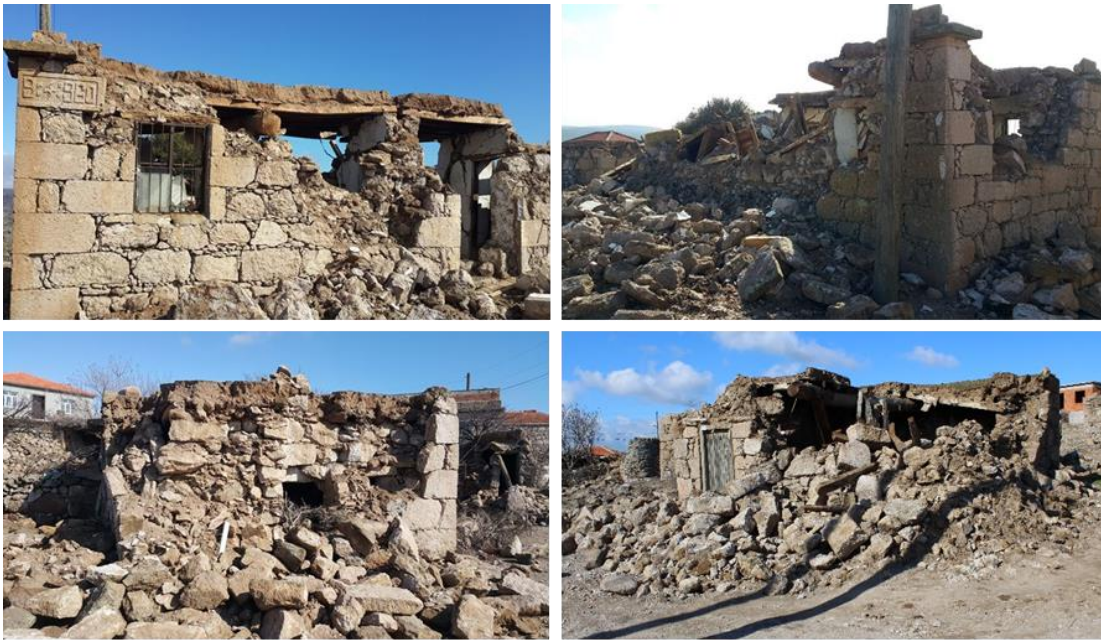
Another important ~~reason that causes~~cause of damage is the roofs made from a thick and heavy layer of mud spread upon wooden logs (Fig. 210). This technique is widely used in ~~some certain~~ parts of Anatolian ~~region~~ where timber is increasingly scarce. These heavy earth roofs are generally ~~made hardening~~hardened by spreading soil with a cylindrical stone. The roof must be thickened more and more over the years To to make the earth roof more durable against water leakage ~~need to be thickened more and more over the years~~. Consequently, ~~heavier earth roof cause bigger~~heavier roofs exert larger shear forces during ~~the an~~ earthquake. In the investigated area, the roofs were either supported by beams and indirectly by walls or beams of the inner structure, and the columns were round or sub-round in cross-section, and the trunks were without the barks. This made it virtually impossible to obtain good connections and bearing surfaces between the beams. Such beams were prone to rolling off during motions induced by earthquakes. Moreover, the round ends of the beams exerted loads (to an excessive degree) on the supporting walls beneath them, and resulted in the collapse of the earth roof or walls.

Figure 21: Examples of heavy earth wall collapse

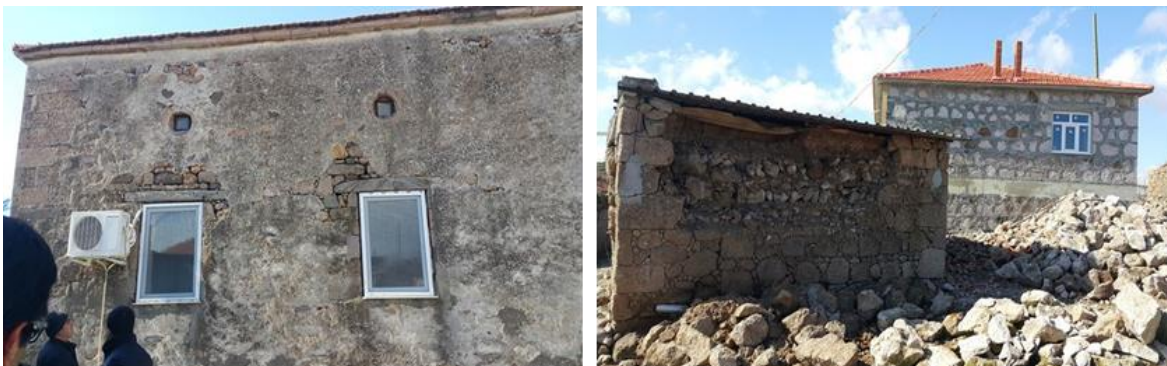
Figure 22: Examples of undamaged dwellings

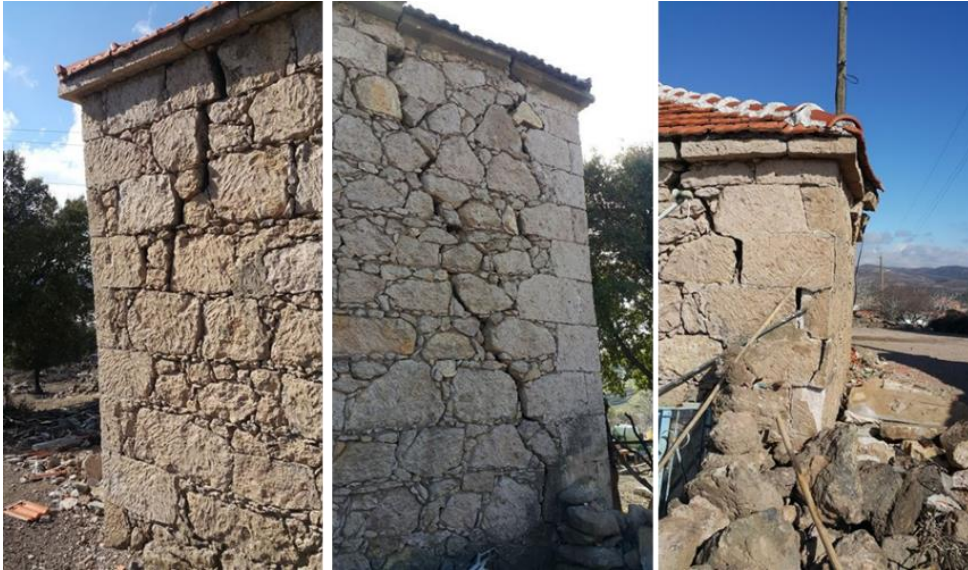
Many weak masonry walls without mortar had diagonal or inclined shear cracking as a result of cyclic shear forces applied exerted during the earthquakes (Fig. 232). But this diagonal shear cracking does not necessarily lead to total collapse in general. However, collapse may be inevitable if the triangular wall blocks on each side of a full diagonal crack become unstable by substantially losing their interlock or friction resistance along the cracks (Fig. 243). Similar failures were have previously been reported around the world (Ural et al., 2012; Klingner, 2006).

Figure 223: Examples of diagonal shear cracking

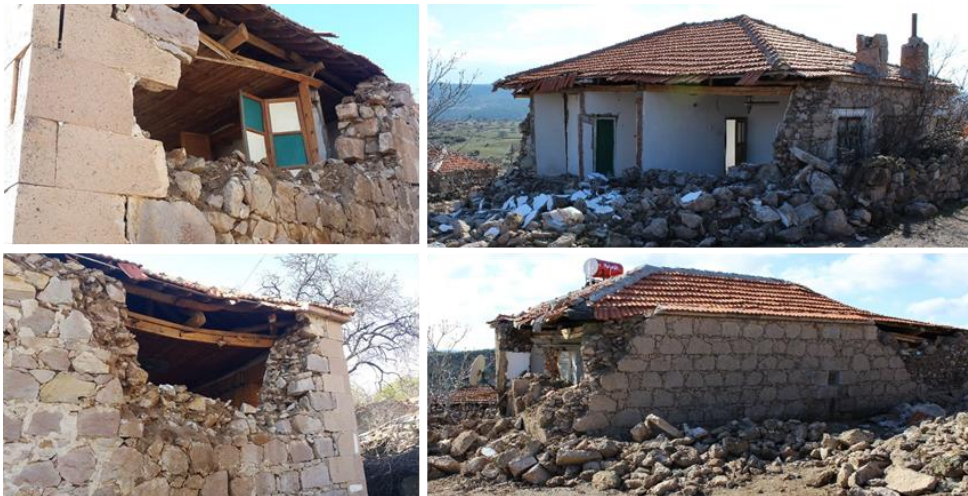
In many cases, distinctive diagonal or inclined cracks ~~have been~~ were observed in load-bearing window piers or walls with low width-to-height ratios as a result of inadequate shear resistance (Tomazevic, 1999). While bending and shear ~~forces from~~ created by a moderate earthquake can be easily resisted by reinforced-masonry with lateral and horizontal elements such as RC or timber (Fig. 22), the dwellings made ~~by~~ from stone ~~in~~ with no mortar cannot resist the ~~seismic~~ forces. This construction defect ~~is causing~~ causes in-plane failures by means of excessive shear force or bending or out of plane failure by bending depending on the aspect ratio of the unreinforced masonry elements.

Figure 243: Out of plane failures depending on due to improper wall thickness and/or height-length ratio
