Damages during February, 6-24 2017 Çanakkale earthquake swarm

Ramazan Livaoğlu¹, Mehmet Ömer Timurağaoğlu¹, Cavit Serhatoğlu¹, Mahmud Sami Döven²

Abstract. On February 6, 2017 a swarm of earthquakes began at the western end of the Turkey. This has been the first recorded swarm at Çanakkale region since continuous seismic monitoring began in 1970. The number of located earthquakes increased during the next ten days. This paper describes the output of a survey carried out in the earthquake prone towns of Ayvacık, Çanakkale, Turkey, in February 2017 after the earthquakes. Observations were made on site regarding traditional buildings at the rural area of Ayvacık. A description of the main structural features and their effects on the most frequently viewed damage modes were made according to in plane, out of plane behaviour of the wall regarding construction practice, connection type etc. It was found that there were no convenient connection details like cavity-ties or sufficient mortar strength resulting in decreased and/or lack of lateral load bearing capacity of the wall.

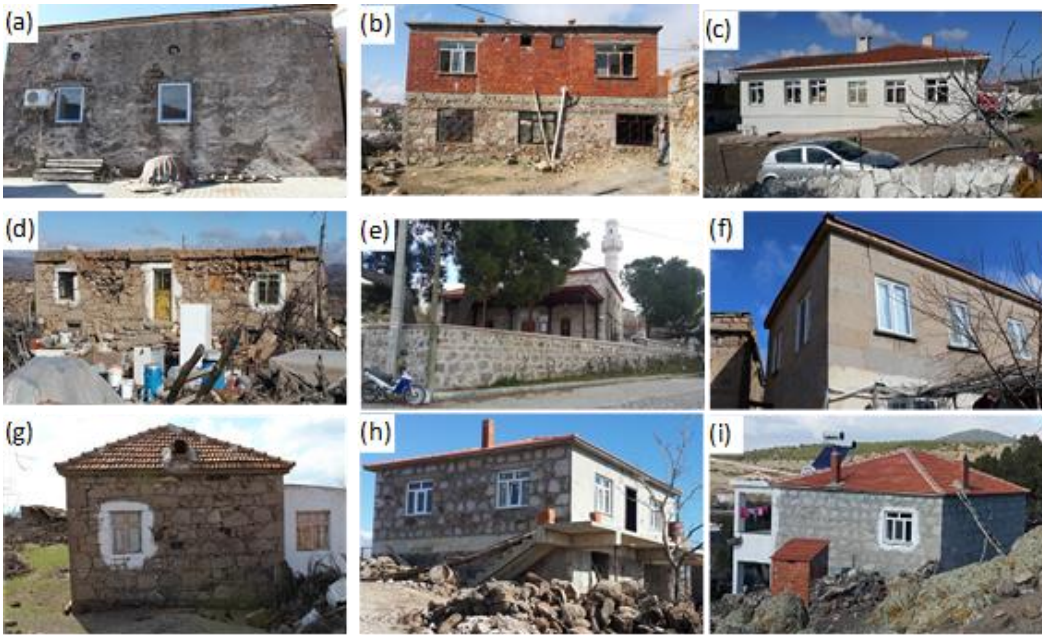
In the reconnaissance area, observations showed that the construction materials and skills were extremely deficient. Modern materials and techniques were only used in a small portion of the observed region. Moreover, cement mortar between stones was not used in almost 50% of the walls. There were a few buildings in which reinforced concrete elements were partly or fully used. Curing of concrete is still not practiced as an integral part of the concreting process. The concrete blocks are of poor quality because of poor quality of the concrete, lack of compaction and very little or no curing. The existing building types in the area are shown in Fig. 4.

Figure 4: Existing building types in reconnaissance area: a) hatıl dwelling b) stone and brick in cement mortar, c) engineered RC building d) hatıl building with heavy roof, e) historical masonry with cut stone, f) cut stone without mortar, g) stone without mortar, h), i) stone in cement mortar with reinforced concrete.

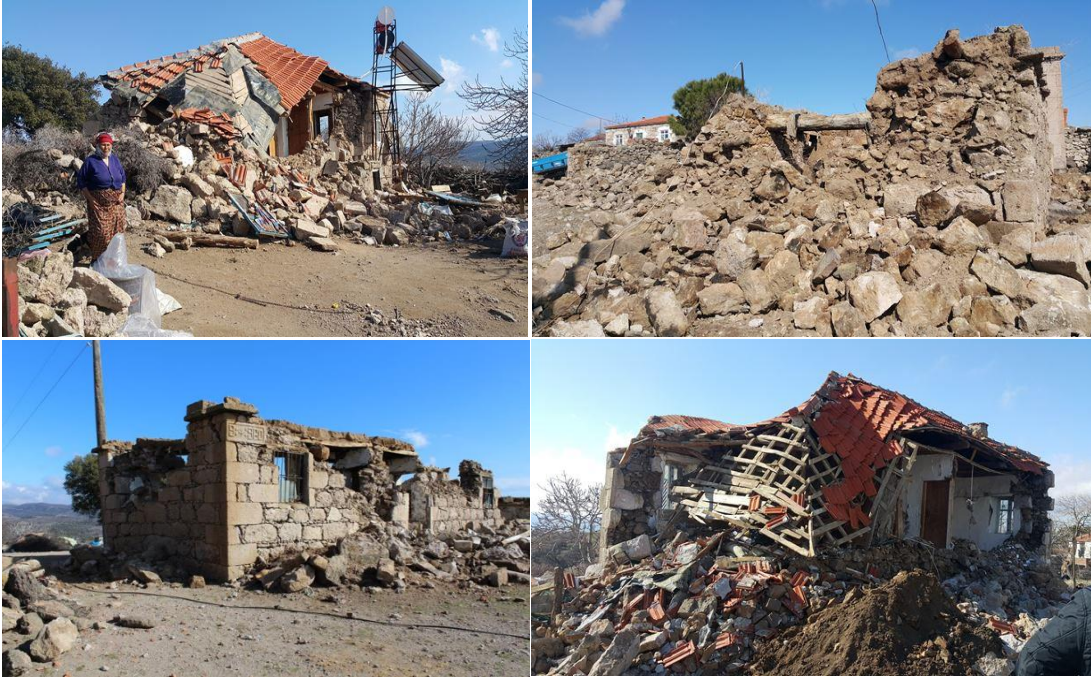
Failure mechanisms observed during the 2017 Çanakkale Earthquakes were also observed in other recent moderate earthquakes in Bala (ML=5.5), Doğubeyazıt (ML=5.1), Dinar (ML=5.9) and so on (Tezcan, 1996; Bayraktar et al., 2007; Adanur, 2008; Ural et al., 2012). Adanur (2010) showed that based on the investigations after 20 and 27 December 2007 Bala (Ankara) earthquakes, masonry buildings were built in three types in the affected area: (1) stone masonry buildings with walls made of natural shaped stones, (2) stone masonry buildings with walls made of cut stones, and (3) mixed masonry buildings with walls made of masonry materials like stones and mud bricks, stones and bricks, or stones and briquette. From all, a total of 945 buildings were heavily damaged or collapsed in Bala. Bayraktar et al. (2007) reported that 1000 buildings were affected from the earthquake in Doğubeyazıt. Similar to the above-mentioned studies, thus far, experiences from such moderate earthquakes in rural areas of Turkey have shown that even low-moderate earthquakes may cause significant damages on non-reinforced masonry structures (Fig. 16). This type of [masonry construction](#) is among the most vulnerable type of buildings during an earthquake. Even under moderate lateral forces, such a masonry structure is damaged or collapsed due to lack of shear strength, improper interlocking mechanism and/or poor bonding between stone-stone or stone-mortar. In this case, shear failure is

unavoidable in the planes forming diagonal cracks ~~or similar cracks suitable for damage~~ along the wall due to workmanship defects. Furthermore, when the wall is not designed with any engineering rule in mind, catastrophic and rapid collapse occurs in out-of-plane bending mode. ~~In addition to the general failure mode mentioned above, the technical causes of damage and crashes observed in the reconnaissance area can be summarized as follows.~~

Figure 16: Examples of totally collapsed structures from Ayvacık, Çanakkale 2017 earthquake swarm

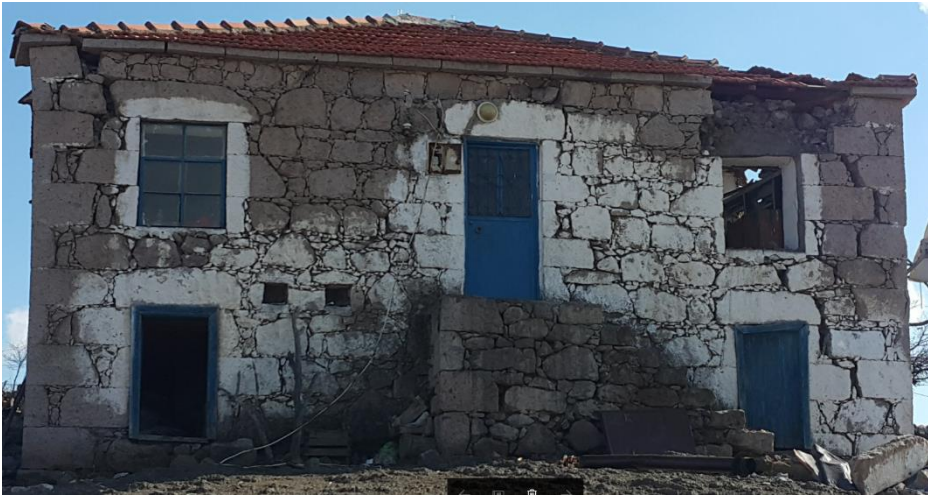
In the rural areas of Turkey, the construction of dwellings is done by the owner–dweller with the help of craftsmen who live in the area but are not full-time builders. These builders often learn their trade via apprenticeship. Hence, they have their own tools and do not follow any scientific rules on the site, as a result, an outdated or faulty construction technique can stay alive in a small region, and construction becomes highly similar between the dwellings. For example, during field observations, it was understood that even thick mortar or mud was not used as binding agent between stone or masonry units in almost all damaged houses. Figure 17 is a striking example of heavy damage during earthquakes due to lack of mortar ~~between~~ among stones. After a few mild earthquakes this masonry dwelling became unstable.

Figure 17: An example of a damaged dwelling due to inadequate interlocking

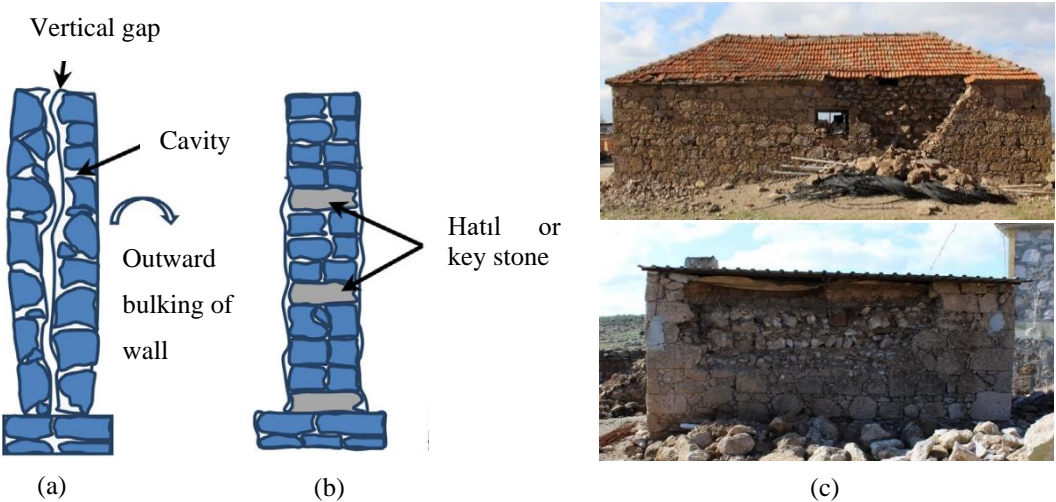
Another damage type observed in the region is outward bulking of walls, which is caused by interlocking deficiency. The reason of this deficiency is the vertical gap between stones creating wall thickness as shown in Fig. 18. In order to prevent this damage, horizontal elements such as ‘hatıl’ or key stone, which provide integrity to masonry walls, can be vertically used in specific intervals. The key stones or ‘hatıl’s can provide limited resistance to lateral seismic loads, and thus probably prevent the out-of-plan failure on some part of masonry walls.

Figure 18: Schematics of (a) conventional wall section without through stone, (b) wall section with key stones (Sharma, 2016), (c) damages observed in the region.

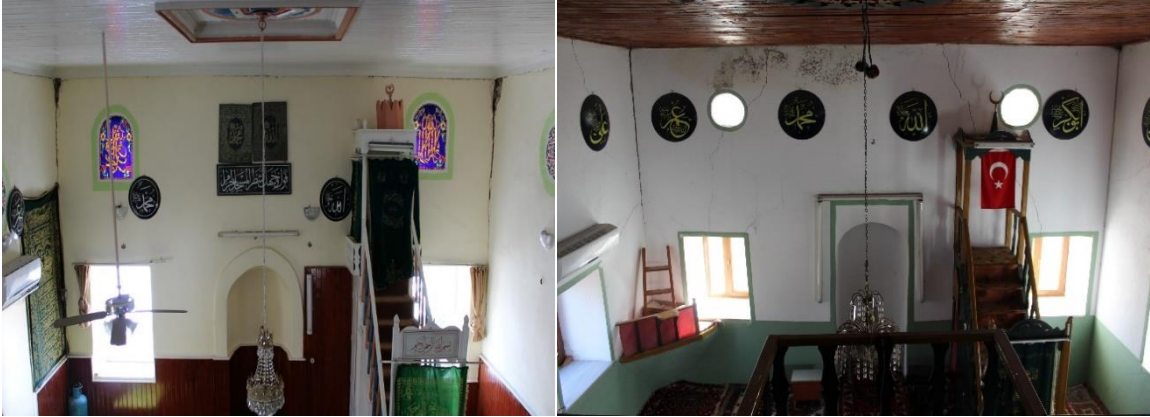
Another interlocking damage type is observed at the intersection of perpendicular walls (Fig. 19). One of the walls acts out of plane while the other remains very stiff in plane, resulting in inevitable cracks. This type of damage can either result in gaps developing between the in-plane and out-of-plane wall or vertical cracks may occur in the out-of-plane wall (Tolles et al. 1996). Further stages of this damage may result in out-of-plane failure of gable-end wall. To avoid intersection damage, the interlocking in the corners between perpendicular walls should be properly designed against lateral earthquake forces.

Figure 19: Observed damages at intersection of perpendicular walls

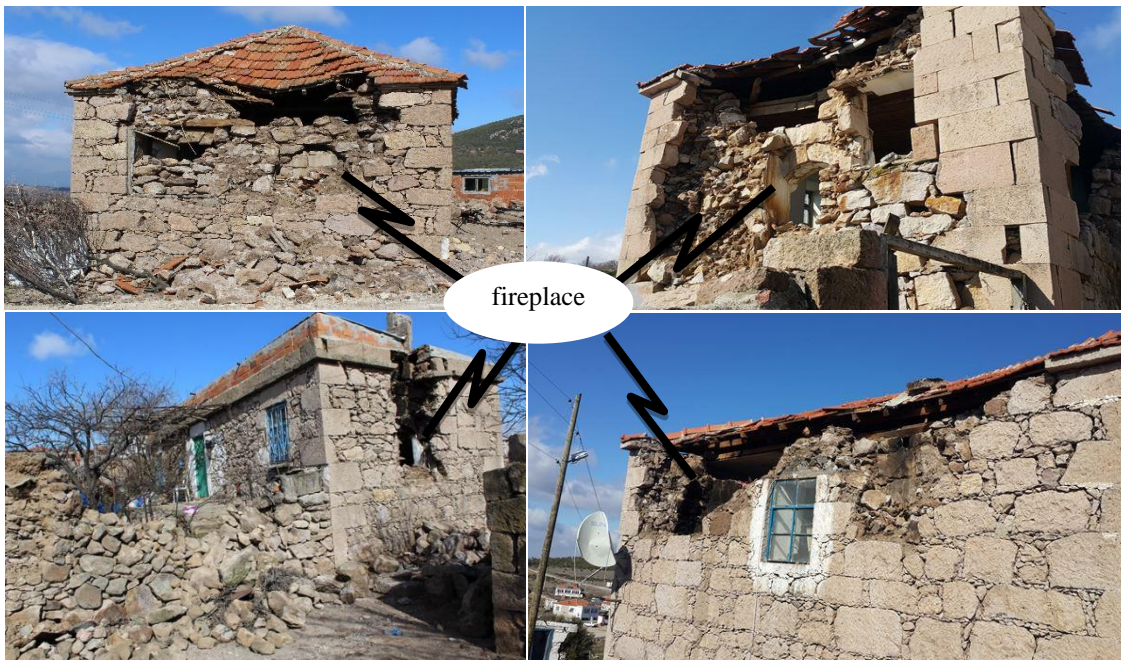
10 The design process of masonry buildings needs more regularity compared to other supporting systems, because ~~the system~~ resisting lateral loadsresisting system must have continuity and regularity in order to ~~meet~~take the stress of the shear forces ~~created by~~due to the earthquake. In rural areas, however, traditional fireplaces have been used in buildings, and they are built within the wall by decreasing the wall thickness or curving the wall outward. In such a case, irretrievable damage is inflicted on the wall because of decreasing shear resistance (Fig. 20). This damage type was observed in different masonry structures

15 in the site. Different cases such as cut stone masonry, stone with plaster, and stone without mortar can be seen in Fig. 20. The common damage type is most likely caused by the lack of craftsmanship or traditional habits.

Figure 20: Examples of out of plane collapse due to wall cavity

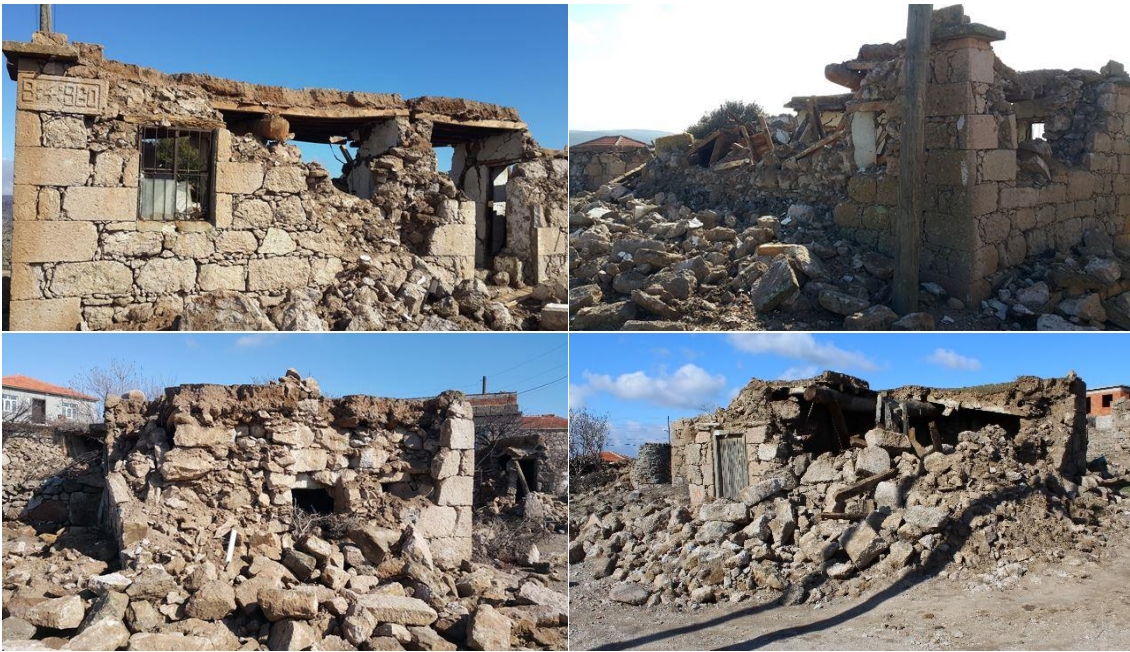
Another important cause of damage is the roofs made from a thick and heavy layer of mud spread upon wooden logs (Fig. 21).

- 5 This technique is widely used in certain parts of Anatolia where timber is increasingly scarce. These heavy earth roofs are generally hardened by spreading soil with a cylindrical stone. The roof must be thickened more and more over the years to make it more durable against water leakage. Consequently, heavier roofs exert larger shear forces during an earthquake. In the investigated area, the roofs were either supported by beams and indirectly by walls or beams of the inner structure, and the columns were round or sub-round in cross-section, and the trunks were without the barks. This made it virtually impossible to

- 10 obtain good connections and bearing surfaces between the beams. Such beams were prone to rolling off during motions induced by earthquakes. Moreover, the round ends of the beams exerted loads (to an excessive degree) on the supporting walls beneath them, and resulted in the collapse of the earth roof or walls.

Figure 21: Examples of heavy earth wall collapse

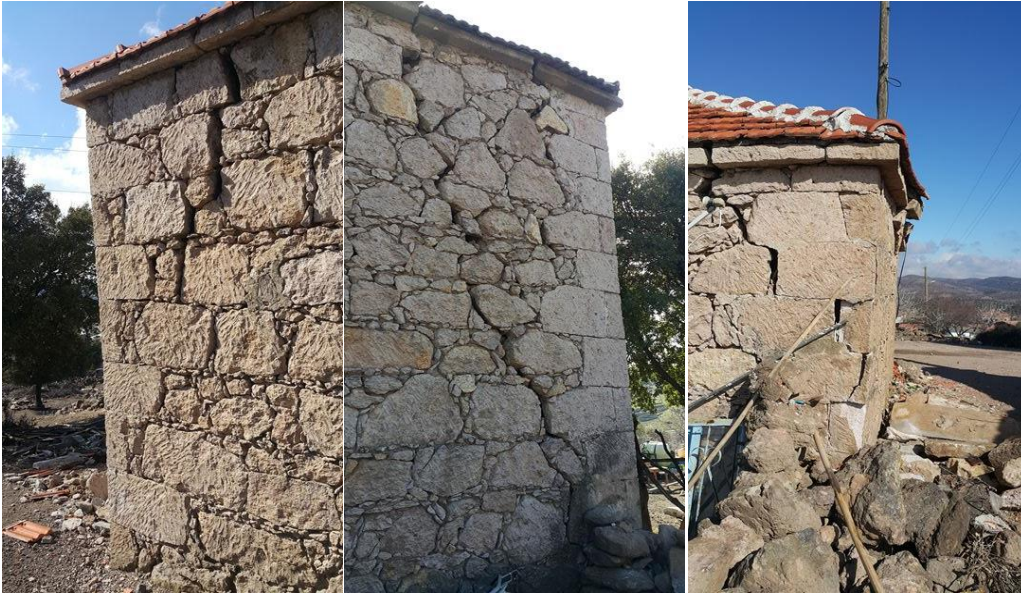
Many weak masonry walls without mortar had diagonal or inclined shear cracking as a result of cyclic shear forces exerted during the earthquakes (Fig. 23). But this diagonal shear cracking does not necessarily lead to total collapse. However, collapse may be inevitable if the triangular wall blocks on each side of a full diagonal crack become unstable by substantially losing their interlock or friction resistance along the cracks (Fig. 24). Similar failures have previously been reported around the world (Ural et al., 2012; Klingner, 2006).

Figure 23: Examples of diagonal shear cracking

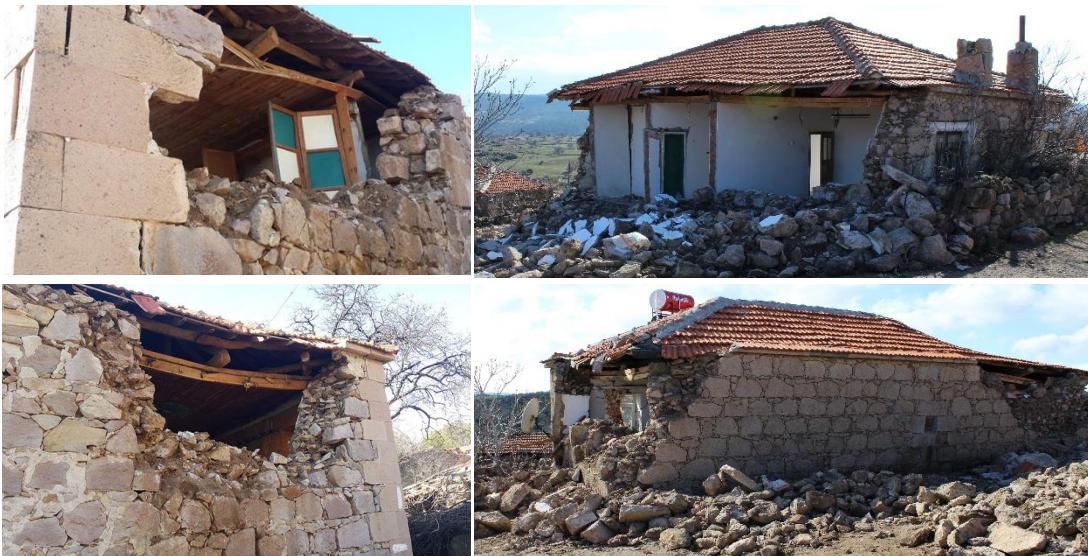
Figure 24: Out of plane failures due to improper wall thickness and/or height-length ratio
