Damages during February, 6-24 2017 Çanakkale earthquake swarm

Abstract. On February 6, 2017 a swarm of earthquakes began at the western end of the Turkey. This has been the first recorded swarm at Çanakkale region since continuous seismic monitoring began in 1970. The number of located earthquakes increased during the next ten days. This paper describes the output of a survey carried out in the earthquake prone towns of Ayvacık, Çanakkale, Turkey, in February 2017 after the earthquakes. Observations were made on site regarding traditional buildings at the rural area of Ayvacık. A description of the main structural features and their effects on the most frequently viewed damage modes were made according to in plane, out of plane behaviour of the wall regarding construction practice, connection type etc. It was found that there were no convenient connection details like cavity-ties or sufficient mortar strength resulting in decreased and/or lack of lateral load bearing capacity of the wall.

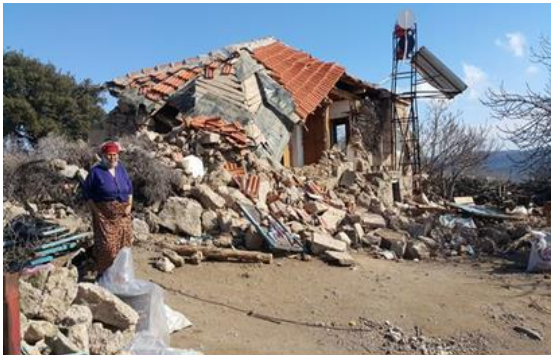
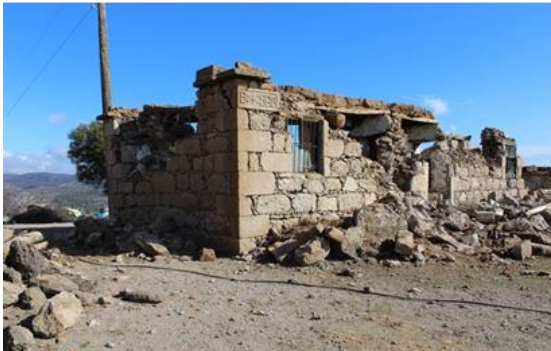
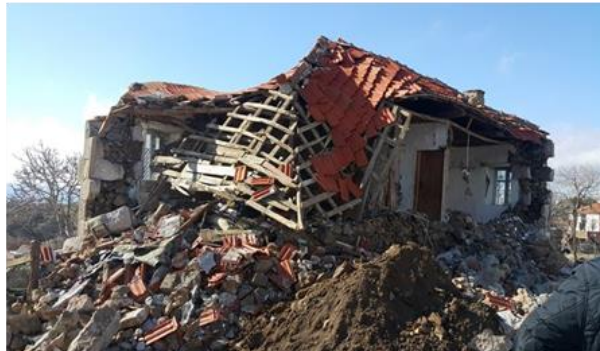
Figure 16: Examples of totally collapsed structures from Ayvacık, Çanakkale 2017 earthquake swarm

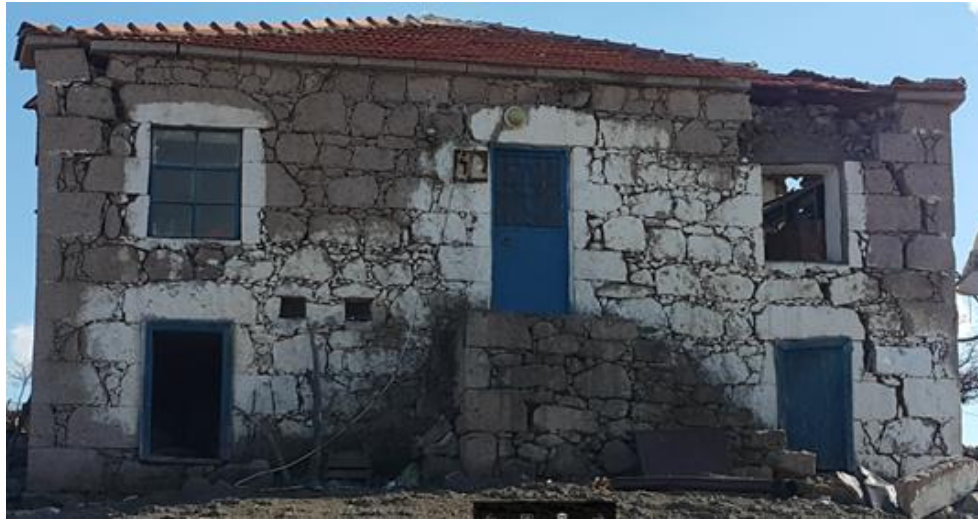
In the rural areas of Turkey, the construction of dwellings is done by the owner–dweller with the help of craftsmen who live in the area but are not full-time builders. These builders often learn their trade via apprenticeship. Hence, they have their own tools and do not follow any scientific rules on the site, as a result, an outdated or faulty construction technique can stay alive in a small region, and construction becomes highly similar between the dwellings. For example, during field observations, it was understood that even thick mortar or mud was not used as binding agent between stone or masonry units in almost all damaged houses. Figure 17 is a striking example of heavy damage during earthquakes due to lack of mortar

between stones. After a few mild earthquakes this masonry dwelling became unstable.

Figure 17: An example of a damaged dwelling due to inadequate interlocking

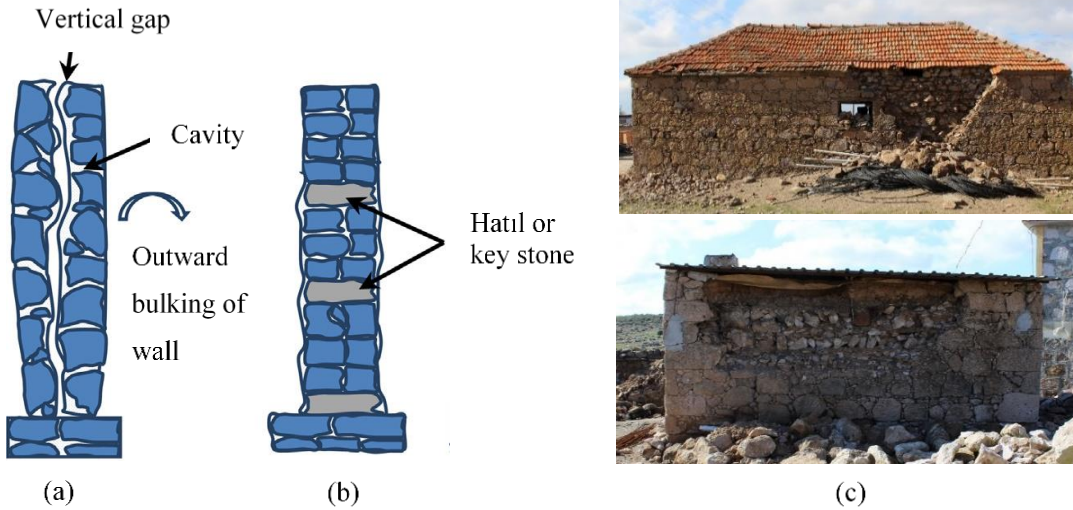
Another damage type observed in the region is outward bulking of walls, which is caused by interlocking deficiency. The reason of this deficiency is the vertical gap between stones creating wall thickness as shown in Fig. 18. In order to prevent this damage, horizontal elements such as ‘hatıl’ or key stone, which provide integrity to masonry walls, can be vertically used in specific intervals. The key stones or ‘hatıl’s can provide limited resistance to lateral seismic loads, and thus probably prevent the out-of-plan failure on some part of masonry walls.

Figure 18: Schematics of (a) conventional wall section without through stone, (b) wall section with key stones (Sharma, 2016), (c) damages observed in the region.

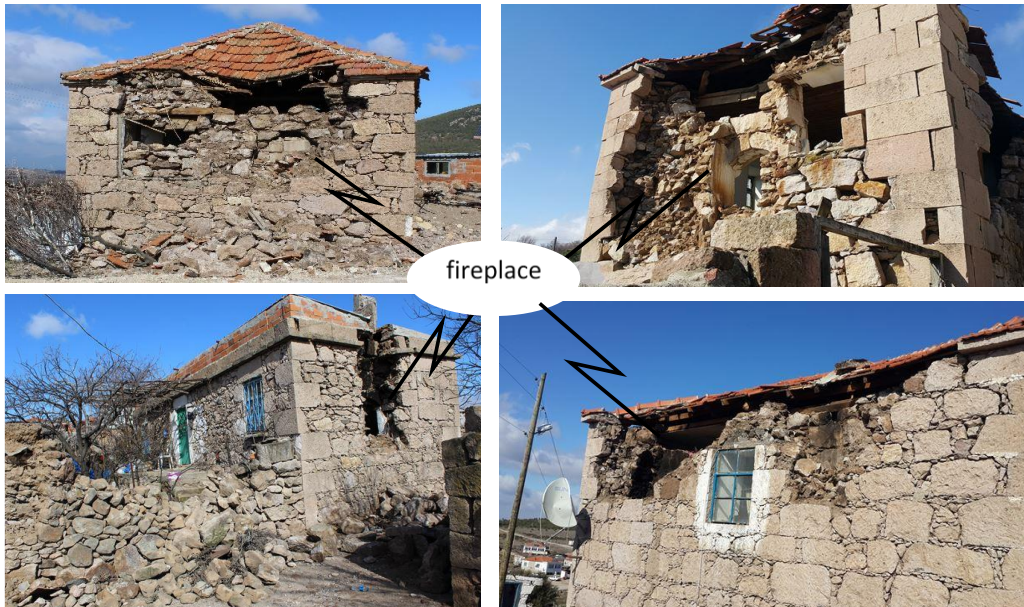
The design process of masonry buildings needs more regularity compared to other supporting systems, because ~~the system~~ ~~resisting lateral loads~~ must have continuity and regularity in order to ~~meet~~ shear forces ~~created by~~ the earthquake. In rural areas, however, traditional fireplaces have been used in buildings, and they are built within the wall by decreasing the wall thickness or curving the wall outward. In such a case, irretrievable damage is inflicted on the wall because of decreasing shear resistance (Fig. 20). This damage type was observed in different masonry structures in the site. Different cases such as cut stone masonry, stone with plaster, and stone without mortar can be seen in Fig. 20. The common damage type is most likely caused by the lack of craftsmanship or traditional habits.

Figure 20: Examples of out of plane collapse due to wall cavity

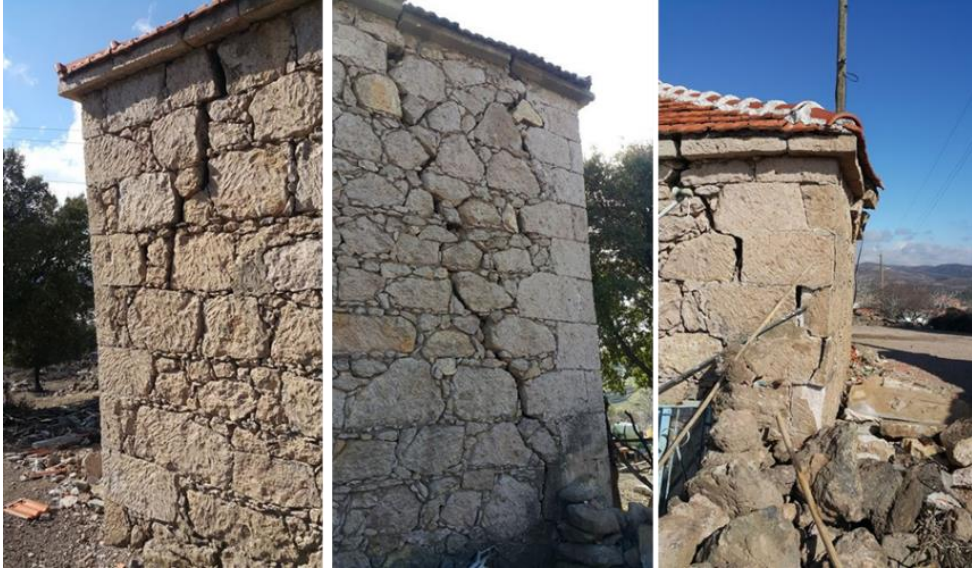
Many weak masonry walls without mortar had diagonal or inclined shear cracking as a result of cyclic shear forces exerted during the earthquakes (Fig. 23). But this diagonal shear cracking does not necessarily lead to total collapse. However, collapse may be inevitable if the triangular wall blocks on each side of a full diagonal crack become unstable by substantially losing their interlock or friction resistance along the cracks (Fig. 24). Similar failures have previously been reported around
5 the world (Ural et al., 2012; Klingner, 2006).

Figure 23: Examples of diagonal shear cracking

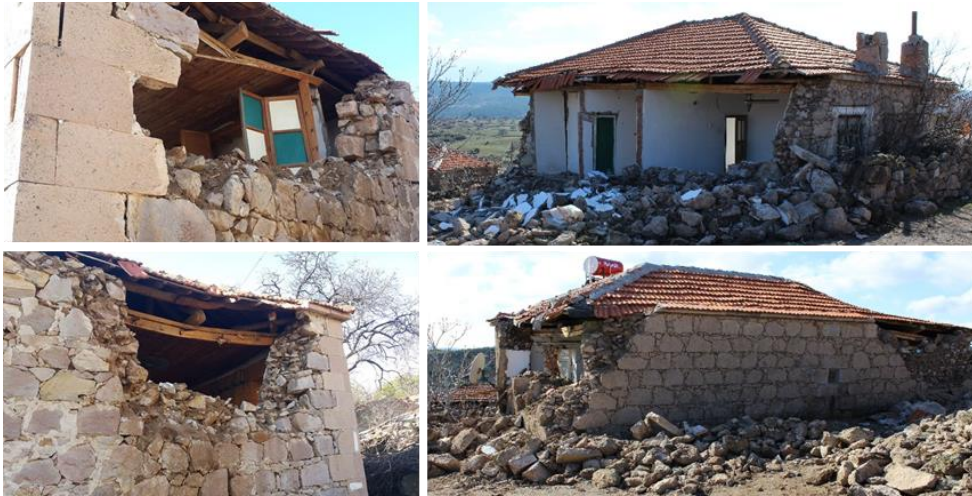
10 **Figure 24: Out of plane failures due to improper wall thickness and/or height-length ratio**
