Damages during February, 6-24 2017 Çanakkale earthquake swarm

Ramazan Livaoğlu¹, Mehmet Ömer Timurağaoğlu¹, Cavit Serhatoğlu¹, Mahmud Sami Döven²

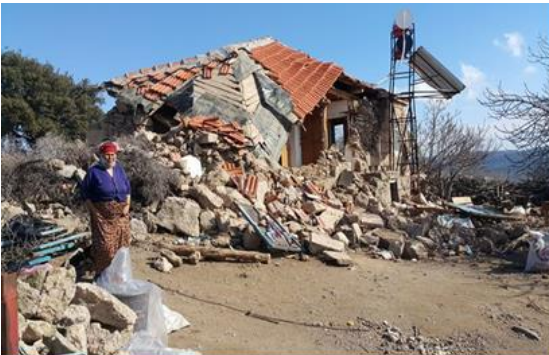
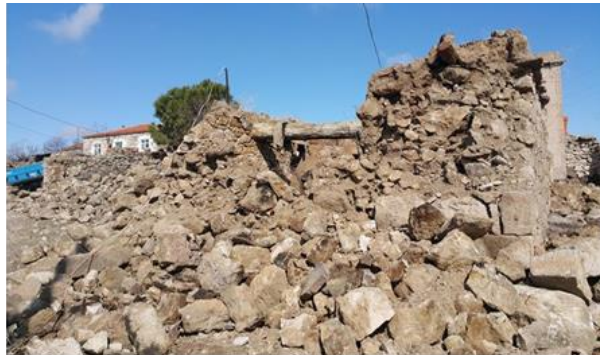
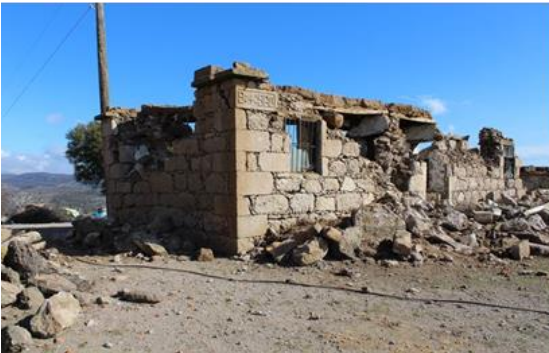
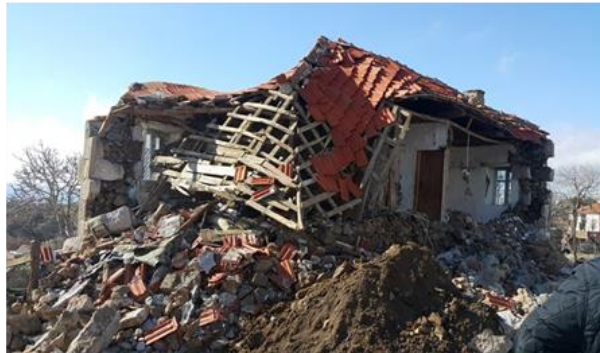
10 moderate earthquakes in rural areas of Turkey have shown that even low-moderate earthquakes may cause significant damages on non-reinforced masonry structures (Fig. 16). This type of masonry is among the most vulnerable type of buildings during an earthquake. Even under moderate lateral forces, such a masonry structure is damaged or collapsed due to lack of shear strength, improper interlocking mechanism and/or poor bonding between stone-stone or stone-mortar. In this case, shear failure is unavoidable in the planes forming diagonal cracks or similar cracks suitable for damage along the wall

15 due to workmanship defects. Furthermore, when the wall is not designed with any engineering rule in mind, catastrophic and rapid collapse occurs in out-of-plane bending mode. In addition to the general failure mode mentioned above, the technical causes of damage and crashes observed in the reconnaissance area can be summarized as follows.

Figure 16: Examples of totally collapsed structures from Ayvacık, Çanakkale 2017 earthquake swarm

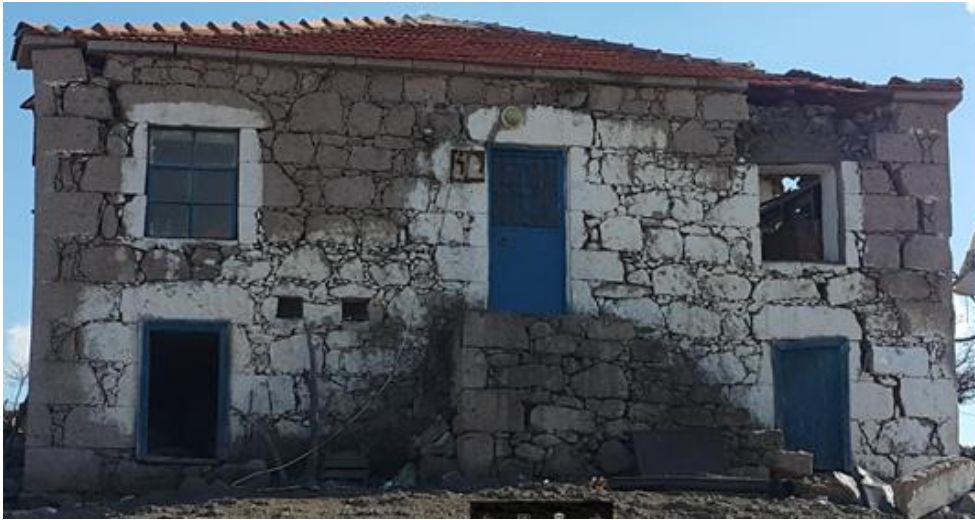
In the rural areas of Turkey, the construction of dwellings is done by the owner–dweller with the help of craftsmen who live in the area but are not full-time builders. These builders often learn their trade via apprenticeship. Hence, they have their own tools and do not follow any scientific rules on the site, as a result, an outdated or faulty construction technique can stay alive in a small region, and construction becomes highly similar between the dwellings. For example, during field observations, it was understood that even thick mortar or mud was not used as binding agent between stone or masonry units in almost all damaged houses. Figure 17 is a striking example of heavy damage during earthquakes due to lack of mortar between stones. After a few mild earthquakes this masonry dwelling became unstable.

Figure 17: An example of a damaged dwelling due to inadequate interlocking

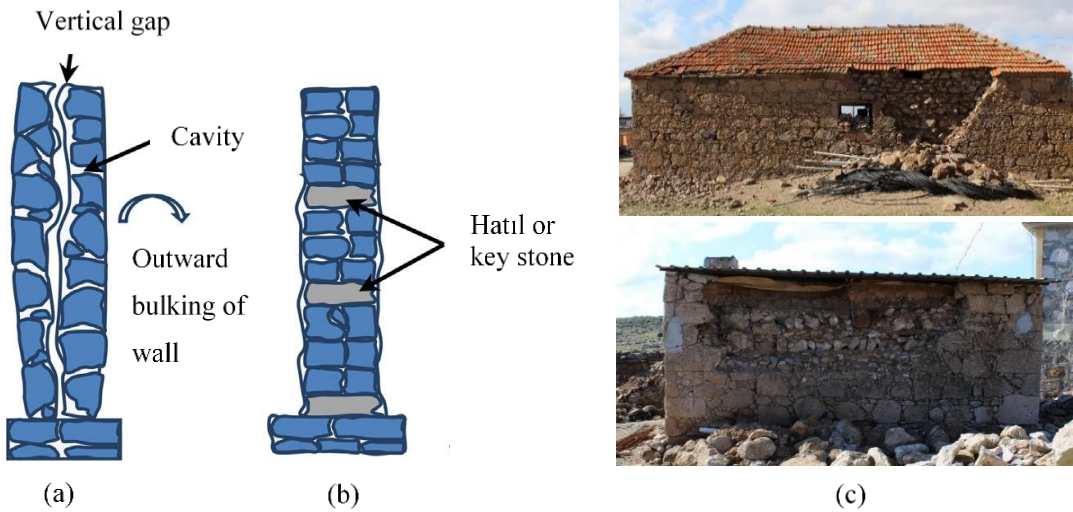
Another damage type observed in the region is outward bulking of walls, which is caused by interlocking deficiency. The reason of this deficiency is the vertical gap between stones creating wall thickness as shown in Fig. 18. In order to prevent this damage, horizontal elements such as ‘hatıl’ or key stone, which provide integrity to masonry walls, can be vertically used in specific intervals. The key stones or ‘hatıl’s can provide limited resistance to lateral seismic loads, and thus probably prevent the out-of-plan failure on some part of masonry walls.

Figure 18: Schematics of (a) conventional wall section without through stone, (b) wall section with key stones (Sharma, 2016), (c) damages observed in the region.

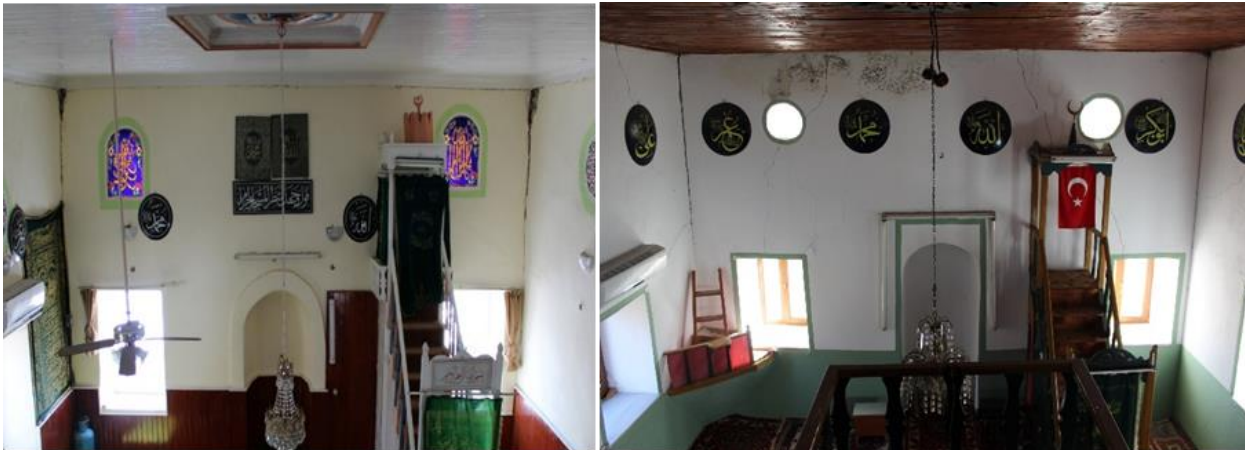
- 5 Another interlocking damage type is observed at the intersection of perpendicular walls (Fig. 19). One of the walls acts out of plane while the other remains very stiff in plane, resulting in inevitable cracks. This type of damage can either result in gaps developing between the in-plane and out-of-plane wall or vertical cracks may occur in the out-of-plane wall (Tolles et al. 1996). Further stages of this damage may result in out-of-plane failure of gable-end wall. To avoid intersection damage, the interlocking in the corners between perpendicular walls should be properly designed against lateral earthquake forces.

Figure 19: Observed damages at intersection of perpendicular walls

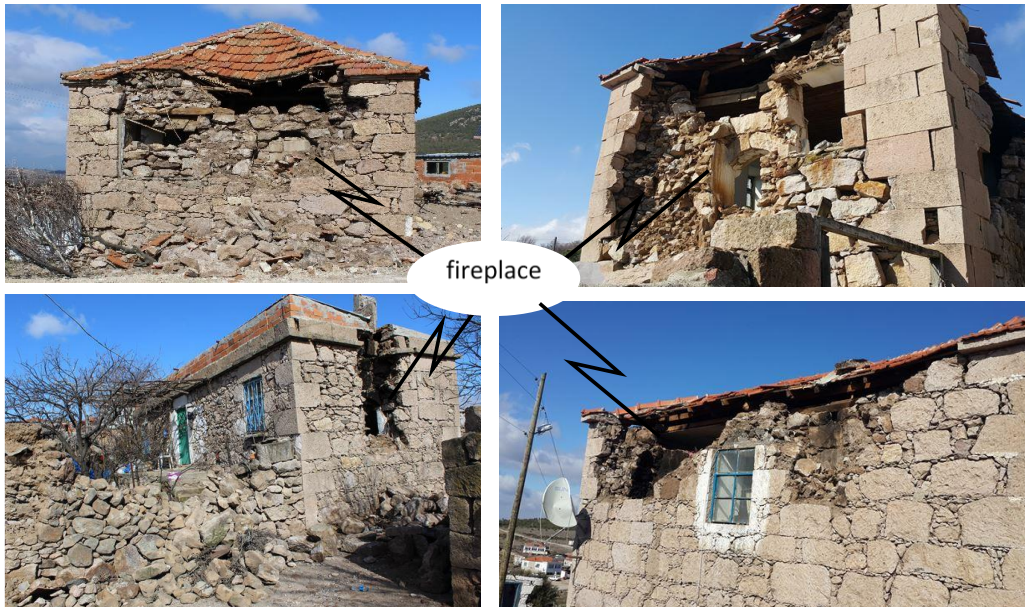
The design process of masonry buildings needs more regularity compared to other supporting systems, because the system resisting lateral loads must have continuity and regularity in order to meet shear forces created by the earthquake. In rural areas, however, traditional fireplaces have been used in buildings, and they are built within the wall by decreasing the wall thickness or curving the wall outward. In such a case, irretrievable damage is inflicted on the wall because of decreasing shear resistance (Fig. 20). This damage type was observed in different masonry structures in the site. Different cases such as cut stone masonry, stone with plaster, and stone without mortar can be seen in Fig. 20. The common damage type is most likely caused by the lack of craftsmanship or traditional habits.

Figure 20: Examples of out of plane collapse due to wall cavity

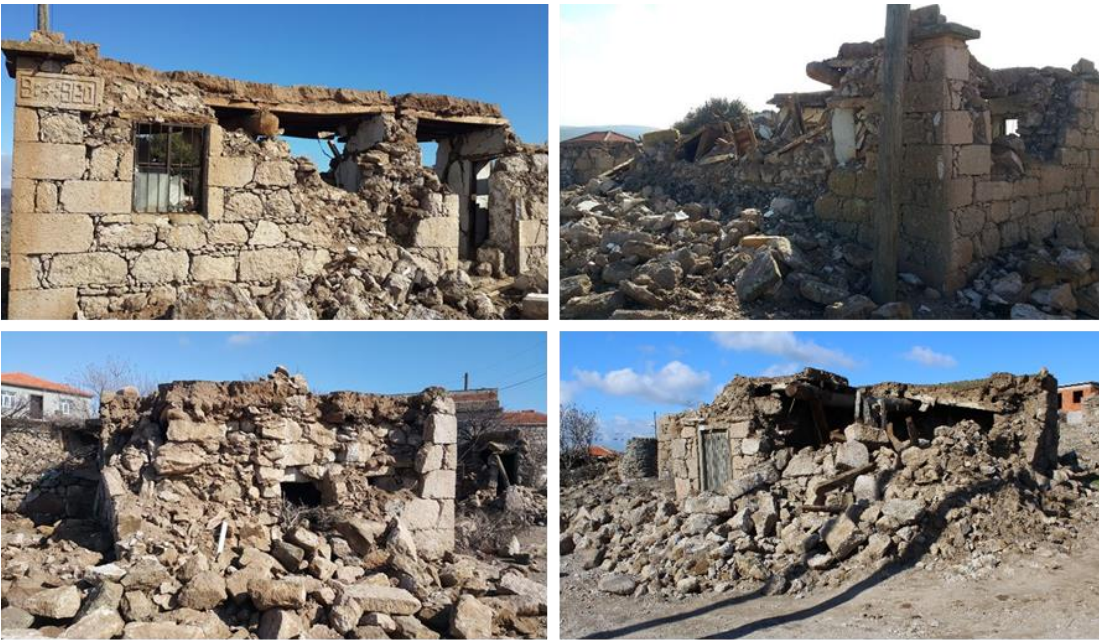
Another important cause of damage is the roofs made from a thick and heavy layer of mud spread upon wooden logs (Fig. 21). This technique is widely used in certain parts of Anatolia where timber is increasingly scarce. These heavy earth roofs are generally hardened by spreading soil with a cylindrical stone. The roof must be thickened more and more over the years to make it more durable against water leakage. Consequently, heavier roofs exert larger shear forces during an earthquake. In the investigated area, the roofs were either supported by beams and indirectly by walls or beams of the inner structure, and the columns were round or sub-round in cross-section, and the trunks were without the barks. This made it virtually impossible to obtain good connections and bearing surfaces between the beams. Such beams were prone to rolling off during motions induced by earthquakes. Moreover, the round ends of the beams exerted loads (to an excessive degree) on the supporting walls beneath them, and resulted in the collapse of the earth roof or walls.

Figure 21: Examples of heavy earth wall collapse

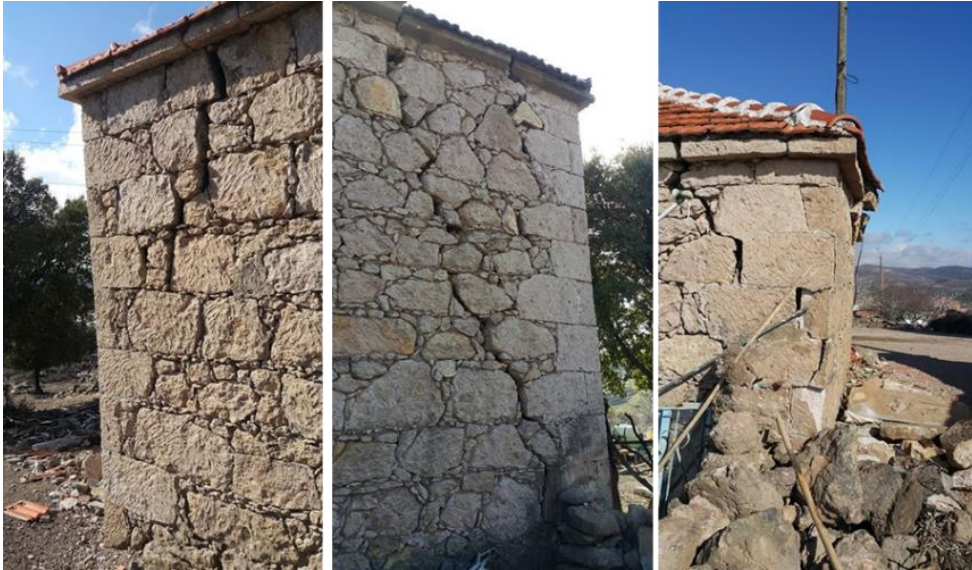
Many weak masonry walls without mortar had diagonal or inclined shear cracking as a result of cyclic shear forces exerted during the earthquakes (Fig. 23). But this diagonal shear cracking does not necessarily lead to total collapse. However, collapse may be inevitable if the triangular wall blocks on each side of a full diagonal crack become unstable by substantially losing their interlock or friction resistance along the cracks (Fig. 24). Similar failures have previously been reported around the world (Ural et al., 2012; Klingner, 2006).

Figure 23: Examples of diagonal shear cracking

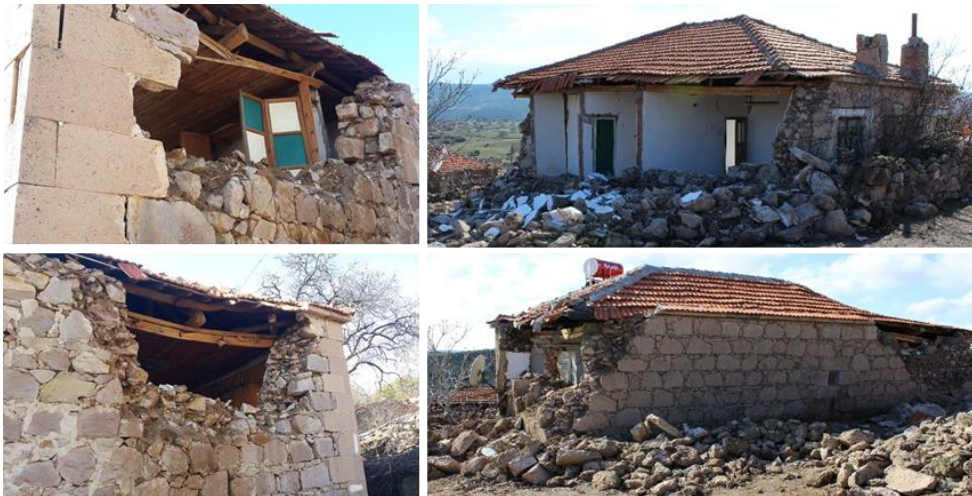
10 **Figure 24: Out of plane failures due to improper wall thickness and/or height-length ratio**
