Damages during February, 6-24 2017 Çanakkale earthquake swarm

Ramazan Livaoğlu¹, Mehmet Ömer Timurağaoğlu¹, Cavit Serhatoğlu¹, Mahmud Sami Döven²

Abstract. On February 6, 2017 a swarm of earthquakes began at the western end of the Turkey. This has been the first recorded swarm at Çanakkale region since continuous seismic monitoring began in 1970. The number of located earthquakes increased during the next ten days. This paper describes the output of a survey carried out in the earthquake prone towns of Ayvacık, Çanakkale, Turkey, in February 2017 after the earthquakes. Observations were made on site regarding traditional buildings at the rural area of Ayvacık. A description of the main structural features and their effects on the most frequently viewed damage modes were made according to in plane, out of plane behaviour of the wall regarding construction practice, connection type etc. It was found that there were no convenient connection details like cavity-ties or sufficient mortar strength resulting in decreased and/or lack of lateral load bearing capacity of the wall.

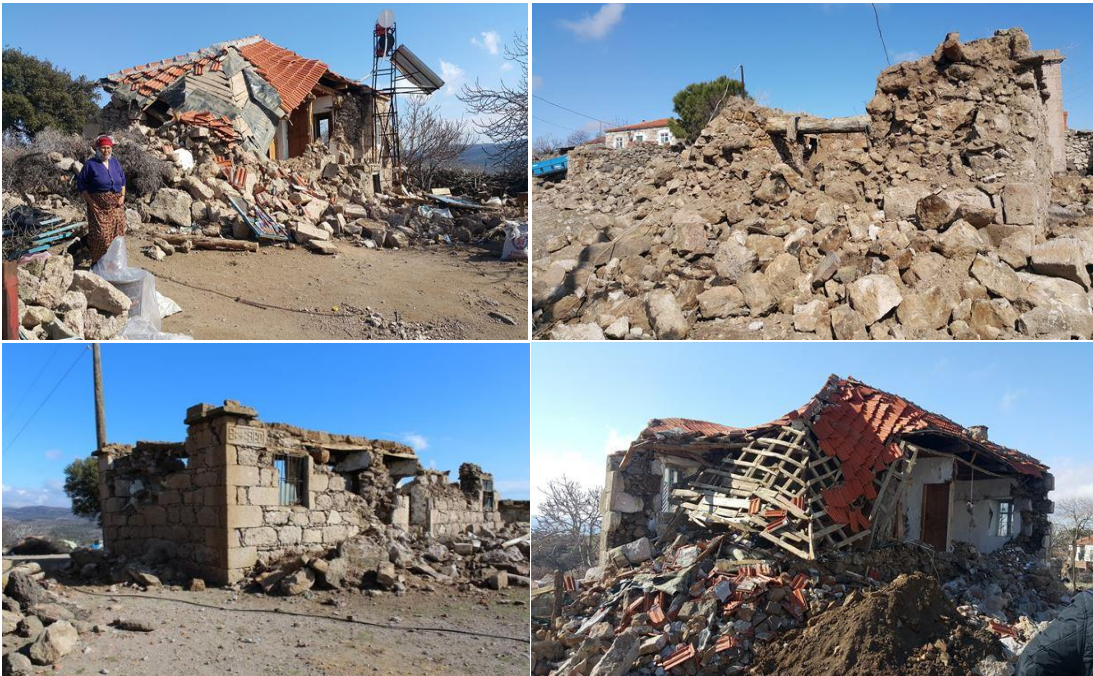
Failure mechanisms observed during the 2017 Çanakkale Earthquakes were also observed in other recent moderate earthquakes in Bala (ML=5.5), Doğubeyazıt (ML=5.1), Dinar (ML=5.9) and so on (Tezcan, 1996; Bayraktar et al., 2007; Adanur, 2008; Ural et al., 2012). Adanur (2010) showed that based on the investigations after 20 and 27 December 2007 Bala (Ankara) earthquakes, masonry buildings were built in three types in the affected area: (1) stone masonry buildings with walls made of natural shaped stones, (2) stone masonry buildings with walls made of cut stones, and (3) mixed masonry buildings with walls made of masonry materials like stones and mud bricks, stones and bricks, or stones and briquette. From all, a total of 945 buildings were heavily damaged or collapsed in Bala. Bayraktar et al. (2007) reported that 1000 buildings were affected from the earthquake in Doğubeyazıt. Similar to the above-mentioned studies, thus far, experiences from such moderate earthquakes in rural areas of Turkey have shown that even low-moderate earthquakes may cause significant damages on non-reinforced masonry structures (Fig. 16). This type of construction is among the most vulnerable type of buildings during an earthquake. Even under moderate lateral forces, such a masonry structure is damaged or collapsed due to lack of shear strength, improper interlocking mechanism and/or poor bonding between stone-stone or stone-mortar. In this case, shear failure is unavoidable in the planes forming diagonal cracks along the wall due to workmanship defects. Furthermore, when the wall is not designed with any engineering rule in mind, catastrophic and rapid collapse occurs in out-of-plane bending mode.

Figure 16: Examples of totally collapsed structures from Ayvacık, Çanakkale 2017 earthquake swarm

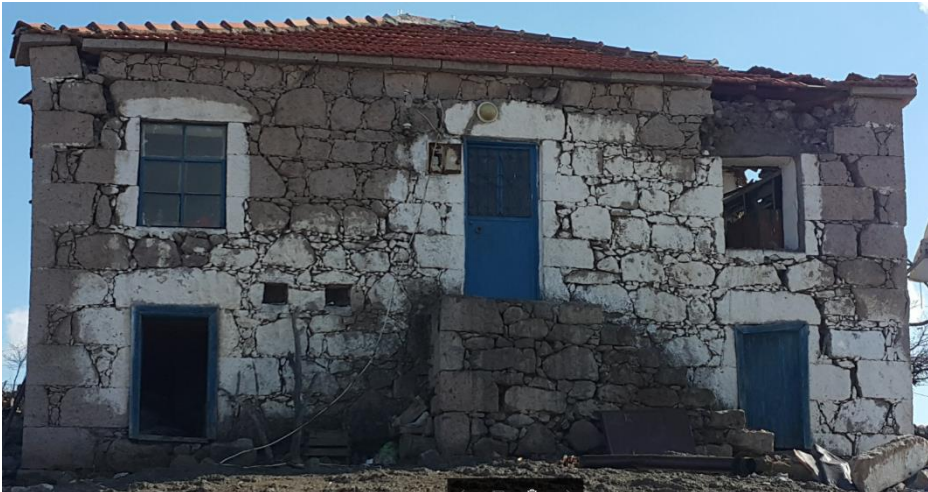
5 In the rural areas of Turkey, the construction of dwellings is done by the owner–dweller with the help of craftsmen who live in the area but are not full-time builders. These builders often learn their trade via apprenticeship. Hence, they have their own tools and do not follow any scientific rules on the site, as a result, an outdated or faulty construction technique can stay alive in a small region, and construction becomes highly similar between the dwellings. For example, during field observations, it was understood that even thick mortar or mud was not used as binding agent between stone or masonry units in almost all
10 damaged houses. Figure 17 is a striking example of heavy damage during earthquakes due to lack of mortar among stones. After a few mild earthquakes this masonry dwelling became unstable.

Figure 17: An example of a damaged dwelling due to inadequate interlocking

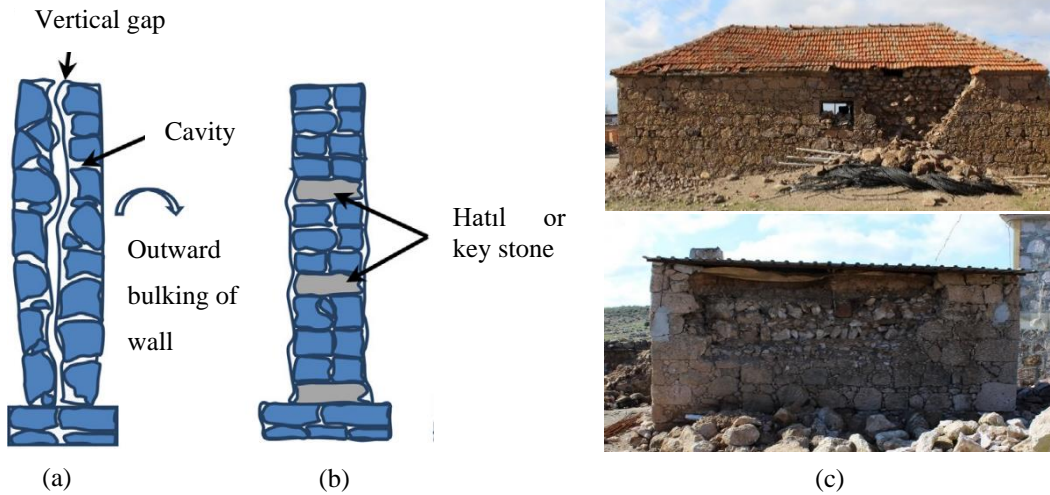
15 Another damage type observed in the region is outward bulking of walls, which is caused by interlocking deficiency. The reason of this deficiency is the vertical gap between stones creating wall thickness as shown in Fig. 18. In order to prevent this damage, horizontal elements such as ‘hatıl’ or key stone, which provide integrity to masonry walls, can be vertically used in specific intervals. The key stones or ‘hatıl’s can provide limited resistance to lateral seismic loads, and thus probably prevent the out-of-plan failure on some part of masonry walls.

Figure 18: Schematics of (a) conventional wall section without through stone, (b) wall section with key stones (Sharma, 2016), (c) damages observed in the region.

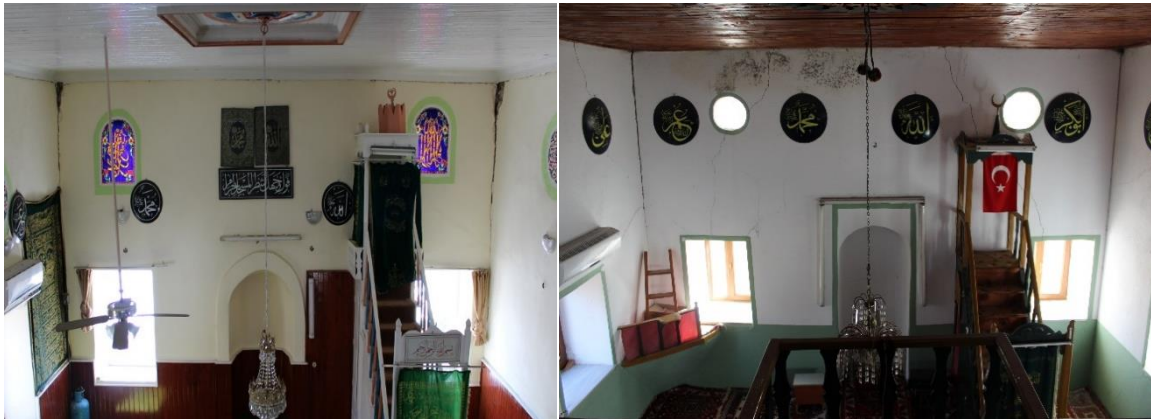
Another interlocking damage type is observed at the intersection of perpendicular walls (Fig. 19). One of the walls acts out of plane while the other remains very stiff in plane, resulting in inevitable cracks. This type of damage can either result in gaps developing between the in-plane and out-of-plane wall or vertical cracks may occur in the out-of-plane wall (Tolles et al. 1996). Further stages of this damage may result in out-of-plane failure of gable-end wall. To avoid intersection damage, the interlocking in the corners between perpendicular walls should be properly designed against lateral earthquake forces.

Figure 19: Observed damages at intersection of perpendicular walls

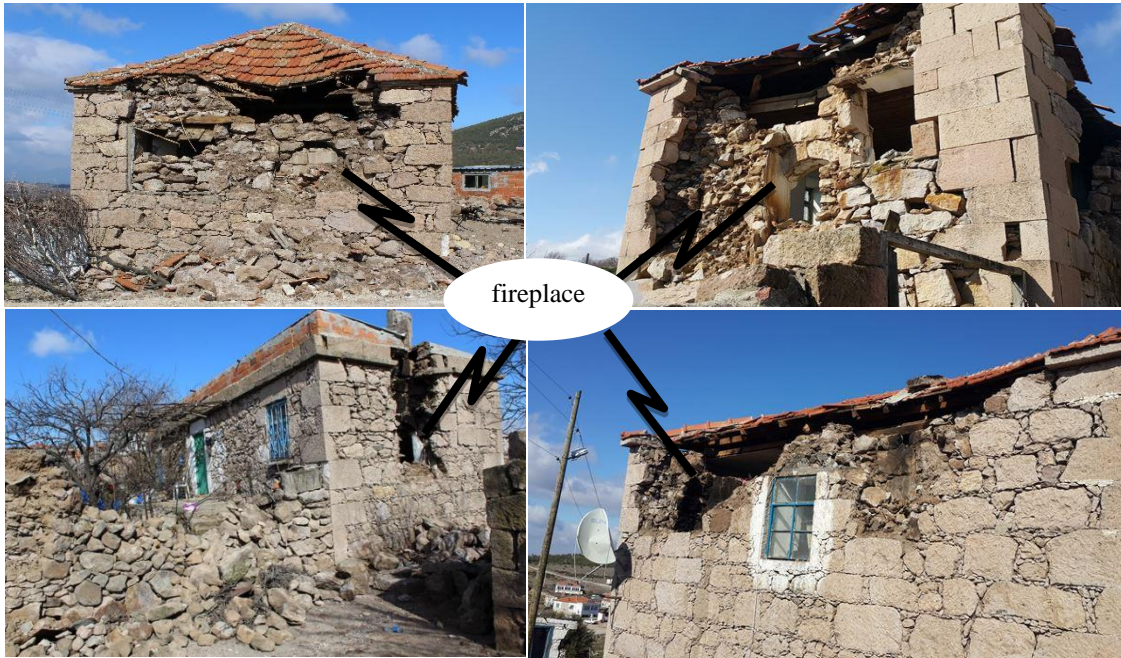
however, traditional fireplaces have been used in buildings, and they are built within the wall by decreasing the wall thickness or curving the wall outward. In such a case, irretrievable damage is inflicted on the wall because of decreasing shear resistance (Fig. 20). This damage type was observed in different masonry structures in the site. Different cases such as cut stone masonry, stone with plaster, and stone without mortar can be seen in Fig. 20. The common damage type is most likely caused by the

5 lack of craftsmanship or traditional habits.

Figure 20: Examples of out of plane collapse due to wall cavity
