Damages during February, 6-24 2017 Çanakkale earthquake swarm

Ramazan Livaoğlu¹, Mehmet Ömer Timurağaoğlu¹, Cavit Serhatoğlu¹, Mahmud Sami Döven²

Abstract. On February 6, 2017 earthquake swarm began at the western end of the Turkey. This has been the first recorded swarm at Çanakkale region since continuous seismic monitoring began in 1970. The number of located earthquakes increased during the next ten days. This paper describes the output of a survey carried out in the earthquake prone towns of Ayvacık, Çanakkale, Turkey, in February 2017 after the earthquakes. Observations were made on site regarding traditional buildings at the rural area of Ayvacık. A description of the main structural features and their effects on the most frequently viewed damage modes were made according to in plane, out of plane behaviour of the wall regarding construction practice, connection type etc. It was found that there were no convenient connection details like cavity-ties or sufficient mortar strength resulting in decreased and/or lack of lateral load bearing capacity of the wall. Furthermore, distribution maps of damaged/undamaged buildings according to villages, damage ratios, structures and d

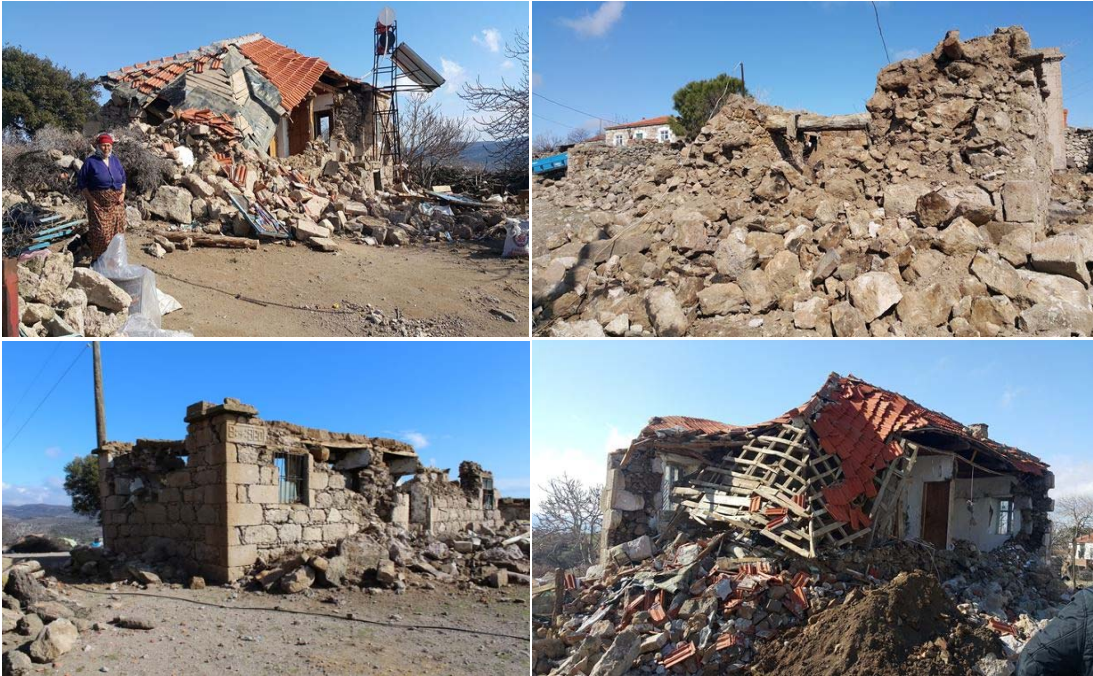
Failure mechanisms observed during the 2017 Çanakkale earthquake swarm were also observed in other recent moderate earthquakes in Bala (ML=5.5), Doğubeyazıt (ML=5.1), Dinar (ML=5.9) and so on (Tezcan, 1996; Bayraktar et al., 2007; Adanur, 2008; Ural et al., 2012). Adanur (2010) showed that based on the investigations after 20 and 27 December 2007 Bala (Ankara) earthquakes, masonry buildings were built in three types in the affected area: (1) stone masonry buildings with walls made of natural shaped stones, (2) stone masonry buildings with walls made of cut stones, and (3) mixed masonry buildings with walls made of masonry materials like stones and mud bricks, stones and bricks, or stones and briquette. From all, a total of 945 buildings were heavily damaged or collapsed in Bala. Bayraktar et al. (2007) reported that 1000 buildings were affected from the earthquake in Doğubeyazıt. Similar to the above-mentioned studies, thus far, experiences from such moderate earthquakes in rural areas of Turkey have shown that even low-moderate earthquakes may cause significant damages on non-reinforced masonry structures (Fig. 16). This type of construction is among the most vulnerable type of buildings during an earthquake. Even under moderate lateral forces, such a masonry structure is damaged or collapsed due to lack of shear strength, improper interlocking mechanism and/or poor bonding between stone-stone or stone-mortar. In this case, shear failure is unavoidable in the planes forming diagonal cracks along the wall due to workmanship defects. Furthermore, when the wall is not designed with any engineering rule in mind, catastrophic and rapid collapse occurs in out-of-plane bending mode.

Figure 16: Examples of totally collapsed structures from Ayvacık, Çanakkale 2017 earthquake swarm

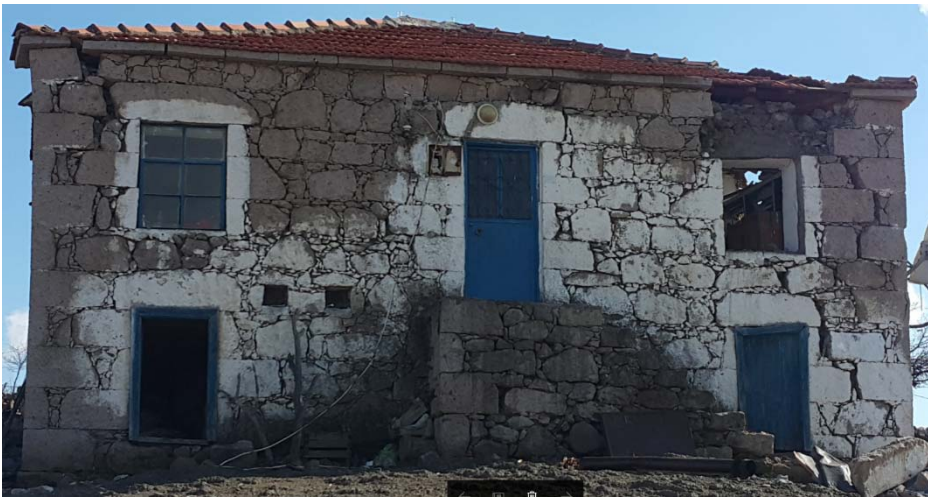
5 In the rural areas of Turkey, the construction of dwellings is done by the owner–dweller with the help of craftsmen who live in the area but are not full-time builders. These builders often learn their trade via apprenticeship. Hence, they have their own tools and do not follow any scientific rules on the site, as a result, an outdated or faulty construction technique can stay alive in a small region, and construction becomes highly similar between the dwellings. For example, during field observations, it was understood that even thick mortar or mud was not used as binding agent between stone or masonry units in almost all
10 damaged houses. Figure 17 is a striking example of heavy damage during earthquakes due to lack of mortar among stones. After a few mild earthquakes this masonry dwelling became unstable.

Figure 17: An example of a damaged dwelling due to inadequate interlocking

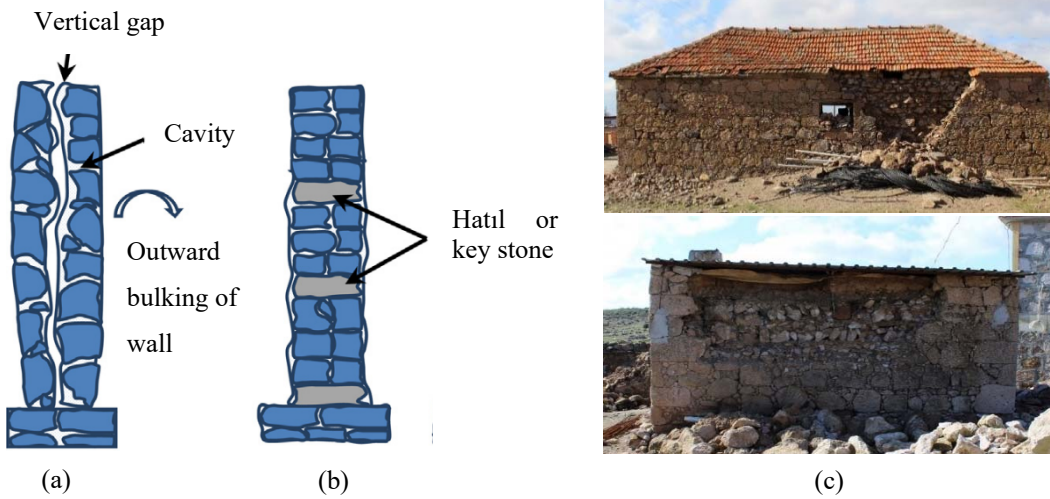
15 Another damage type observed in the region is outward bulking of walls, which is caused by interlocking deficiency. The reason of this deficiency is the vertical gap between stones creating wall thickness as shown in Fig. 18. In order to prevent this damage, horizontal elements such as ‘hatıl’ or key stone, which provide integrity to masonry walls, can be vertically used in specific intervals. The key stones or ‘hatıl’s can provide limited resistance to lateral seismic loads, and thus probably prevent the out-of-plan failure on some part of masonry walls.

Figure 18: Schematics of (a) conventional wall section without through stone, (b) wall section with key stones (Sharma, 2016), (c) damages observed in the region.

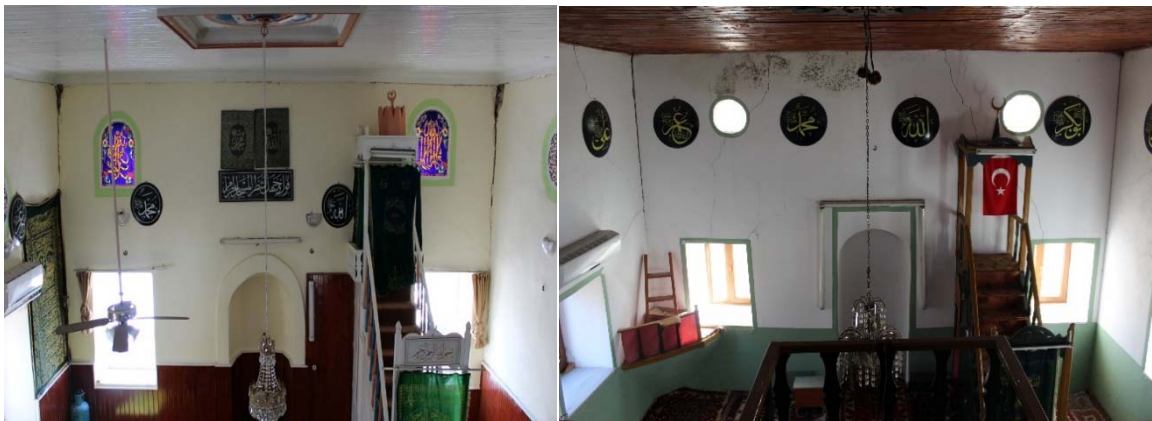
Another interlocking damage type is observed at the intersection of perpendicular walls (Fig. 19). One of the walls acts out of plane while the other remains very stiff in plane, resulting in inevitable cracks. This type of damage can either result in gaps developing between the in-plane and out-of-plane wall or vertical cracks may occur in the out-of-plane wall (Tolles et al. 1996). Further stages of this damage may result in out-of-plane failure of gable-end wall. To avoid intersection damage, the interlocking in the corners between perpendicular walls should be properly designed against lateral earthquake forces.

Figure 19: Observed damages at intersection of perpendicular walls

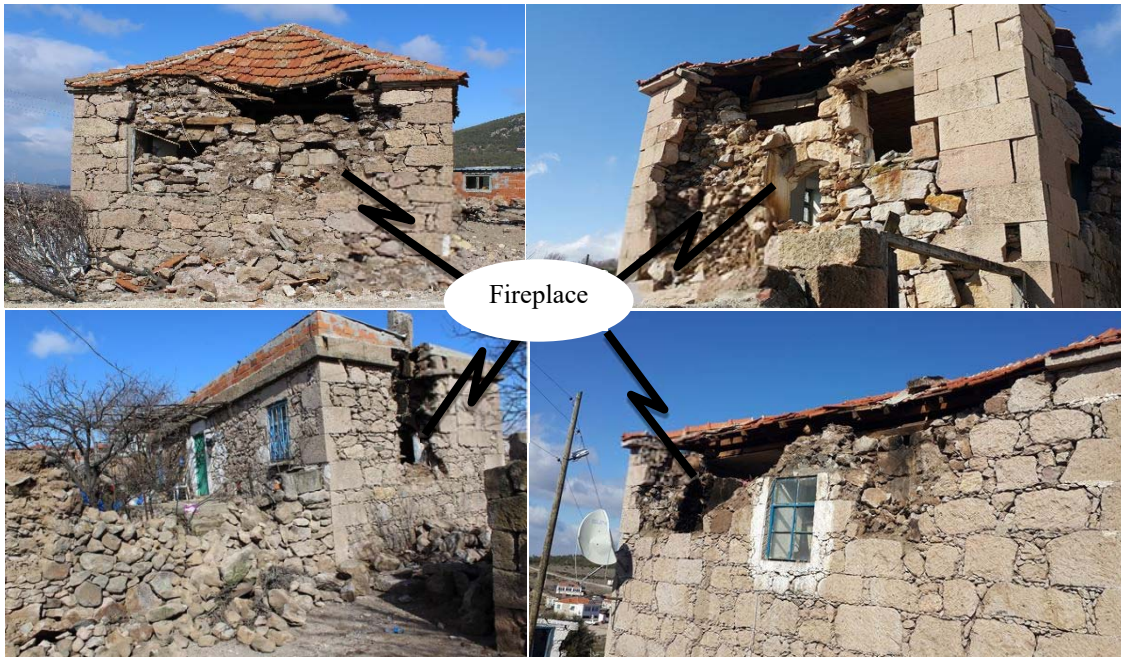
however, traditional fireplaces have been used in buildings, and they are built within the wall by decreasing the wall thickness or curving the wall outward. In such a case, irretrievable damage is inflicted on the wall because of decreasing shear resistance (Fig. 20). This damage type was observed in different masonry structures in the site. Different cases such as cut stone masonry, stone with plaster, and stone without mortar can be seen in Fig. 20. The common damage type is most likely caused by the

5 lack of craftsmanship or traditional habits.

Figure 20: Examples of out of plane collapse due to wall cavity

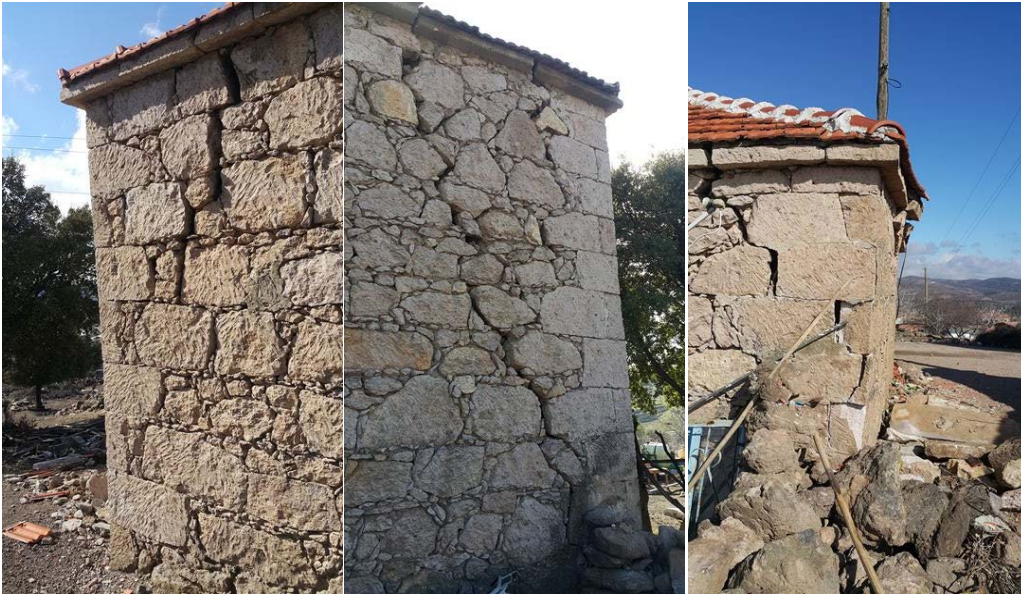
Many weak masonry walls without mortar had diagonal or inclined shear cracking as a result of cyclic shear forces exerted during the earthquakes (Fig. 23). But this diagonal shear cracking does not necessarily lead to total collapse. However, collapse may be inevitable if the triangular wall blocks on each side of a full diagonal crack become unstable by substantially losing their interlock or friction resistance along the cracks (Fig. 24). Similar failures have previously been reported around the world (Ural et al., 2012; Klingner, 2006).

Figure 23: Examples of diagonal shear cracking

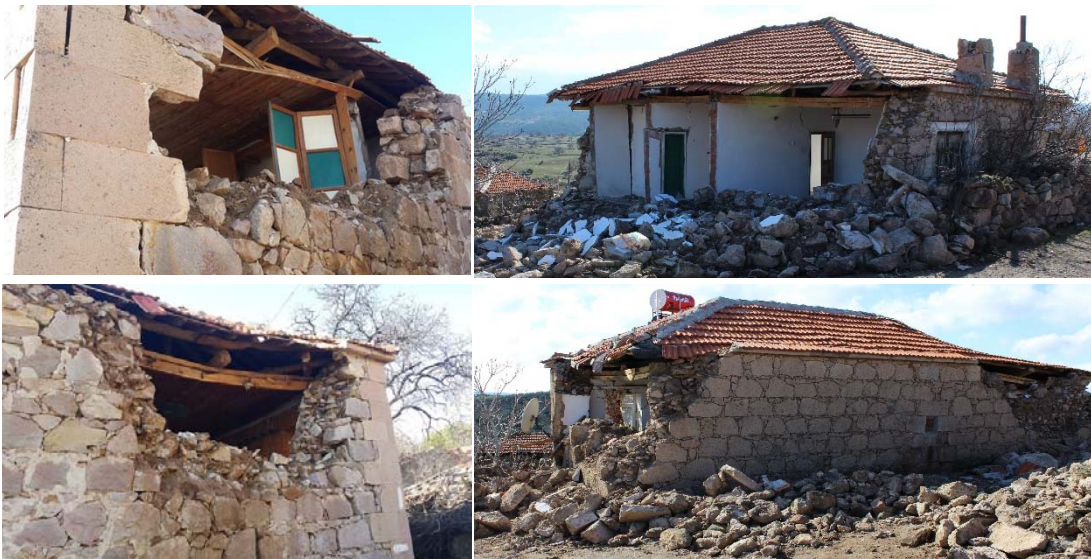
Figure 24: Out of plane failures due to improper wall thickness and/or height-length ratio
