Damages during February, 6-24 2017 Çanakkale earthquake swarm

Ramazan Livaoğlu¹, Mehmet Ömer Timurağaoğlu¹, Cavit Serhatoğlu¹, Mahmut Sami Döven²

Abstract. On February 6, 2017 a swarm of earthquakes began at the western end of the Turkey. This has been the first recorded swarm at Çanakkale region since continuous seismic monitoring began in 1970. The number of located earthquakes increased during the next ten days. This paper describes the output of a survey carried out in the earthquake prone towns of Ayvacık, Çanakkale, Turkey, in February 2017 after the earthquakes. Observations collected on site regard traditional
10 buildings at the rural area of Ayvacık. A description of the main structural features and their effects on the most frequently viewed damage modes are related in plane, out of plane behavior of the wall regarding construction practice, connection type etc. It was found that there were no convenient connection details like cavity-ties or sufficient mortar strength resulting in decreased and/or lack of lateral load bearing capacity of the wall.

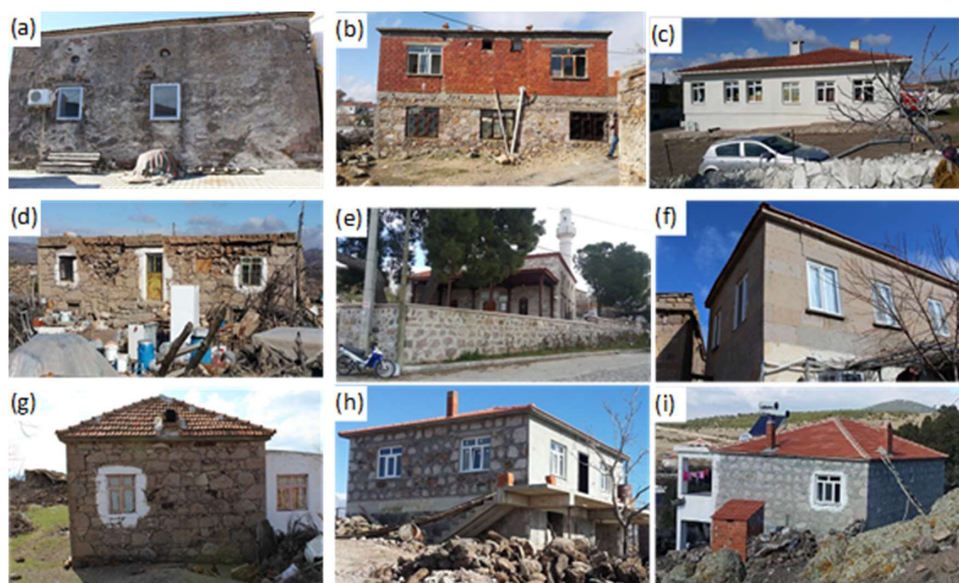
In the reconnaissance area, observation showed that the construction materials and skills are extremely deficient. Modern materials and techniques are just used in a small part of the observed region. Moreover, cement mortar between stone was not used for almost 50% of the wall. There are a few of building in which reinforced concrete element partly or fully used in the reconnaissance area. Curing of concrete is still not practiced as an integral part of the concreting process. The concrete blocks are of poor quality because of the poor quality of the concrete, a lack of compaction and very little or no curing. The existing building types in the area are shown in Fig. 5.

15 **Figure 5 Existing building types in reconnaissance area: a) hatıl dwelling b) stone and brick in cement mortar, c) engineered RC building d) hatıl building with heavy roof, e) historical masonry with cut stone, f) cut stone without mortar, g) stone without mortar, h), i) stone in cement mortar with reinforced concrete.**

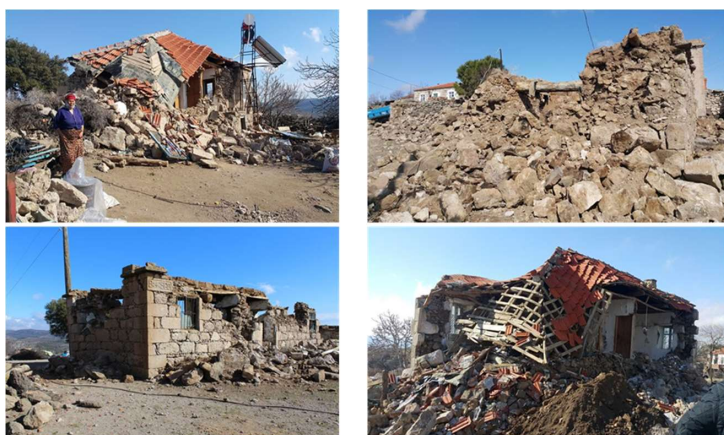
masonry structures (Fig. 9). This type of masonry is among the most vulnerable type of buildings during an earthquake. Even under moderate lateral force such a masonry structure is damaged or collapsed, due to lack of shear strength, improper interlocking mechanism and/or poor bond between stone-stone or stone-mortar. In this case shear failure is inevitable in plane forming of diagonal cracks or similar cracks wherever is suitable to damage through the wall because of defects due to workmanship. Furthermore, when the wall did not design considering any engineered rule, the catastrophic and rapid collapses occur in out-of-plane flexure mode. In addition to the general failure mode above mentioned, the technical reasons for damages and collapse observed reconnaissance may be summarized in detail as follows.

10 **Figure 9** Totally collapsed examples from Ayvacık, Çanakkale 2017 earthquakes swarm

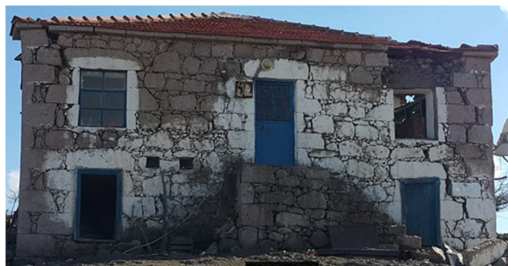
In the rural area of Turkey, the construction of dwelling is by the owner –occupier with aid of craftsmen who live in the locality but who are not full-time builders. These builders are usually taught their trade as a result of apprenticeship. Consequently, they have their own tools without any scientific rule and in the site the construction technique is still alive and building technique is so similar among the dwelling. For example, during the observation it is apparently shown that even thick mortar or mud was not used as binding agent between stone or masonry unit for almost all damaged dwellings. The Fig. 10 is a conspicuous example that heavy damages during the earthquakes were taken place for lack of mortar between stones. At the end of several moderate earthquakes this masonry dwelling became unstable.

Figure 10 An example of damaged dwelling due to inadequate interlocking

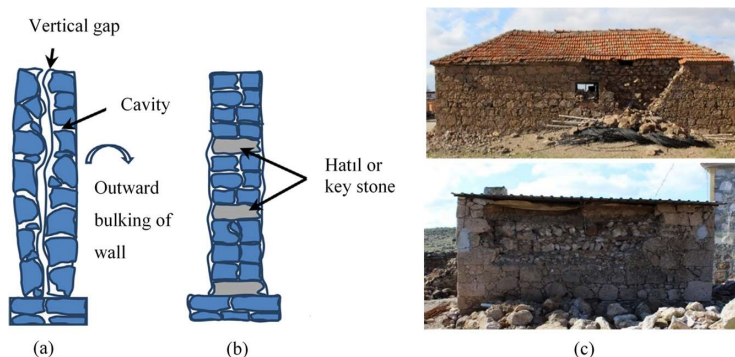
Another damage type observed in the region is outward bulking of wall which caused by interlocking deficiency. The reason of this deficiency is vertical gap between stones creating wall thickness as shown in Fig. 11. In order to prevent this damage, horizontal elements such as hatil or key stone, which provide integrity to masonry wall, can be used in specific intervals vertically. The key stones or hatils can provide limited resistance to lateral seismic loads and thus probably prevent the out-of-plan failure on some part of masonry walls.

Figure 11 Schematics of a conventional wall section without through stone, b wall section with through stones (Sharma, 2016) c observed damages in the region.

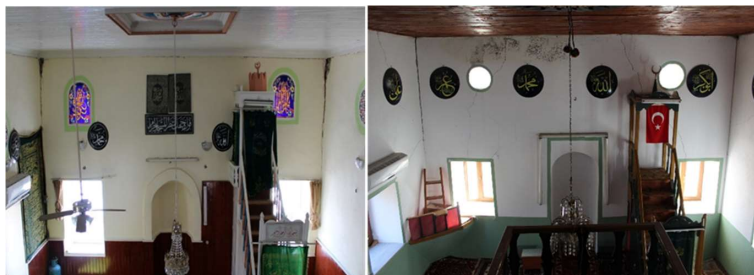
An additional interlocking damage type is observed at the intersection of perpendicular walls (Fig. 12). One of the walls acts out of plane while other remains very stiff in plane resulting in inevitable cracks. Damages in this type can either result in gaps developing between the in-plane and the out of plane wall or vertical cracks may occur in the out of plane wall (Tolles et al. 1996). Further phase of this damage may result in out of plane failure of gable-end wall. To avoid intersection damage, interlocking between perpendicular walls in the corners should be appropriately designed against lateral earthquake forces.

Figure 12 Observed damages at intersection of perpendicular walls

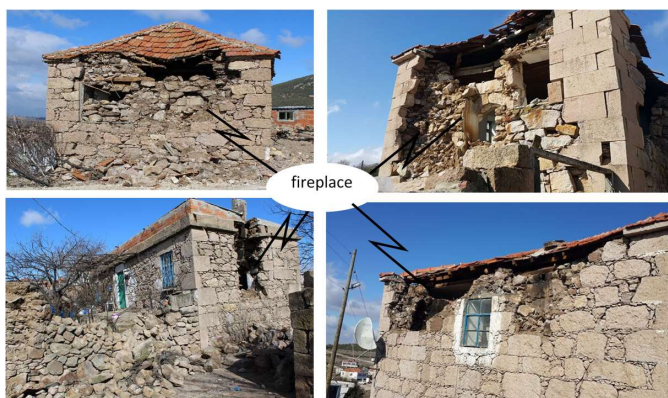
The design process of the masonry buildings needs to regularity more than other supporting system, because lateral load
5 resisting system must have continuity to meet shear force stemming from earthquake. In the rural area, however, traditional
fireplace was used in the buildings and it is built within the wall by decreasing the wall thickness or curving the wall
outward. In such a case irretrievable damage is occurred on the wall because of the decreasing the shear resistance (Fig. 13).
This damage type was observed for different masonry structures in the site. For example, it can be seen from Fig. 13 that
10 there were different examples like cut stone masonry, stone with plaster and stone without mortar. The common damage type
is most likely stemming from the lack of skill of craftsman or traditional habits.

Figure 13 Examples of out of plane collapse due to wall cavity

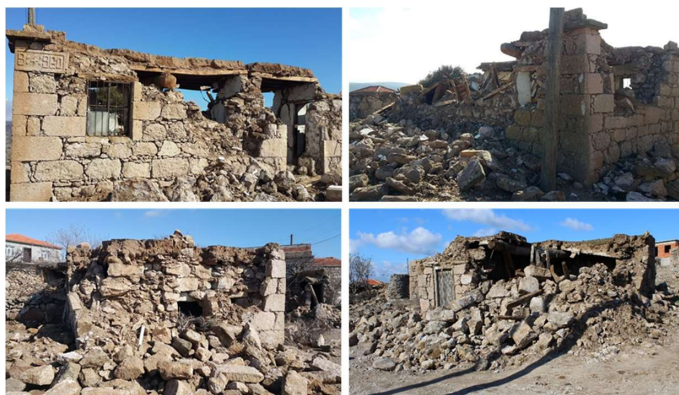
15 Another important reason that causes damage is the roof made from a thick and heavy layer of mud spread upon wooden
logs (Fig. 14). This technique is widely used in some part of Anatolian region where timber is increasingly scarce. These
heavy earth roofs are generally made hardening spreading soil with a cylindrical stone. To make the earth roof more durable

against water leakage need to be thickened more and more over the years. Consequently, heavier earth roof cause bigger shear force during the earthquake. In general, the roof either supported by the beam and indirectly by the wall or inner structures beams and columns were round or sub-round in section, the trunk without its bark. This made connections and good bearing surfaces between them virtually impossible. Such beams were prone to roll off the other during the earthquake induced motions. Also, the round beam-ends point loaded (to an excessive degree) the supporting walls beneath and then collapse of the earth roof or wall is inevitable.

Figure 14 Examples of heavy earth wall collapse

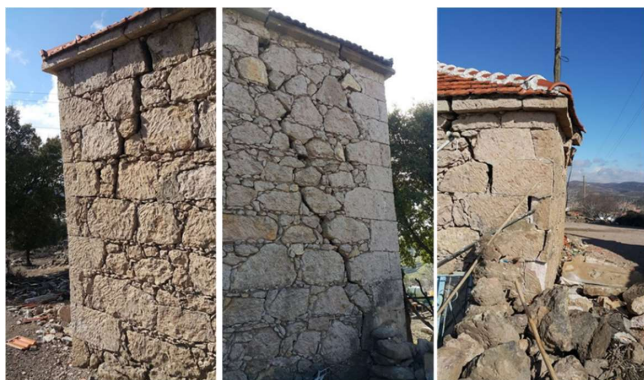
Many weak masonry walls without mortar had diagonal or inclined shear cracking as a result of cyclic shear forces applied during the earthquakes (Fig. 16). But this diagonal shear cracking does not necessarily lead to total collapse in general. However, collapse may be inevitable if the triangular wall blocks on each side of a full diagonal crack become unstable by substantially losing their interlock or friction resistance along the cracks (Fig. 17). Similar failures were previously reported around the world (Ural et al., 2012; Klingner, 2006).

Figure 16 Examples of diagonal shear cracking

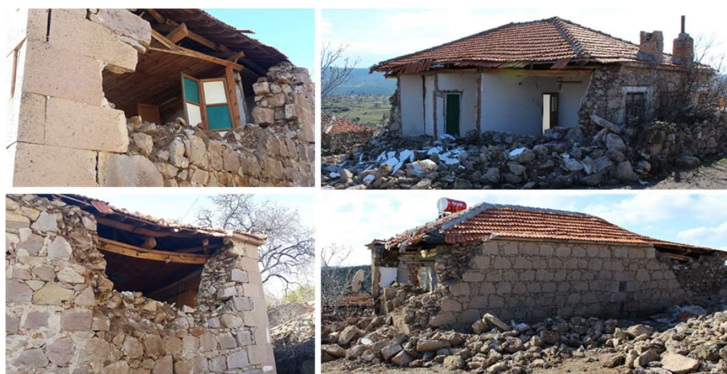
Figure 17 Out of plane failures depending on improper wall thickness and/or height-length ratio
