Seismic vulnerability of vernacular Newari buildings in Nepal: observations and analysis of damage due to 1934, 1988, 2011, and 2015 earthquakes

Abstract. This paper reports the seismic vulnerability of vernacular Newari buildings based on the damage observations during four major earthquakes (1934, 1988, 2011 and 2015) that struck Bhaktapur city. Some specific features that contributed to collapse prevention in traditional masonry buildings are also highlighted in this paper. In this paper, we have outlined the insights of each earthquake using forensic interpretations and the recommendations by various researchers after 1934 and 1988 earthquakes are compared in terms of their implementation. With the help of damage database recorded during 1934, 1988 and 2015 earthquakes, we have created damage probability matrices and empirical fragility functions for traditional masonry structures. The fragility functions and damage probability matrices derived in this study highlight that most of the vernacular Newari buildings are likely to be collapsed in the case of strong to major earthquakes.

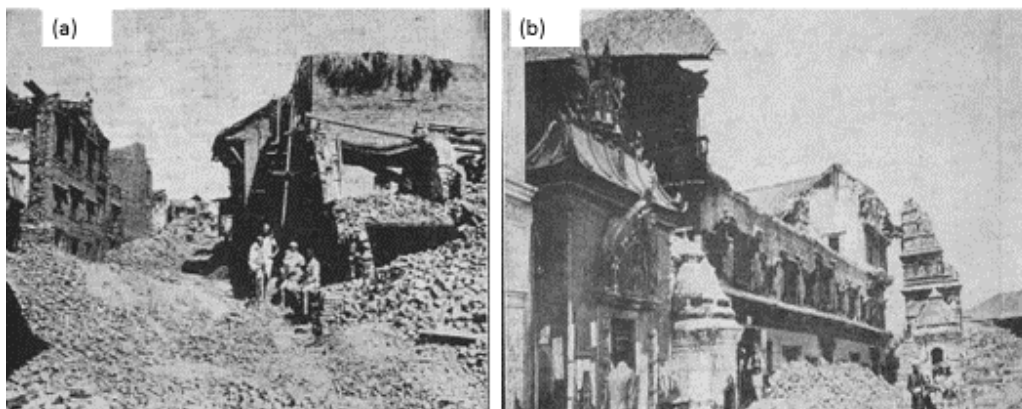
In total, 6224 residential buildings were damaged due Bihar-Nepal earthquake (Rana, 1935). More than 177 heritage structures were also damaged due to the earthquake. The most common failure mode was reported to be the combination of in plane and out of plane mechanism as shown in Fig. 4a. Apart from this, poor binding among the masonry units can be observed in damaged wall section. Fig. 4b depicts the collapse of heavy gable wall as contemporary practices were based on homogenous walls throughout the building.

Figure 4: (a) Combined in-plane and out-of-plane failure in masonry walls (courtesy: Rana (1935)) (b) Collapse occurred in the upper story due to mass concentration (courtesy: Rana (1935)).

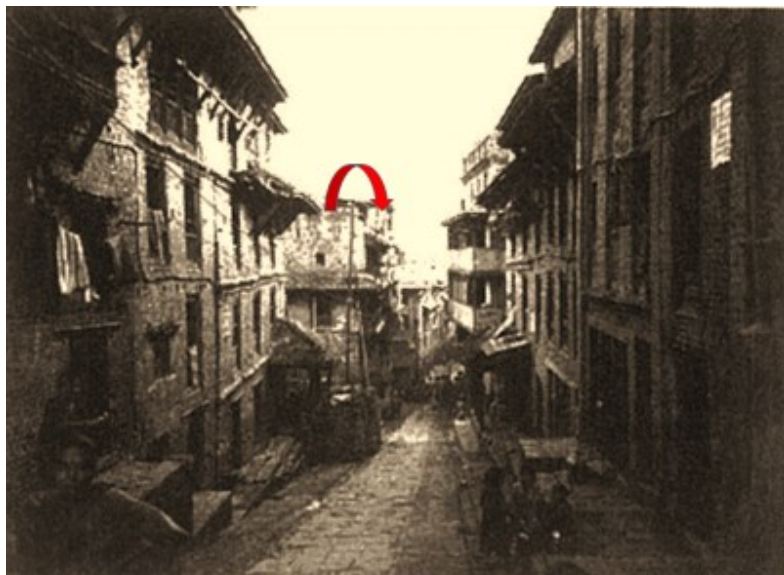
Figure 5: Damaged houses in sloping ground due to 1988 earthquake (courtesy: Gupta (1988)).

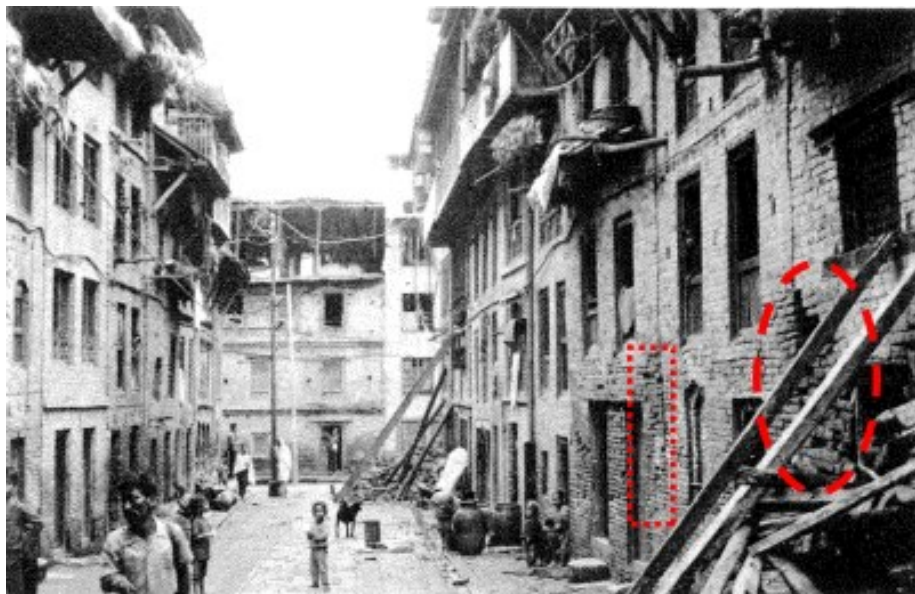
Figure 6: Damage due to structural pounding occurred due to 1988 earthquake (courtesy: Gupta (1988)).

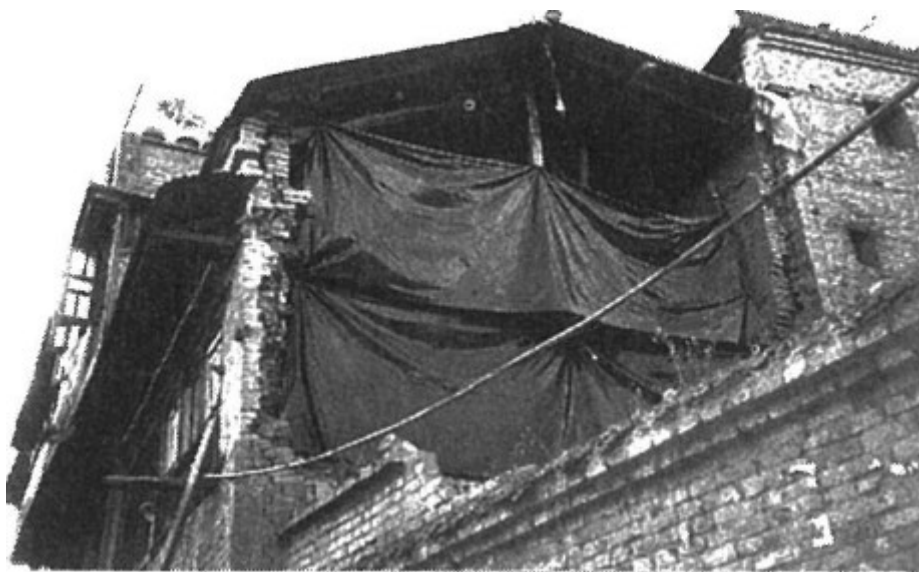
25 heavy gable construction and roofing (Fig. 7); l) heavy masonry wall (thickness ~500 mm); m) in-plane and out-of-plane mechanisms (Fig. 8); n) improper opening placement (Fig. 9); and o) cantilevered projections.

Figure 7: Gable collapse reported by Fujiwara et al. (1989) during 1988 earthquake.

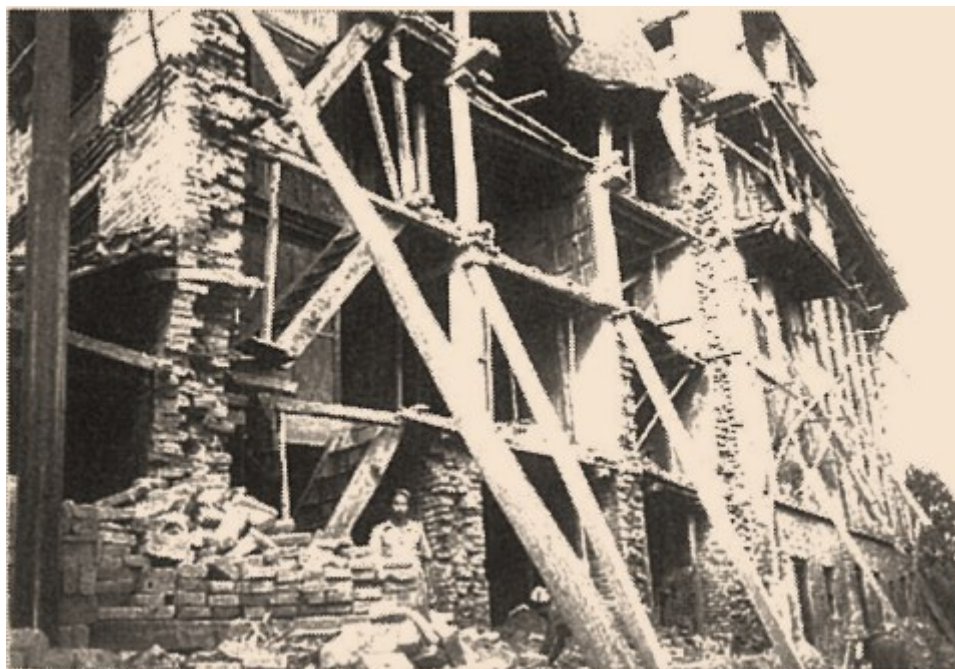
Figure 8: Damage due to in-plane and out-of-plane actions during 1988 earthquake (courtesy: Fujiwara et al. (1989)).

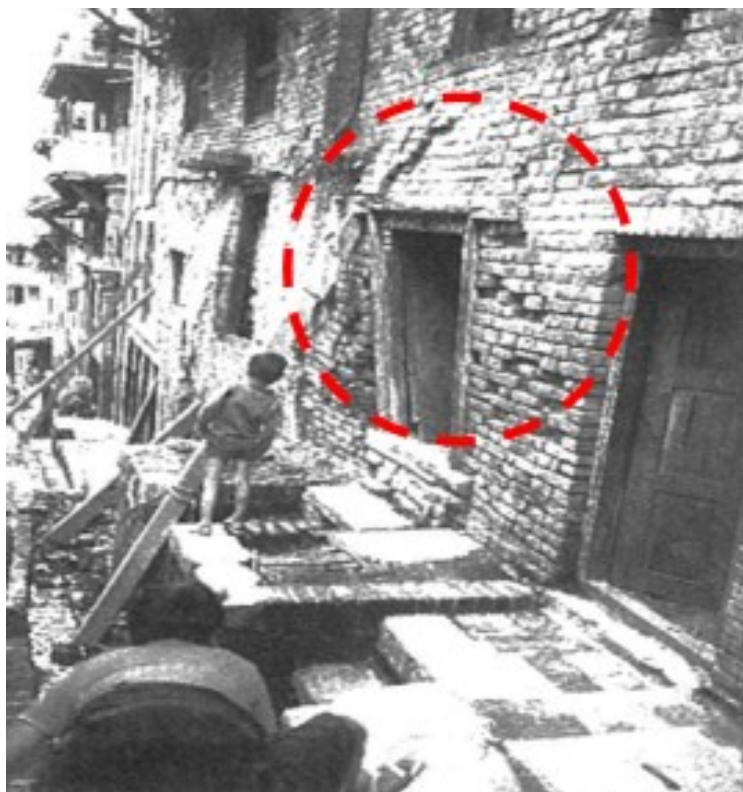
Figure 9: Bulging of wall observed above the doors due to 1988 earthquake (courtesy: Fujiwara et al. (1989)).

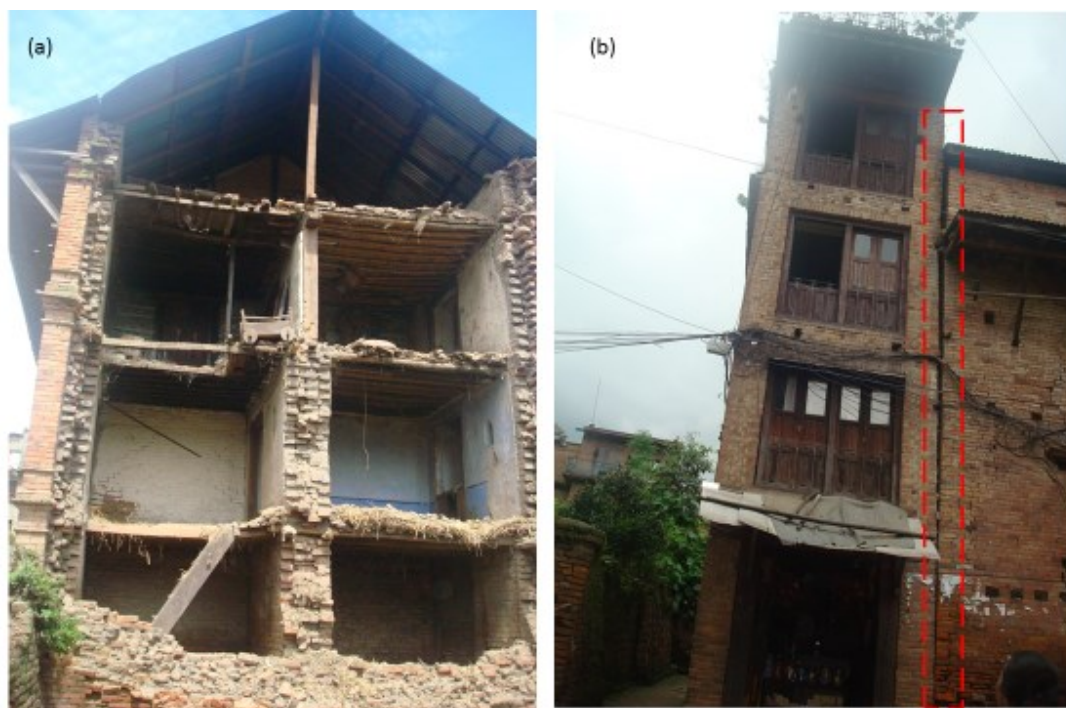
- 5 During the field investigation, it was known that the damaged buildings were the ones already partially damaged due to 1988 Udayapur earthquake. Although the accelerometric records in Kathmandu valley show low peak ground acceleration (~0.05g), some of the buildings in Bhaktapur sustained partial collapse and some others sustained partial damage. Interestingly, some of the already bulged buildings due to the 1988 Udayapur earthquake remained unaffected in some locations of Bhaktapur. Notably, two cases of out of plane wall collapse were observed (Fig. 10a) in Bhaktapur. In addition, one case of structural

- 10 pounding was noted probably due to sharp variation in dynamic properties among the adjoin buildings (Fig. 10b). Damages in heavy gable wall (Fig. 11a), cracks on masonry walls especially at corner region (Fig. 11b), and damage in heavy roof (Fig. 11c) were identified other observed damage modes during the field reconnaissance. Since 1934, the construction strategy was not found to be changed as the similar failure modes and construction materials and technology were observed during field reconnaissance.

Figure 10: (a) Out of plane collapse of masonry wall (courtesy: Ganesh Kumar Bhattarai), and (b) structural pounding due to 2011 earthquake (courtesy: Ganesh Kumar Bhattarai).

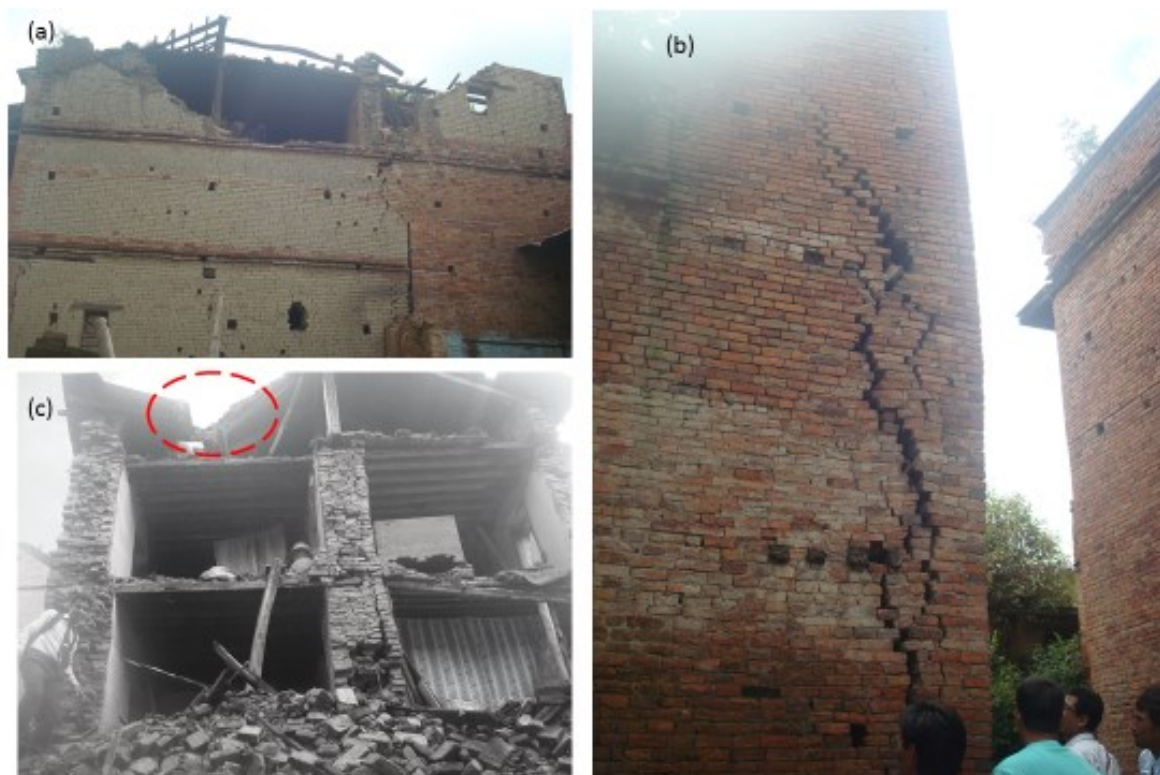
Figure 11: (a) Gable collapse occurred in two adjoining buildings (courtesy: Ganesh Kumar Bhattarai), (b) cracks propagated towards the corners (courtesy: Ganesh Kumar Bhattarai), (c) heavy roof collapse and out of plane failure of brick masonry wall occurred due to 2011 earthquake (courtesy: Ganesh Kumar Bhattarai).

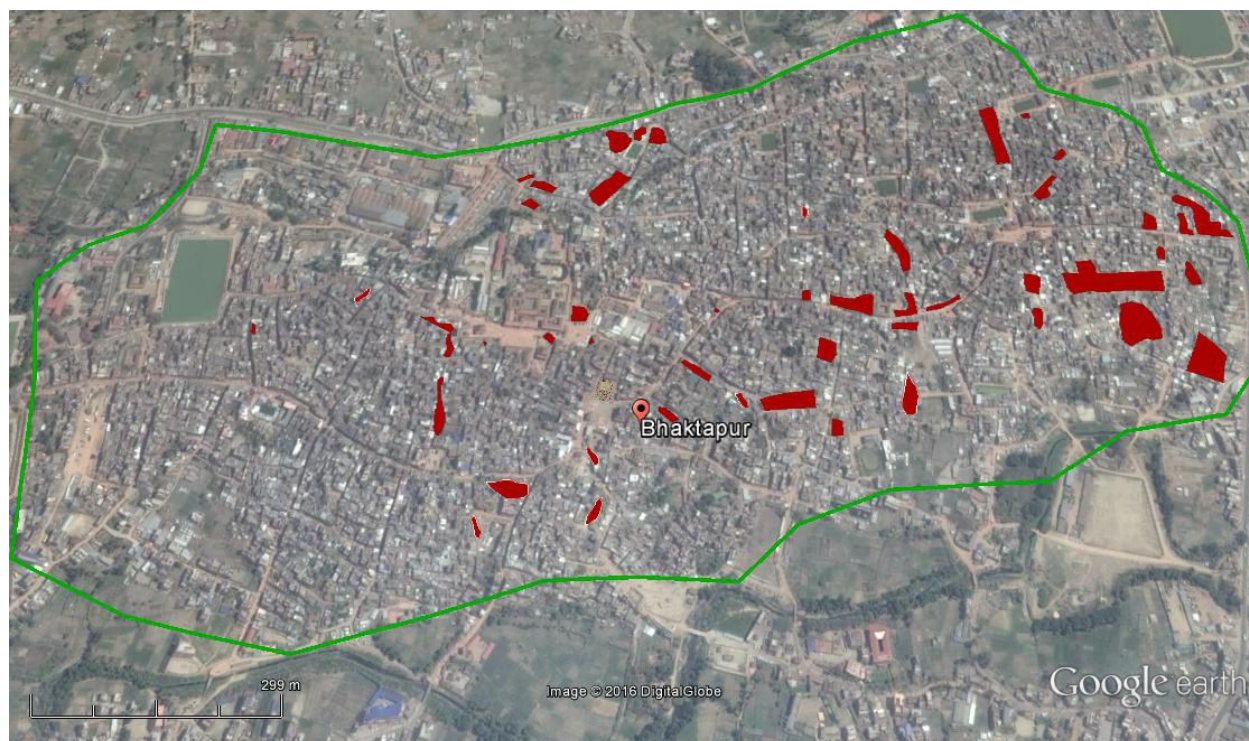
Figure 12: Major building collapse areas within the ancient settlement of Bhaktapur city (modified from: <https://www.google.com/earth/>).

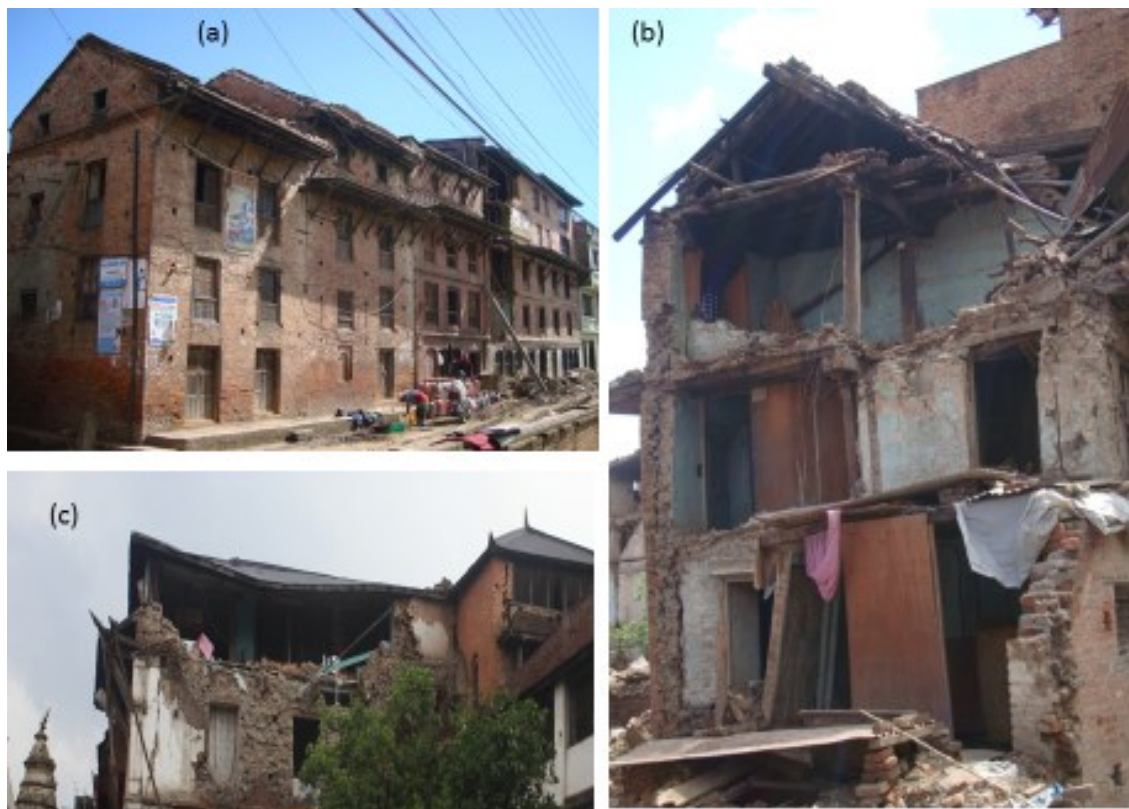
Figure 13: (a) Minor damage on roof (b) out of plane collapse of walls (c) gable collapse occurred due to Gorkha earthquake sequence.

Damage element/aspect	Damage scenario
Roof	<ul style="list-style-type: none"> - Heavy roofs constructed using roof tiles were suffered in terms partial roof collapse (Fig. 13a) - Galvanized iron sheets performed well
Gable wall	<ul style="list-style-type: none"> - Out of plane failure was commonly observed (Fig. 13b) - Majority of the buildings were lacking proper connection between gable and the masonry wall (Fig. 13c)
Projections	<ul style="list-style-type: none"> - Wooden projections (various forms of windows) performed well (Fig. 14a)
Wall	<ul style="list-style-type: none"> - Out of plane failure was observed as the most prevalent failure mechanism (Fig. 13c) - Walls on the edge of the settlement suffered progressive collapse in out-of-plane direction (Fig. 14b) - Out of plane collapse of heavy wall constructed in upper stories (Fig. 13c) - Walls were separated due to lack of proper connection and binding between orthogonal walls as well as the structural and partition walls (Fig. 15a) - Veneered partition walls performed better than the heavy brick masonry partitions - Few cases of in-plane wall failures were observed in the buildings having many openings and relatively larger in size - Delamination of wythes was observed in some cases (Fig. 15b)

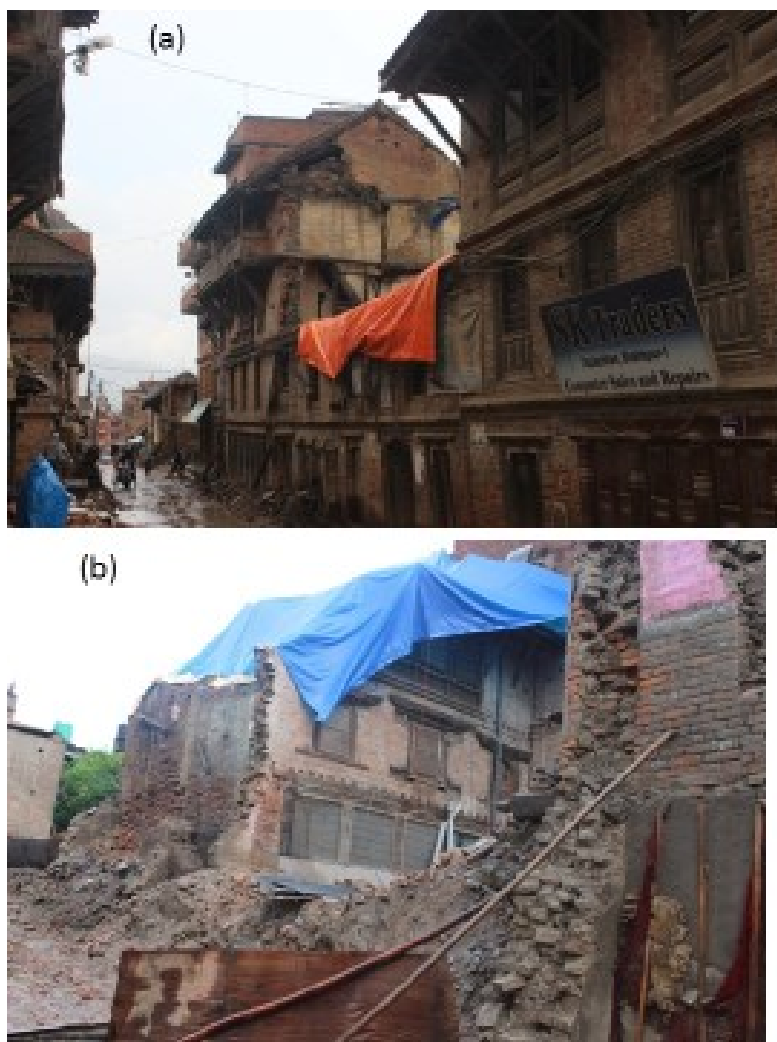
Figure 14: (a) Undamaged projections supported by cantilevered timber joists (b) collapsed wall on the building situated at the corner of row housing settlement due to Gorkha earthquake.

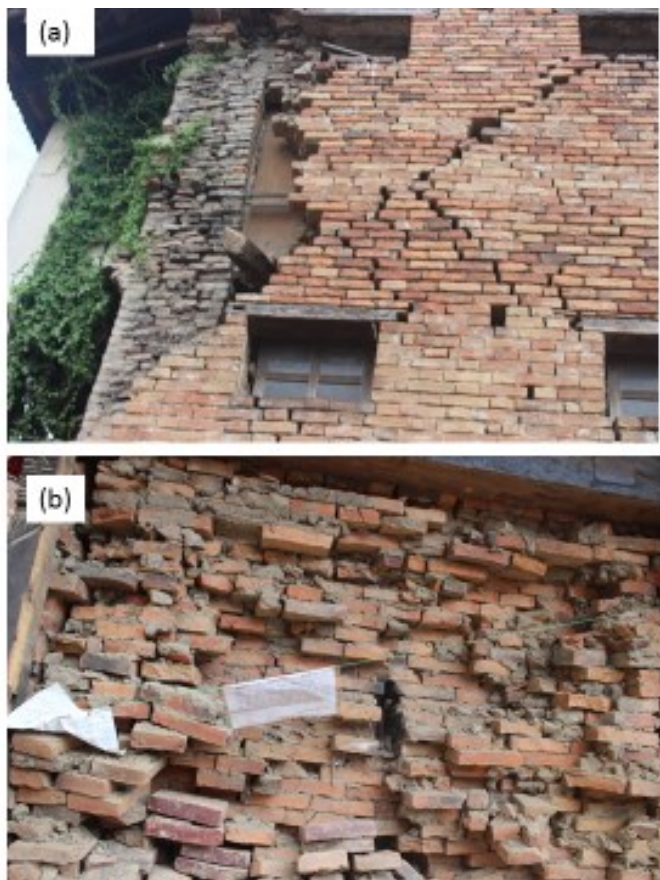
Figure 15: (a) Separation of orthogonal walls (b) delamination of wythes observed after the Gorkha earthquake.

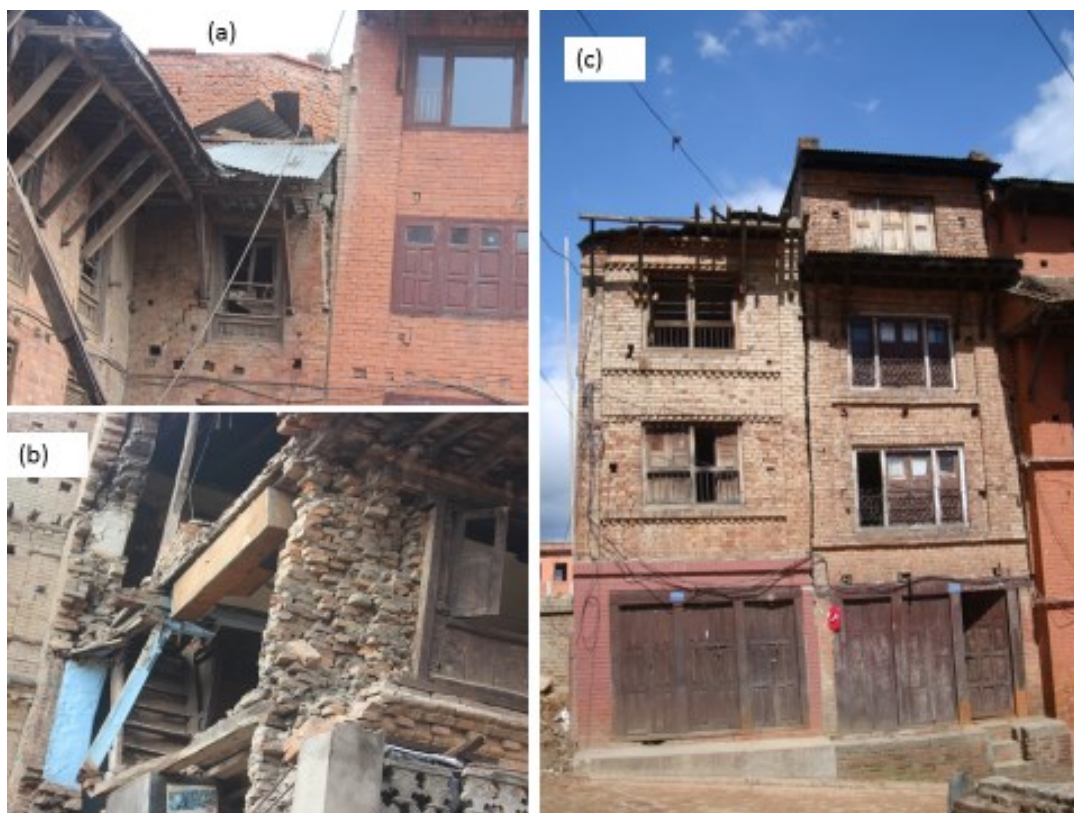
Figure 16: (a) Reentrant corner damage along with structural pounding (b) separated masonry units and the mud-mortar (c) structural pounding led separation due to variation in dynamic characteristic of jointed buildings observed during Gorkha earthquake.

Corner	<ul style="list-style-type: none"> - Reentrant corners were bulged out and large cracks were damaged in the interaction zone (Fig. 16a) - Corners were constructed without any special provisions - Mud mortar was found to be suffered from shrinkage and throughout the structural system, brick units were observed to be remaining in isolation marring the structural integrity (Fig. 16b)
Structural pounding	<ul style="list-style-type: none"> - Due to row housing system and intermediate modifications (reconstruction) and due to high variation in dynamic properties of adjoining structures, many cases of structural pounding led damaged were observed (Fig. 16c) - Sometimes single building was found to be separated exactly into two halves and partial reconstruction done, leading to damage in the remaining portion of building. Change in slenderness ratio due to division of single building was also observed in many buildings.

Ground floor	<ul style="list-style-type: none"> - For commercial purpose, usually ground floor was not found to be provided with structural wall rather shutters (wooden/iron) were prevalent and such buildings with more height were observed to be damaged (Fig. 16c)

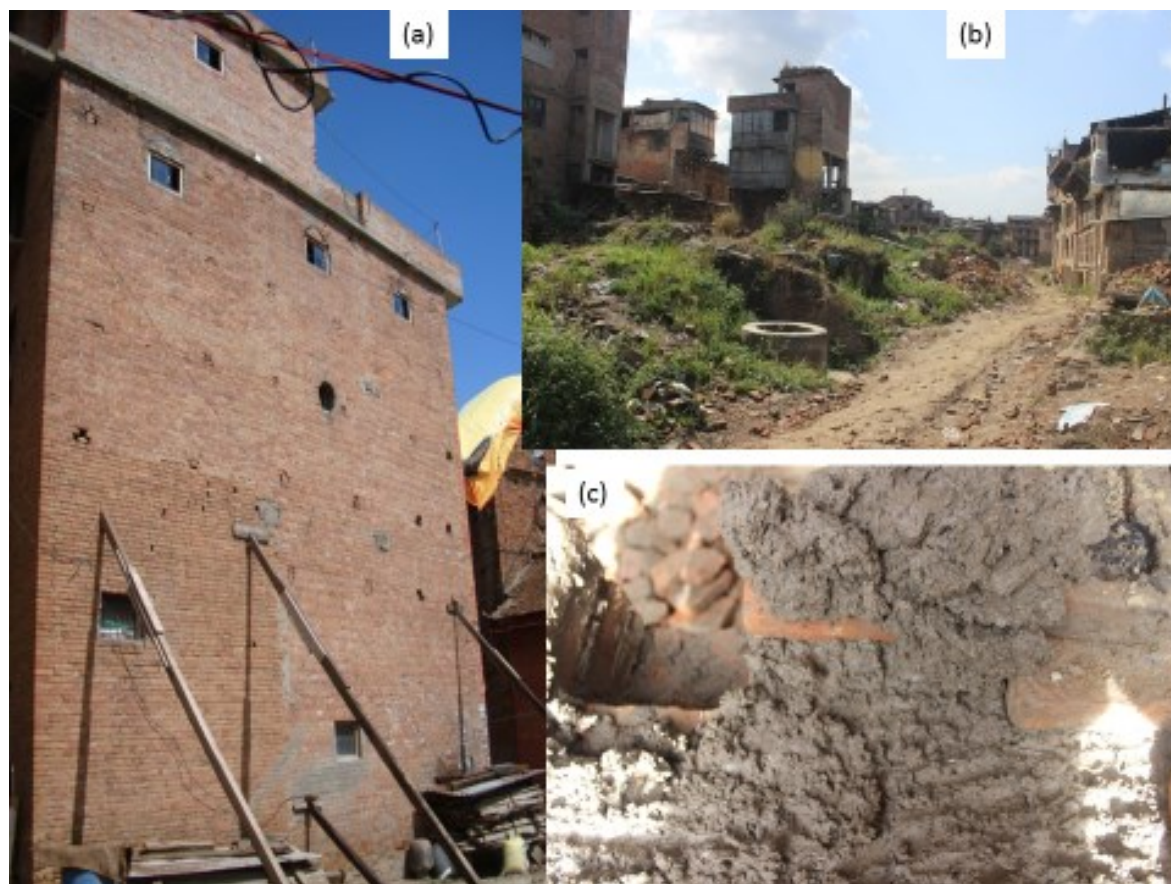
Figure 17: (a) RC slab constructed in pre-existing masonry building that underwent increment construction (b) destroyed neighborhood in Jenla ridgeline (c) mud mortar used for reconstruction after the earthquake.

RC slabs over masonry walls	-	Such erroneous practice was observed in significant number of structures and the collapse do RC slab led severe damage either in terms of brittle collapse or heavy damage in entire structure (Fig. 17a)
Construction site	-	Areas like Suryamadhi, Inacho, Golmadhi, Byasi, Jela were more affected due to inclined terrain and in some cases, due to ridgeline effect. A tow rows of more than 100 buildings were destroyed in Jenla (Fig. 17b) and beside the Suryamadhi square and Byasi all buildings except few RC were collapsed
Mortar	-	Even after the earthquake, mud mortar was being used (Fig. 17c) for reconstruction and almost 60% buildings were constructed with mud mortar that led to either collapse or heavy damage
Incremental construction	-	Many cases of incremental constructions were identified and surprisingly one or two stories of substandard reinforced concrete construction were found (Fig. 18a). Even in partly damaged buildings, after three months of the earthquake some stories of RC were found to be added

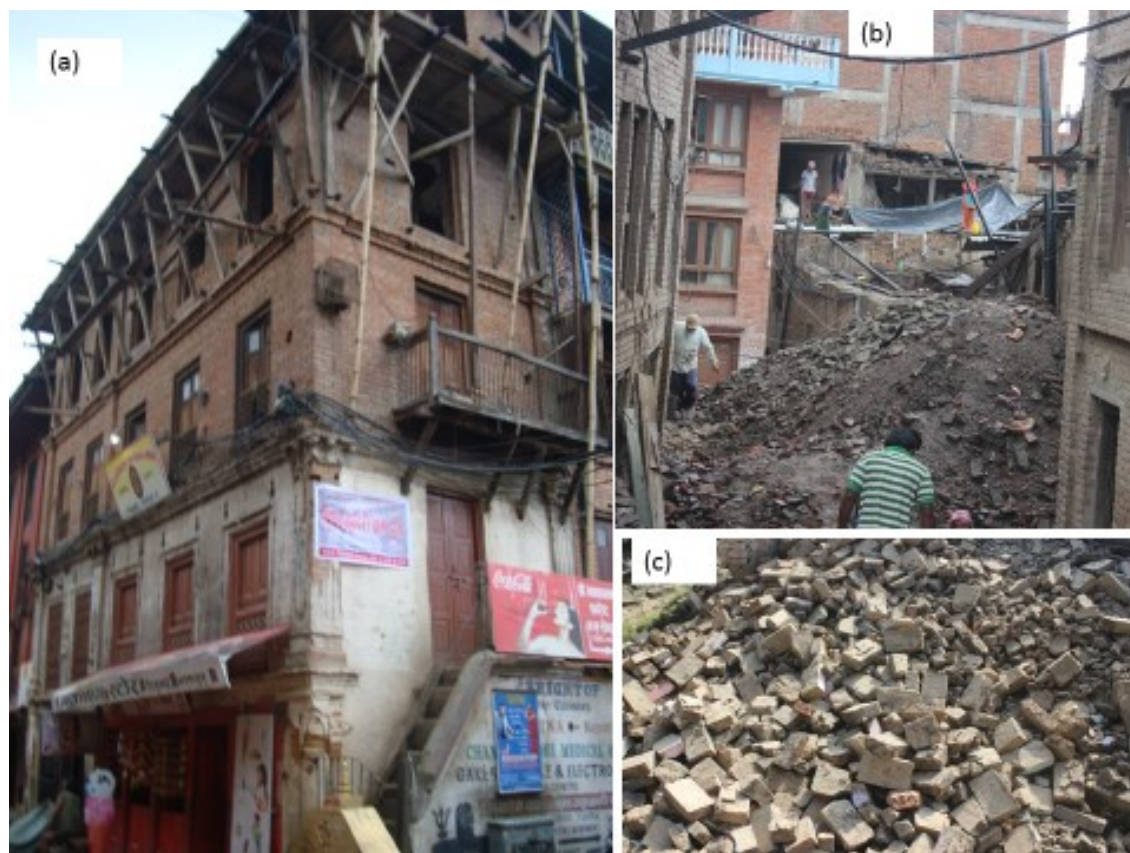
Figure 18: (a) Building with one masonry and next RC incremental construction above the vernacular masonry construction (b) debris reflects decay of construction material (c) irregular size and poor quality of bricks used for structural wall.

Building age and occupancy scenario	-	Many of the damaged buildings were told be used for at least three generations without any periodic strengthening even after the earthquakes during 1988 and 2011, the debris from collapsed buildings was observed to be decayed (Fig. 18b)

-	Countable fraction of buildings of age more than 82 that sustained the 1934 Bihar-Nepal earthquake were identified during field reconnaissance
Masonry units	-	Virtually all collapsed and heavily damaged structures manifested the marginal quality of brick- improperly dried and irregular shape (Fig. 18c)

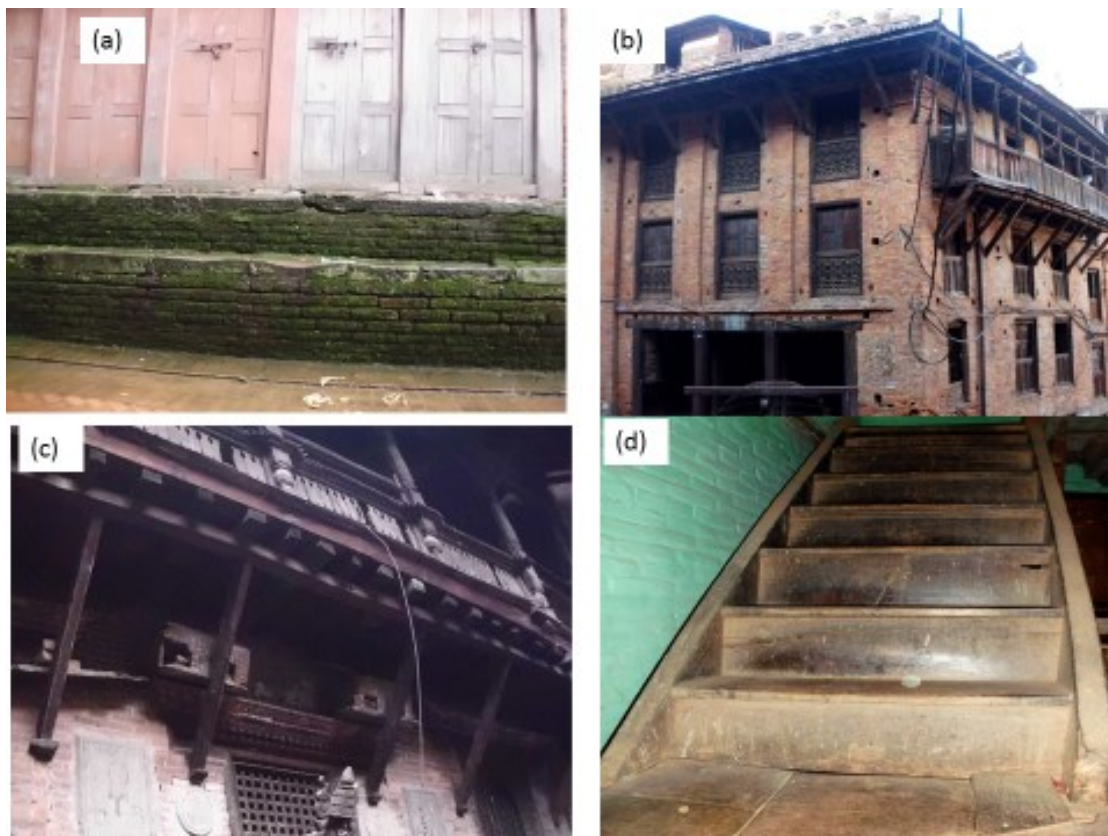
Figure 19: Identified seismic features: (a) plinth constructed in sloping ground (b) symmetrical building practice (c) timber struts for mainstreaming cantilevered load (d) wooden ladder.

Seismic features	Observed/expected contribution
Plinth construction	- Some of the buildings in sloping sites were found to be provided plinths and damage occurrence was relatively insignificant (Fig. 19a)
Building shape	- Virtually all buildings were found to be rectangular assuring $L/B < 3$ provision of Nepal Building Code (Fig. 19b)
Openings	- Many buildings with smaller openings were observed and damage was found to be marginal, however the opening size was not responsible for survival of structure (Fig. 19b) - Measurement in above 40 buildings showed $B \times H$: 1.35×0.64 m size of door in average
Timber struts	- Timber struts when provided were found to be effective in avoidance of roof heavy roof collapse (Fig. 19c) - Cantilevered load was observed to be mainstreamed through timber struts in number of vernacular buildings
Vertical transportation system	- Most impressive feature was in the form of light weight wooden ladder (often moveable) constructed from wooden planks (Fig. 19d)

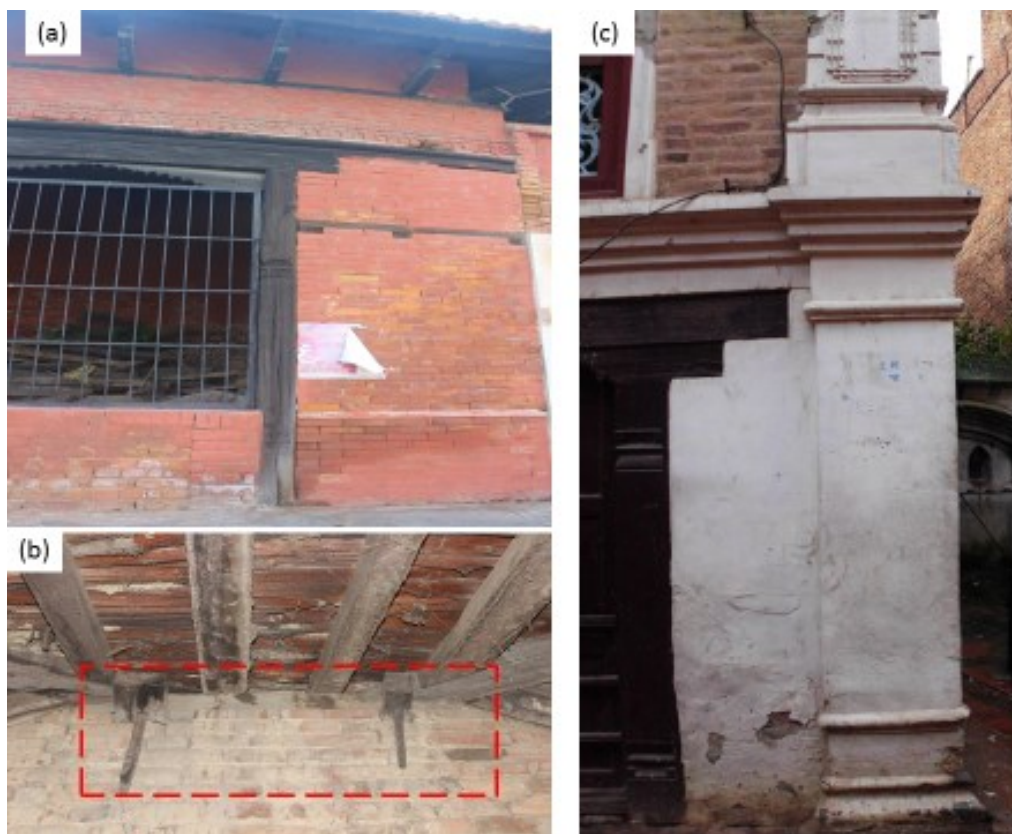
Figure 20: Identified seismic features: (a) timber bands at various levels (b) wooden pegs used to stitch connections (c) corner post.

Timber bands at various level	- Timber bands (sill/lintel/roof) or “ <i>Nas</i> ” were found to be used in some houses (Fig. 20a) and out-of-plane action was not observed in such buildings
Wooden pegs	- In case of vernacular buildings, several timber units were found to be tied together with wooden pegs and distortions were not observed in local scale
Corner post	- Quite a few corner posts (brick masonry) were observed, and it was clearly observed that the damage propagation was effectively controlled by corner posts (Fig. 20b)
