## The 22 December 2018 Mount Anak Krakatau Volcanogenic Tsunami on Sunda Strait Coasts, Indonesia: tsunami and damage characteristics

### ABSTRACT

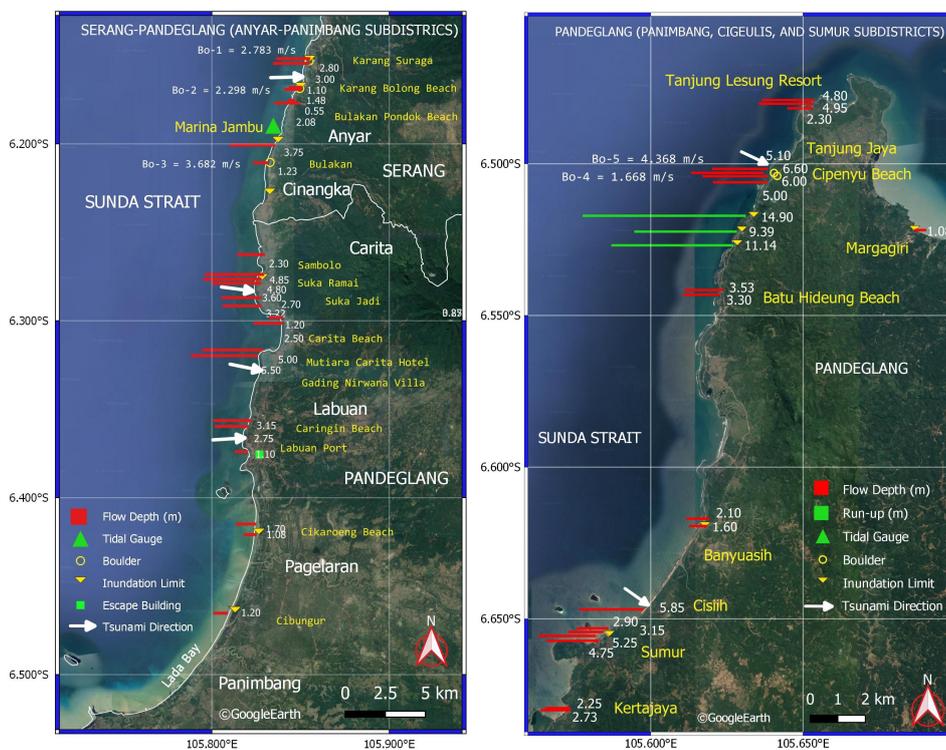
35 Impacts of the tsunami in Banten were found to be more severe than in Lampung. Along the western coast of Banten, impacts were visible but not seen to be continuous. **Fig. 3** shows tsunami flow depth distribution and run-up limits measured at Banten coasts. There were some areas where evidence of tsunami waves could not be identified based on physical observations and eyewitness interviews. The northernmost extent of the tsunami effects was located at Anyar coast. The northernmost point of the tsunami depth was identified at a villa named Villa A Pahmi, located at Karang Suragak village. Here, the tsunami depth was 2.80 m (F02), identified from gazebo roof damage in the back yard of the villa.

**Fig. 3.** Tsunami flow depths distribution around Serang and northern area of Pandeglang district (left figure) and around southern Pandeglang area (Panimbang-Sumur) (right figure). (The map is adopted from Google Earth).

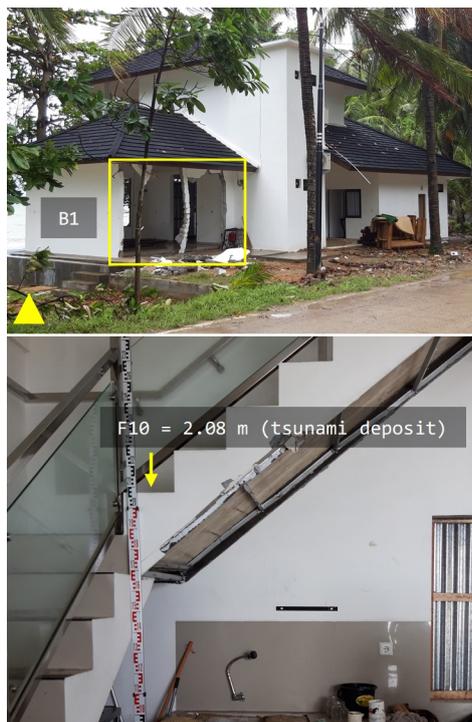
**Fig. 4.** A villa's wall destroyed by a tsunami in Bulukan Pondok beach (left) and a 2.08 m flow depth recorded on the stair inside the villa (right). A one-story house had major damage, while damage to the two-story house was moderate.

**Fig. 4.** A villa's wall destroyed by tsunami in Bulukan Pondok beach (left) and a 2.08 m of flow depth recorded on the stair inside the villa (right). One story house had a major damage, meanwhile the two-storeys house was moderate.

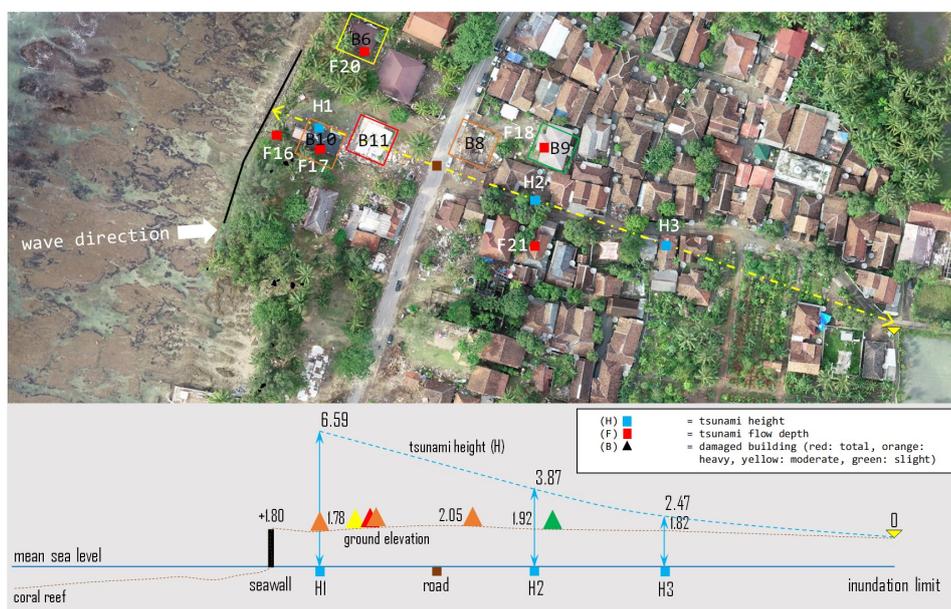
At this location, a transect was performed to measure tsunami height. **Fig. 5** also shows the profile of tsunami flow heights, ground elevations and house damage type. Height was calibrated with local tide data. Here, the tsunami flow's height was 6.59 m (H1). As the crown of a seawall along this coastline was 1.80 above mean sea level, the tsunami wave was considered significantly large enough to destroy

**Fig. 5.** A cross profile of tsunami height in Suka Ramai, Carita of Banten. The upper figure is the location of the transect plotted on an aerial image captured on December 28, 2018.

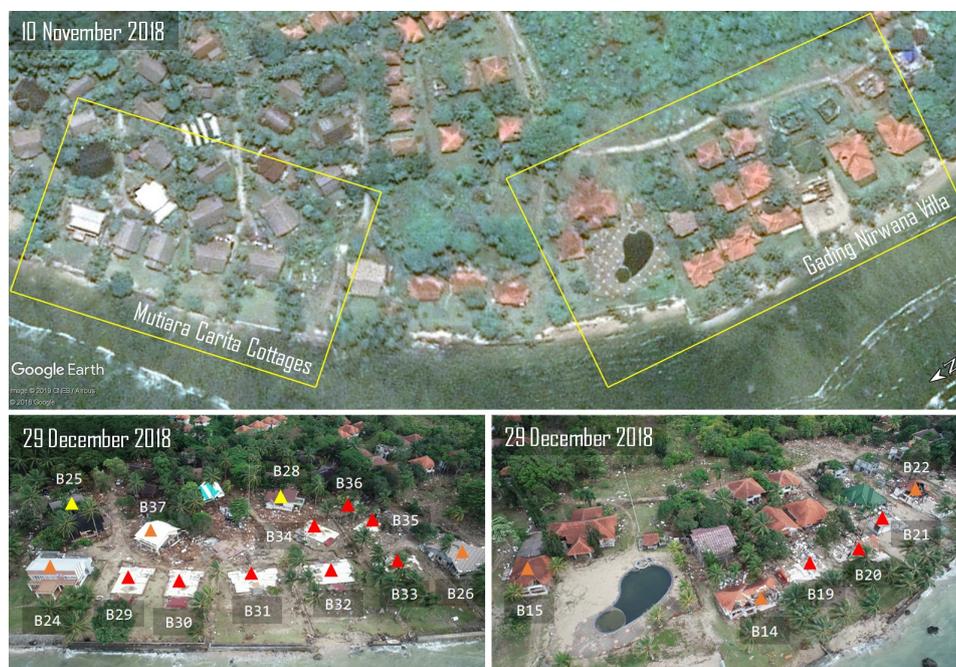
Further damages were identified in the Carita area of Pandeglang. The survey team investigated Mutiara Carita Cottage and Gading Nirwana Villa. The two resort complexes are situated close to the coastline and some of the buildings directly face the sea. Most of the buildings in this area were located about 15 m from the coastline, and apparently were not constructed for mitigating any waves coming from the strait. Most of the buildings were flattened by the tsunami wave, leaving only floors. Based on a wall clock found at an inundated house, the clock stopped at 09.45 PM local time (14.45 UTC). At Mutiara Carita, measured tsunami flow depth was 3.50 m, identified by a broken tree branch, and 3.34 m, which was identified from a broken roof element of the cottage. These are Point F33 and F34 in the Appendix. A higher tsunami flow depth was found at Gading Nirwana Villa, which was 5.50 m (point F36). Flow depth was identified from a broken roof at the villa. An aerial view of the cottage captured on 25 December 2019 can be seen in **Fig. 6**.

**Figure 6.** Aerial view of land destruction in Mutiara Carita Cottages and Gading Nirwana Villa, Banten.

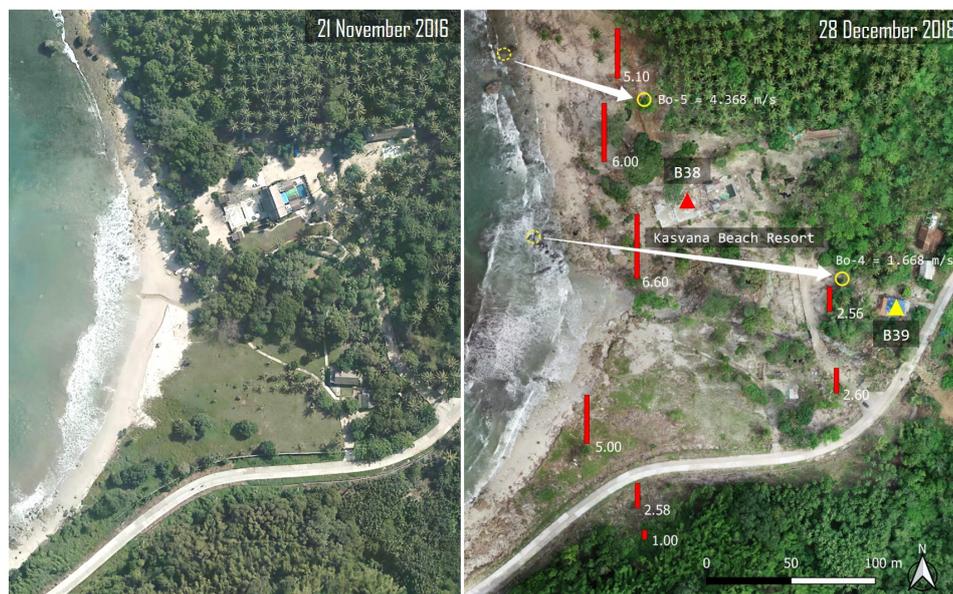
5 **Fig. 7** shows conditions at Cipunyu coast, located west of Tanjung Lesung resort, comparing scenes before and after the tsunami. The figure also shows the distribution of tsunami flow depths. Although no significant residential area was found here, traces of the massive impacts of the tsunami could be identified at Kasvana Beach Resort. Maximum flow depths around this resort were at 6.60 m (F47),  
10 identified from a broken branch of a *Pandanus Odorifer* sp. tree. According to an interview with the resort staff, seven people died. They were guests and staff of the resort. Severe erosion was also seen along the coastline near the resort. The deadly force of the tsunami wave was also revealed by a large tsunami boulder (Bo-5), which was found around 87 m from its initial source (see **Fig. 8**). The boulder's origin was based on eyewitness interviews stating that the boulder was at the beach area close to the resort before the tsunami. Another tsunami flow depth's mark close to the boulder was measured at 5.10 m (Point F54 in the Appendix). The topography around the area was relatively flat. Based on eq (1), it is inferred that the minimum velocity that transported the boulder was about 4.37 m/s.

**Fig. 7.** The land destruction and flow depth distribution in Cipenyu Beach, Banten. Left hand-side photo is a google earth image captured before the tsunami (from © Google Earth). Right hand-side photo is an aerial view captured by drone on December 29, 2018.

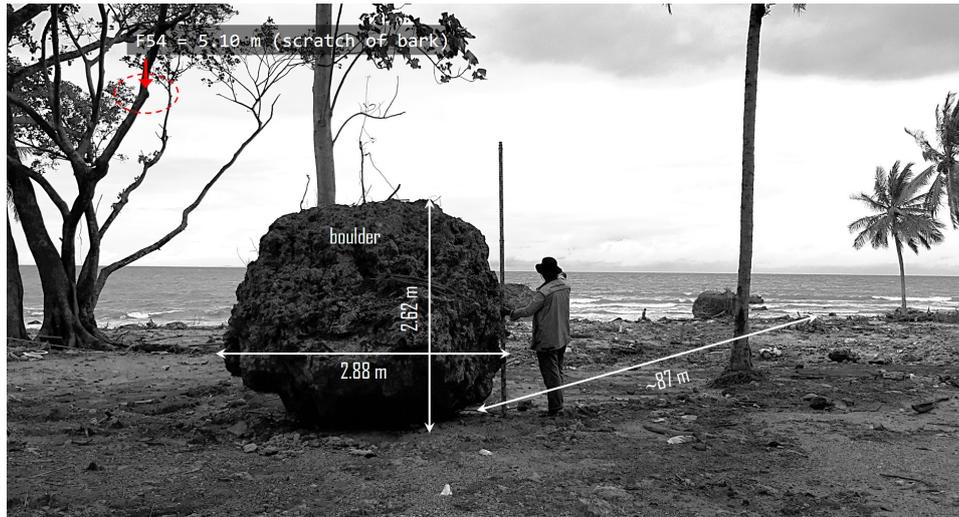
**Fig. 8.** The largest boulder found in Cipunyu Beach-Banten was transported about 87 m from its original place. Arrow shows the estimated transport direction of the boulder with an estimated velocity of 4.37 m/s.

Fig. 8. The largest boulder found in Cipenyu Beach, Banten; captured on December 28, 2018.

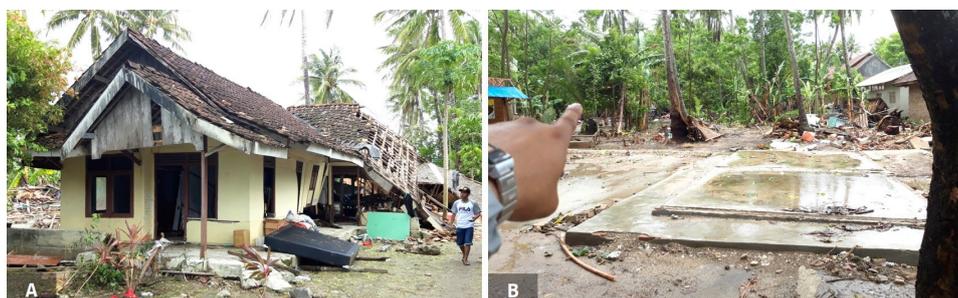
There were 25 wooden houses surveyed in the affected area. Due to the limited number of surveyed wooden houses, analysis of the damage was performed by classifying the damage as seen in Table 1. Only three classifications of damage could be identified, namely, DS2, DS3 and DS4. Two houses could be classified as DS2, seven houses were DS3, and 19 houses were DS4. Examples of the damage found at wooden houses due to tsunami impacts can be seen in **Fig. 13**. Based on the number of surveyed wooden houses, it was found that a tsunami flow depth higher than 2.0 m could completely wash away the houses, provided there was no debris in the flow. If the tsunami flow contained debris, the limit of the tsunami flow depth that could wash away a house was lower. In cases where the flow depths were lower than 2.0 m, damage was found to be due to failure of the bottom plates of the walls. Similar investigations of the impacts of tsunami bores on wooden walls were completed by Linton et al. (2013) and Wilson et al. (2009). They revealed that (1) the tsunami flow at the foundations beneath the walls could generate an uplifting force, and (2) if the wave broke near the wooden structure, it also increased loading. Although the location of the tsunami breaking wave in the 2018 Mount Anak Krakatau tsunami remains unknown, the pattern of damage to the lower parts of the wooden walls were similar to those in these studies.

**Fig. 13.** Examples of damage to wooden houses: (a) major damage and (b) complete damage/washout.

**Fig. 13.** Examples of damages at wooden houses: (a) Major damages and (b) complete damage/washed away.
