The 22 December 2018 Mount Anak Krakatau Volcanogenic Tsunami on Sunda Strait Coasts, Indonesia: tsunami and damage characteristics

Syamsidik^{1,2}, Benazir^{1,2}, Mumtaz Luthfi¹, Anawat Suppasri³, and Louise K. Comfort⁴

ABSTRACT

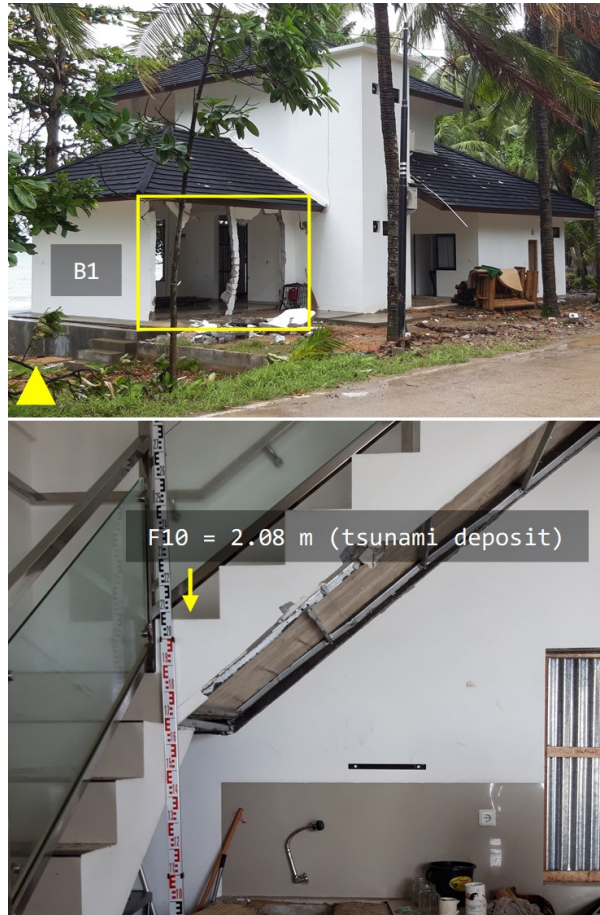
Fig. 4. A villa's wall destroyed by tsunami in Bulukan Pondok beach (the upper figure) and a 2.08 m of flow depth recorded on the stair inside the villa (the lower figure). One story house had a major damage, meanwhile the two-storeys house was moderate.

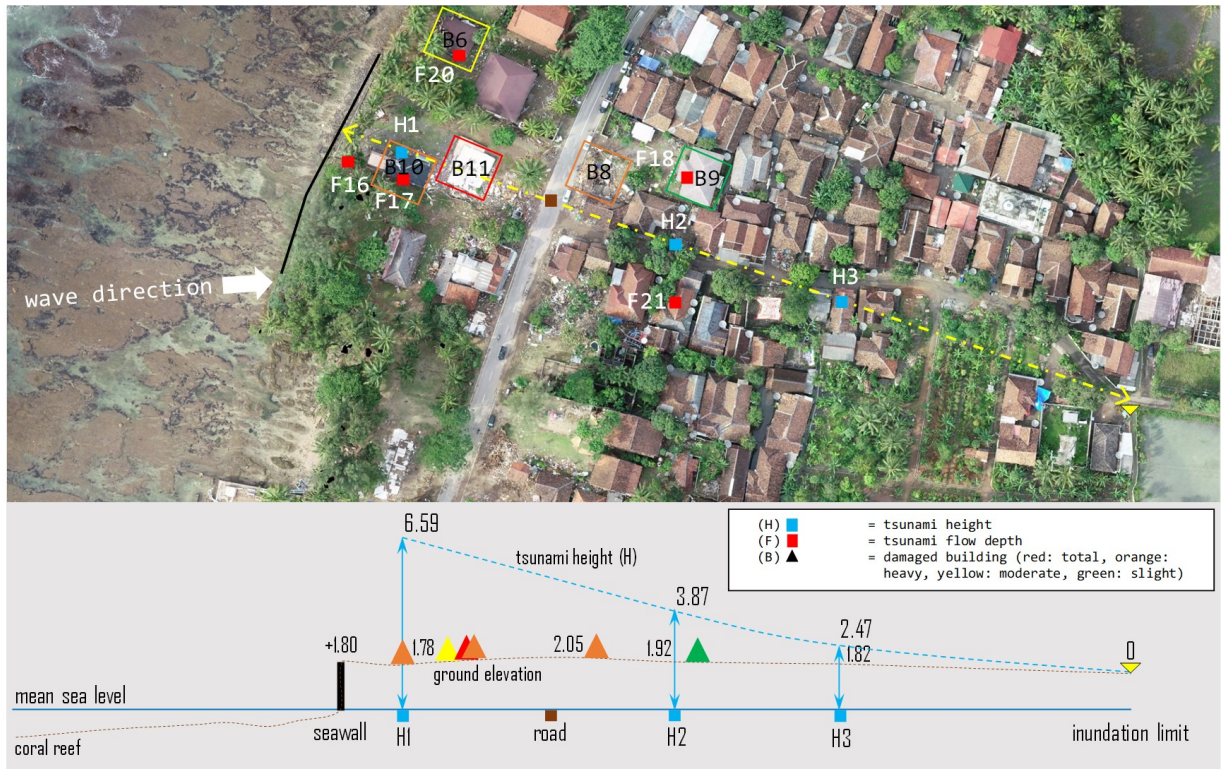
At this location, a transect was performed to measure tsunami height. **Fig. 5** also shows the profile of tsunami flow heights, ground elevations and house damage type. Height was calibrated with local tide data. Here, the tsunami flow's height was 6.59 m (H1). As the crown of a seawall along this coastline was 1.80 above mean sea level, the tsunami wave was considered significantly large enough to destroy houses and other types of buildings in the area. Tsunami inundation distance reached 249 m, overpassing a dense residential area.

Fig. 5. A cross profile of tsunami height in Suka Ramai, Carita of Banten. The upper figure is the location of the transect plotted on an aerial image captured on December 28, 2018.

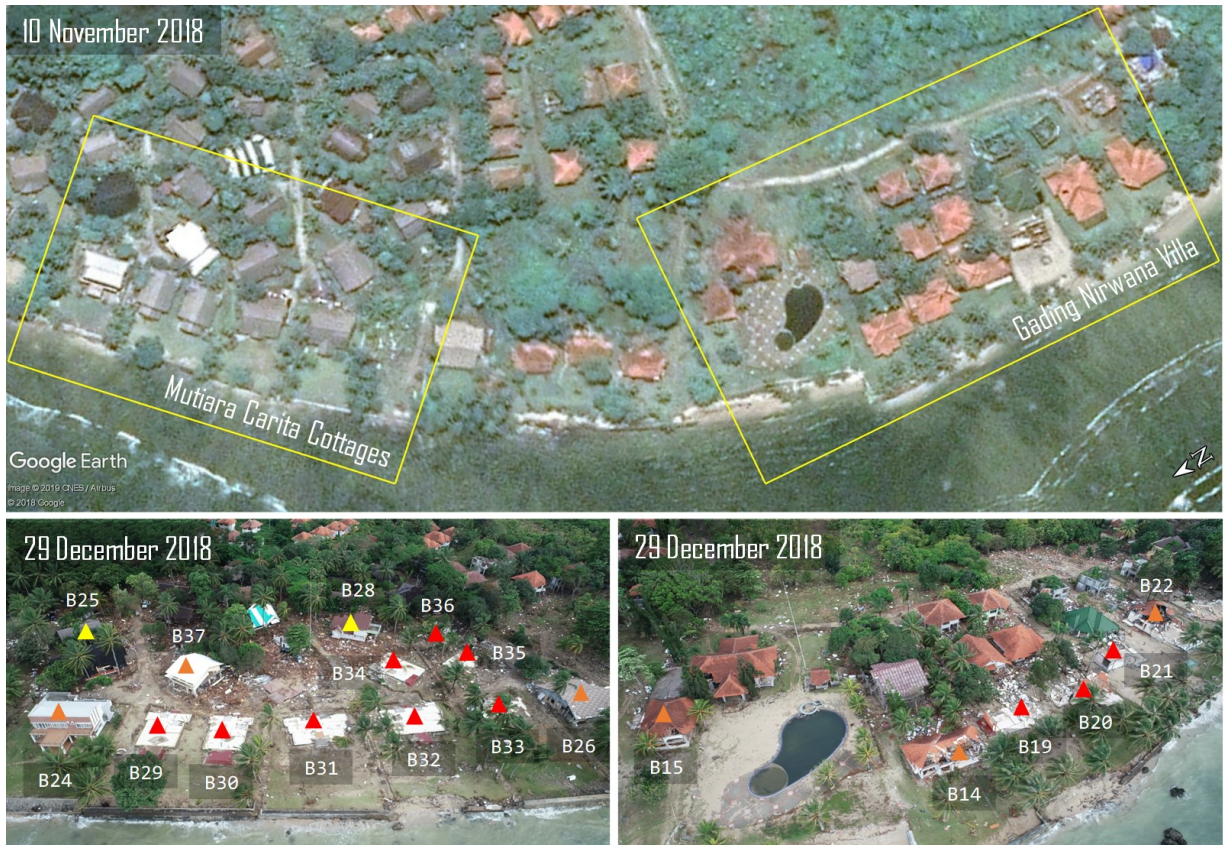
Further damages were identified in the Carita area of Pandeglang. The survey team investigated Mutiara Carita Cottage and Gading Nirwana Villa. The two resort complexes are situated close to the coastline and some of the buildings directly face the sea. Most of the buildings in this area were located about 15 m from the coastline, and apparently were not constructed for mitigating any waves coming from the strait. Most of the buildings were flattened by the tsunami wave, leaving only floors. Based on a wall clock found at an inundated house, the clock stopped at 09.45 PM local time (14.45 UTC). At Mutiara Carita, measured tsunami flow depth was 3.50 m, identified by a broken tree branch, and 3.34 m, which was identified from a broken roof element of the cottage. These are Point F33 and F34 in data of this survey (Syamsidik et al., 2019b). A higher tsunami flow depth was found at Gading Nirwana Villa, which was 5.50 m (Syamsidik et al., 2019b). Flow depth was identified from a broken roof at the villa. An aerial view of the cottage captured on 25 December 2019 can be seen in **Fig. 6**.

Figure 6. Aerial view of land destruction in Mutiara Carita Cottages and Gading Nirwana Villa, Banten. The upper figure was adopted from Google Earth.

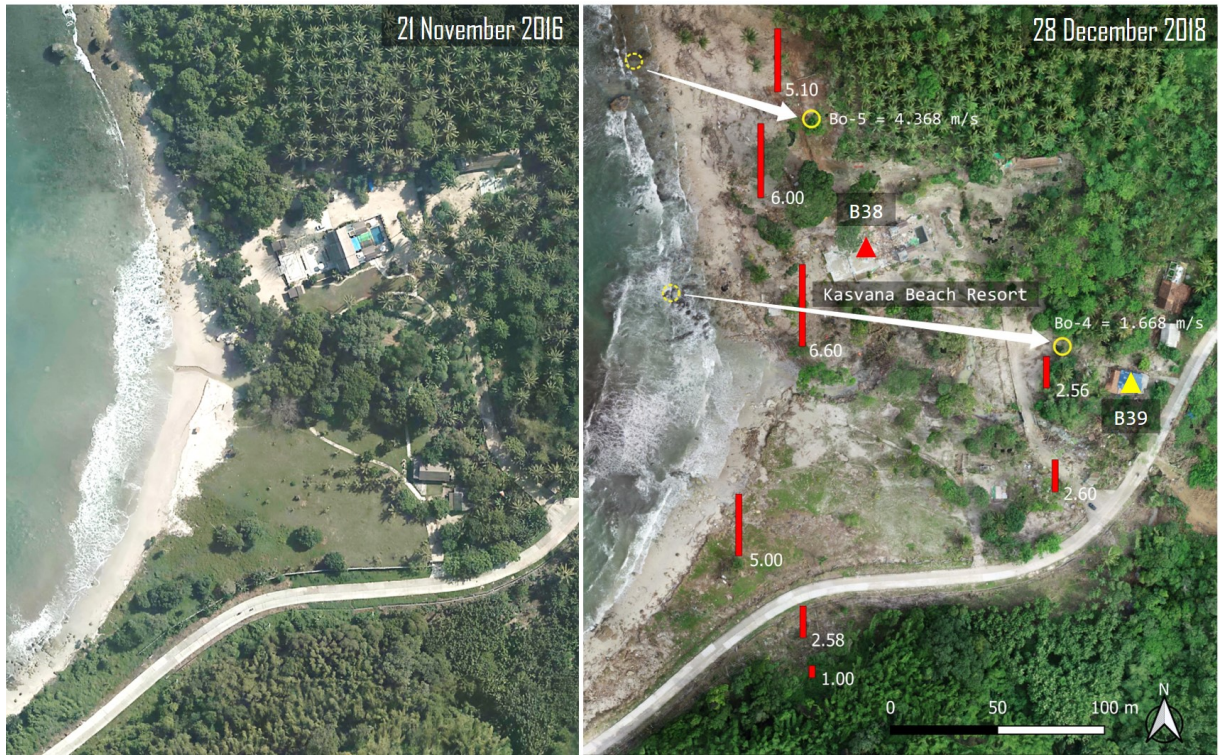
Fig. 7 shows conditions at Cipenyu coast, located west of Tanjung Lesung resort, comparing scenes before and after the tsunami. The figure also shows the distribution of tsunami flow depths. Although no significant residential area was found here, traces of the massive impacts of the tsunami could be identified at Kasvana Beach Resort. Maximum flow depths around this resort were at 6.60 m (F47), identified from a broken branch of a *Pandanus Odorifer* sp. tree. According to an interview with the resort staff, seven people died. They were guests and staff of the resort. Severe erosion was also seen along the coastline near the resort. The deadly force of the tsunami wave was also revealed by a large tsunami boulder (Bo-5), which was found around 87 m from its initial source (see **Fig. 8**). The boulder's origin was based on eyewitness interviews stating that the boulder was at the beach area close to the resort before the tsunami. Another tsunami flow depth's mark close to the boulder was measured at 5.10 m (Point F54 in Syamsidik et al. (2019b)). The topography around the area was relatively flat. Based on eq (1), it is inferred that the minimum velocity that transported the boulder was about 4.37 m/s.

Fig. 7. The land destruction and flow depth distribution in Cipenyu Beach, Banten. Left hand-side photo is an image captured before the tsunami (from Google Earth). Right hand-side photo is an aerial view captured by drone on December 29, 2018.

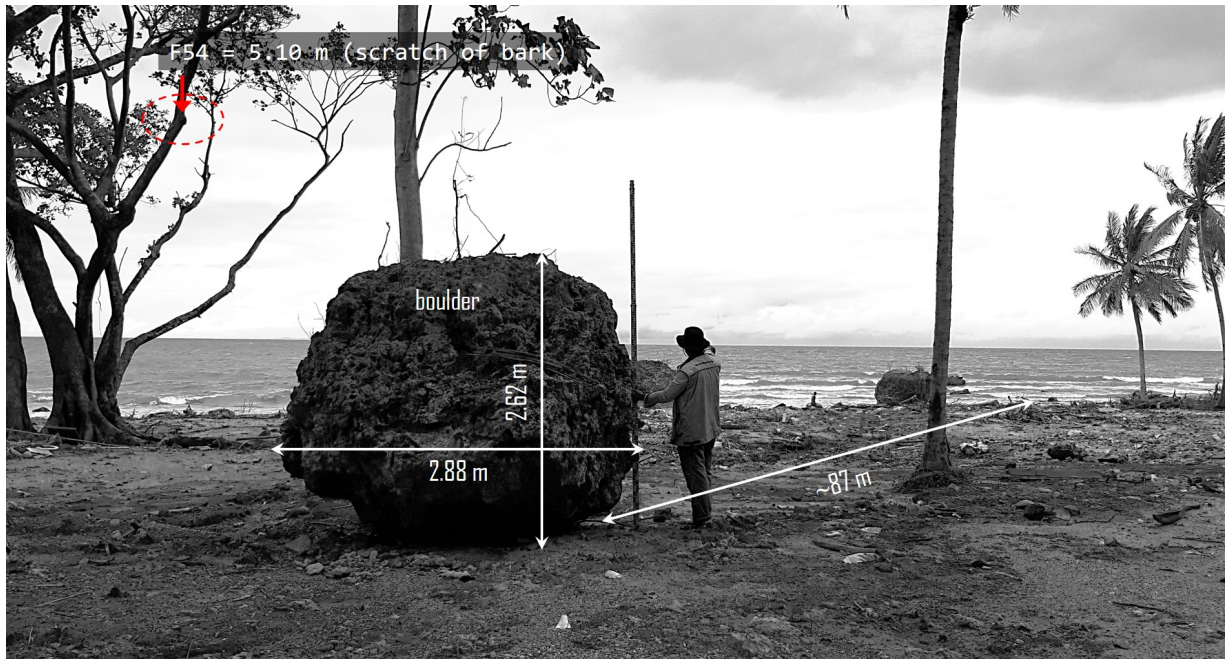
Fig. 8. The largest boulder found in Cipenyu Beach of Banten was transported about 87 m from its original place. An arrow shows the estimated transport direction of the boulder with an estimated velocity of 4.37 m/s.; captured on December 28, 2018.

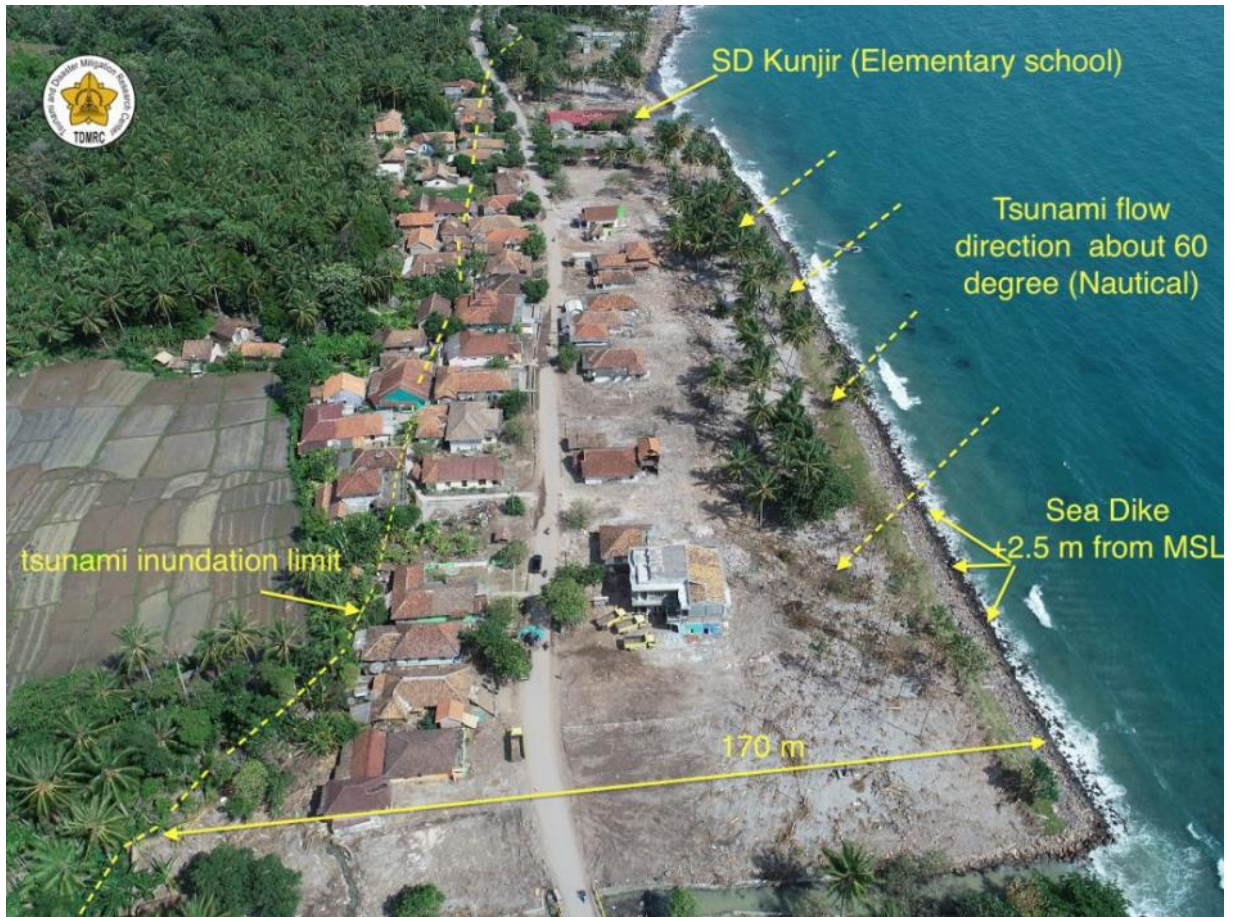
Fig. 11 shows an aerial view of the damage caused by the tsunami in Batu Balak and Kunjir villages. At the hatchery plant, tsunami flow depth was measured at 3.82 m from ground level (Point F88 in Syamsidik et al. (2019b)). An elementary school in Kunjir located close to the coastline sustained massive damage. At this school, tsunami flow depth was measured at 3.33 m (Point F91). The tsunami inundation limit was located 160 m from the coastline. Although Kunjir area was protected by a revetment structure with a crown 2.5 m above mean sea level, it could not protect the area from the tsunami. On the revetment, tsunami flow depth was at 2.10 m, based on a tree mistakenly grown on top of the structure. In Way Muli, the highest tsunami flow depth was 3.92 m (Point F105).

Fig. 11. An aerial view from tsunami-affected area around Batu Balak and Kunjir villages, Lampung, captured on December 31, 2018.

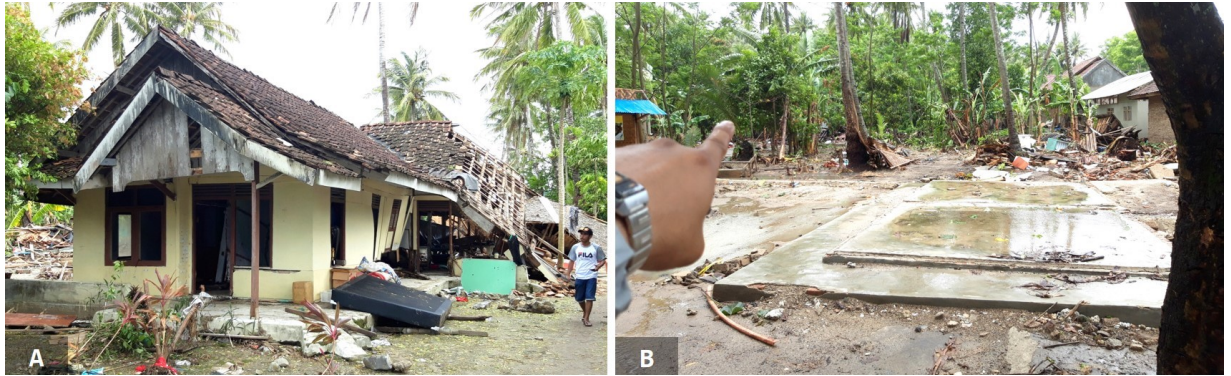
30 There were 25 wooden houses surveyed in the affected area. Due to the limited number of surveyed wooden houses, analysis of the damage was performed by classifying the damage as seen in **Table 1**. Only three classifications of damage could be identified, namely, DS2, DS3 and DS4. Two houses could be classified as DS2, seven houses were DS3, and 19 houses were DS4. Examples of the damage found
35 at wooden houses due to tsunami impacts can be seen in **Fig. 13**. Based on the number of surveyed wooden houses, it was found that a tsunami flow depth higher than 2.0 m could completely wash away the houses, provided there was no debris in the flow. If the tsunami flow contained debris, the limit of the tsunami flow depth that could wash away a house was lower. In cases where the flow depths were lower than 2.0 m, damage was found to be due to failure of the bottom plates of the walls. Similar

40 investigations of the impacts of tsunami bores on wooden walls were completed by Linton et al. (2013) and Wilson et al. (2009). They revealed that (1) the tsunami flow at the foundations beneath the walls

could generate an uplifting force, and (2) if the wave broke near the wooden structure, it also increased loading. Although the location of the tsunami breaking wave in the 2018 Mount Anak Krakatau tsunami remains unknown, the pattern of damage to the lower parts of the wooden walls were similar to those in these studies.

Fig. 13. Examples of damages at wooden houses: (a) major damages and (b) complete damage/washed away.

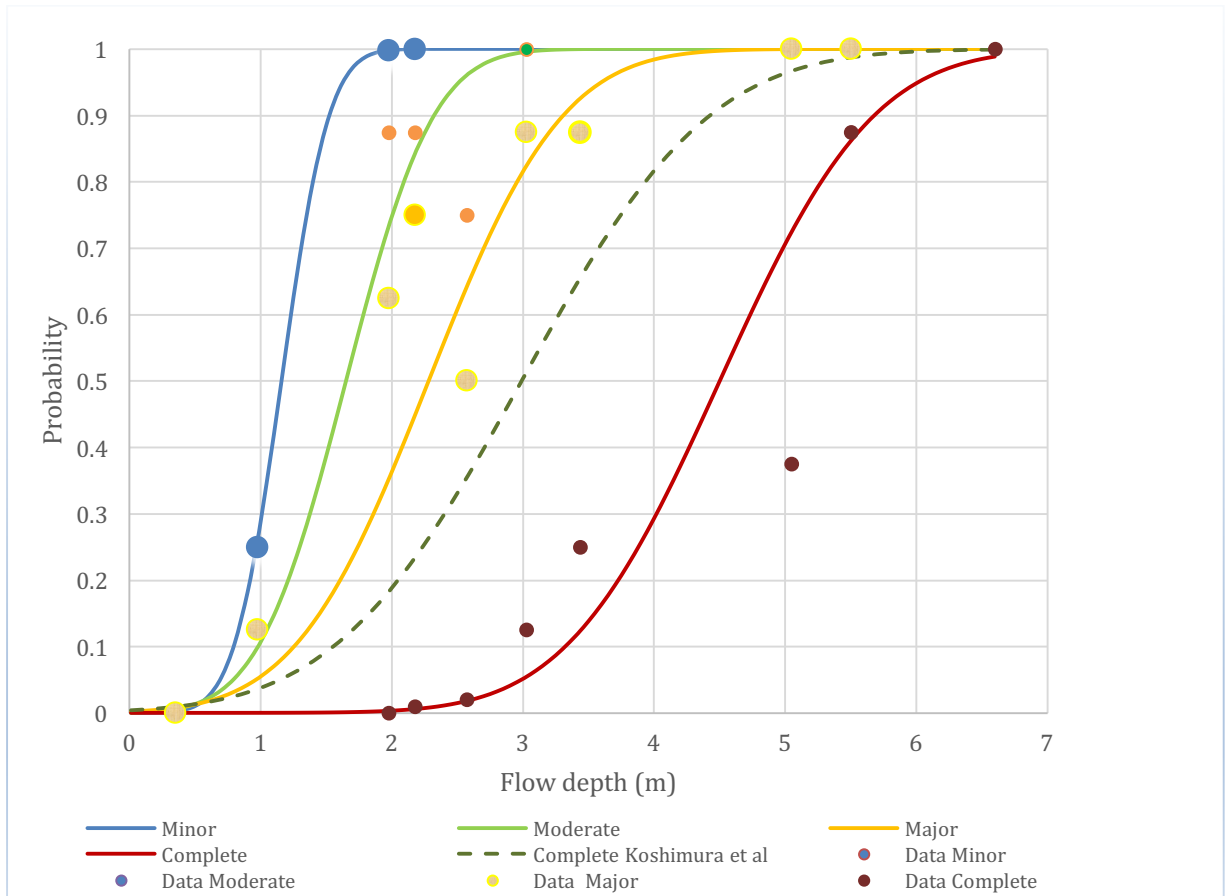
25 Fragility curves in **Fig. 14** reveal that the absolute damage due to the tsunami waves occurred at a flow depth of 6.5 m. Lower probabilities of complete damage were found in this study compared to the 2004 Indian Ocean tsunami in Banda Aceh (Koshimura et al., 2009). These findings were significantly different from the 2018 Palu tsunami (Paulik et al., 2019) where earthquake and liquefaction (liquefied gravity flows) also contributed to the damage (Sassa and Takagawa, 2019).

Fig. 14. Fragility curves of Confined Masonry type houses, as impacts of the 2018 Mount Anak Krakatau volcano-genic tsunami. Dashed-line represents a complete damage fragility curve produced by Koshimura et al. (2009).

5 As a majority of the houses in the coastal areas of Indonesia are CM, it is highly recommended to increase quality control of these structures, such as in the bounding strength between walls and tie-beams or tie-columns. In the case of purely tsunami force, this type of structure would likely perform better if stricter quality standards are met.
