The 22 December 2018 Mount Anak Krakatau Volcanogenic Tsunami on Sunda Strait Coasts, Indonesia: tsunami and damage characteristics

Syamsidik^{1,2}, Benazir^{1,2}, Mumtaz Luthfi¹, Anawat Suppasri³, and Louise K. Comfort⁴

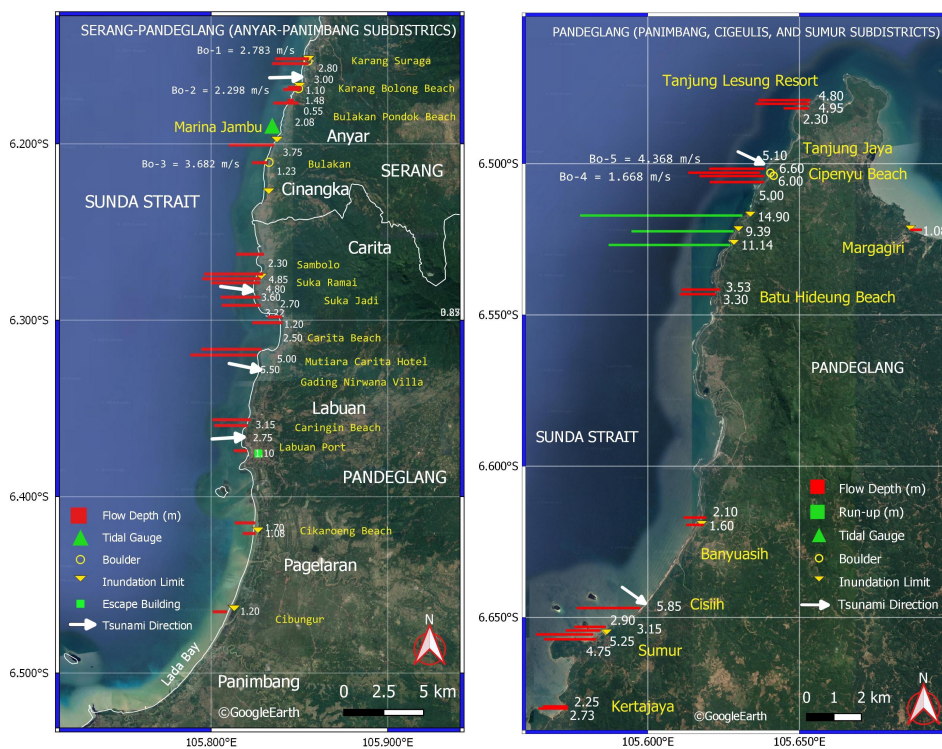
35 Impacts of the tsunami in Banten were found to be more severe than in Lampung. Along the western coast of Banten, impacts were visible but not seen to be continuous. **Fig. 3** shows tsunami flow depth distribution and run-up limits measured at Banten coasts. There were some areas where evidence of tsunami waves could not be identified based on physical observations and eyewitness interviews. The northernmost extent of the tsunami effects was located at Anyar coast. The northernmost point of the tsunami depth was identified at a villa named Villa A Pahmi, located at Karang Suragak village. Here, the tsunami depth was 2.80 m (F02), identified from gazebo roof damage in the back yard of the villa.

Fig. 3. Tsunami flow depths distribution around Serang and northern area of Pandeglang district (left figure) and around southern Pandeglang area (Panimbang-Sumur) (right figure). (The map is adopted from Google Earth).

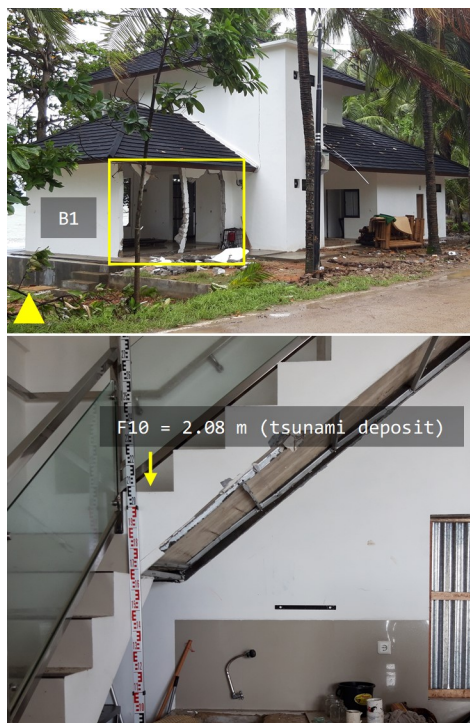
Fig. 4. A villa's wall destroyed by a tsunami in Bulukan Pondok beach (left) and a 2.08 m flow depth recorded on the stair inside the villa (right). A one-story house had major damage, while damage to the two-story house was moderate.

Fig. 4. A villa's wall destroyed by tsunami in Bulukan Pondok beach (left) and a 2.08 m of flow depth recorded on the stair inside the villa (right). One story house had a major damage, meanwhile the two-storeys house was moderate.

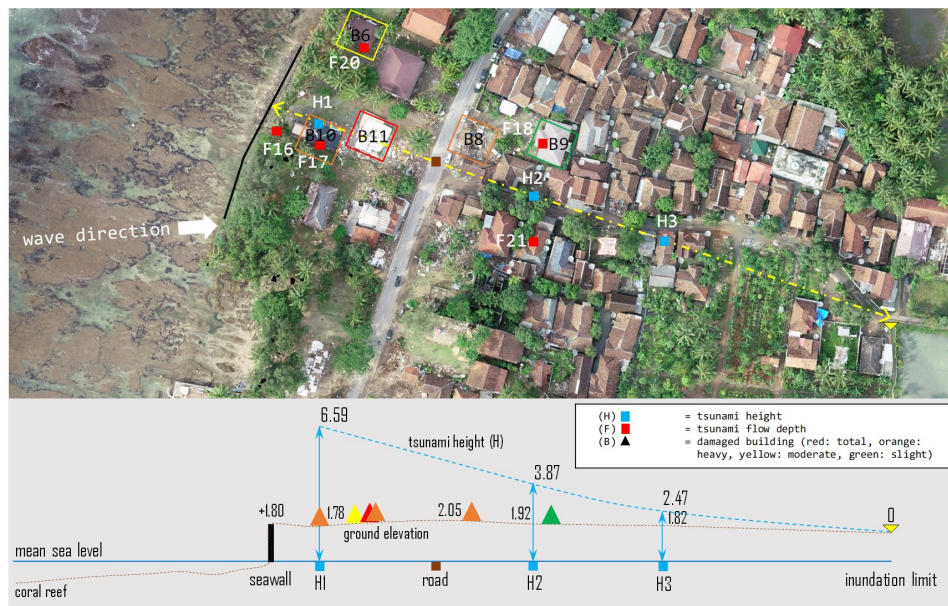
At this location, a transect was performed to measure tsunami height. **Fig. 5** also shows the profile of tsunami flow heights, ground elevations and house damage type. Height was calibrated with local tide data. Here, the tsunami flow's height was 6.59 m (H1). As the crown of a seawall along this coastline was 1.80 above mean sea level, the tsunami wave was considered significantly large enough to destroy

Fig. 5. A cross profile of tsunami height in Suka Ramai, Carita of Banten. The upper figure is the location of the transect plotted on an aerial image captured on December 28, 2018.

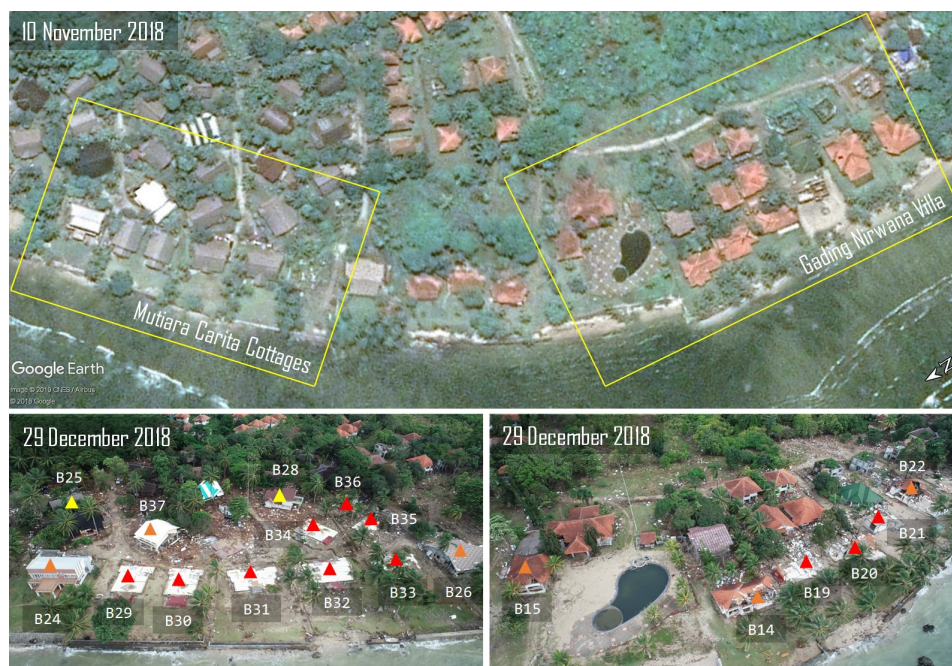
Further damages were identified in the Carita area of Pandeglang. The survey team investigated Mutiara Carita Cottage and Gading Nirwana Villa. The two resort complexes are situated close to the coastline and some of the buildings directly face the sea. Most of the buildings in this area were located about 15 m from the coastline, and apparently were not constructed for mitigating any waves coming from the strait. Most of the buildings were flattened by the tsunami wave, leaving only floors. Based on a wall clock found at an inundated house, the clock stopped at 09.45 PM local time (14.45 UTC). At Mutiara Carita, measured tsunami flow depth was 3.50 m, identified by a broken tree branch, and 3.34 m, which was identified from a broken roof element of the cottage. These are Point F33 and F34 in the Appendix. A higher tsunami flow depth was found at Gading Nirwana Villa, which was 5.50 m (point F36). Flow depth was identified from a broken roof at the villa. An aerial view of the cottage captured on 25 December 2019 can be seen in **Fig. 6**.

Figure 6. Aerial view of land destruction in Mutiara Carita Cottages and Gading Nirwana Villa, Banten.

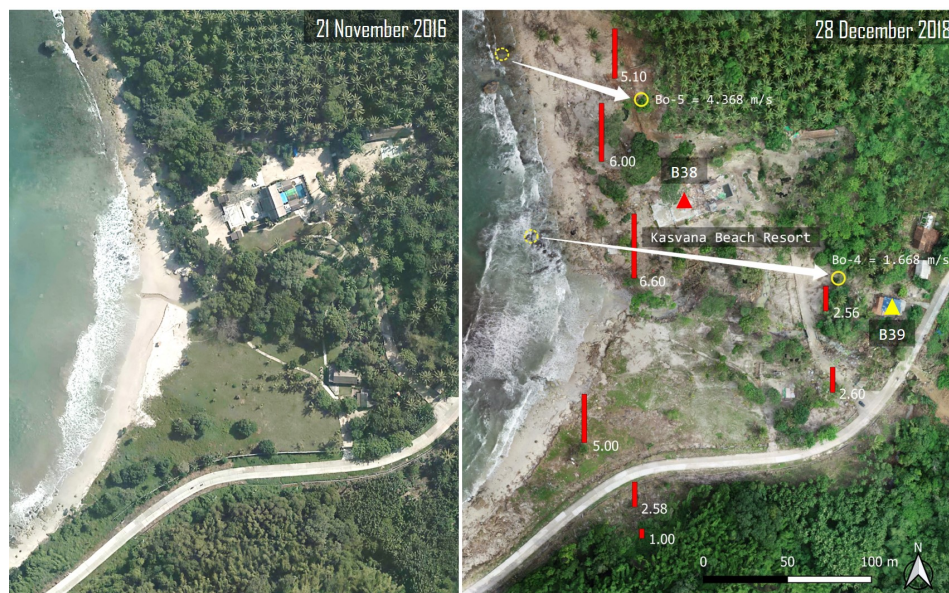
5 **Fig. 7** shows conditions at Cipunyu coast, located west of Tanjung Lesung resort, comparing scenes before and after the tsunami. The figure also shows the distribution of tsunami flow depths. Although no significant residential area was found here, traces of the massive impacts of the tsunami could be identified at Kasvana Beach Resort. Maximum flow depths around this resort were at 6.60 m (F47),
10 identified from a broken branch of a *Pandanus Odorifer* sp. tree. According to an interview with the resort staff, seven people died. They were guests and staff of the resort. Severe erosion was also seen along the coastline near the resort. The deadly force of the tsunami wave was also revealed by a large tsunami boulder (Bo-5), which was found around 87 m from its initial source (see **Fig. 8**). The boulder's origin was based on eyewitness interviews stating that the boulder was at the beach area close to the resort before the tsunami. Another tsunami flow depth's mark close to the boulder was measured at 5.10 m (Point F54 in the Appendix). The topography around the area was relatively flat. Based on eq (1), it is inferred that the minimum velocity that transported the boulder was about 4.37 m/s.

Fig. 7. The land destruction and flow depth distribution in Cipenyu Beach, Banten. Left hand-side photo is a google earth image captured before the tsunami (from © Google Earth). Right hand-side photo is an aerial view captured by drone on December 29, 2018.

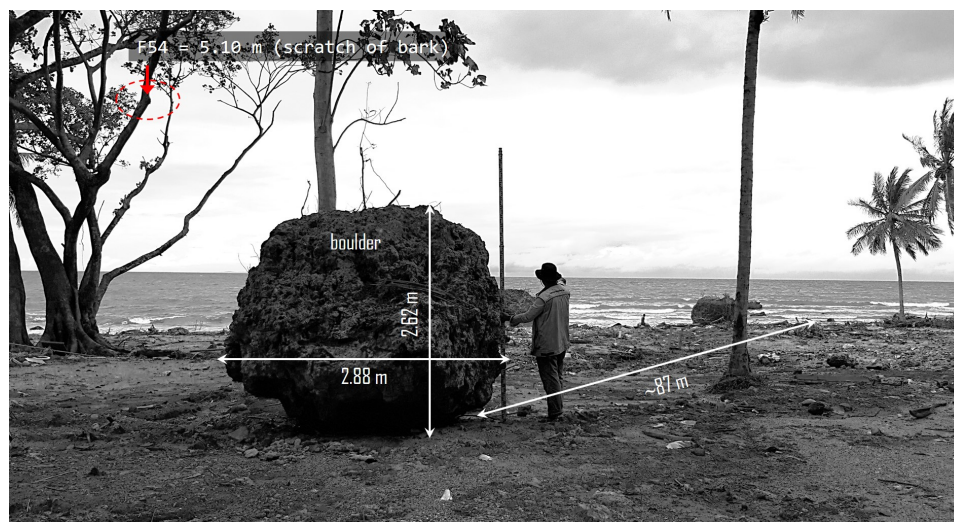
40 **Fig. 8.** The largest boulder found in Cipunyu Beach-Banten was transported about 87 m from its original place. Arrow shows the estimated transport direction of the boulder with an estimated velocity of 4.37 m/s.

Fig. 8. The largest boulder found in Cipenyu Beach, Banten; captured on December 28, 2018.

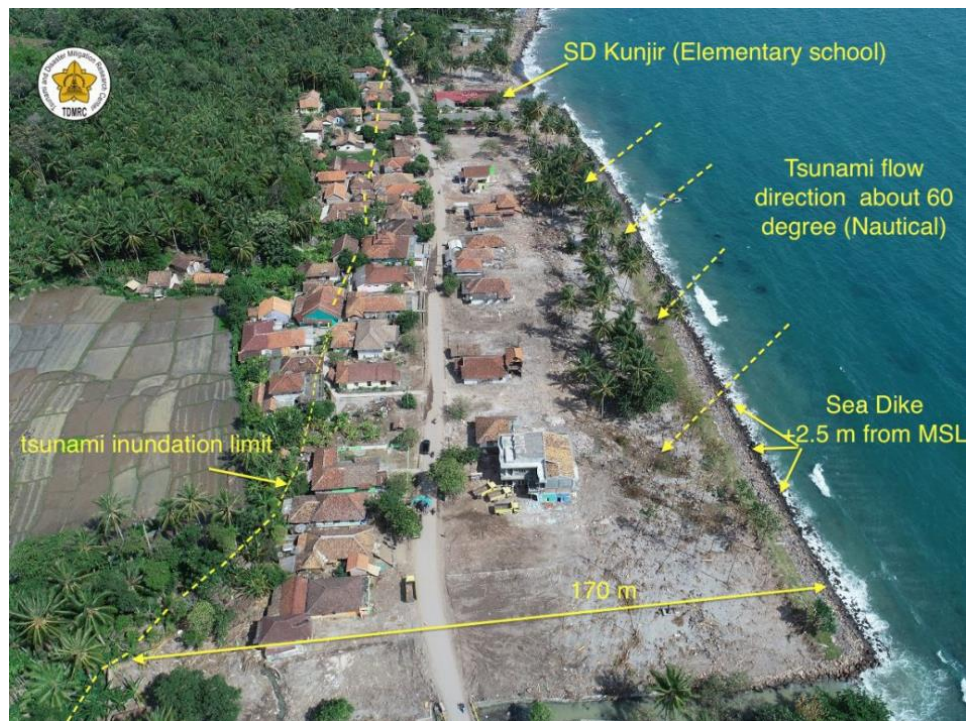
Fig. 12 shows an aerial view of the damage caused by the tsunami in Batu Balak and Kunjir villages. At the hatchery plant, tsunami flow depth was measured at 3.82 m from ground level (Point F88 in the Appendix). An elementary school in Kunjir located close to the coastline sustained massive damage. At this school, tsunami flow depth was measured at 3.33 m (Point F91). The tsunami inundation limit was located 160 m from the coastline. Although Kunjir area was protected by a revetment structure with a crown 2.5 m above mean sea level, it could not protect the area from the tsunami. On the revetment, tsunami flow depth was at 2.10 m, based on a tree mistakenly grown on top of the structure. In Way Muli, the highest tsunami flow depth was 3.92 m (Point F105).

Fig. 12. An aerial view from tsunami-affected area around Batu Balak and Kunjir villages, Lampung, captured on December 31, 2018.

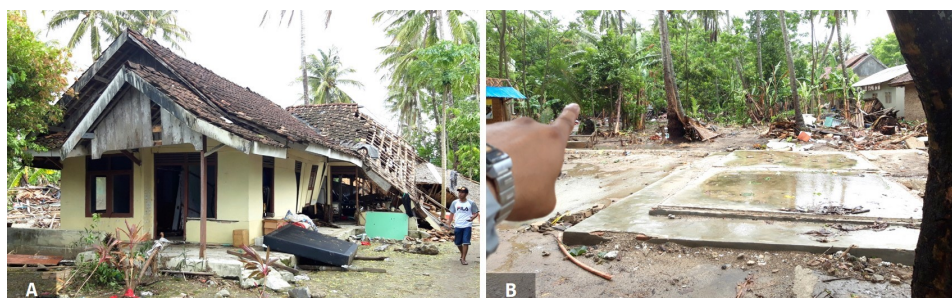
forces were not found. Damage to columns was observed as collateral failure of walls combined with
impacts of hydrodynamic forces. **Fig. 13** shows completely destroyed houses (DS4), where their types
and material composition were known; these were also directly within tsunami flow depths as measured
around the houses. Due to the limited number of surveyed houses, the fragility function was analysed
35 using CM-type houses. A summary of the fragility functions analysis is given in **Table 2**. Fragility curves
for all four types of damage can be seen in **Fig. 14**.

There were 25 wooden houses surveyed in the affected area. Due to the limited number of surveyed wooden houses, analysis of the damage was performed by classifying the damage as seen in Table 1. Only three classifications of damage could be identified, namely, DS2, DS3 and DS4. Two houses could be classified as DS2, seven houses were DS3, and 19 houses were DS4. Examples of the damage found at wooden houses due to tsunami impacts can be seen in **Fig. 13**. Based on the number of surveyed wooden houses, it was found that a tsunami flow depth higher than 2.0 m could completely wash away the houses, provided there was no debris in the flow. If the tsunami flow contained debris, the limit of the tsunami flow depth that could wash away a house was lower. In cases where the flow depths were lower than 2.0 m, damage was found to be due to failure of the bottom plates of the walls. Similar investigations of the impacts of tsunami bores on wooden walls were completed by Linton et al. (2013) and Wilson et al. (2009). They revealed that (1) the tsunami flow at the foundations beneath the walls could generate an uplifting force, and (2) if the wave broke near the wooden structure, it also increased loading. Although the location of the tsunami breaking wave in the 2018 Mount Anak Krakatau tsunami remains unknown, the pattern of damage to the lower parts of the wooden walls were similar to those in these studies.

Fig. 13. Examples of damage to wooden houses: (a) major damage and (b) complete damage/washout.

Fig. 13. Examples of damages at wooden houses: (a) Major damages and (b) complete damage/washed away.

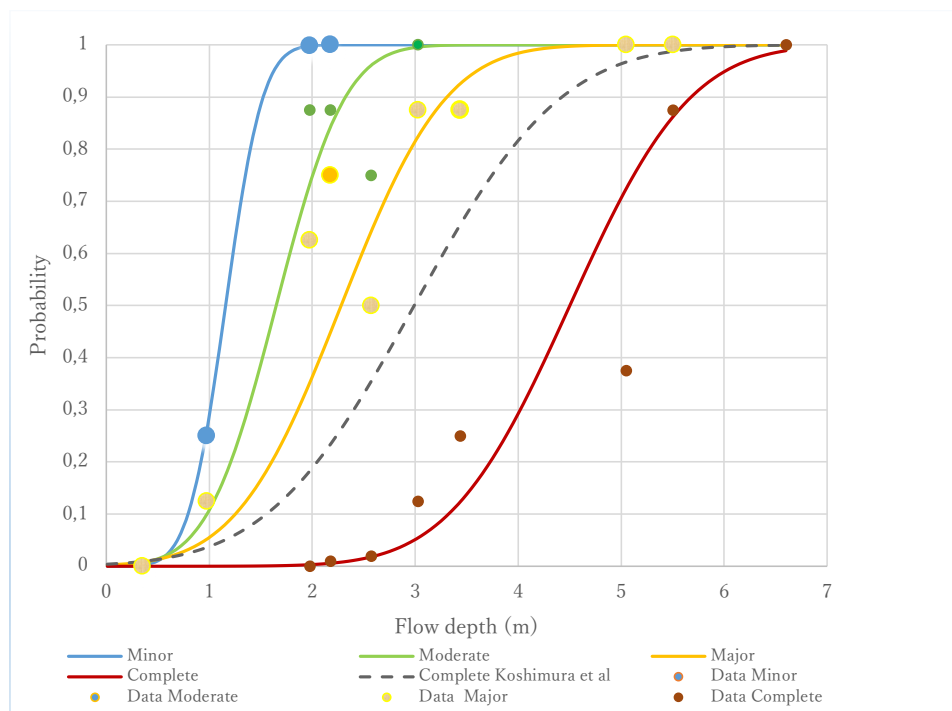
Fragility curves in **Fig. 14** reveal that the absolute damage due to the tsunami waves occurred at a flow depth of 6.5 m. Lower probabilities of complete damage were found in this study compared to the 2004 Indian Ocean tsunami in Banda Aceh (Koshimura et al., 2009). These findings were significantly different from the 2018 Palu tsunami (Paulik et al., 2019) where earthquake and liquefaction (liquefied gravity flows) also contributed to the damage (Sassa and Takagawa, 2019).

Fig. 14. Fragility curves of Confined Masonry type houses, as impacts of the 2018 Mount Anak Krakatau volcano-genic tsunami. Dashed-line represents a complete damage fragility curve produced by Koshimura et al. (2009).
