Post-event Field Survey of 28 September 2018 Sulawesi Earthquake and Tsunami

Abstract. An earthquake with a magnitude of $M_w = 7.5$ that occurred in Sulawesi, Indonesia on September 28, 2018, triggered liquefaction and tsunamis that caused severe damage and many casualties. This paper reports the results of a post-tsunami field survey conducted by a team with members from Indonesia and Taiwan that began 13 days after the earthquake. The main purpose of this survey was to measure the runup of tsunami waves and inundation and observe the damage caused by the tsunami. Measurements were made in 18 selected sites, most in Palu Bay. The survey results show that the runup height and inundation distance reached 10.7 m in Tondo and 488 m in layana respectively. The arrival times of the tsunami waves were quite short and different for each site, typically about 3-8 minutes from the time of the main earthquake event. This study also describes the damage to buildings and infrastructures, and coastal landslides.

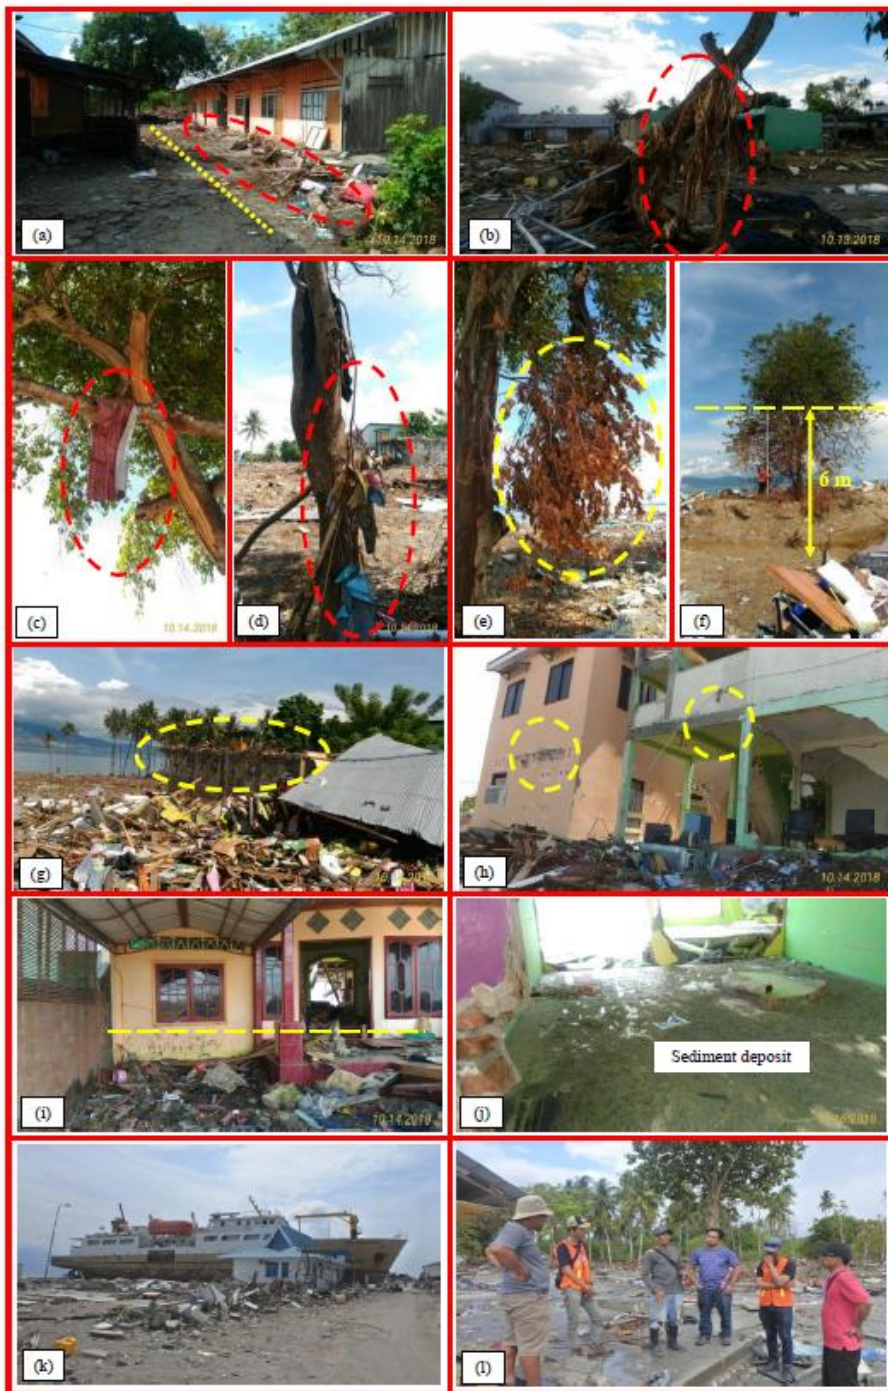
Finding evidence of runup heights, boundaries of inundation, and elevation of tsunami water levels is challenging. Some detective work is often necessary. [October is the beginning of the rainy season in Indonesia, including Sulawesi. Palu City is located near the equator, as shown by latitudes in Table 1. It is one of the driest areas in Indonesia, with rainfall recorded at the Mutiara Meteorology Station in 2017 of 774.3 mm. Since the earthquake incident until the date of the end of the survey, it rained four times, three of which occurred during our survey period, with a duration of less than 2 hours and with low to moderate intensity. It was a challenging work to look for tsunami footprint on surfaces that were exposed to surface runoff caused by rains.](#) The team collected hundreds of traces and water marks left by the tsunami. The tracks were in the form of: a) debris lines, b) debris left on trees, c) broken branches, d) sand trapped in buildings, e) damaged building elements, and f) brown leaves (submerged in salt water during tsunami event). Fig. 2 shows some evidence of runup and inundation traces.

Figure 2: Evidence of tsunami runup and inundation. (a) Debris left behind in the residential area of Tondo, (b) debris caught in a tree in Mamboro, (c) and (d) debris stuck in a tree in Tondo, (e) leaves turned brown due to being submerged in salt water, (f) a tree had green leaves at the top and brown at the lower part, indicating the tsunami inundation height (flow depth) limit in Layana, (g) debris lodged on top of a building, (h) broken house element showing tsunami water level, (i) watermark on a house wall in Lero village, (j) sand deposit on building floor in Donggala City, (k) a 45-m-long ship moved to land in Wani harbour, (l) interview with an survivor in Mamboro.

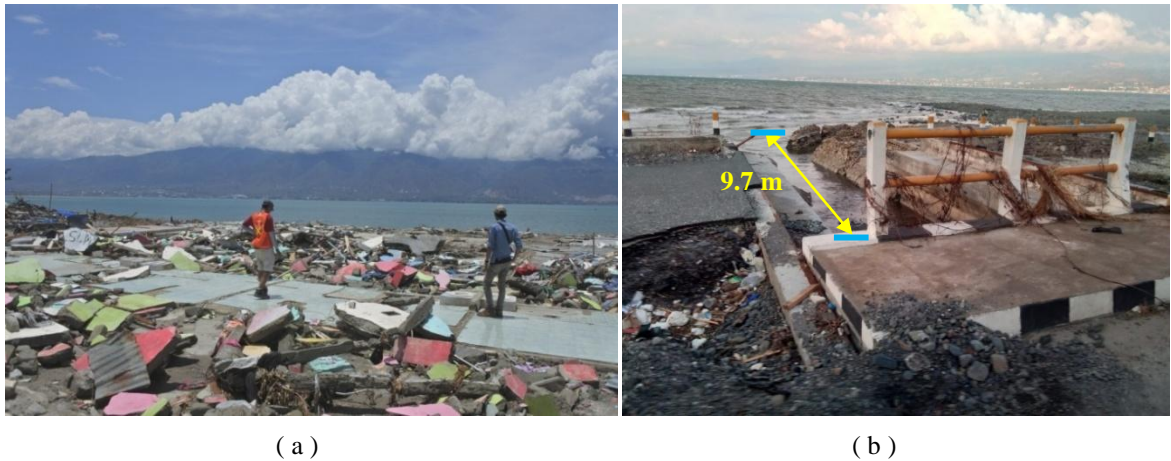
A detail measurement was done to a special phenomenon. A reinforced concrete bridge with simple support beam type on Cumi-cumi Road, Palu City (Fig 6b) shifted as far as 9.7 m. It gives a clue regarding the tsunami's strength. This bridge is made of reinforced concrete with a bridge span of 5.0 m and a width of 19.1 m. It passed over an open channel which had a

width of 4.1 m and a depth of 1.6 m. It had 14 beam girders with dimensions of 0.25 m × 0.30 m with a girder distance of 1.35 m. Its plate had a thickness of 0.20 m. Based on these dimensions, the surface area of the bridge was 244.7 m², the volume was 23.4 m³, and the mass was approximated to be around 56 tons. The bridge was estimated to have been submerged by tsunami water as deep as 2.5–4.0 m based on the tsunami marks around it. Debris caught in the bridge fence (Fig. 6b) was evidence of the tsunami water soaking the bridge. The shift stopped because the bridge body was stuck in the wall of a building. Furthermore, we can investigate this case with the help of Google Earth, as shown in Fig. 7, where Figs. 7a and 7b show satellite images taken on September 26, 2017, and October 2, 2018, respectively. As shown, the asphalt layer of the road was broken and the bridge over the open channel was shifted away from the coast by the tsunami. The position of this bridge is at the end of Palu Bay (-0.88123°S; 119.83907°E).

Figure 6: (a) Damage caused by the tsunami in Tondo, a residential complex where a lot of private boarding houses were inhabited by students at the University of Tadulako, and (b) a reinforced concrete bridge on Cumi-cumi Road Palu City shifted by 9.7 m by the tsunami.

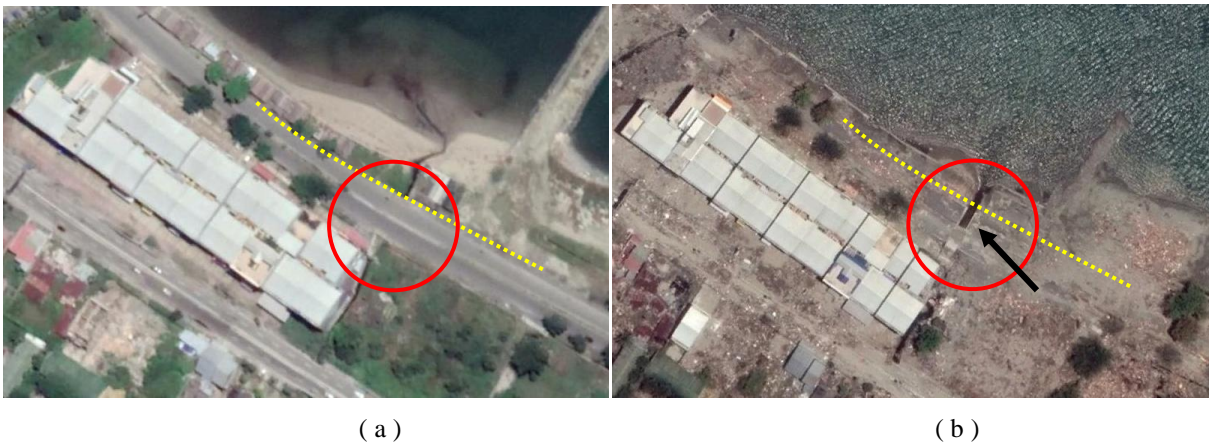
Figure 7: Satellite images taken on (a) September 26, 2017 and (b) October 2, 2018, showing the bridge shift.

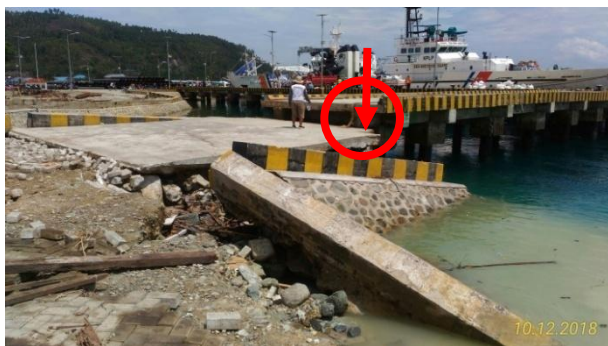
Figure 10: Landslide in Donggala City. (a) A trestle dropped 0.8 m in Donggala Port, (b) a building on the seaside slip down significantly, (c) the surface of an alley in a settlement dropped 0.4 m, and (d) a layered courtyard with paving blocks dropped around 1.5 m.

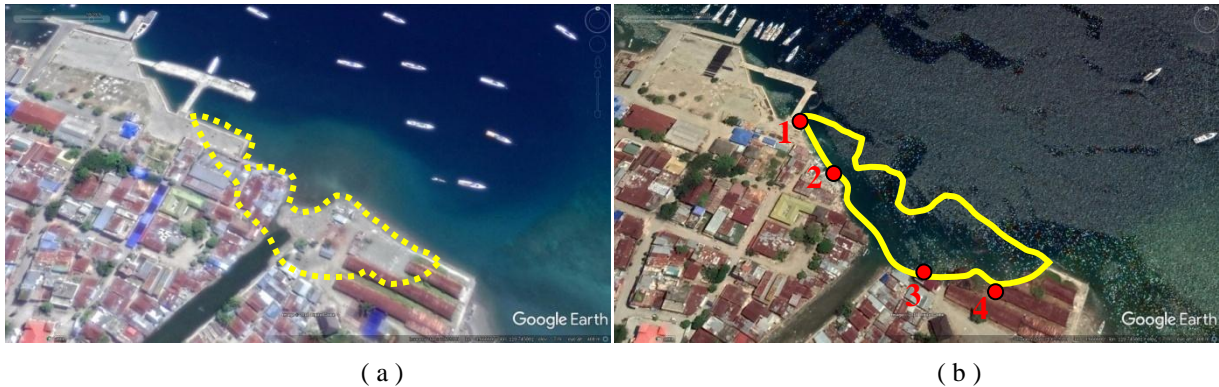
5 **Figure 11:** Possible landslide areas in Donggala (yellow dotted lines). Images were obtained from Google Earth. Satellite images taken on (a) 6 July, 2016 (more than a year before the earthquake) and (b) 2 October, 2018 (4 days after the earthquake and tsunami). The yellow bounded area is around 10,068 m² or 1 hectare. Number 1, 2, 3 and 4 in Fig. 12 b corresponds to Fig. 11 (a), (b), (c), and (d).

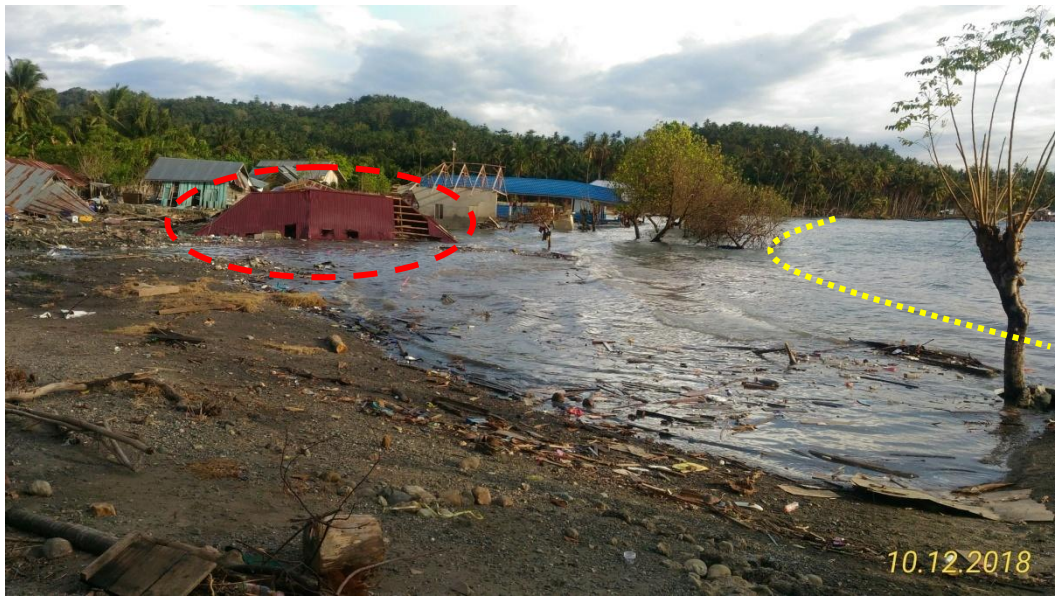
In Lero village, some houses and their inhabitants drowned when the tremor struck. Figure 12 shows a house going down so that the ceiling was in the previous floor position. A typical house in Indonesia has a ceiling height of 3 to 4 m. This is an indication that the landslide in Lero village has reduced the land surface in the range of 3 to 4 m. In addition, an eyewitness reported that seabed around 10 m from coastline changed from 1 m deep to “invisible” depth seen by naked eyes. He heard roaring sound a minute after the main earthquake.

10 **Figure 12:** Quick landsubsidence in Lero Village. Photograph taken two weeks after the event. Some houses dropped suddenly, around 3-4 m, when the earthquake occurred. Residents of these houses, especially that indicated by the oval, could not save themselves. The yellow dotted line is the former coastline.

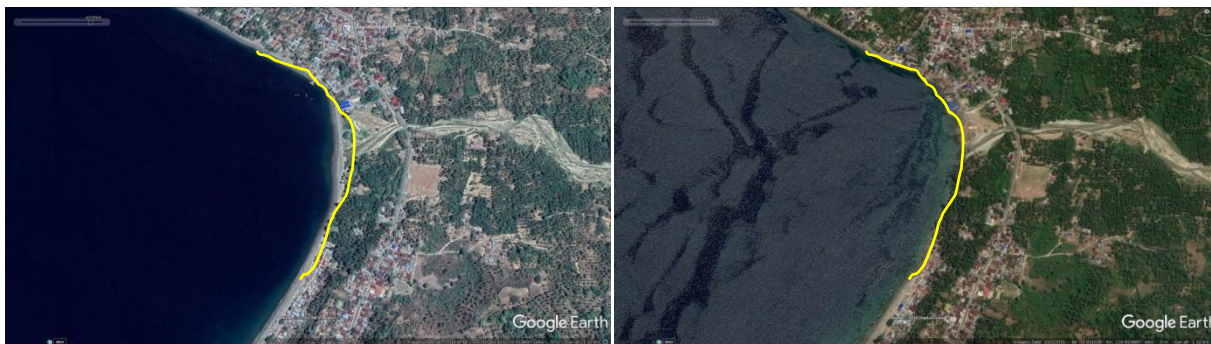
Figure 13: Quick land subsidence in Lero Village. Satellite images taken on (a) 7 April, 2016, and (b) 2 October, 2018, from Google Earth, showing conditions after the earthquake and tsunami. The area of land that dropped is 22,971 m² or almost 2.3 hectares.
