Post-event Field Survey of 28 September 2018 Sulawesi Earthquake and Tsunami

Wahyu Widiyanto^{1,2}, Purwanto B. Santoso², Shih-Chun Hsiao¹, Rudy T. Imananta³

Abstract. An earthquake with a magnitude of $M_W = 7.5$ that occurred in Sulawesi, Indonesia on September 28, 2018, triggered liquefaction and tsunamis that caused severe damage and many casualties. This paper reports the results of a post-tsunami field survey conducted by a team with members from Indonesia and Taiwan that began 13 days after the earthquake. The main purpose of this survey was to measure the runup of tsunami waves and inundation and observe the damage caused by the tsunami. Measurements were made in 18 selected sites, most in Palu Bay. The survey results show that the runup height and inundation distance reached 10.7 m in Tondo and 488 m in layana respectively. The arrival times of the tsunami waves were quite short and different for each site, typically about 3-8 minutes from the time of the main earthquake event. This study also describes the damage to buildings and infrastructures, and coastal landslides.

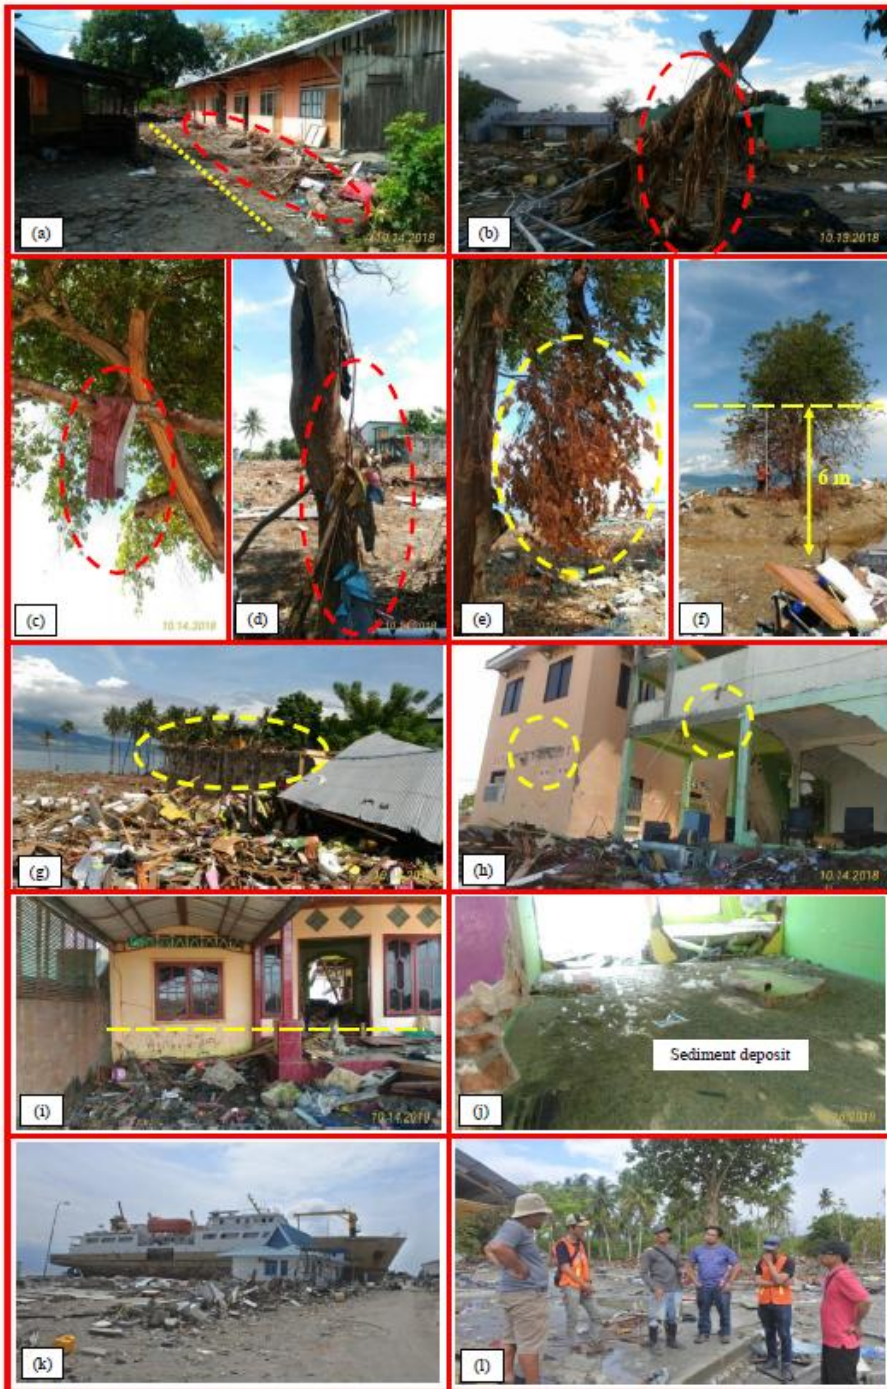
Finding evidence of runup heights, boundaries of inundation, and elevation of tsunami water levels is challenging. Some detective work is often necessary. October is the beginning of the rainy season in Indonesia, including Sulawesi. Palu City is located near the equator, as shown by latitudes in Table 1. It is one of the driest areas in Indonesia, with rainfall recorded at the Mutiara Meteorology Station in 2017 of 774.3 mm. Since the earthquake incident until the date of the end of the survey, it rained four times, three of which occurred during our survey period, with a duration of less than 2 hours and with low to moderate intensity. It was a challenging work to look for tsunami footprint on surfaces that were exposed to surface runoff caused by rains. The team collected hundreds of traces and water marks left by the tsunami. The tracks were in the form of: a) debris lines, b) debris left on trees, c) broken branches, d) sand trapped in buildings, e) damaged building elements, and f) brown leaves (submerged in salt water during tsunami event). Fig. 2 shows some evidence of runup and inundation traces.

Figure 2: Evidence of tsunami runup and inundation. (a) Debris left behind in the residential area of Tondo, (b) debris caught in a tree in Mamboro, (c) and (d) debris stuck in a tree in Tondo, (e) leaves turned brown due to being submerged in salt water, (f) a tree had green leaves at the top and brown at the lower part, indicating the tsunami inundation height (flow depth) limit in Layana, (g) debris lodged on top of a building, (h) broken house element showing tsunami water level, (i) watermark on a house wall in Lero village, (j) sand deposit on building floor in Donggala City, (k) a 45-m-long ship moved to land in Wani harbour, (l) interview with an survivor in Mamboro.

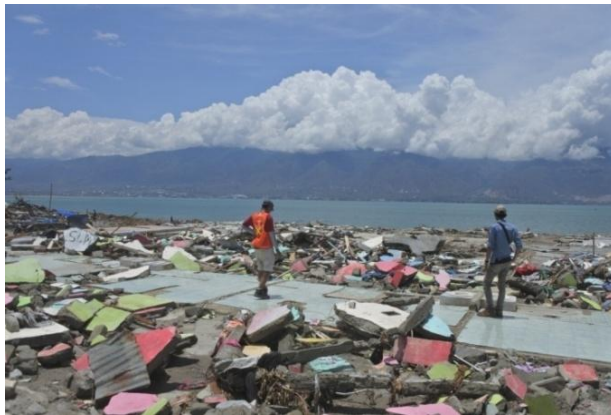
10 Survey sites in the eastern coast area of Palu Bay consisted of Site 10 to 16. Site 10 was located in Tondo. This area has many private boarding houses for students of the University of Tadulako, the biggest university in the city of Palu. The topography of this area is relatively steep with a slope of 0.04 (4%). The runup height of 10.73 m is the highest in this survey (Fig. 5) caused a few building surviving. This area was very crowded when the earthquake and tsunami event. Most students were in their boarding houses during the earthquake because it occurred after working hours. Surprisingly, fewer than 10
15 deaths were recorded. This is likely due to most of the young residents have agility to save themselves when the tsunami arrived.

Figure 6: (a) Damage caused by the tsunami in Tondo, a residential complex where a lot of private boarding houses were inhabited by students at the University of Tadulako, and (b) a reinforced concrete bridge on Cumi-cumi Road Palu City shifted by 9.7 m by the tsunami. (c) Mamboro village with 90% houses destruction (d) Asphalt layer of small road turned 90° in Tondo

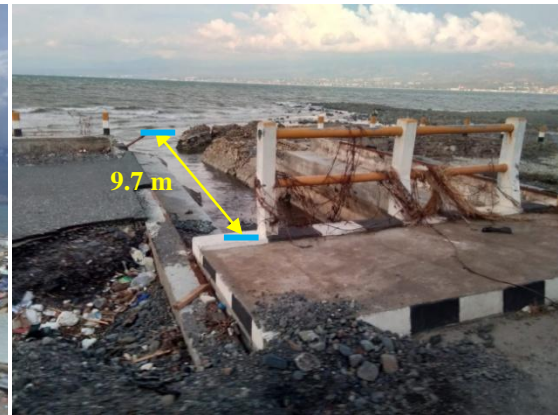
(b)

A detail measurement was done to a special phenomenon. A reinforced concrete bridge with simple support beam type on Cumi-cumi Road, Palu City (Fig 6b) shifted as far as 9.7 m. It gives a clue regarding the tsunami's strength. This bridge is made of reinforced concrete with a bridge span of 5.0 m and a width of 19.1 m. It passed over an open channel which had a width of 4.1 m and a depth of 1.6 m. It had 14 beam girders with dimensions of 0.25 m × 0.30 m with a girder distance of 1.35 m. Its plate had a thickness of 0.20 m. Based on these dimensions, the surface area of the bridge was 244.7 m², the volume was 23.4 m³, and the mass was approximated to be around 56 tons. The bridge was estimated to have been submerged by tsunami water as deep as 2.5-4.0 m based on the tsunami marks around it. Debris caught in the bridge fence (Fig. 6b) was evidence of the tsunami water soaking the bridge. The shift stopped because the bridge body was stuck in the wall of a building. Furthermore, we can investigate this case with the help of Google Earth, as shown in Fig. 7, where Figs. 7a and 7b show satellite images taken on September 26, 2017, and October 2, 2018, respectively. As shown, the asphalt layer of the road was broken and the bridge over the open channel was shifted away from the coast by the tsunami. The position of this bridge is at the end of Palu Bay (-0.88123°S; 119.83907°E).

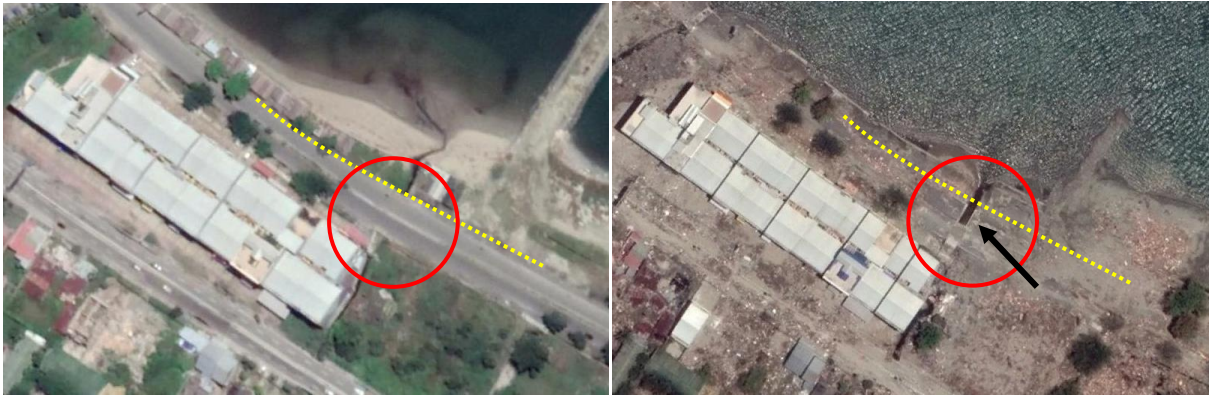
Figure 7: Satellite images taken on (a) September 26, 2017 and (b) October 2, 2018, showing the bridge shift.

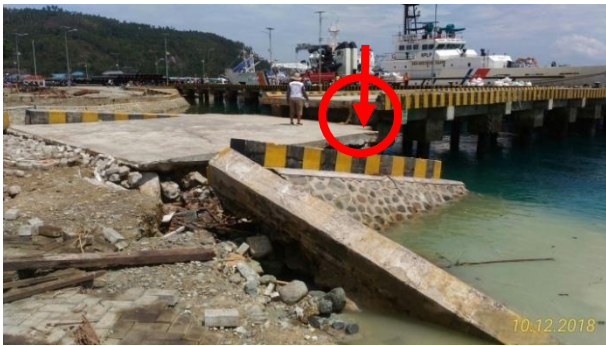
Total coastal landslides in Palu Bay related to 28 September 2018 event occurred at 7 locations (Sassa and Takagawa, 2018), 6 locations (Arikawa, 2018) or 10 locations (Omira et al., 2019). Our team found two locations of coastal landslides. These add landslide locations which have been found by other survey team. The two locations are around the river mouth in Donggala City (Figs. 11 and 12) and around the river mouth in Lero Village (Figs. 13 and 14). Landslides in Donggala were indicated by the loss of land around the Donggala River. Around 30 houses were reported to have suddenly sunk along with some of the residents. The wharf in the port of Donggala dropped by about 80 cm. The pile that was being installed for the foundation of a large building sank deep into the soil layer suddenly and was no longer found.

Figure 10: Landslide in Donggala City. (a) A trestle dropped 0.8 m in Donggala Port, (b) a building on the seaside slip down significantly, (c) the surface of an alley in a settlement dropped 0.4 m, and (d) a layered courtyard with paving blocks dropped around 1.5 m.

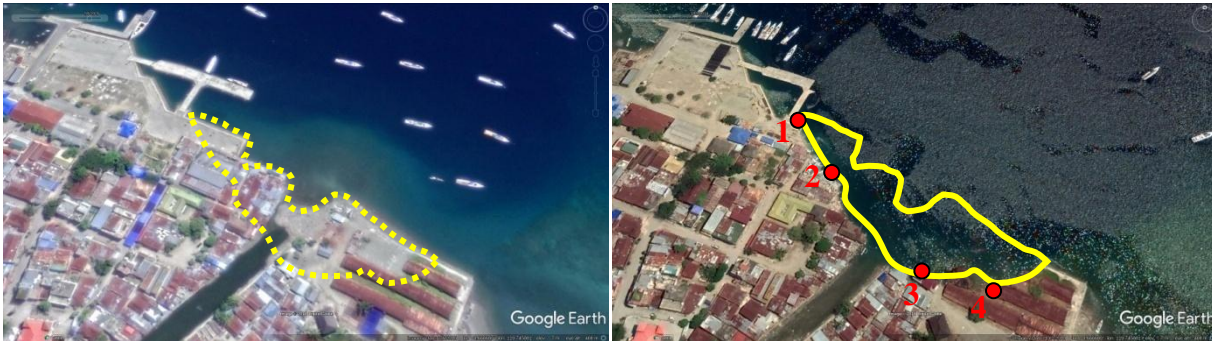
- 5 **Figure 11:** Possible landslide areas in Donggala (yellow dotted lines). Images were obtained from Google Earth. Satellite images taken on (a) 6 July, 2016 (more than a year before the earthquake) and (b) 2 October, 2018 (4 days after the earthquake and tsunami). The yellow bounded area is around 10,068 m² or 1 hectare. Number 1, 2, 3 and 4 in Fig. 12 b corresponds to Fig. 11 (a), (b), (c), and (d).

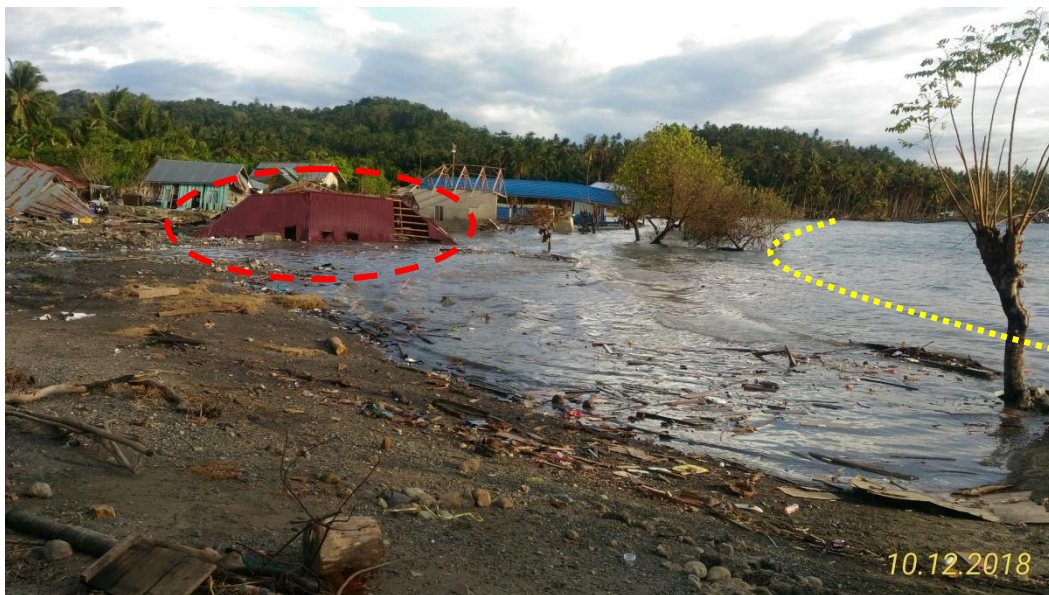
In Lero village, some houses and their inhabitants drowned when the tremor struck. Figure 12 shows a house going down so that the ceiling was in the previous floor position. A typical house in Indonesia has a ceiling height of 3 to 4 m. This is an indication that the landslide in Lero village has reduced the land surface in the range of 3 to 4 m. In addition, an eyewitness reported that seabed around 10 m from coastline changed from 1 m deep to “invisible” depth seen by naked eyes. He heard roaring sound a minute after the main earthquake.

- 10 **Figure 12:** Quick landsubside in Lero Village. Photograph taken two weeks after the event. Some houses dropped suddenly, around 3-4 m, when the earthquake occurred. Residents of these houses, especially that indicated by the oval, could not save themselves. The yellow dotted line is the former coastline.

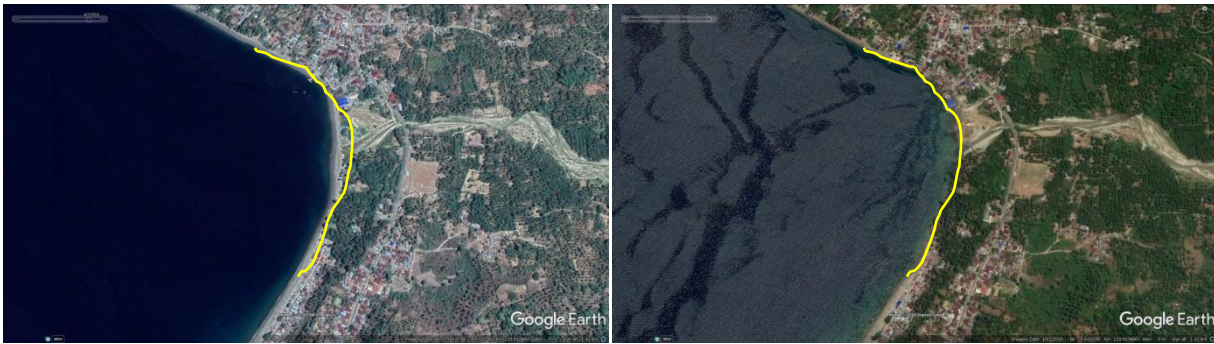
Figure 13: Quick land subsidence in Lero Village. Satellite images taken on (a) 7 April, 2016, and (b) 2 October, 2018, from Google Earth, showing conditions after the earthquake and tsunami. The area of land that dropped is 22,971 m² or almost 2.3 hectares.
