# Post-event Field Survey of 28 September 2018 Sulawesi Earthquake and Tsunami

**Abstract.** An earthquake with a magnitude of  $M_W = 7.5$  that occurred in Sulawesi, Indonesia on September 28, 2018, triggered liquefaction and tsunamis that caused severe damage and many casualties. This paper reports the results of a post-tsunami field survey conducted by a team with members from Indonesia and Taiwan that began 13 days after the earthquake. The main purpose of this survey was to measure the runup of tsunami waves and inundation and observe the damage caused by the tsunami. Measurements were made in 18 selected sites, most in Palu Bay. The survey results show that the runup height and inundation distance reached 10.7 m in Tondo and 488 m in Layana, respectively. Inundation depth of 2 to 4 m were common at most site and the highest was 8.4 m in Taipa. The arrival times of the tsunami waves were quite short and different for each site, typically about 3-8 minutes from the time of the main earthquake event. This study also describes the damage to buildings and infrastructure and coastal landslides.

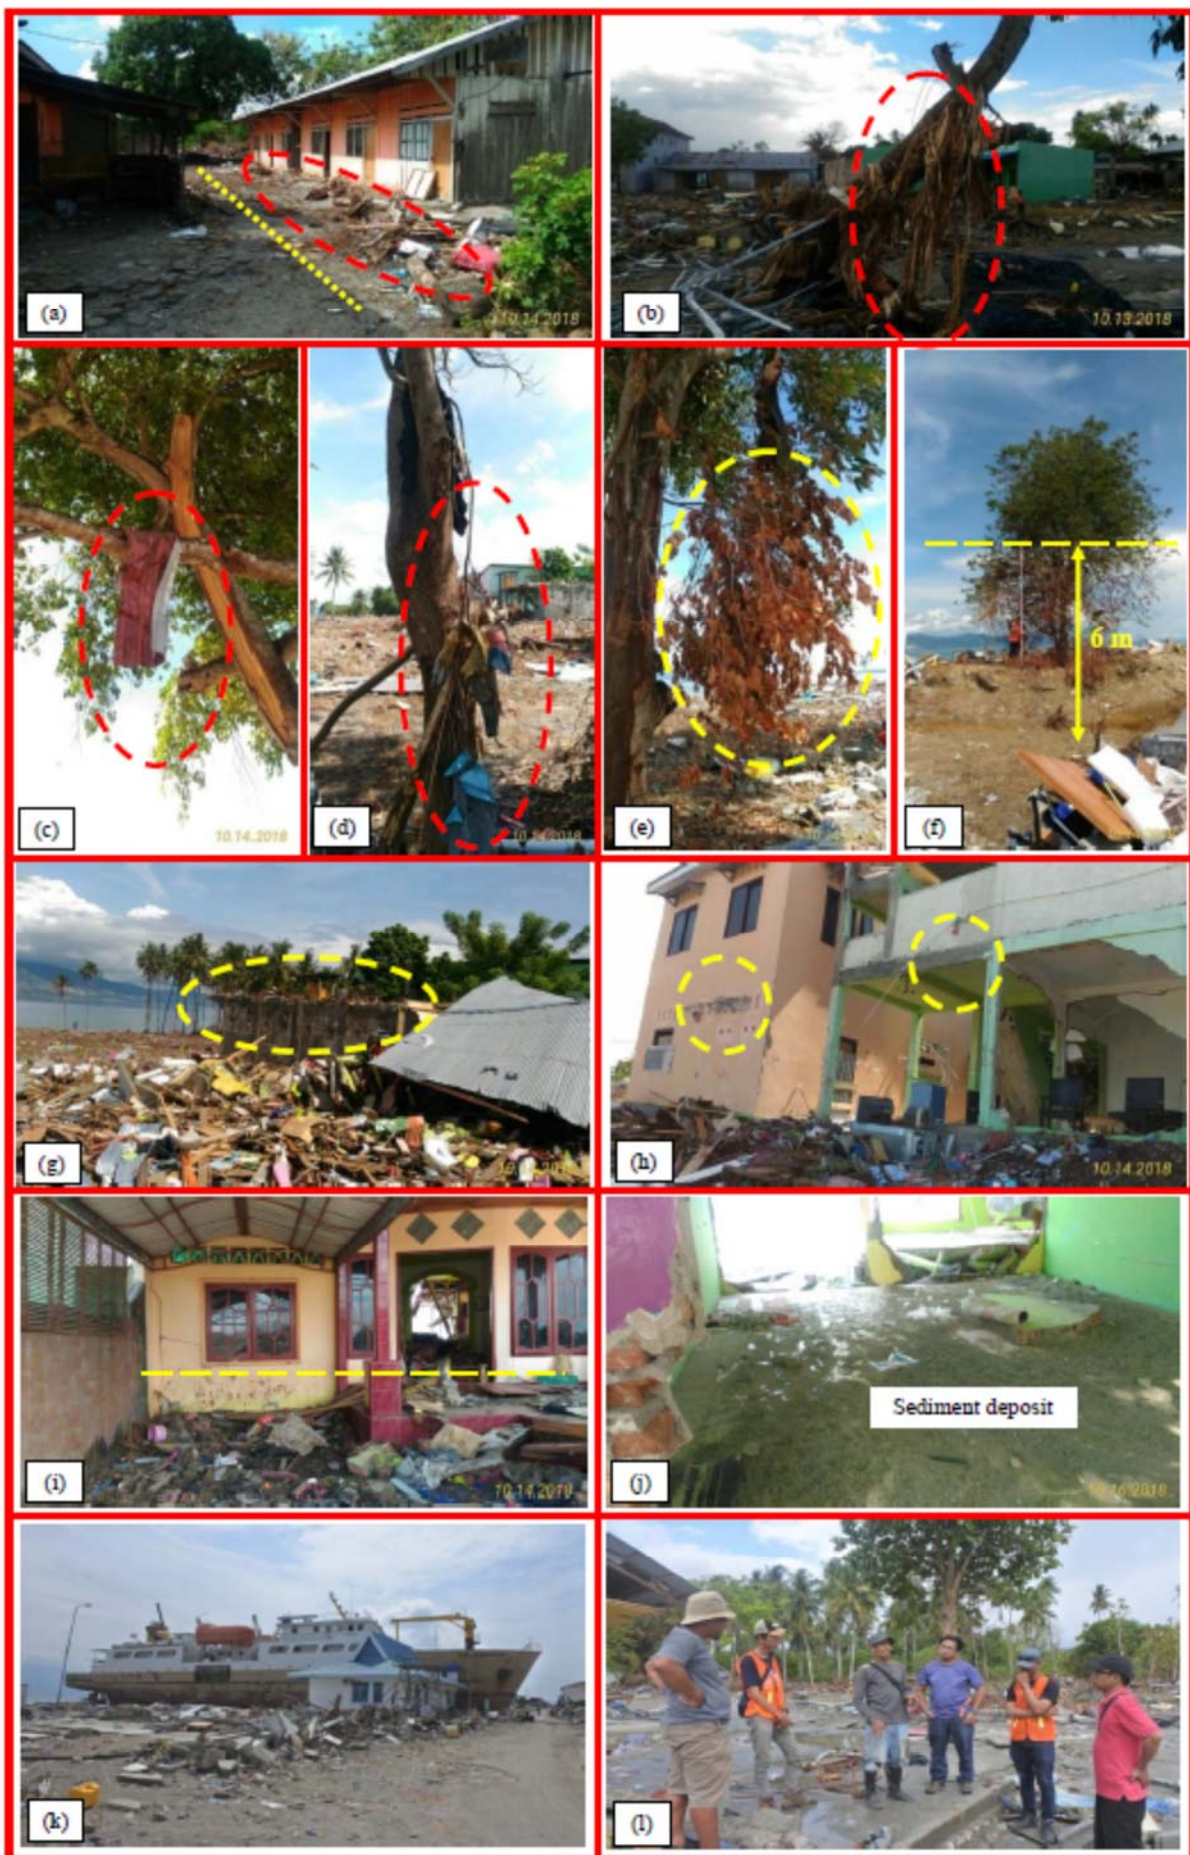
Finding evidence of runup heights, boundaries of inundation, and elevation of tsunami water levels is challenging. Some detective work is often necessary. October is the beginning of the rainy season in Indonesia, including Sulawesi. Palu City is located near the equator, as shown in Table 1. It is one of the driest areas in Indonesia, with rainfall recorded at the Mutiara Meteorology Station in 2017 of 774.3 mm. From the earthquake incident until the end of the survey, it rained four times, three of which occurred during our survey period, with a duration of less than 2 hours and with low to moderate intensity. It was challenging to find tsunami footprints on surfaces exposed to surface runoff caused by rain. The team collected hundreds of traces and water marks left by the tsunami. The tracks were in the form of: a) debris lines, b) debris left on trees, c) broken branches, d) sand trapped in buildings, e) damaged building elements, and f ) brown leaves (submerged in salt water during tsunami event). Fig. 2 shows some evidence of runup and inundation traces.

**Figure 2:** Evidence of tsunami runup and inundation. (a) Debris left behind in the residential area of Tondo, (b) debris caught in a tree in Mamboro, (c) and (d) debris stuck in a tree in Tondo, (e) leaves turned brown due to being submerged in salt water, (f) a tree had green leaves at the top and brown at the lower part, indicating the tsunami inundation height (flow depth) limit in Layana, (g) debris lodged on top of a building, (h) broken house element showing tsunami water level, (i) watermark on a house wall in Lero Village, (j) sand deposit on building floor in Donggala City, (k) a 45-m-long ship moved to land in Wani Harbour, (l) interview with a survivor in Mamboro.

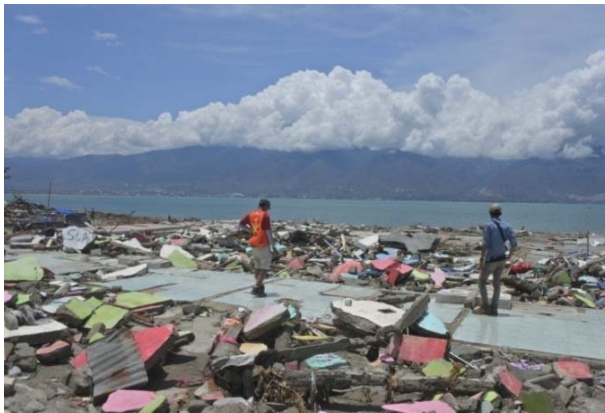
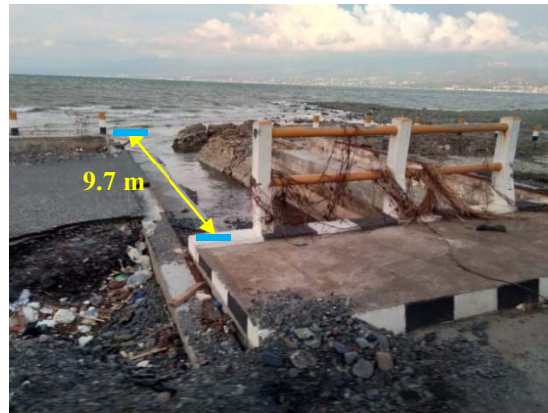
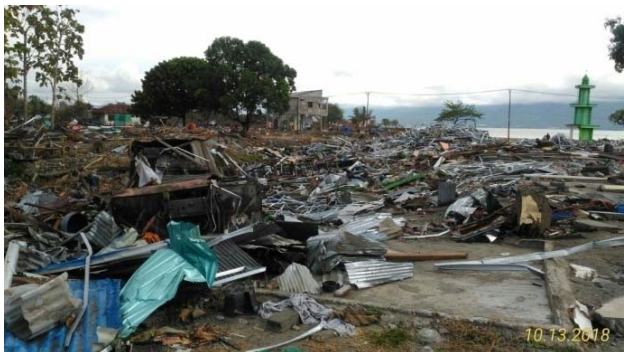
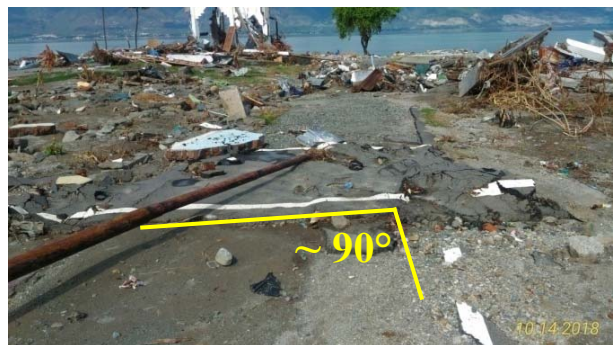
Detail measurements were taken of a reinforced concrete bridge with simple support beams on Cumi-cumi Road, near Palu Grand Mall, Palu City (Fig. 6(b)). This bridge shifted by as far as 9.7 m. It provided clues regarding the strength of the tsunamis. This bridge is made of reinforced concrete with a bridge span of 5.0 m and a width of 19.1 m. It passed over an open channel, which had a width of 4.1 m and a depth of 1.6 m. It had 14 beam girders with dimensions of 0.25 m × 0.30 m and a girder distance of 1.35 m (its sketch is available in the supplement). Its plate had a thickness of 0.20 m. Based on these dimensions, the surface area of the bridge was 244.7 m<sup>2</sup>, the volume was 23.4 m<sup>3</sup>, and the mass was estimated to be around 56 tons. The bridge was estimated to have been submerged by tsunami water as deep as 3.0–4.5 m based on the tsunami marks around it (Site 7 / Lere). Debris caught in the bridge fence (Fig. 6(b)) was evidence of the tsunami water soaking the bridge. The shift stopped because the bridge body was stuck in the wall of a building. Furthermore, we investigated this case with the help of Google Earth, as shown in Figs. 7(a) and 7(b), which show satellite images taken on September 26, 2017, and October 2, 2018, respectively. As shown, the asphalt layer of the road was broken and the bridge over the open channel was shifted away from the coast by the tsunami. The position of this bridge is at the end of Palu Bay (-0.88123°S; 119.83907°E).

**Figure 6:** (a) Damage caused by the tsunami in Tondo, a residential complex where a lot of private boarding houses were inhabited by students at the University of Tadulako, (b) a reinforced concrete bridge on Cumi-cumi Road Palu City shifted by 9.7 m by the tsunami, (c) Mamboro Village with 90% of houses destroyed, and (d) asphalt layer of small road turned 90° in Tondo.

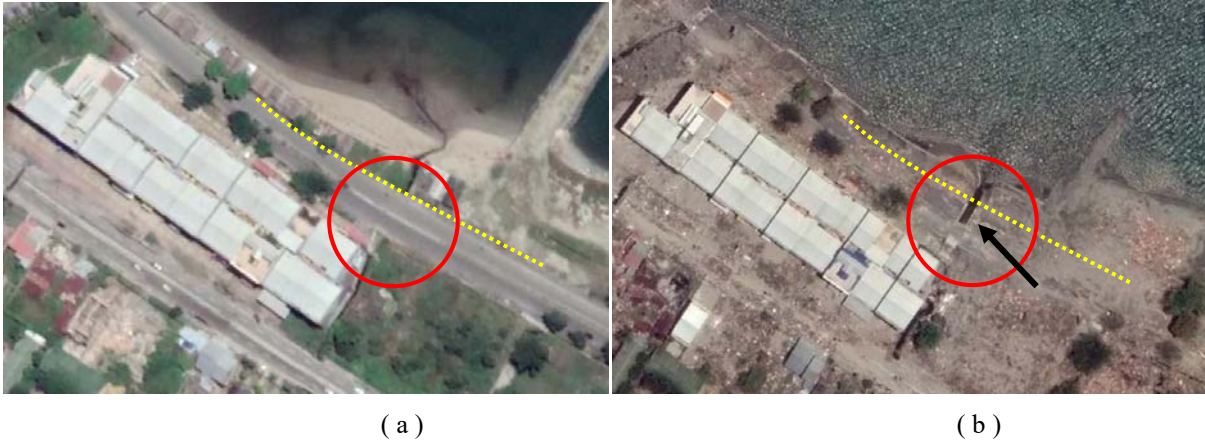
**Figure 7:** Satellite images taken on (a) September 26, 2017 and (b) October 2, 2018, showing the bridge shift.

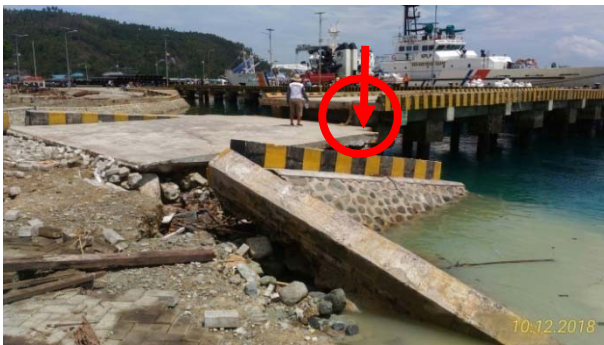
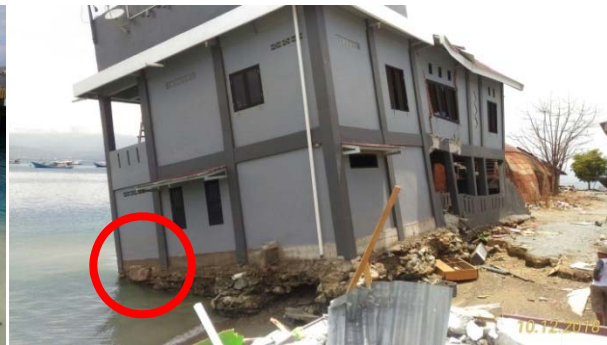
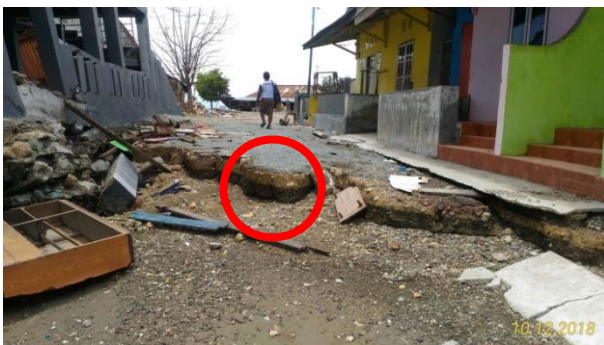
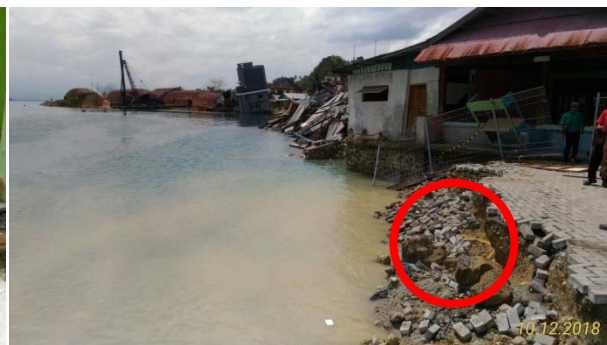
**Figure 10:** Landslide in Donggala City. (a) A trestle dropped 0.8 m in Donggala Port, (b) a building on the seaside slip down significantly, (c) the surface of an alley in a settlement dropped 0.4 m, and (d) a layered courtyard with paving blocks dropped around 1.5 m.

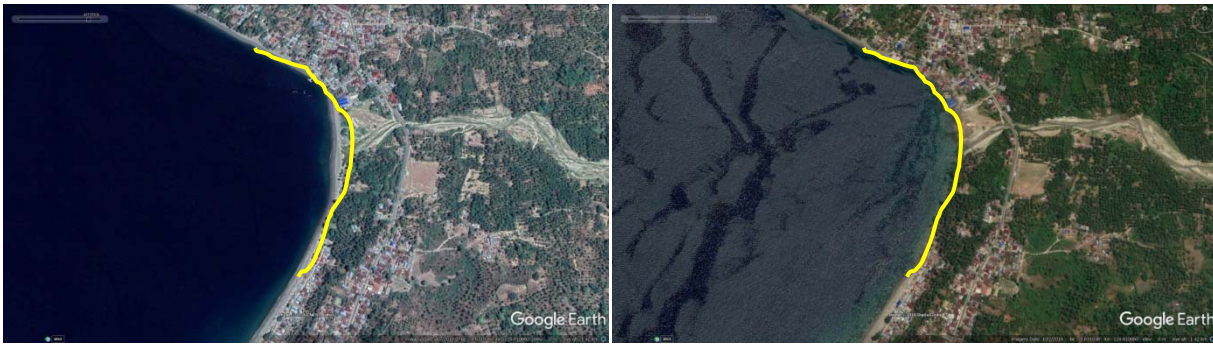
Total coastal landslides in Palu Bay related to the 28 September 2018 event occurred at 7 locations (Sassa and Takagawa, 2018), 6 locations (Arikawa, 2018), or 10 locations (Omira et al., 2019). Our team found two additional locations of coastal landslides. These are landslide locations not found by other survey teams. The two locations are around the river mouth in Donggala City (Figs. 11 and 12) and around the river mouth in Lero Village (Figs. 13 and 14). Landslides in Donggala were indicated by the loss of land around the Donggala River. Around 30 houses were reported to have suddenly sunk along with some of the residents. The wharf in the port of Donggala dropped by about 80 cm. The pile that was being installed for the foundation of a large building sank deep into the soil layer suddenly and was lost.

**Figure 13:** Quick land subsidence in Lero Village. Satellite images taken on (a) 7 April, 2016, and (b) 2 October, 2018, from Google Earth, showing conditions after the earthquake and tsunami. The area of land that dropped is 22,971 m<sup>2</sup> or almost 2.3 hectares.
