Post-event Field Survey of 28 September 2018 Sulawesi Earthquake and Tsunami

Wahyu Widiyanto^{1,2}, Purwanto B. Santoso², Shih-Chun Hsiao¹, Rudy T. Imananta³

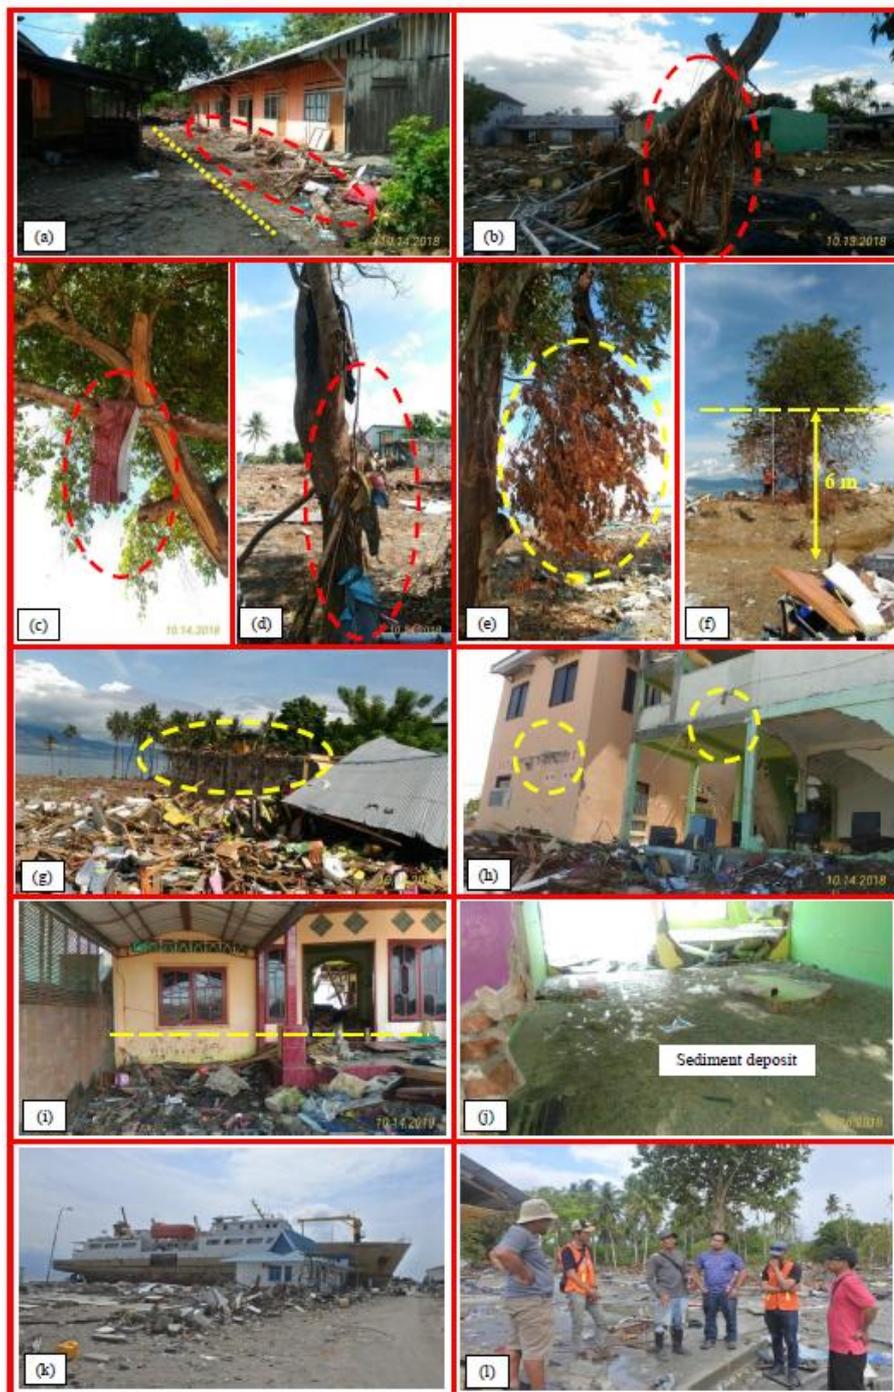
Finding evidence of runup heights, boundaries of inundation, and elevation of tsunami water levels is challenging. Some
15 detective work is often necessary. October is the beginning of the rainy season in Indonesia, including Sulawesi. Palu City is located near the equator, as shown by latitudes in Table 1. It is one of the driest areas in Indonesia, with rainfall recorded at the Mutiara Meteorology Station in 2017 of 774.3 mm. Since the earthquake incident until the date of our team's return, it rained four times, three of which occurred during our survey period, with a duration of less than 2 hours and with low to moderate intensity. Fortunately, from the point of view of conducting a survey, surface runoff due to rain seems insignificant
20 and does not erase the tsunami footprint. Our team collected hundreds of traces and water marks left by the tsunami. The tracks were in the form of: a) debris lines, b) debris left on trees, c) broken branches, d) sand trapped in buildings, e) damaged building elements, and f) brown leaves (submerged in salt water during tsunami event). Figure 2 shows some evidence of runup and inundation traces.

Figure 2: Evidence of tsunami runup and inundation. (a) Debris left behind in the residential area of Tondo, (b) debris caught in a tree in Mamboro, (c) and (d) debris stuck in a tree in Tondo, (e) leaves turned brown due to being submerged in salt water, (f) a tree had green leaves at the top and brown at the lower part, indicating the tsunami inundation height limit in Layana, (g) debris lodged on top of a

building, (h) broken house element showing tsunami water level, (i) watermark on a house wall in Lero village, (j) sand deposit on building floor in Donggala City, (k) a 45-m-long ship moved to land in Wani harbour, (l) interview with an eyewitness in Mambo.

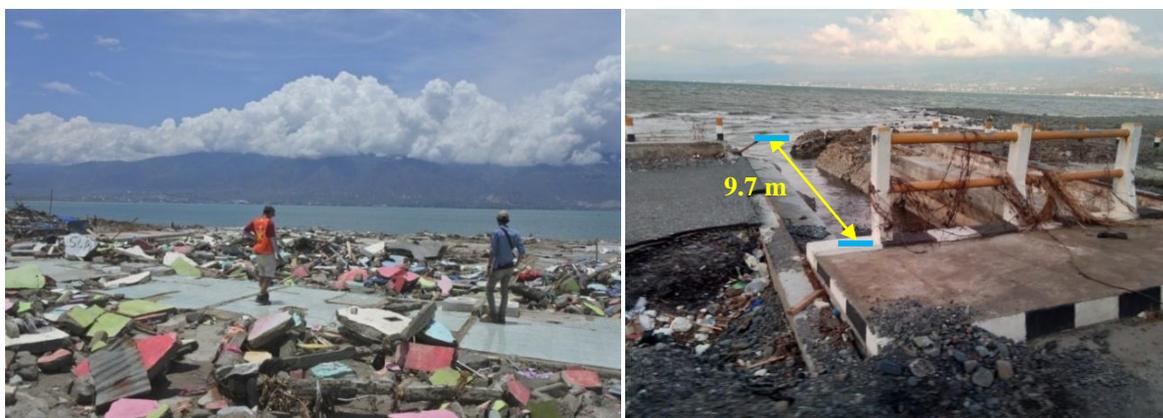
The highest point of the tsunami creeping was found at the Tondo site (Fig. 5). This area has many private boarding houses for students of the University of Tadulako, a state university in the city of Palu. The topography of this area is relatively steep with a slope of 0.06 (6%). Evidence of tsunami water rise was in the form of debris on top of buildings, truncated building elements, collapsed walls, trash carried away, and fixed debris. Eyewitnesses also showed the highest places of tsunami water in this area. A total of 4 cross sections of these coast were measured by our team. The measured runup heights were 12.20, 9.44, 11.61, and 9.97 m, respectively, as shown in Table 1. The runup height of 12.2 m (10.5 m after correction based on astronomical tides) is the highest at the Palu disaster area site. This area was flattened by tsunami (Fig. 6a), buildings collapse. This area is very crowded. Most students were in their boarding houses during the earthquake because it occurred after working hours. Surprisingly, fewer than 10 deaths were recorded. This is likely due to most of the young residents being quite nimble and able to save themselves when the tsunami arrived. This is an important observation for future mitigation efforts.

A reinforced concrete bridge on Cumi-cumi Road, Palu City (**Error! Reference source not found.**b), gives a clue regarding the tsunami's strength. This bridge is made of reinforced concrete with a bridge span of 5.0 m and a width of 19.1 m. This bridge has a relatively small span because it passes over a sewer from the city of Palu, not a large river. The sewer has a width of 4.1 m and a depth of 1.6 m. The width of the bridge is relatively large (two lanes). The bridge has 14 beam girders with dimensions of 0.25 m × 0.30 m with a girder distance of 1.35 m. The bridge has simple support. The bridge plate has a thickness of 0.20 m. Based on these dimensions, the mass of the bridge was estimated to be around 38 tons. A large and perpendicular direction of the tsunami's velocity shifted the bridge by as far as 9.7 m without damage. The surface area of the bridge perpendicular to the direction of arrival of the tsunami is 3.4 m², including the area of the projected bridge fence. The bridge was estimated to have been submerged by tsunami water as deep as 2.5-4.0 m based on the tsunami marks around it. Debris caught in the bridge fence (Fig. 6b) was evidence of the tsunami water soaking the bridge. The shift stopped because the bridge body was stuck in the wall of a building. We can investigate this case with the help of Google Earth, as shown in Fig. 7, where Figs. 7a and 7b show satellite images taken on September 26, 2017, and October 2, 2018, respectively. As shown, the asphalt layer of the road was broken and the bridge over the sewer channel was shifted away from the coast by the tsunami. The position of this bridge is at the end of Palu Bay (-0.88123°S 119.83907°E). This phenomenon can be further analyzed to determine the tsunami force.

Figure 6: (a) Damage caused by the tsunami in Tondo, a residential complex where a lot of private boarding houses were inhabited by students at the University of Tadulako, and (b) a reinforced concrete bridge on Cumi-cumi Road Palu City shifted by 9.7 m by the tsunami.

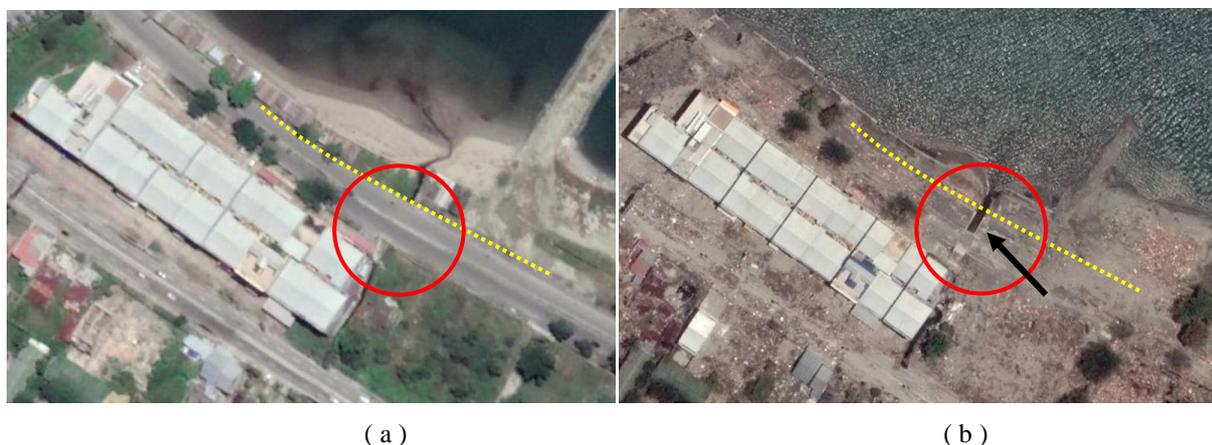
Figure 7: Satellite images taken on (a) September 26, 2017 and (b) October 2, 2018, showing the bridge shift.

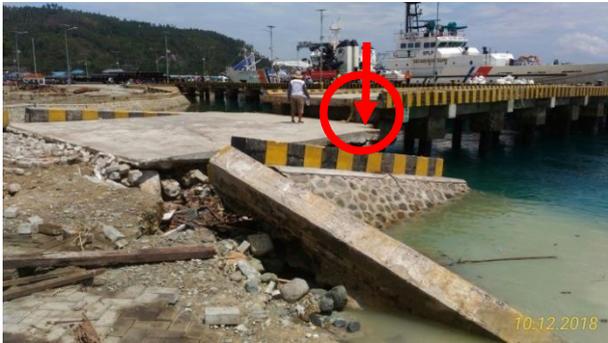
Figure 11: Landslide in Donggala City. (a) A trestle dropped 0.8 m in Donggala Port, (b) a building on the seaside slip down significantly, (c) the surface of an alley in a settlement dropped 0.4 m, and (d) a layered courtyard with paving blocks dropped around 1.5 m.

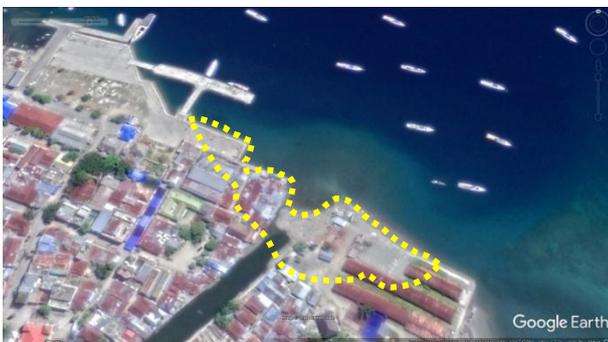
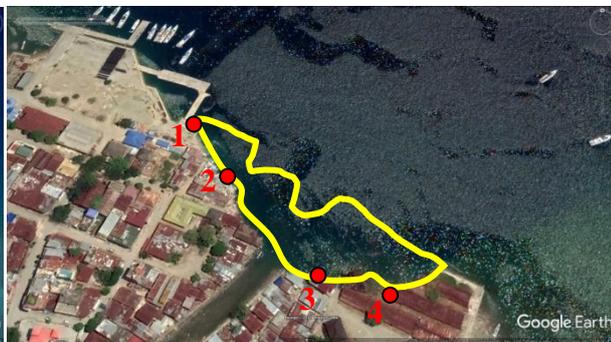
Figure 12: Possible landslide areas in Donggala (yellow dotted lines). Images were obtained from Google Earth. Satellite images taken on (a) 6 July, 2016 (more than a year before the earthquake) and (b) 2 October, 2018 (4 days after the earthquake and tsunami). The yellow bounded area is around 10,068 m² or 1 hectare. Number 1, 2, 3 and 4 in Fig. 12 b corresponds to Fig. 11 (a), (b), (c), and (d).

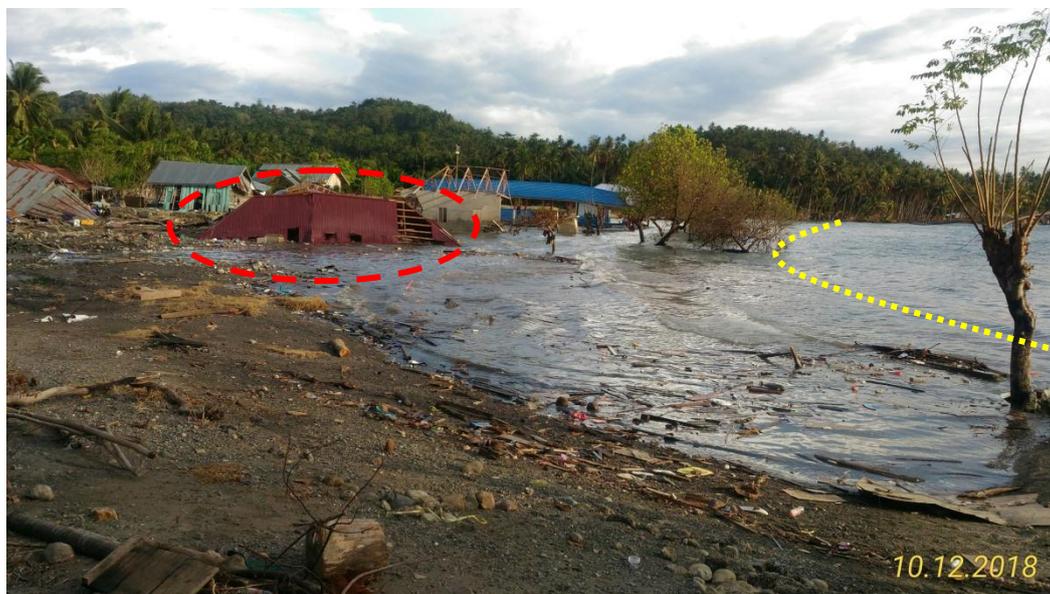
Some evidence from videos and eyewitnesses indicates that landslides or coastal land subsidence occurred inside Palu Bay area. Therefore, the Indonesian Navy deployed the KRI Spica Ship, a new survey vessel equipped with a multibeam echosounder, to record underwater data on October 15, 2018, after the tsunami. The Agency for the Assessment and Application of Technology (BPPT) sent a Baruna Jaya 1 survey ship to conduct a bathymetry survey of Palu Bay after the tsunami. Although the focus of our team was to measure runup and inundation, we also obtained evidence that might be related to underwater landslides. Total collapses and flows of coastal land due to liquefaction occurred in at least nine locations (Sassa and Takagawa, 2019). We found two of them with indicators of land subsidence on the coast. The two locations are around the river mouth in Donggala City (Figs. 11 and 12) and around the river mouth of Lero Village (Figs. 13 and 14).

Figure 13: Quick landsubidence in Lero Village. Photograph taken two weeks after the event. Some houses dropped suddenly, around 3-4 m, when the earthquake occurred. Residents of these houses, especially that indicated by the oval, could not save themselves. The yellow dotted line is the former coastline.

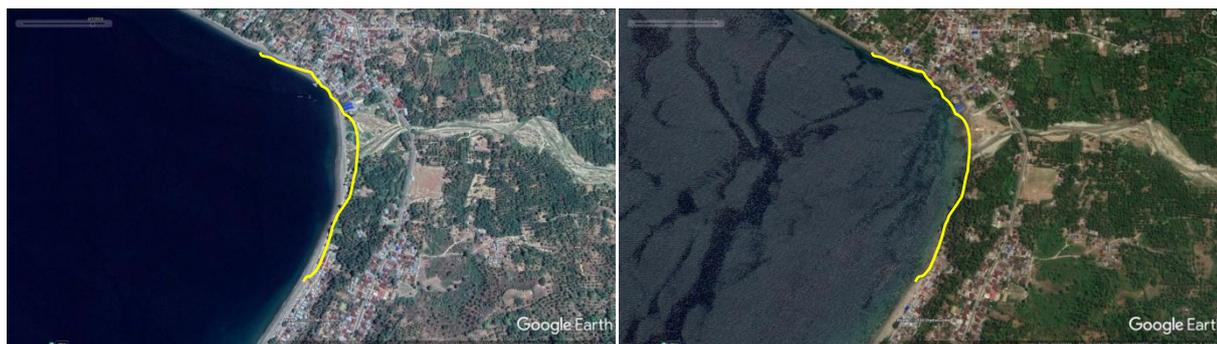
Figure 14: Quick land subsidence in Lero Village. Satellite images taken on (a) 7 April, 2016, and (b) 2 October, 2018, from Google Earth, showing conditions after the earthquake and tsunami. The area of land that dropped is 22,971 m² or almost 2.3 hectares.
