Brief communication: monitoring a soft-rock coastal cliff using webcams and strain sensors

Abstract. In this brief communication, we describe a case study about monitoring a soft-rock coastal cliff using webcams and a strain sensor, located in the Apulia region (southeastern Italy). In this urban and touristic area, coastal recession is extremely rapid and rockfalls are very frequent. Using low-cost and open source hardware and software, we are monitoring the area, trying to correlate both meteorological information with measures obtained from the crack-meter and webcams, aiming to recognize potential precursor signals that could be triggered by instability phenomena.

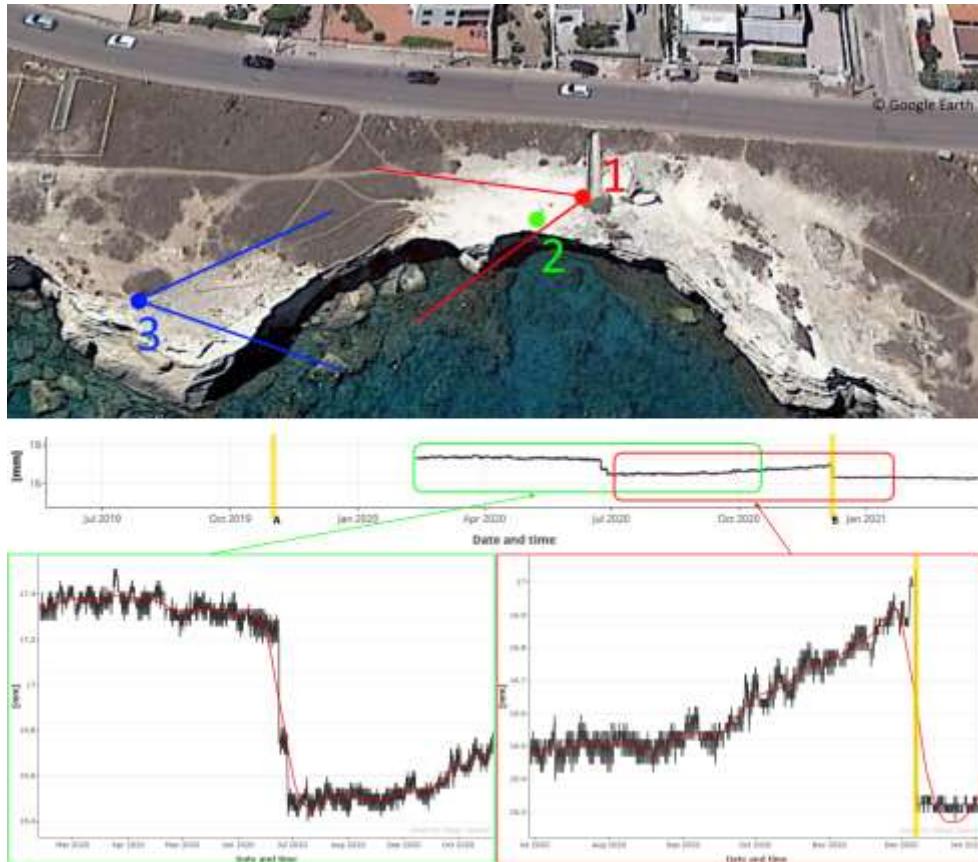
The last recorded event is related to the rockfall that occurred on 7 December 2020 h04.15. In this case, crack-meter data starting from July 2020 show a slight trend of the monitored fissure, which is seen to gradually enlarge, up to the time of failure (bottom of fig. 1, red area). Unfortunately, at that time, the optical instrumentation was off due to the lack of power caused by the adverse weather conditions: in the previous 96 hours, a rather intense rainfall event occurred, which reached a peak of 24h-
100 cumulative precipitation of 80 mm. Despite this issue, however, the images and videos obtained before and after the event are consistent with what was detected by the sudden deviation in the data of the crack-meter. The fracture monitored by the

Figure 1: on top, plan of the monitored cliff area (taken from Google Earth) – In red (marked with “1”), the main camera [position and the Raspberry Camera Module field of view](#); in blue (marked with “3”) the secondary camera; the green dot marked with “2” is the position of the crack-meter. On bottom, the crack-meter data – In the green box the first period of data obtained using the automatic crack-meter (from 12 February 2020 up to 20 October 2020). In the red box the second period of data of the same crack-meter (going from 29 June 2020 to 04 January 2021). Two main rockfalls have been noticed in this period and have been marked with the “A” and “B” yellow lines.

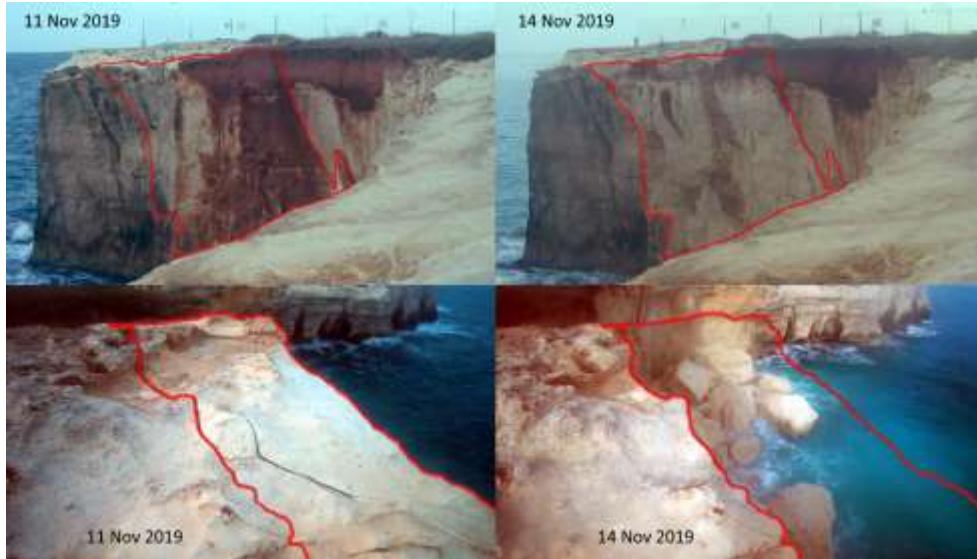
In these two years of activity, the monitoring system recorded several events. The first remarkable event occurred between 12
85 November 2019 (after h09:00) and 14 November 2019 (before h08:30) when a collapse of a large part of the cliff took place (see fig. 2). Unfortunately, when the failure occurred, the instrumentation was inactive due to the lack of energy caused by the severe rainstorm that struck the area for few days; moreover, no crack-meter was still available (see bottom of fig. 1). Despite these issues, both images and videos just before and after the collapse were available. Based on such information and the application of Image Change Detection techniques, we estimated a volume of the collapse equal to $300 \text{ m}^3 \pm 30\%$ following
90 the methods described in Giordan et al. (2020).

Figure 2: the first rockfall (marked with "A" on fig. 1) – Top left image shows the cliff as it was on 11 November 2019 and the top right image shows as it was 3 days later ([both images are taken from the Raspberry Camera Module – see fig. 1 for the position](#)). Bottom images shows the same event but from a different point of view (the secondary camera – [see fig. 1 for the position](#)): on the left, a picture taken before the collapse and on the right, a picture taken on 14 November 2019.

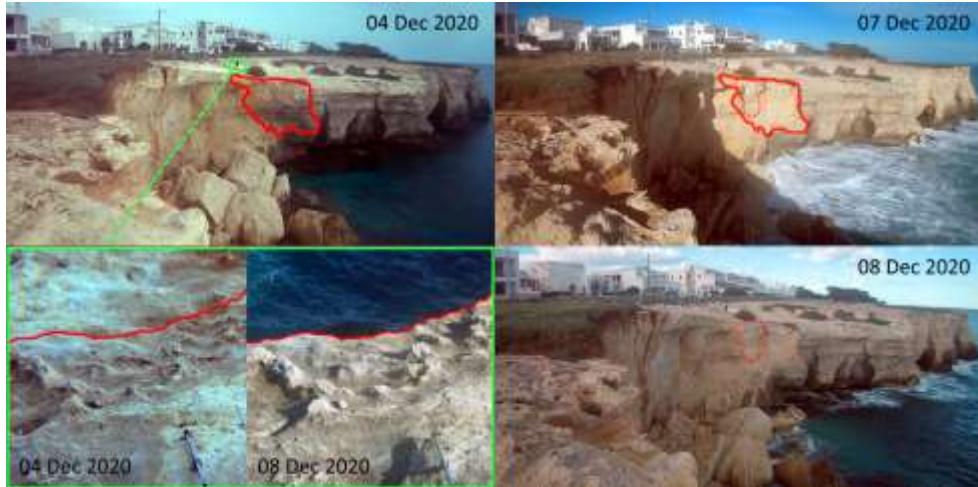
instrument was not directly affected by the collapse, since the collapse involved a rock block not far from it, while the crack-meter itself recorded, at the time of failure, a contraction of approximately 1 mm. In this case, following the same approach, it 105 was possible to estimate the volume of the collapse, which resulted to be about $20 \text{ m}^3 \pm 30\%$. Based on the data acquired by the secondary camera, we have also observed that the collapse itself occurred in two stages: the most conspicuous part, as already mentioned, collapsed around h04.15, while a second detachment, considerably smaller, occurred between h11.00 and h16.30 on the same day, without affecting the crack-meter measurements (see fig. 3).

Figure 3: the second rockfall (marked with "B" on fig. 1) – Top left image shows the cliff as it was on 4 December 2020 and the top right image shows as it was on the morning of the 7 December 2020, after the main collapse (marked by the thick red line). Bottom right images shows the cliff as it was on the 8 December 2020, after a minor rockfall (marked by the thin red line). Those three images are taken from the secondary camera (see fig. 1 for the position). On the bottom left part, two smaller images that shows the collapse from another point of view (the main camera, that could also be seen in the top left image, highlighted in green – see fig. 1 for the position) both before the rockfall (on the left) and after it (on the right). On those images, the newly installed automatic crack-meter is also visible.
