Brief communication: monitoring a soft-rock coastal cliff using webcams and strain sensors

Abstract. In this brief communication, we describe a case study about monitoring a soft-rock coastal cliff using webcams and a strain sensor, located in the Apulia region (southeastern Italy). In this urban and touristic area, coastal recession is extremely 15 rapid and rockfalls are very frequent. Using low-cost and open source hardware and software, we are monitoring the area, trying to correlate both meteorological information with measures obtained from the crack-meter and webcams, aiming to recognize potential precursor signals that could be triggered by instability phenomena.

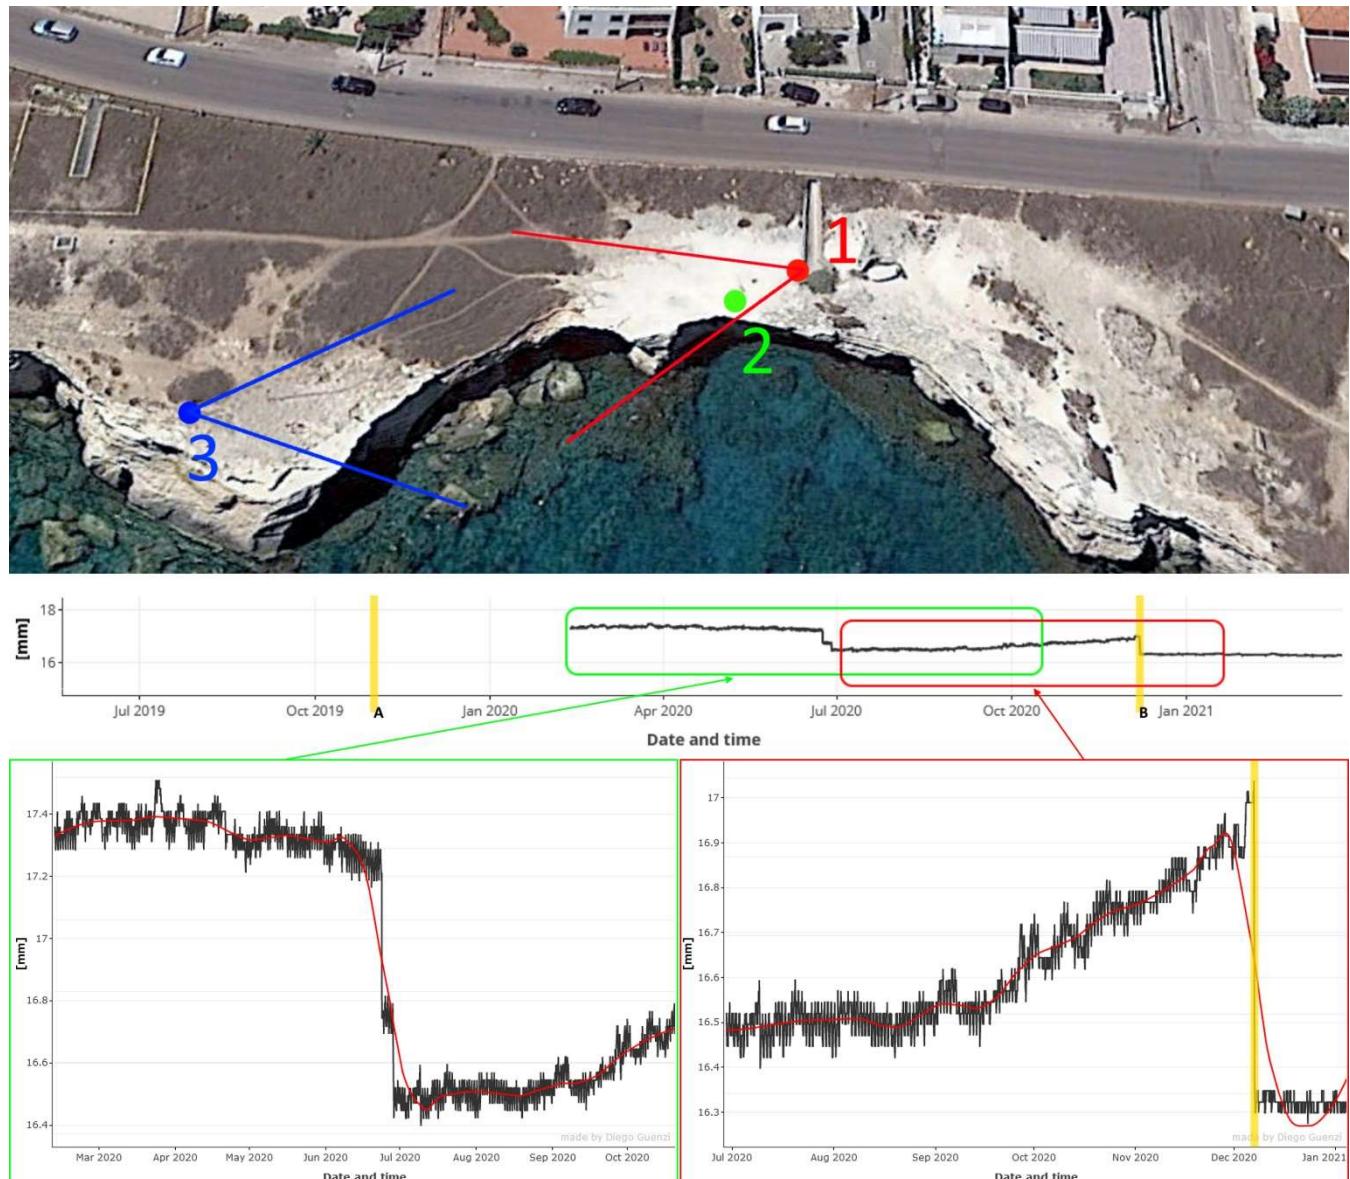
80 Two other rockfall events took place on 23 June 2020, around h17.05 (bottom of fig. 1, green area), and on 28 June 2020, approximately between h9.00 and h11.00. In the latter event, the cameras, despite the area being under restricted access, also detected the presence of a passer-by; this anthropogenic disturbance interfered with the crack-meter measurements. This event confirmed that crack-meter devices alone cannot be used to monitor areas like the examined one and an optical system is fundamental to have an additional control on the global factors acting on the site.

Figure 1: on top, plan of the monitored cliff area (taken from Google Earth) – In red (marked with “1”), the main camera and in blue (marked with “3”) the secondary camera; the green dot marked with “2” is the position of the crack-meter. On bottom, the crack-meter data – In the green box the first period of data obtained using the automatic crack-meter (from 12 February 2020 up to 20 October 2020). In the red box the second period of data of the same crack-meter (going from 29 June 2020 to 04 January 2021).
 160 Two main rockfalls have been noticed in this period and have been marked with the “A” and “B” yellow lines.

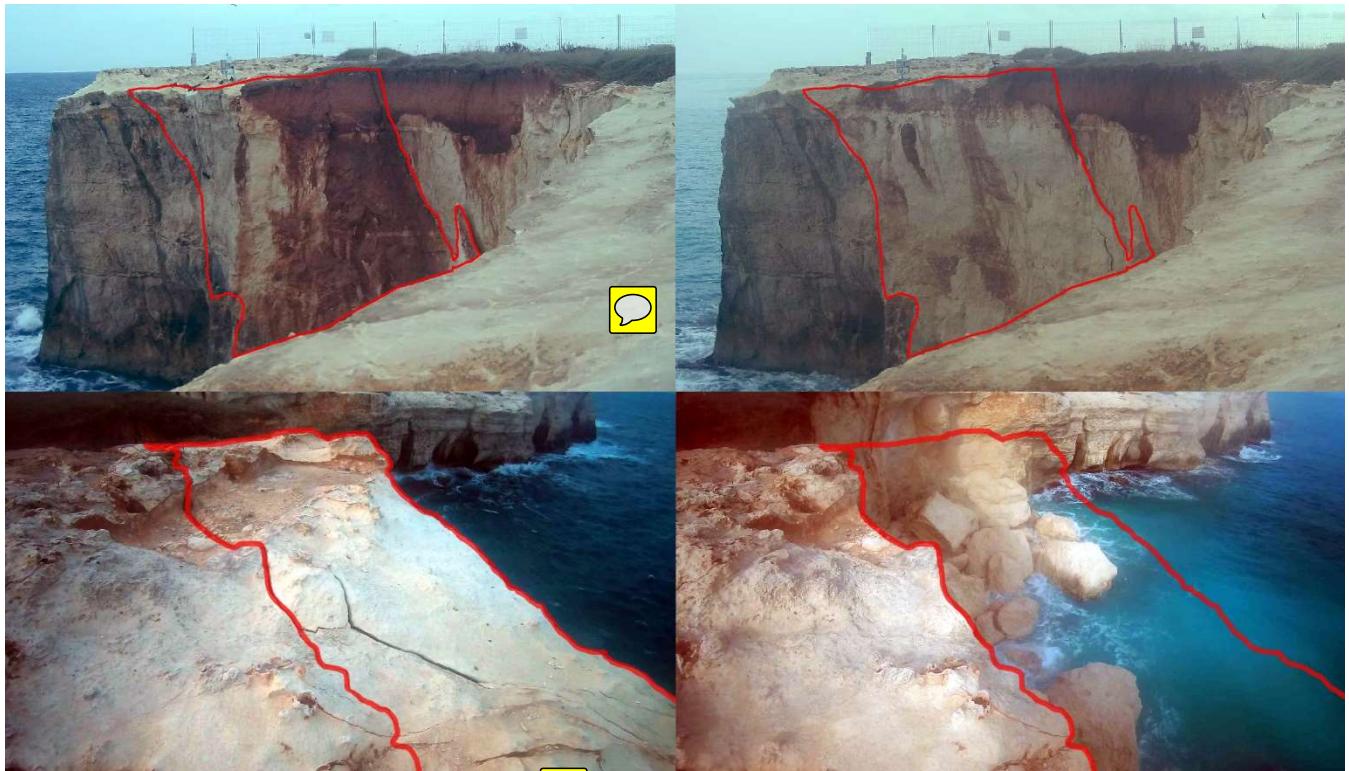
In these two years of activity, the monitoring system recorded several events. The first remarkable event occurred between 12 November 2019 (after h09:00) and 14 November 2019 (before h08:30) when a collapse of a large part of the cliff took place 75 (see fig. 2). Unfortunately, when the failure occurred, the instrumentation was inactive due to the lack of energy caused by the severe rainstorm that struck the area for few days; moreover, no crack-meter was still available (see bottom of fig. 1). Despite these issues, both images and videos just before and after the collapse were available. Based on such information and the application of Image Change Detection techniques, we estimated a volume of the collapse equal to $300 \text{ m}^3 \pm 30\%$ following the methods described in

Figure 2: the first rockfall (marked with “A” on fig). Top left image shows the cliff as it was on 11 November 2019 and the top right image shows as it was 3 days later. Bottom images shows the same event but from a different point of view (the secondary camera): on the left, a picture taken before the collapse and on the right, a picture taken on 14 November 2019.

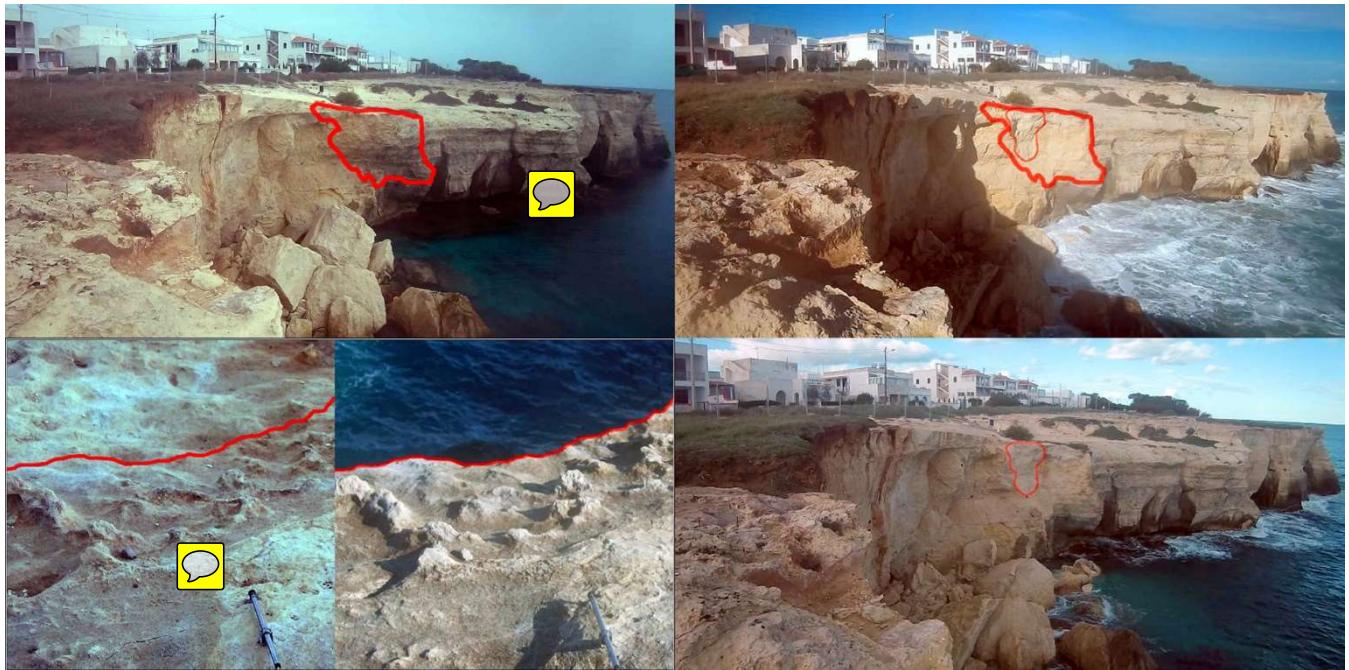
85 The last recorded event is related to the rockfall that occurred on 7 December 2020 h04.15. In this case, crack-meter data starting from July 2020 show a slight trend of the monitored fissure, which is seen to gradually enlarge, up to the time of failure (bottom of fig. 1, red area). Unfortunately, at that time, the optical instrumentation was off due to the lack of power caused by the adverse weather conditions: in the previous 96 hours, a rather intense rainfall event occurred, which reached a peak of 24h-cumulative precipitation of 80 mm. Despite this issue, however, the images and videos obtained before and after the event are 90 consistent with what was detected by the sudden deviation in the data of the crack-meter. The fracture monitored by the instrument was not directly affected by the collapse, since the collapse involved a rock block not far from it, while the crack-meter itself recorded, at the time of failure, a contraction of approximately 1 mm. In this case, following the same approach, it was possible to estimate the volume of the collapse, which resulted to be about $20 \text{ m}^3 \pm 30\%$. Based on the data acquired by the secondary camera, we have also observed that the collapse itself occurred in two stages: the most conspicuous part, as

95 already mentioned, collapsed around h04.15, while a second detachment, considerably smaller, occurred between h11.00 and h16.30 on the same day, without affecting the crack-meter measurements (see fig. 3).

Figure 3: the second rockfall (marked with “B” on fig. 2) – Top left image shows the cliff as it was on 4 December 2020 and the top right image shows as it was on the morning of the 7 December 2020, after the main collapse (marked by the thick red line). Bottom right images shows the cliff as it was on the 8 December 2020, after a minor rockfall (marked by the thin red line). On the bottom left part, two smaller images that shows the collapse from another point of view (the main camera) both before the rockfall (on the left) and after it (on the right). On those images, the newly installed automatic crack-meter is also visible.
