Brief communication: monitoring a soft-rock coastal cliff using webcams and strain sensors

Abstract. In this brief communication, we describe a case study about monitoring a soft-rock coastal cliff using webcams and a strain sensor, located in the Apulia region (southeastern Italy). In this urban and touristic area, coastal recession is extremely rapid and rockfalls are very frequent. Using low-cost and open source hardware and software, we are monitoring the area, trying to correlate both meteorological information with measures obtained from the crack-meter and webcams, aiming to recognize potential precursor signals that could be triggered by instability phenomena.

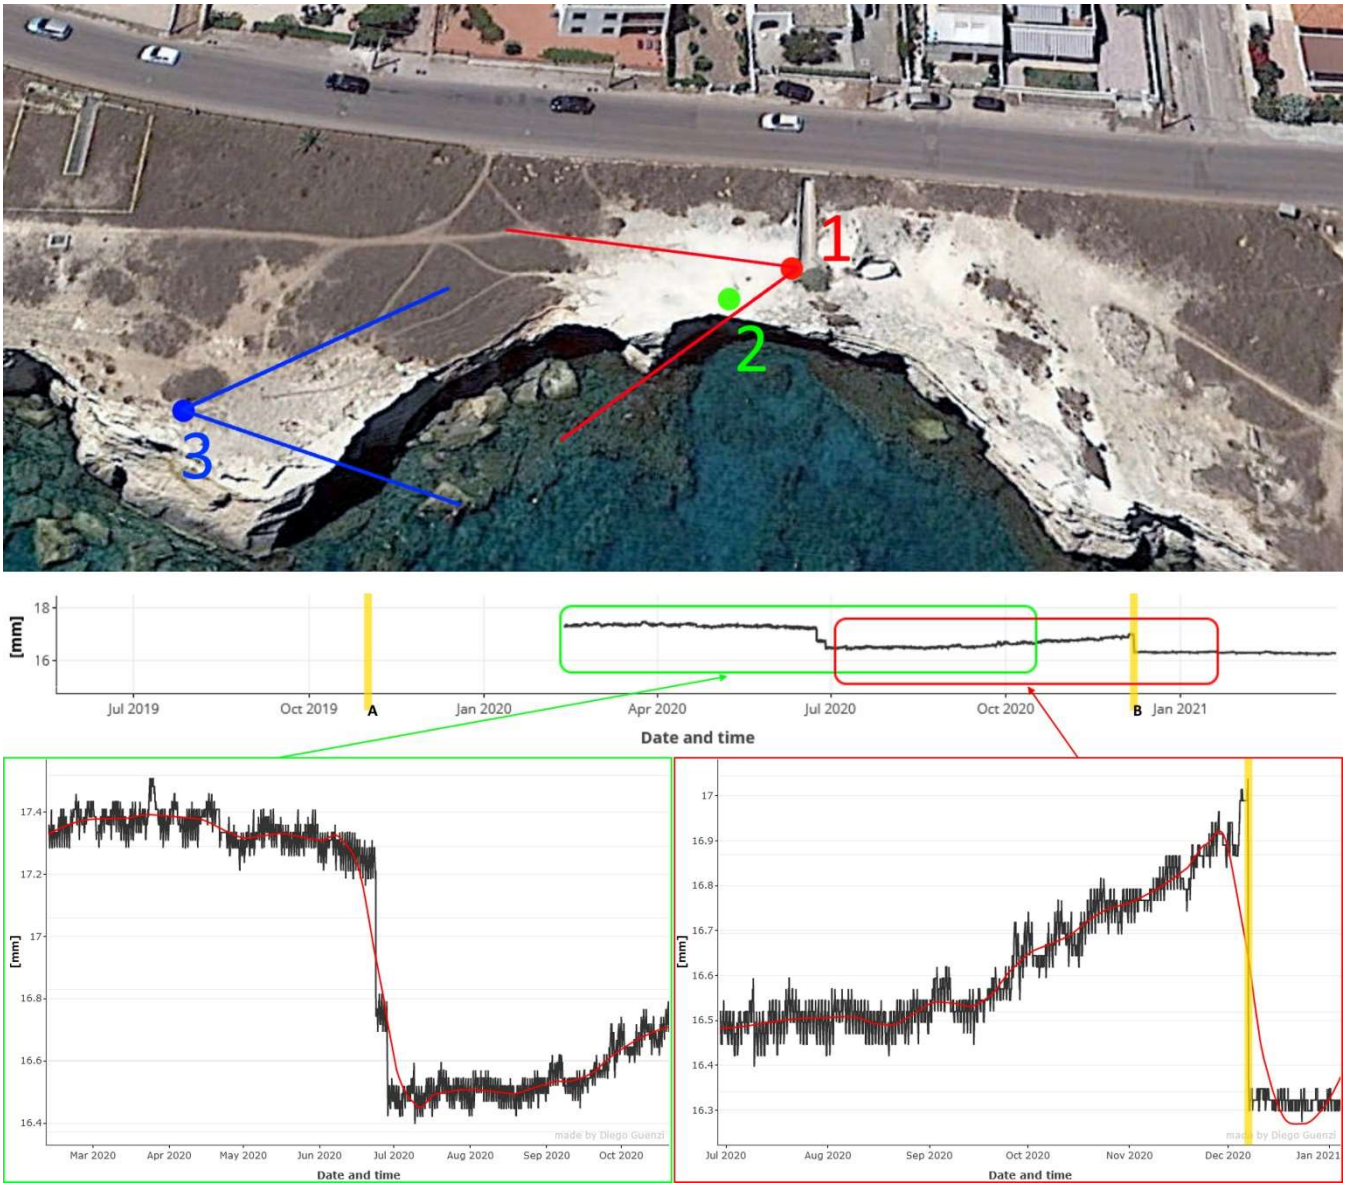
The last recorded event is related to the rockfall that occurred on 7 December 2020 h04.15. In this case, crack-meter data starting from July 2020 show a slight trend of the monitored fissure, which is seen to gradually enlarge, up to the time of failure (bottom of fig. 1, red area). Unfortunately, at that time, the optical instrumentation was off due to the lack of power caused by the adverse weather conditions: in the previous 96 hours, a rather intense rainfall event occurred, which reached a peak of 24h-cumulative precipitation of 80 mm. Despite this issue, however, the images and videos obtained before and after the event are consistent with what was detected by the sudden deviation in the data of the crack-meter. The fracture monitored by the instrument was not directly affected by the collapse, since the collapse involved a rock block not far from it, while the crack-meter itself recorded, at the time of failure, a contraction of approximately 1 mm. In this case, following the same approach, it was possible to estimate the volume of the collapse, which resulted to be about $20 \text{ m}^3 \pm 30\%$. Based on the data acquired by the secondary camera, we have also observed that the collapse itself occurred in two stages: the most conspicuous part, as

Figure 1: on top, plan of the monitored cliff area (taken from Google Earth) – In red (marked with “1”), the main camera and in blue (marked with “3”) the secondary camera; the green dot marked with “2” is the position of the crack-meter. On bottom, the crack-meter data – In the green box the first period of data obtained using the automatic crack-meter (from 12 February 2020 up to 20 October 2020). In the red box the second period of data of the same crack-meter (going from 29 June 2020 to 04 January 2021). Two main rockfalls have been noticed in this period and have been marked with the “A” and “B” yellow lines.

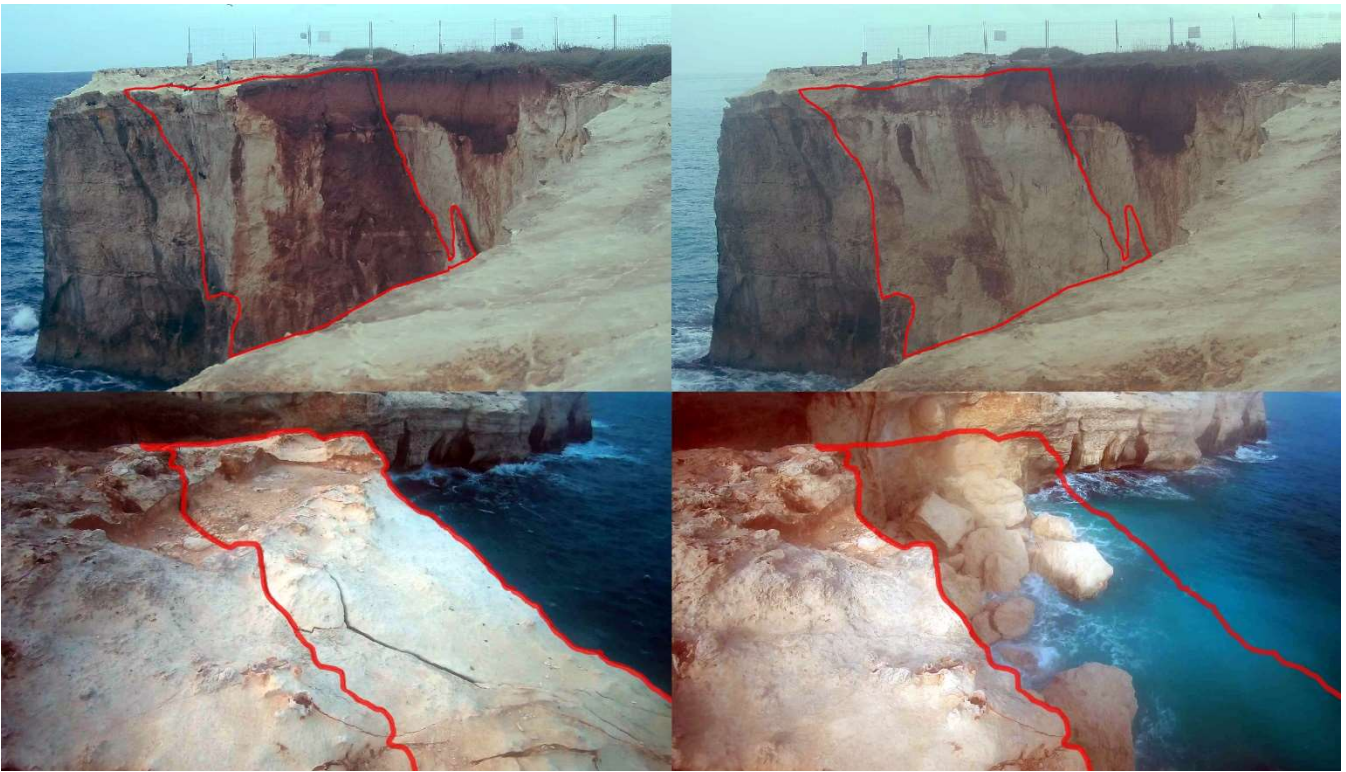
In these two years of activity, the monitoring system recorded several events. The first remarkable event occurred between 12 November 2019 (after h09:00) and 14 November 2019 (before h08:30) when a collapse of a large part of the cliff took place (see fig. 2). Unfortunately, when the failure occurred, the instrumentation was inactive due to the lack of energy caused by the severe rainstorm that struck the area for few days; moreover, no crack-meter was still available (see bottom of fig. 1). Despite these issues, both images and videos just before and after the collapse were available. Based on such information and the application of Image Change Detection techniques, we estimated a volume of the collapse equal to $300 \text{ m}^3 \pm 30\%$ following the methods described in (Giordan et al. 2020).

165 **Figure 2: the first rockfall (marked with “A” on fig. 2) – Top left image shows the cliff as it was on 11 November 2019 and the top right image shows as it was 3 days later. Bottom images shows the same event but from a different point of view (the secondary camera): on the left, a picture taken before the collapse and on the right, a picture taken on 14 November 2019.**

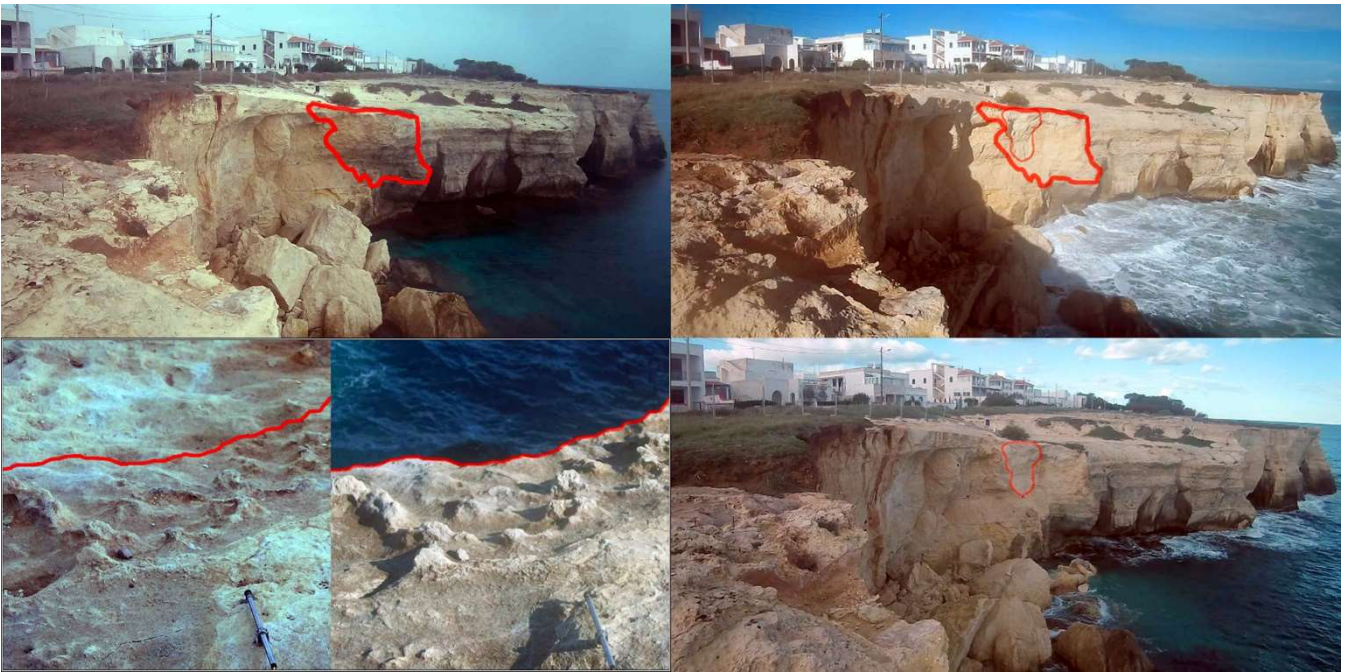
95 already mentioned, collapsed around h04.15, while a second detachment, considerably smaller, occurred between h11.00 and h16.30 on the same day, without affecting the crack-meter measurements (see fig. 3).

170 Figure 3: the second rockfall (marked with “B” on fig. 2) – Top left image shows the cliff as it was on 4 December 2020 and the top right image shows as it was on the morning of the 7 December 2020, after the main collapse (marked by the thick red line). Bottom right images shows the cliff as it was on the 8 December 2020, after a minor rockfall (marked by the thin red line). On the bottom left part, two smaller images that shows the collapse from another point of view (the main camera) both before the rockfall (on the left) and after it (on the right). On those images, the newly installed automatic crack-meter is also visible.
