Brief communication: monitoring a soft-rock coastal cliff using webcams and strain sensors

5 Diego Guenzi¹, Danilo Godone¹, Paolo Allasia¹, Nunzio Luciano Fazio², Michele Perrotti², Piernicola Lollino²

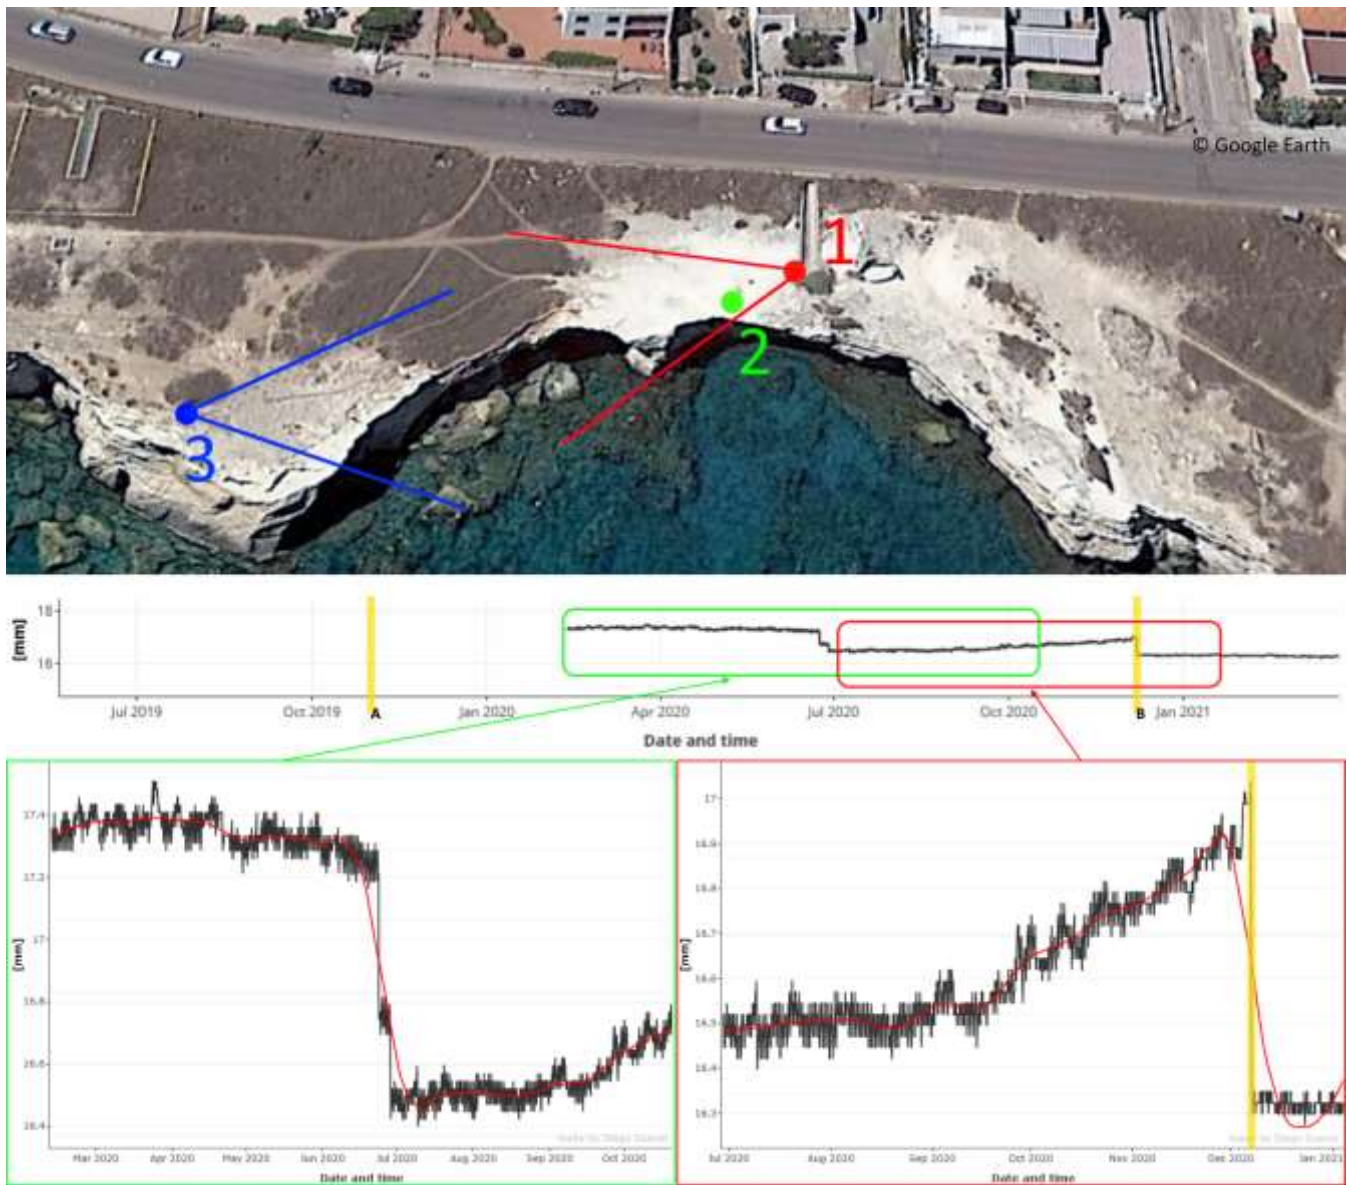
The last recorded event is related to the rockfall that occurred on 7 December 2020 h04.15. In this case, crack-meter data starting from July 2020 show a slight trend of the monitored fissure, which is seen to gradually enlarge, up to the time of failure (bottom of fig. 1, red area). Unfortunately, at that time, the optical instrumentation was off due to the lack of power caused by the adverse weather conditions: in the previous 96 hours, a rather intense rainfall event occurred, which reached a peak of 24h-cumulative precipitation of 80 mm. Despite this issue, however, the images and videos obtained before and after the event are consistent with what was detected by the sudden deviation in the data of the crack-meter. The fracture monitored by the

instrument was not directly affected by the collapse, since the collapse involved a rock block not far from it, while the crack-
95 meter itself recorded, at the time of failure, a contraction of approximately 1 mm. In this case, following the same approach, it
was possible to estimate the volume of the collapse, which resulted to be about $20 \text{ m}^3 \pm 30\%$. Based on the data acquired by
the secondary camera, we have also observed that the collapse itself occurred in two stages: the most conspicuous part, as
already mentioned, collapsed around h04.15, while a second detachment, considerably smaller, occurred between h11.00 and
h16.30 on the same day, without affecting the crack-meter measurements (see fig. 3).

165 **Figure 1:** on top, plan of the monitored cliff area (taken from Google Earth) – In red (marked with “1”), the main camera position and the Raspberry Camera Module field of view; in blue (marked with “3”) the secondary camera; the green dot marked with “2” is the position of the crack-meter. On bottom, the crack-meter data – In the green box the first period of data obtained using the automatic crack-meter (from 12 February 2020 up to 20 October 2020). In the red box the second period of data of the same crack-meter (going from 29 June 2020 to 04 January 2021). Two main rockfalls have been noticed in this period and have been marked with the “A” and “B” yellow lines.

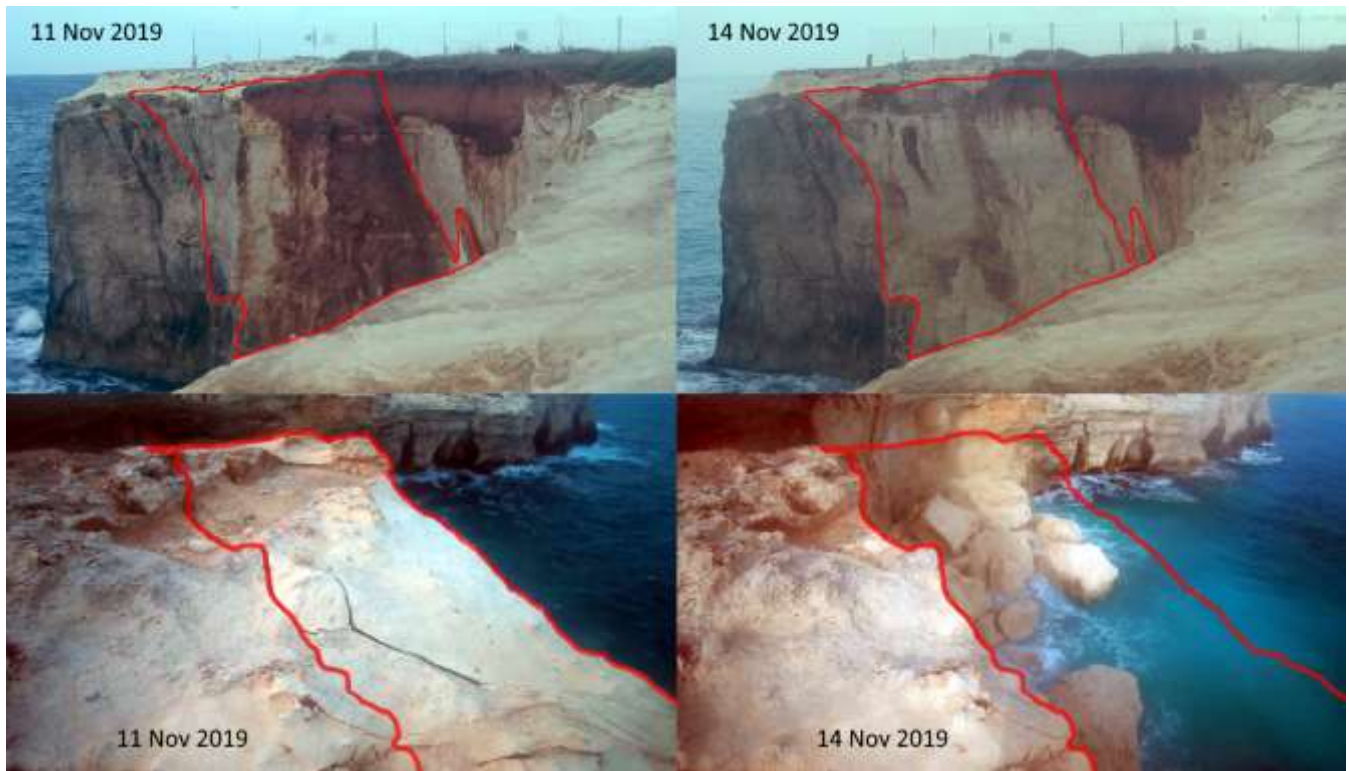
In these two years of activity, the monitoring system recorded several events. The first remarkable event occurred between 12 November 2019 (after h09:00) and 14 November 2019 (before h08:30) when a collapse of a large part of the cliff took place (see fig. 2). Unfortunately, when the failure occurred, the instrumentation was inactive due to the lack of energy caused by the severe rainstorm that struck the area for few days; moreover, no crack-meter was still available (see bottom of fig. 1). Despite these issues, both images and videos just before and after the collapse were available. Based on such information and the application of Image Change Detection techniques, we estimated a volume of the collapse equal to $300 \text{ m}^3 \pm 30\%$ following the methods described in Giordan et al. (2020).

170 **Figure 2: the first rockfall (marked with “A” on fig. 1) – Top left image shows the cliff as it was on 11 November 2019 and the top right image shows as it was 3 days later (both images are taken from the Raspberry Camera Module – see fig. 1 for the position). Bottom images shows the same event but from a different point of view (the secondary camera – see fig. 1 for the position): on the left, a picture taken before the collapse and on the right, a picture taken on 14 November 2019.**

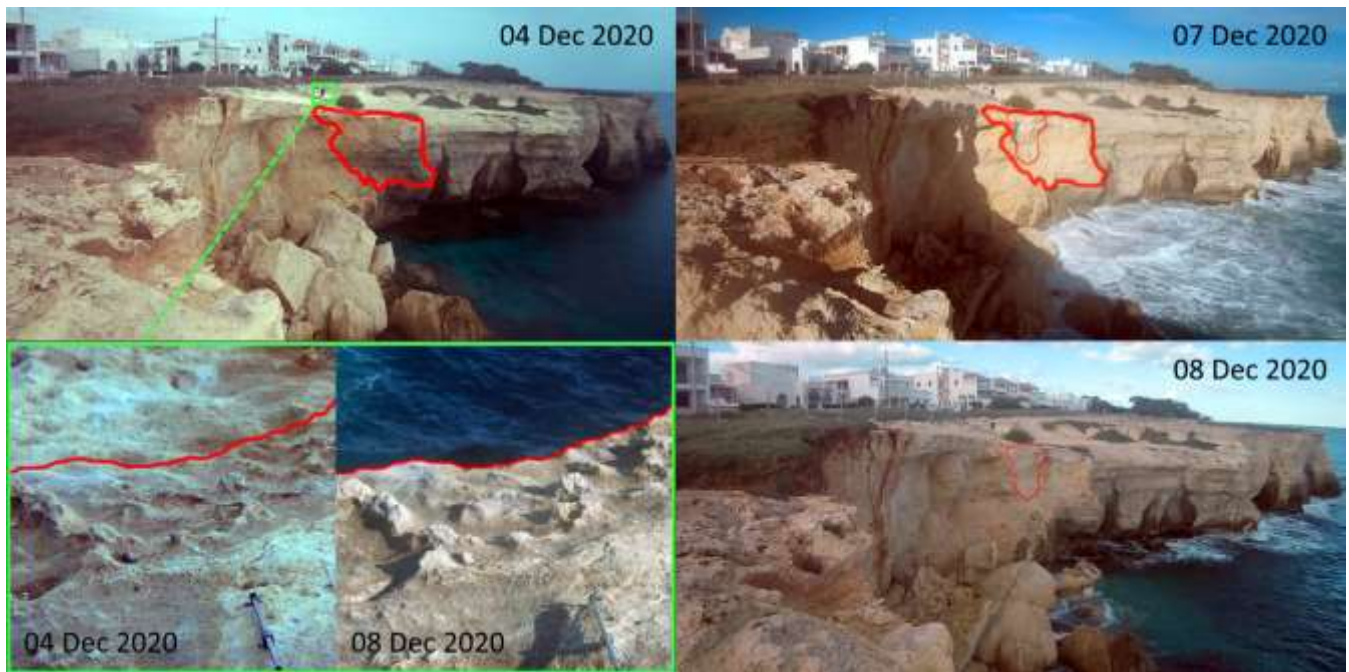
Figure 3: the second rockfall (marked with “B” on fig. 1) – Top left image shows the cliff as it was on 4 December 2020 and the top right image shows as it was on the morning of the 7 December 2020, after the main collapse (marked by the thick red line). Bottom right images shows the cliff as it was on the 8 December 2020, after a minor rockfall (marked by the thin red line). Those three images are taken from the secondary camera (see fig. 1 for the position). On the bottom left part, two smaller images that shows the collapse from another point of view (the main camera, that could also be seen in the top left image, highlighted in green – see fig. 1 for the position) both before the rockfall (on the left) and after it (on the right). On those images, the newly installed automatic crackmeter is also visible.
