Brief communication: monitoring a soft-rock coastal cliff using webcams and strain sensors

Diego Guenzi¹, Danilo Godone¹, Paolo Allasia¹, Nunzio Luciano Fazio², Michele Perrotti², Piernicola Lollino²

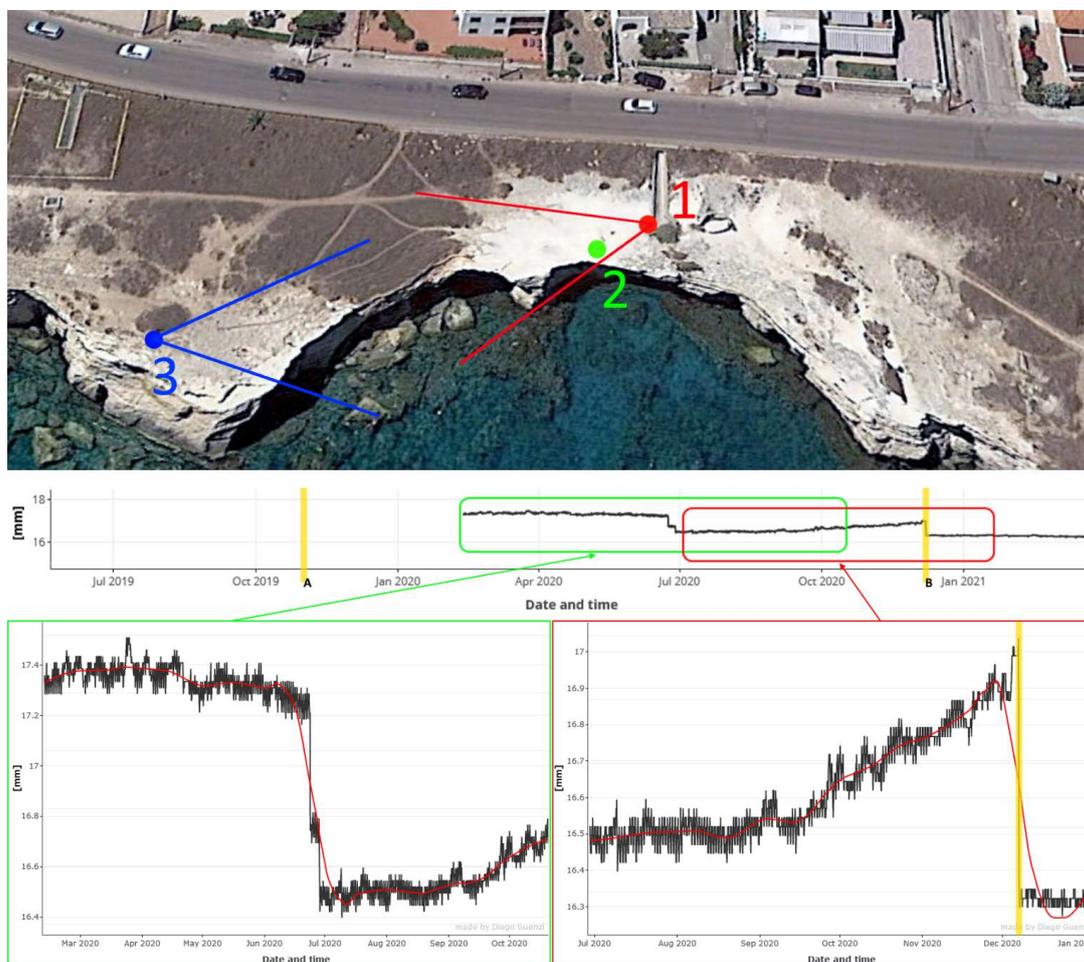
The two webcams are mounted on two different poles distant approximately 50 meters, watching each other and looking at different sides of the cliff (see top of fig. 1). Each camera (that is around 5 meters from the cliff) has its own solar panel, charge controller and 12V battery; on the main camera pole, there is also a 4G wireless router with an IP voltmeter and a relay. Thanks
60 to the router, it is possible to connect remotely to the Raspberry (i.e. via SSH) to have a complete control, in addition to changing webcams configuration and orientation. Moreover, the IP voltmeter let us know in real time the system voltage, while

Two other rockfall events took place on 23 June 2020, around h17.05 (bottom of fig. 1, green area), and on 28 June 2020, approximately between h9.00 and h11.00. In the latter event, the cameras, despite the area being under restricted access, also detected the presence of a passer-by; this anthropic disturbance interfered with the crack-meter measurements. This event confirmed that crack-meter devices alone cannot be used to monitor areas like the examined one and an optical system is fundamental to have an additional control on the global factors acting on the site.

Figure 1: on top, plan of the monitored cliff area (taken from © Google Earth) – In red (marked with “1”), the main camera and in blue (marked with “3”) the secondary camera; the green dot marked with “2” is the position of the crack-meter. On bottom, the crack-meter data – In the green box the first period of data obtained using the automatic crack-meter (from 12 February 2020 up to 20 October 2020). In the red box the second period of data of the same crack-meter (going from 29 June 2020 to 04 January 2021).

130 Two main rockfalls have been noticed in this period and have been marked with the “A” and “B” yellow lines.

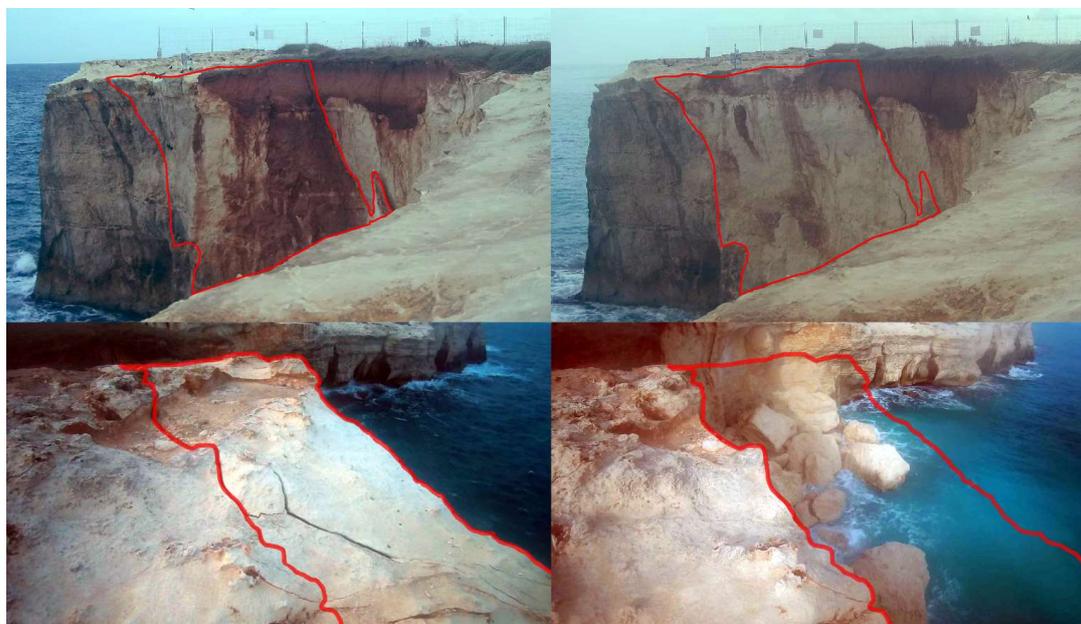
In these two years of activity, the monitoring system recorded several events. The first remarkable event occurred between 12 November 2019 (after h09:00) and 14 November 2019 (before h08:30) when a collapse of a large part of the cliff took place (see fig. 2). Unfortunately, when the failure occurred, the instrumentation was inactive due to the lack of energy caused by the severe rainstorm that struck the area for few days; moreover, no crack-meter was still available (see bottom of fig. 1). Despite these issues, both images and videos just before and after the collapse were available. Based on such information and the application of ICC techniques, a volume of the collapse equal to $300 \text{ m}^3 \pm 30\%$ was estimated.

135 **Figure 2:** the first rockfall (marked with “A” on fig. 2) – Top left image shows the cliff as it was on 11 November 2019 and the top right image shows as it was 3 days later. Bottom images shows the same event but from a different point of view (the secondary camera): on the left, a picture taken before the collapse and on the right, a picture taken on 14 November 2019.

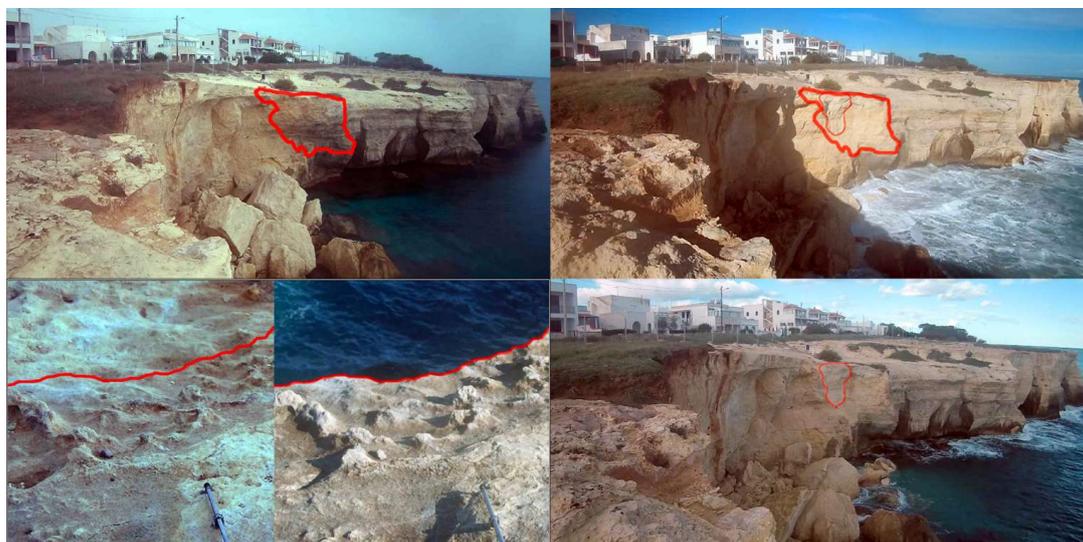
The last recorded event is related to the rockfall that occurred on 7 December 2020 h04.15. In this case, crack-meter data starting from July 2020 show a slight trend of the monitored fissure, which is seen to gradually enlarge, up to the time of failure (bottom of fig. 1, red area). Unfortunately, at that time, the optical instrumentation was off due to the lack of power caused by the adverse weather conditions: in the previous 96 hours, a rather intense rainfall event occurred, which reached a peak of 24h-cumulative precipitation of 80 mm. Despite this issue, however, the images and videos obtained before and after the event are consistent with what was detected by the sudden deviation in the data of the crack-meter. The fracture monitored by the instrument was not directly affected by the collapse, since the collapse involved a rock block not far from it, while the crack-meter itself recorded, at the time of failure, a contraction of approximately 1 mm. In this case, following the same approach, it was possible to estimate the volume of the collapse, which resulted to be about $20 \text{ m}^3 \pm 30\%$. Based on the data acquired by the secondary camera, we have also observed that the collapse itself occurred in two stages: the most conspicuous part, as already mentioned, collapsed around h04.15, while a second detachment, considerably smaller, occurred between h11.00 and h16.30 on the same day, without affecting the crack-meter measurements (see fig. 3).

140 **Figure 3:** the second rockfall (marked with “B” on fig. 2) – Top left image shows the cliff as it was on 4 December 2020 and the top right image shows as it was on the morning of the 7 December 2020, after the main collapse (marked by the thick red line). Bottom right images shows the cliff as it was on the 8 December 2020, after a minor rockfall (marked by the thin red line). On the bottom left part, two smaller images that shows the collapse from another point of view (the main camera) both before the rockfall (on the left) and after it (on the right). On those images, the newly installed automatic crack-meter is also visible.
