# The catastrophe of the Niedów dam - the causes of the dam's breach, its development and consequences

Stanisław Kostecki<sup>1,\*</sup> and Robert Banasiak<sup>2,\*</sup>

<sup>1</sup>Faculty of Civil Engineering, Wrocław University of Science and Technology

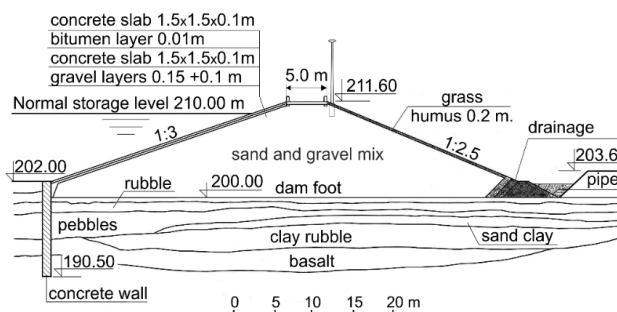
The structure and geometry of the earth dam are presented in Figure 4. The maximum height of the embankment with respect to the base ground level was 11.6 m. The body of the dam was made of well compacted sand without a clay core. The slope upstream was of a ratio of 1:3, while the slope downstream had a ratio of 1:2.5. Because the sand had a high permeability coefficient of  $2.8 \times 10^{-3} \text{ ms}^{-1}$ , the upstream slope was shielded with a double layer of concrete slabs with dimensions of  $1.5 \times 1.5 \times 0.1 \text{ m}$ , which were sealed with a bituminous material. The shield from the upstream water was supported by a vertical reinforced concrete cut-off wall, which was reaching down to the basement rock. The downstream slope was covered with humus and grass. In the lower part of the slope, there was a drainage of mixed gravel and stone. The dam's crest was 5 m wide and served as a road made of concrete slabs with asphalt. The power plant and water outlet sections were connected to the dam with abutments. The total volume of the earth dam was ca.  $61,000 \text{ m}^3$

**Figure 4.** Cross-section of the earth dam

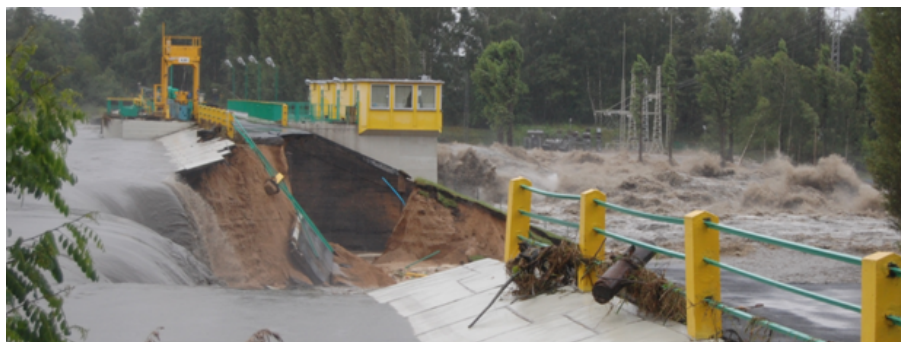
**Figure 7.** View from the right bank. Behind the concrete structure, an immense outflow is visible after the abutment had collapsed. Water level in the reservoir ca. 210.60 m a.s.l.

17.15	Beginning of the flow over the right side of the dam.
17.42	Water level reaches a maximum of 212.05 m a.s.l. Washing out of the downstream slope of the dam, destruction of the road on the top of the dam – dam breach width of ca. 40 m on the left side and 30 m on the right side.

18.10	Water level at 211.60 m a.s.l. The breaching probably reaches the dam's floor. The collapse of the headwall of the left side of the dam resulted in the immense outflow through the breach.

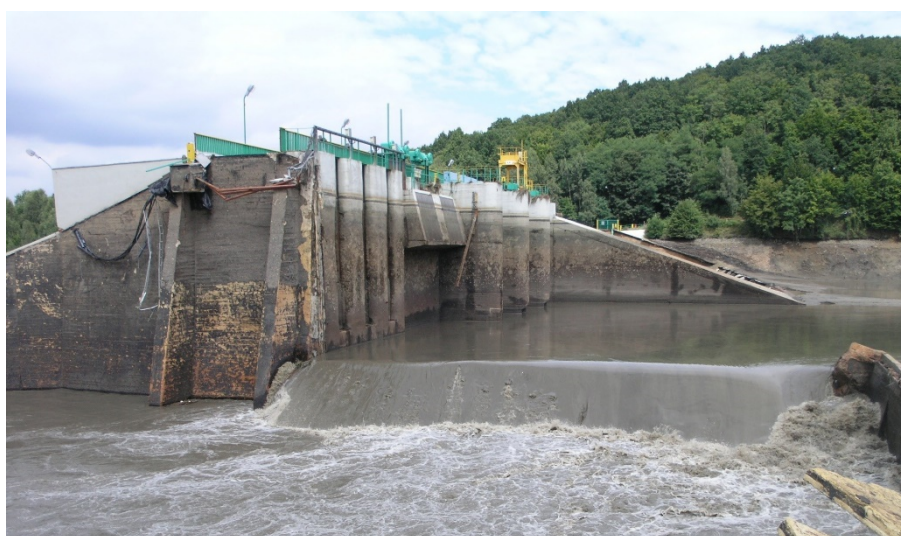
around the lamp post's foundations, and then on the slope covered with grass, which is documented in Sup. 1. This process took  
about half an hour and resulted in the gradual disintegration of the road on the dam's crest. The concrete slabs then lost their  
support and fell due to the washing away of the sand that constituted the dam's body. Remarkably, the concrete slabs, when  
145 losing support, broke in a series like chocolate, and were swept away by the intensified flow. Afterwards, another important  
moment occurred. As the support of the earth embankment vanished, the left training wall flanking the central concrete dam  
collapsed due to upstream water pressure. This resulted in a further rapid outbreak. This phase was relatively short but intense,  
and resulted in a torrential flood wave downstream, which is documented in Figure 7. After the next 80 minutes, the left side  
of the earth dam was almost completely swept away (Fig. 8).

**Figure 8.** Broken left retaining wall of the control structure

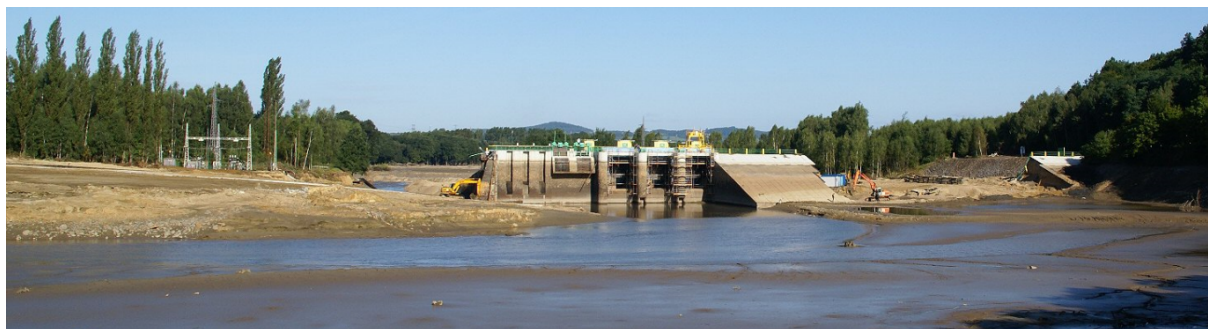
**Figure 9.** The final breach of the dam - an upstream view

18.47	The breach of the left side of the dam finishes, and has a length of 106 m.
18.56	Water level - 209.00 m a.s.l. The right side of the dam continues to breach.

19.25	The breach of the right side of the dam is complete. The dam is washed out along the width of 58 m. The reservoir releases the remaining water.
21.00	The reservoir is empty.
