Brief communication: Landslide activity on the Argentinian Santa Cruz river mega dam works confirmed by PSI DInSAR

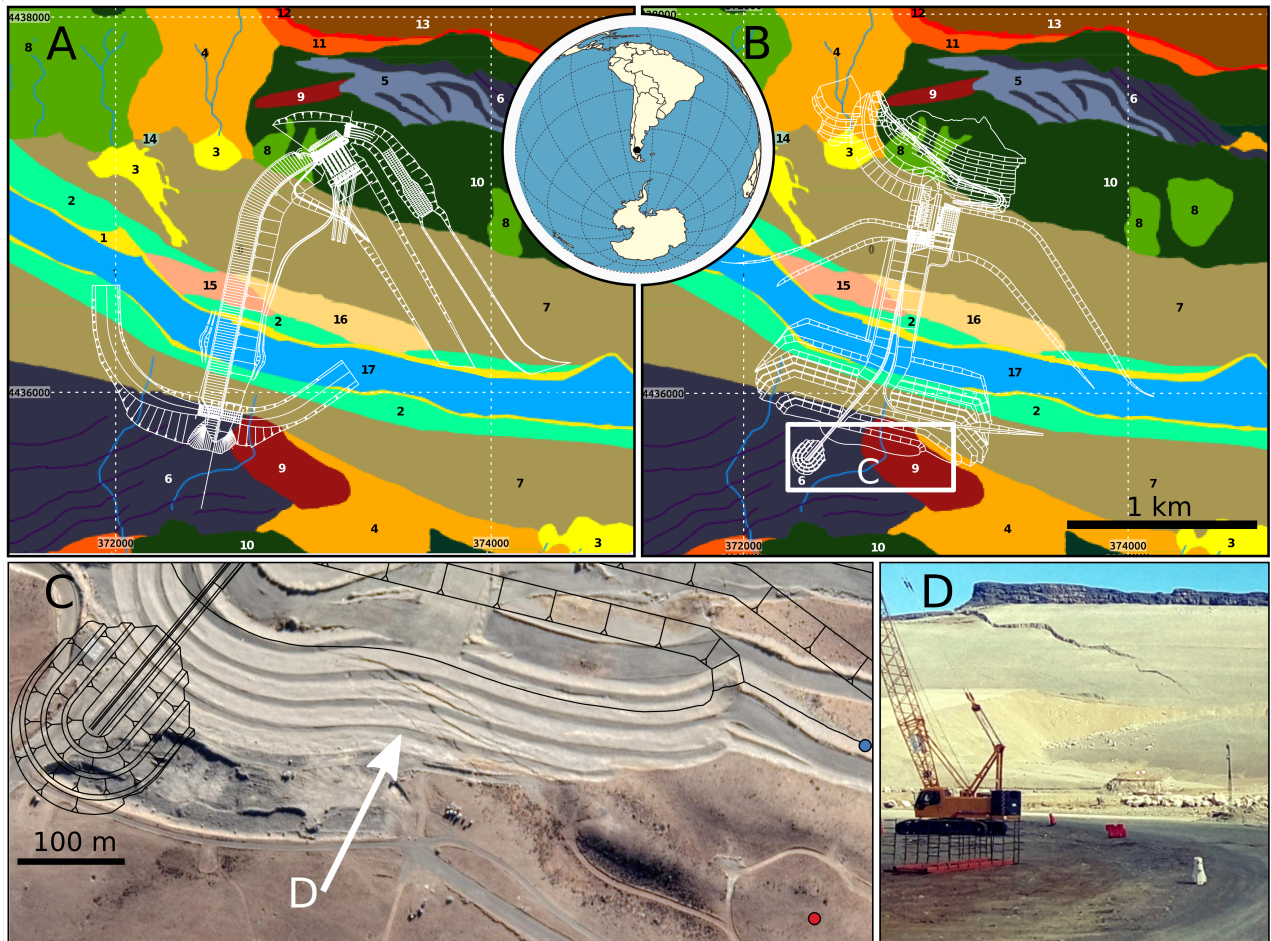
According to official documentation (IEASA, 2020), at the end of 2018 and beginning of 2019, during the foundation excavations of the main wall of the CC-NK dam, several landslides appeared in the areas of the abutments on both banks of the river, endangering the construction and, therefore, leading to the interruption of the works and the complete redesign of the dam. The new design keeps its productive characteristics, but with a completely different morphology (Fig. 1 A and B). Because of this

Figure 1. A dot in the very center of the planisphere (between A and B) shows the project location (50.21° South, 70.78° West), coordinates in planar system are UTM zone 19S. A: First design of the CC-NK dam (2015). B: Second design of the CC-NK dam after experiencing structural issues (2020). At the background, the geomorphological map with the following categories may be observed: 1, Alluvial plain. 2, Fluvial terraces. 3, Active alluvial fan. 4, Flank pediment. 5, Basal moraine. 6, Marginal moraine. 7, Glaciofluvial terrace covered by catastrophic flow deposits. 8, Rock avalanche deposits. 9, lateral spread and rotational landslides. 10, Rotational landslides. 11, Scree slope. 12, Rock fall. 13, Lava flow. 14, Seasonal lagoon. 15, Wind blowout. 16, Parabolic dune. 17, Santa Cruz river channel. Box C shows the optical satellite image where the cracks of the south bank can be seen. In D, a view from the ground of the crack on the south margin may be observed. Source: Our own elaboration based on (EBISA, 2017; IEASA, 2020), © Google Maps, www.worldmapgenerator.com [accessed August 2022] and on fieldwork.

- on the north bank: basal moraine (8), lateral expansion and rotational slide (18), rotational slide (20);
- and on the south bank: marginal moraine (9) and lateral expansion and rotational slide (18).

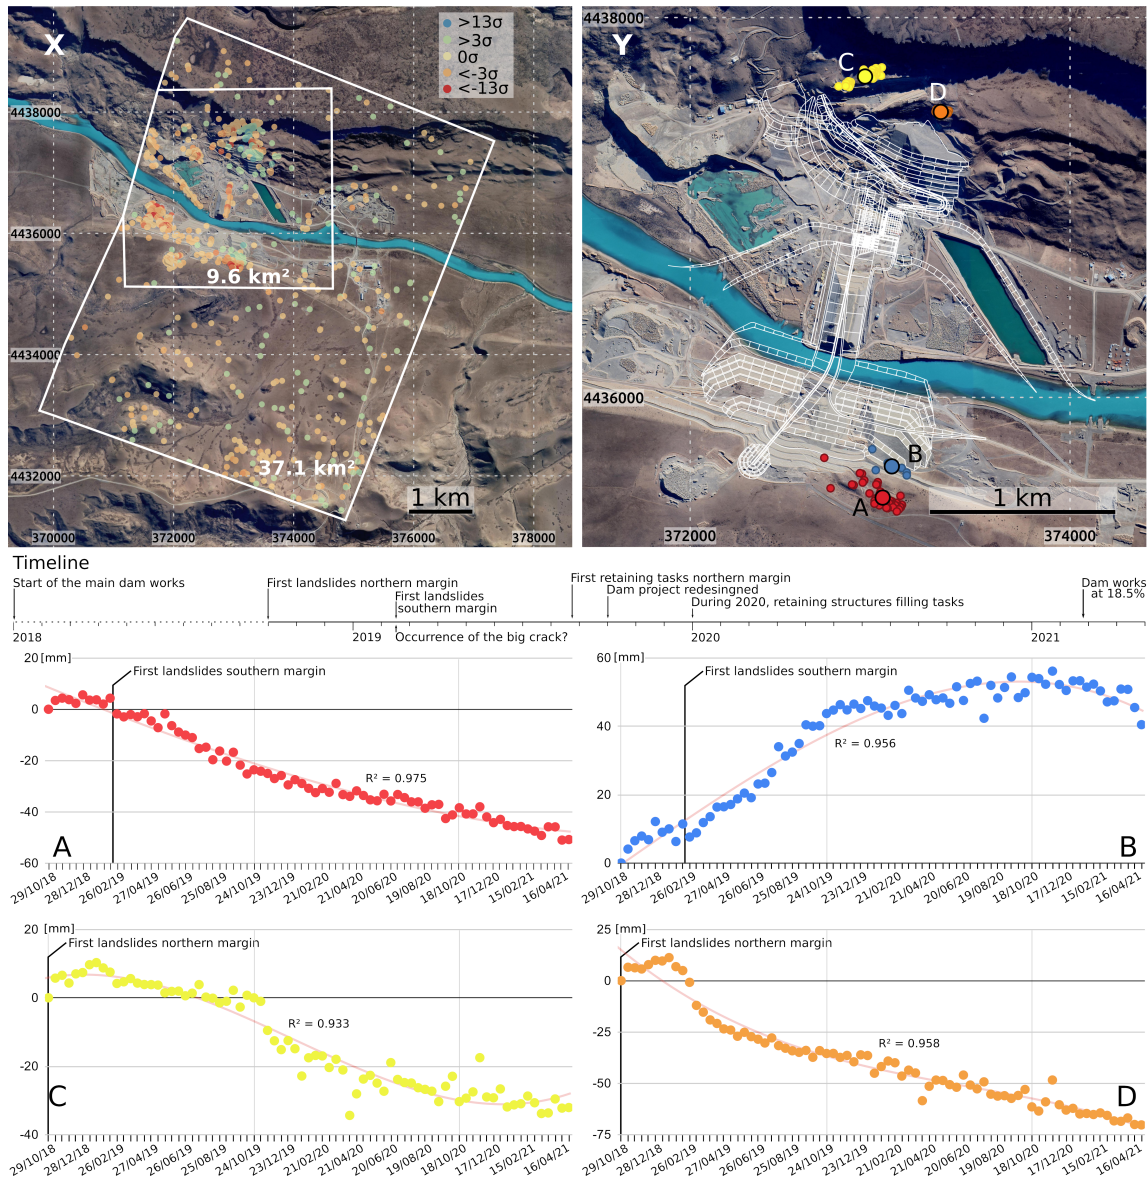
Figure 2. Top left (X). Area covered by the PSI processing. White polygons circumscribes the general (big polygon) and the detailed (small polygon) areas under study. The optical background image is from Google from July 2022 (© Google Maps). Coordinates are UTM zone 19S. Only reflectors showing deformation $>3\sigma$ are represented, magenta negative and cyan positive deviation, scale ranges until 13σ . Top right (Y): construction site. The PSs of each landslide subgroup are represented on the southern (A, B) and northern (C, D) margins. Charts A to D correspond with the deformation time series of the calculated average for each one of the landslide (A to D). The plan of the second dam design has been superimposed. A timeline showing the phases in the dam construction is found at the figure center. The period not covered by the PSI analysis is shown as a dashed line over the timeline axis.

135 The results are presented in Fig. 2. On the south bank, two deformation phenomena are identified, sector A with 51 (red) PSs and sector B with 18 (blue). On the north bank the identified deformation phenomena are: sector C with 33 PSs (yellow) and D with 15 (orange).

Maximum accumulated displacements between extreme values range from 40 to 80 mm. This represents 16 mm/yr for area C, and 32 mm/yr in sector D. A polynomial fit line with a determination coefficient R^2 (Mirmazloumi et al., 2022) has been superimposed in the chart to show the absence of noise in the measurements. It is worth underlining that the magnitudes measured do not accurately reflect the real magnitude of the movements since:

Sector A is located in a flat area, so it could be said that most of the movement is vertical, which, according to the orbit direction of the satellite, is in agreement with the negative values of the LOS measurement showing subsidence.

Sector B is located on the slope, so horizontal and vertical displacements are measured. The general orientation of this area is not the optimal to be observed with the descending satellite trajectory, but the considerable magnitude of the deformation facilitated obtaining to obtain results. Presumably, deformation to the west and east of the A-B locations became invisible to the radar either by the large magnitude of the ground displacements (at west, in the crack, where data decorrelation is present, see Fig. B1-I in Appendix B) or due to the deficient orientation of the slope and the smaller magnitude of the displacements (to the east).

155 Observing the situation on sectors A and B (with inverse trend sign), it is possible to suggest that a rotational mass wasting is taking place, which agrees with the bibliography (Astini et al., 2015), but additional information is required to provide a more definitive conclusion.

Since sector C is mainly flat, it is possible to infer a relevant vertical component of the displacement. However, the PSI information is not enough to determine the exact direction of the deformation vector. In the chart (Fig. 2-C), a step in the trend is visible in October 2019, which coincides with the start of containment works in the area as revealed by the optical sources.

160 Finally, as sector D is found in a steep slope, both vertical and horizontal displacements are relevant, but further measurements are required to fully understand the situation. The strong slope of the curve around February 2019 (Fig. 2-D) confirms the ground instability trends described in the company reports (IEASA, 2020).

The time series of the four sectors shown in Fig. 2 show no signs of stabilization, so it is possible to affirm that the sliding processes were still active in April 2021 (date of the last observation). The construction works in general, and the deformation
165 phenomena in particular, are clearly located in areas of Quaternary sedimentation and materials resulting from paleo mass wasting processes that had already been described as potentially conflictive in the preliminary project reports (see Fig. 1 A and B), such as:

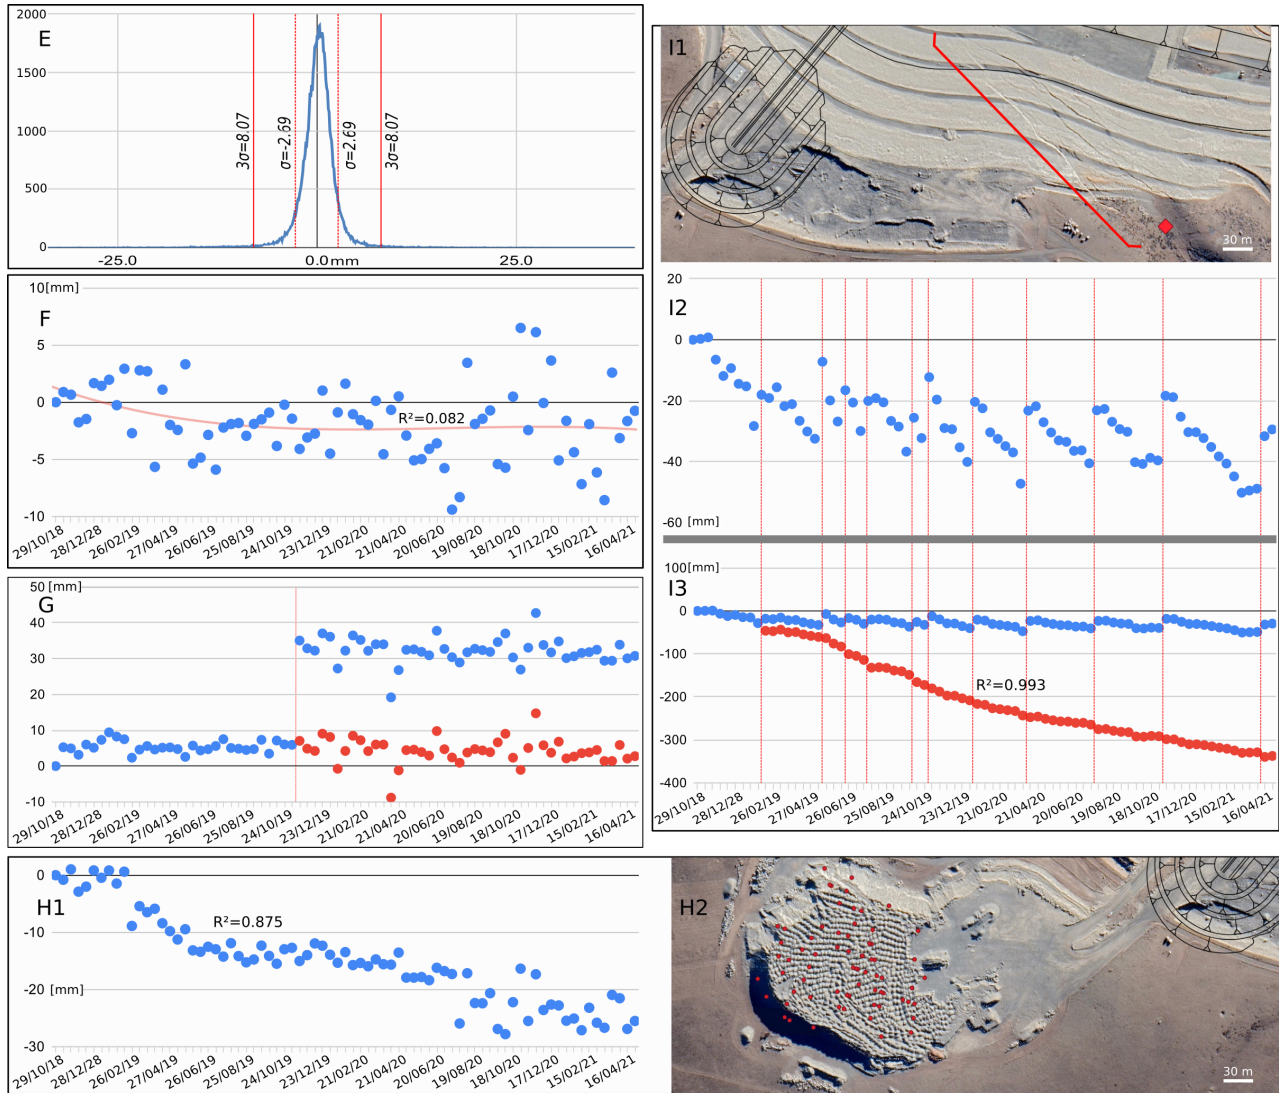
- E. Frequency distribution graph of the accumulated displacement of the PSs reflectors in the study area and the 3σ threshold.
 - F. Time series of a stable PS with dispersed measurements due to random errors. Elevated σ between 2 and 3, $R^2=0.082$.

- 235 – G. Phase unwrapping error (PUE). 40 reflectors average. Red dots in the chart in Fig. B1 represent the series after applying a manual PUE correction jump of 28 mm (Mirmazloumi et al., 2022).

- H. Deformation trend (Fig. B1-H1) caused by construction works (B1-H2). 72 reflectors average.
 - I. 11 phase unwrapping errors for a single reflector located in the root of the big crack in the southern margin (west of studied sectors A and B). This is an exceptional and isolated sample which preserved the coherence along the time series despite the high deformation rate. Chart in Fig. B1-I2 indicates the deformation trend without PUE correction. I3 corresponds to the same chart after applying a manual PUE correction. A visual detail of the crack is shown in Fig. B1-I.3 and the location of that reflector in Fig. B2 as a grey diamond. Official documentation describes the occurrence of the landslide on 14th February 2019. This is clearly visible in the charts (first vertical dashed red line). At the same time, it is clear that the trend was present before (at lower rates) and after this date. Dashed red vertical lines indicate the enforcement of a PUE correction, eleven times in this case. Official reports (IEASA, 2021) describe ground displacements up to 15 mm/day (5.5 m/yr) in the main sector of this big crack, where we could not obtain PSI. Observing this chart, we cannot confirm the end of the deformation trend in April 2021.

Figure B1. Examples of PSs with high σ values which, as presented in page 6 and following the same number notation, have not been studied in this work. Optical satellite images from © Google Maps

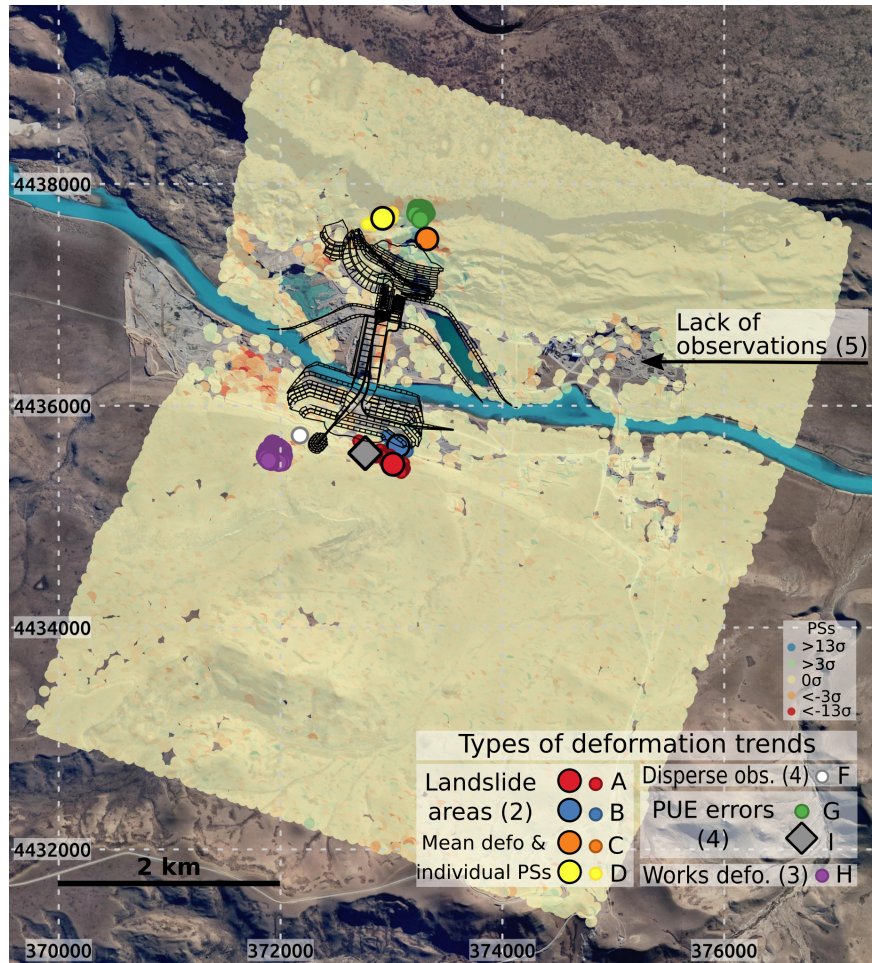
Figure B2. Map of the full PSI results and examples of the identified deformation trends, 1 to 5, as described on the items on page 6 or presented in previous B1. A to D are landslides studied in this work. F to I are the other time series trends briefly described in this Appendix. Arrow (number 5 as in page 6) is an example of the absence of observations due to the surface changes produced by the construction work. Our own elaboration. Background satellite image © Google Maps

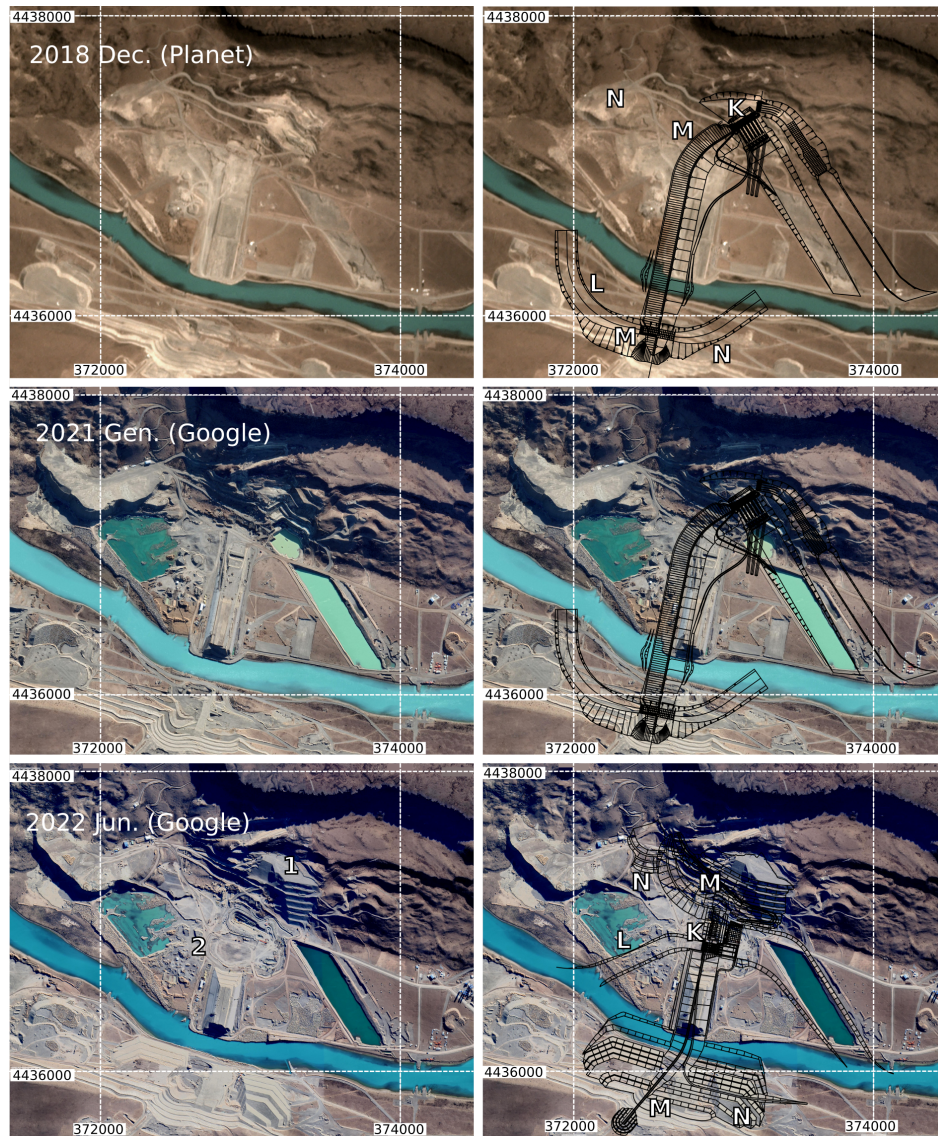
Fig. B3 presents three stages of the project evolution through optical sensors where main project changes can be seen.

Figure B3. Three moments of the dam construction. In the left column, optical image, in the right, the dam plans have been superimposed (the third row corresponds to the new project). Letters identify main structural changes: K) machines hall, L) deviation channel, M) change of the dam wall direction, N) structural retaining walls. Numbers identify main correction works to the original project (modification of structures already built): 1) the space prepared to the main hall have been filled in again (over 1 million m^3), 2) an important part of the dam wall (which was originally planned to have 12.1 millions m^3) has been retired, and a big 10 m wide and 36 m deep exploratory well is built there to study the rock substratum. To dig the well, a volume of around 70,000 m^3 had to be previously removed at the ground level in the area which had already been filled with basement materials of the dam wall. Our own elaboration. Background images from PlanetTM and © Google Maps.
