The vulnerability of buildings to a large-scale debris flow and outburst flood hazard **cascade** that occurred on 30 August 2020 in Ganluo, Southwest China

Abstract: In mountainous areas, damage caused by debris flows is often aggravated by subsequent dam-burst floods within the main river confluence zone. On 30 August 2020, a catastrophic disaster chain occurred at the confluence of the Heixiluo Gully and Niri River in Ganluo County, Southwest China, that consisted of a debris flow, the formation of a barrier lake and subsequent dam **break** that flooded the community. This study **presents** a comprehensive analysis of **the characteristics of two hazards and the resulting** damage to buildings from the **cascading hazards**. The peak discharge of the debris flow in the gully mouth reached **1,871** m³/s, and the change in the main river channel resulting from the dam-burst flood, which had a peak discharge of **2,737** m³/s, resulted in a fourfold increase in the extent of flood inundation compared to an ordinary flood. Three hazard zones were established based on the building damage patterns: (I) primary debris flow burial; (II) secondary dam-burst flood inundation and (III)

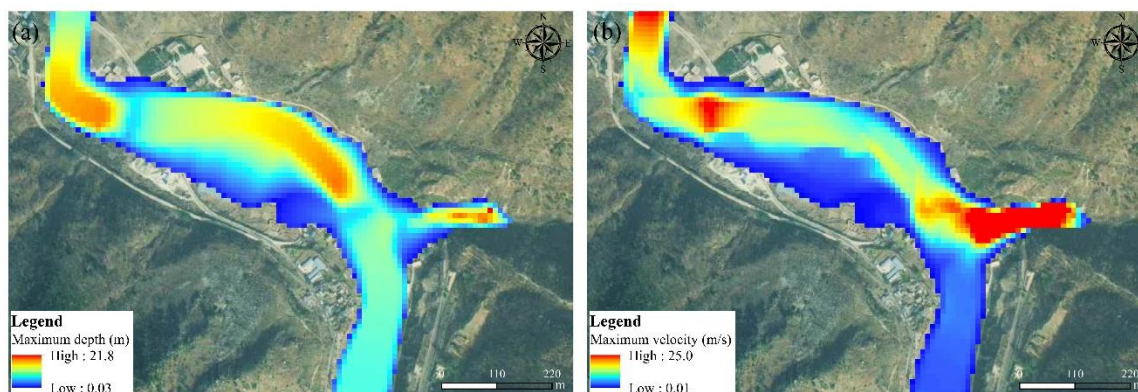
230 The debris flow destroyed the Chengdu-Kunming railway bridge situated at the gully mouth and
231 had a flow depth of approximately 4.7 m and a section area of approximately 188 m². The estimated
232 peak discharge at the gully mouth using Kang's equation (1987) was 1871 m³/s, which resulted in
233 a high impact pressure of 223 kPa.

234 The temporal distributions of the maximum depth and velocity of the debris flow are presented
235 in Fig. 6. Majority of buildings close to the river channel and debris flow channel were buried by
236 the debris flow. The debris flow lasted for approximately 40 minutes and transported approximately
237 1,050,000 m³ of sediment downstream. The deposition zone extended from the gully mouth to the
238 floodplain of the Niri River, covering a length of 320 m. The area measured from the UAV image
239 was approximately 0.15 km². The thickness of the sediment deposits ranged from 5 m to 15 m, with
240 an average value of 7 m. The debris flow flushed into the main river and blocked the Niri River.
241 The river channel was filled with sediment, which led to the formation of a dammed lake that raised
242 the water level by 7-8 m. After 40 minutes, the unstable dammed lake breached, which resulted in
243 a massive flash flood.

244
245 Figure 6 Distribution of maximum depth and velocity of the debris flow

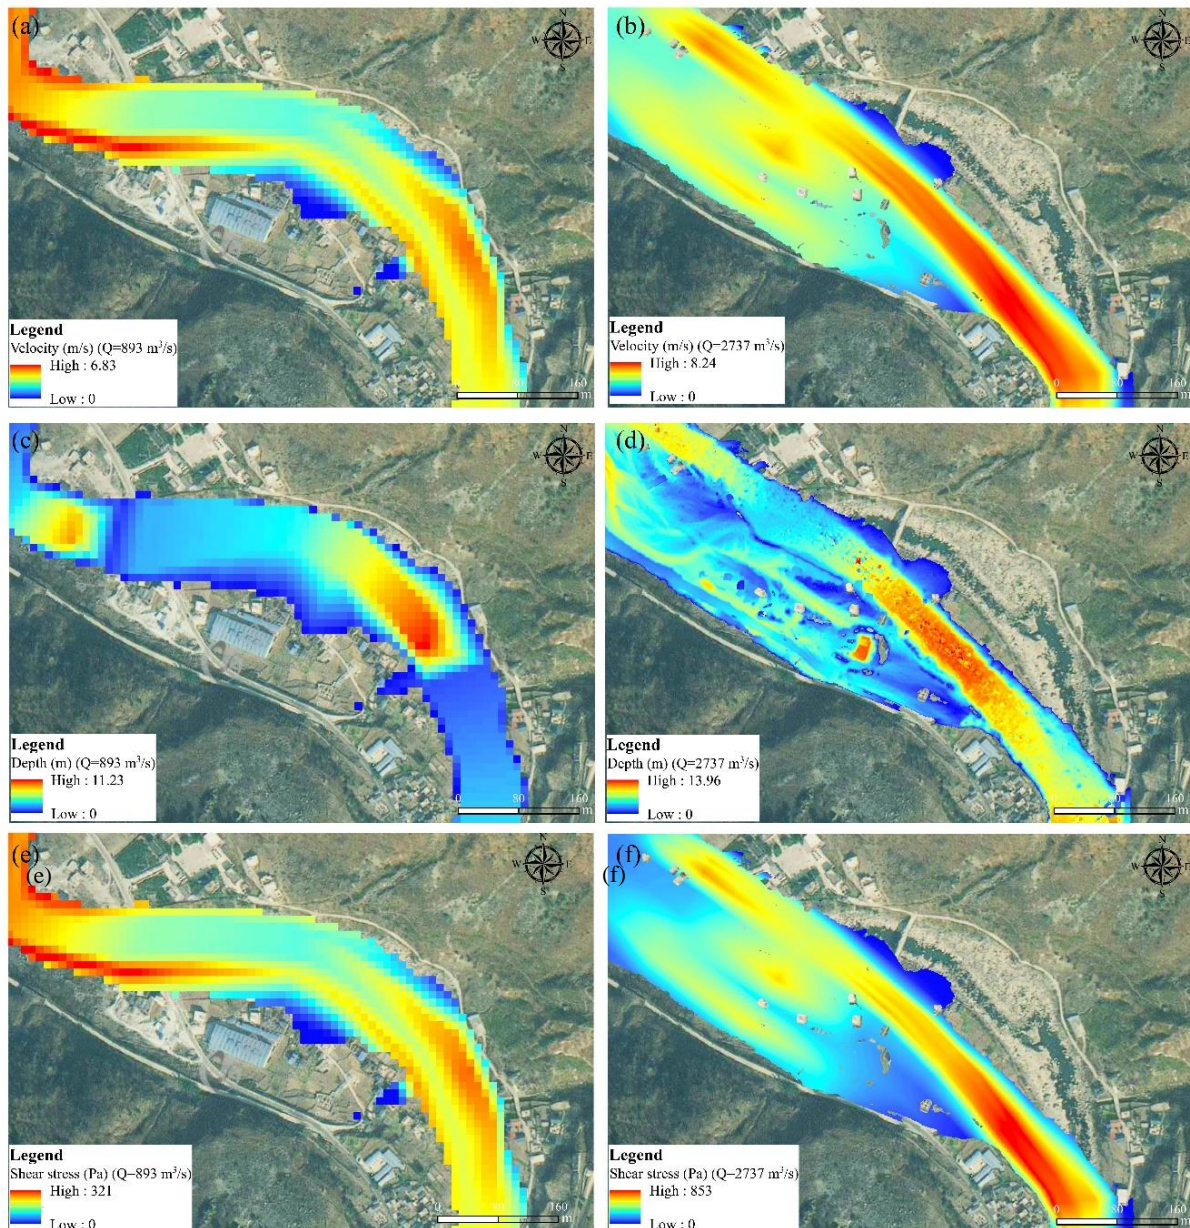
290 the right bank due to the severe erosion of the original river terrace and had a maximum depth of
 291 10 m (Fig. 8). The channel width increased to approximately 100 m, and the channel depth
 292 decreased to less than 5 m.

Figure 7 Distribution of depth, velocity, and shear stress of ordinary flood and dam-burst flood: (a) Maximum velocity distribution of ordinary flood; (b) Maximum velocity distribution of dam-burst flood; (c) Maximum depth distribution of ordinary flood; (d) Maximum depth distribution of dam-burst flood; (e) Maximum shear stress distribution of ordinary flood; (f) Maximum shear stress distribution of dam-burst flood.

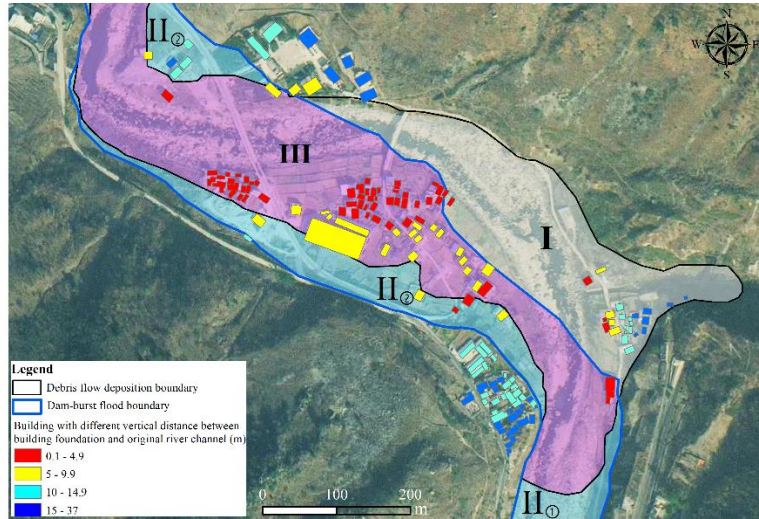
319 Three hazard zones are identified based on the boundary of the debris flow and dam-burst flood,
320 as shown in Fig. 9 and Fig. 10. The damage patterns of buildings in the different hazard zones can
321 be classified into three categories, namely, (I) buildings only buried by debris flow; (II) buildings
322 only inundated by dam-burst flood; and (III) buildings sequentially buried by debris flow and
323 inundated by dam-burst flood. Zone (I) is situated near the Heixiluo gully mouth, where the debris
324 flow transported a large volume of sediment and seriously eroded the sidewall and bed of the
325 channel, expanding the channel's width from 10 m to 40 m. All buildings were inundated by
326 sediment to a depth of over 6 m.

350
 351 **Figure 9** Inundation boundary of debris flow and dam-burst flood and spatial division of the hazard zone
 352 based on building damage patterns: (I) buried by debris flow; (II) inundated by dam-burst flood; (III)
 353 buried by debris flow and the inundated by dam-burst flood.
 354 A total of 108 buildings in the village were impacted by the multi-hazards, accounting for 67.9%
 355 of the total buildings. Among them, 75 buildings located in Zone (III) were impacted by the debris
 356 flow and flood in succession, which accounted for 47.2% of the total buildings. In contrast,
 357 buildings destroyed by the debris flow in Zone (I) and dam-burst flood in Zone (II) accounted for
 358 only 15.1% and 5.7% of the total buildings, respectively (Table 4). Overall, the number of buildings
 359 within the debris flow deposition boundary and flood inundation boundary is 99 and 84,
 360 respectively, accounting for 63.5 % and 53.8% of the total buildings in the village.

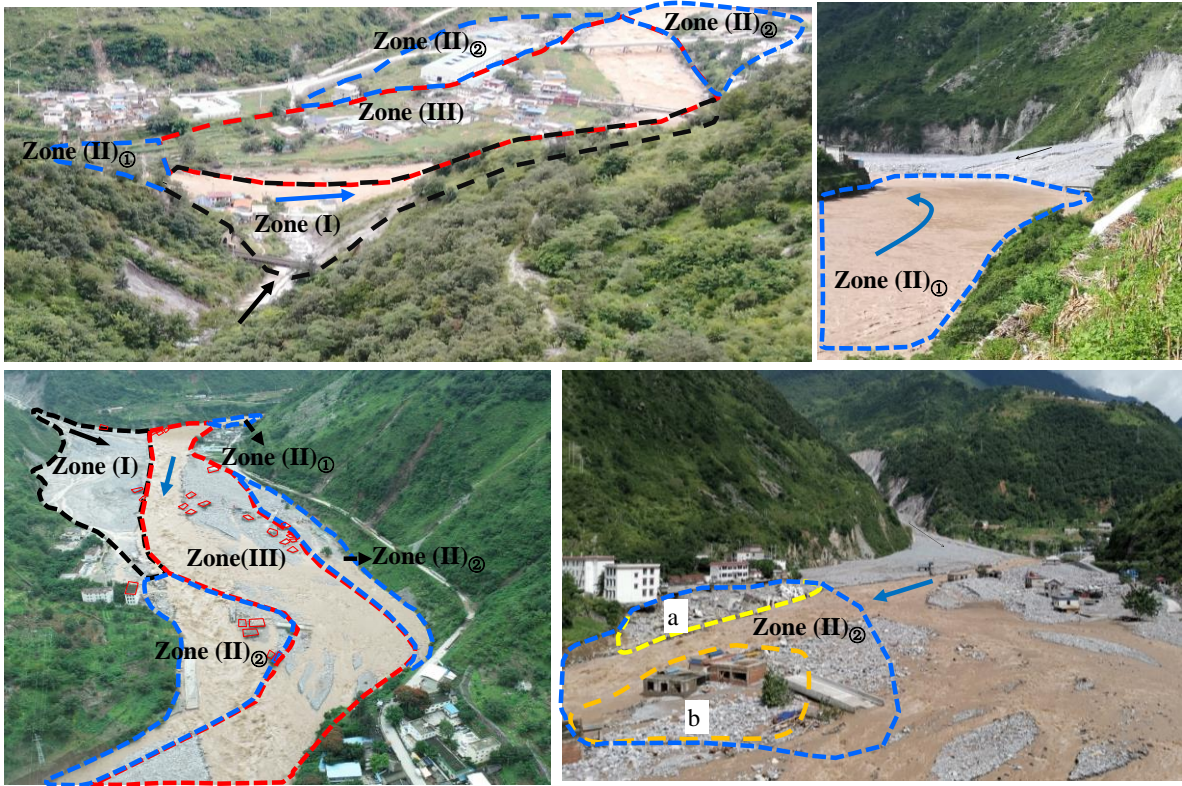
336 Fig. 10(d)). A three-story building was partially destroyed due to foundation erosion. The buildings
337 on the lower part of Zone (II) ② were simultaneously buried by the sediment transported by floods
338 and inundated by floodwater (part (b) in Fig. 10(d)).

339 Zone (III) is primarily located on the left bank of the original river and the lower part of the
340 debris flow fan. The original river channel is filled with debris up to a depth of 10 m. The debris
341 flow transported sediment across the raised riverbed into villages and formed a slope that was high
342 on the right and low on the left in the confluence area. Then, the flood breached the debris flow
343 dam and severely eroded the deposited debris and the original floodplain surface, resulting in a new
344 straight channel. The buildings on the left bank of the river, which were buried by the debris flow,
345 were sequentially impacted by the dam-breach flood. The flood heavily damaged buildings near
346 the new river channel and floodwater from the channel was observed to always inundate the
347 buildings. Notably, the boundaries of the different damage zones are not static. The extent of the

Figure 10 Spatial distribution of the three hazard zones before and after the disaster: (a) before the disaster; (b) (c) (d) after the disaster.

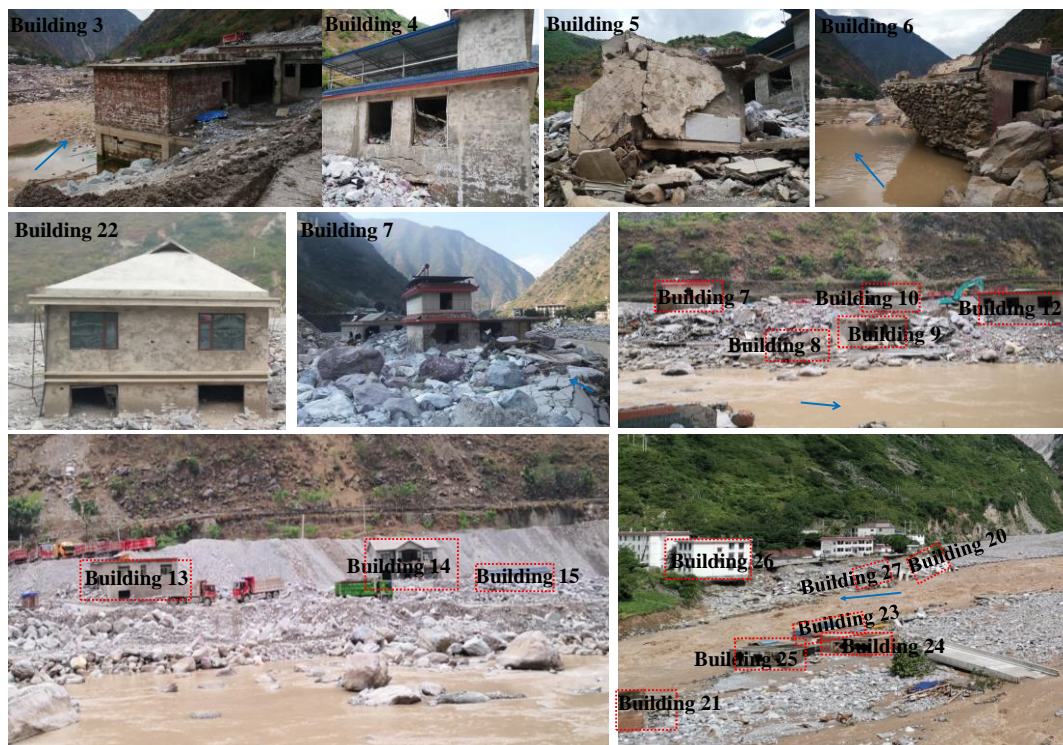
383 structures located in the three hazard zones were selected (Fig. 10(c), Fig. 11). Of these, 6 buildings
384 were located in Zone (II), and the rest were distributed throughout Zone (III).

385 The building characteristics and hazard intensity are presented in Table 6. In Zone (III),
386 buildings located near the debris flow dam (such as buildings 1, 2, and 3) were first buried by the
387 debris flow and then inundated by water from the dammed lake for 40 minutes. These buildings
388 were then impacted by the dam-burst flood. Additionally, buildings near the new river channel
389 suffered greater impact pressure than other buildings. For example, the residual broken structures
390 of buildings 5 and 6 were heavily damaged by the direct impact of the flood in the vertical direction.
391 The walls of the two buildings were severely abraded by impact pressures of 75.5 kPa and 71.1
392 kPa, respectively. Additionally, the foundations of the two buildings were partially scoured by
393 floods with high shear stresses of 562 Pa and 553 Pa, respectively.

394 Buildings located in Zone (II) were only severely impacted by the dam-burst flood. For instance,
395 the foundation of the three-story school building (building 26) was severely eroded by the flood to
396 a scour depth of 1 m, and the floors on the right collapsed. There was no evidence on the walls of
397 the building that the debris flow had abraded the structure. The velocity and shear stress of the
398 flood in this location were 4.4 m/s and 463 Pa, respectively. Buildings 23-25, which were close to
399 the new river channel, were thoroughly buried by the sediment transported by the flood and
400 inundated by floodwater.

Figure 11 Buildings with different degrees of damage within three hazard zones.

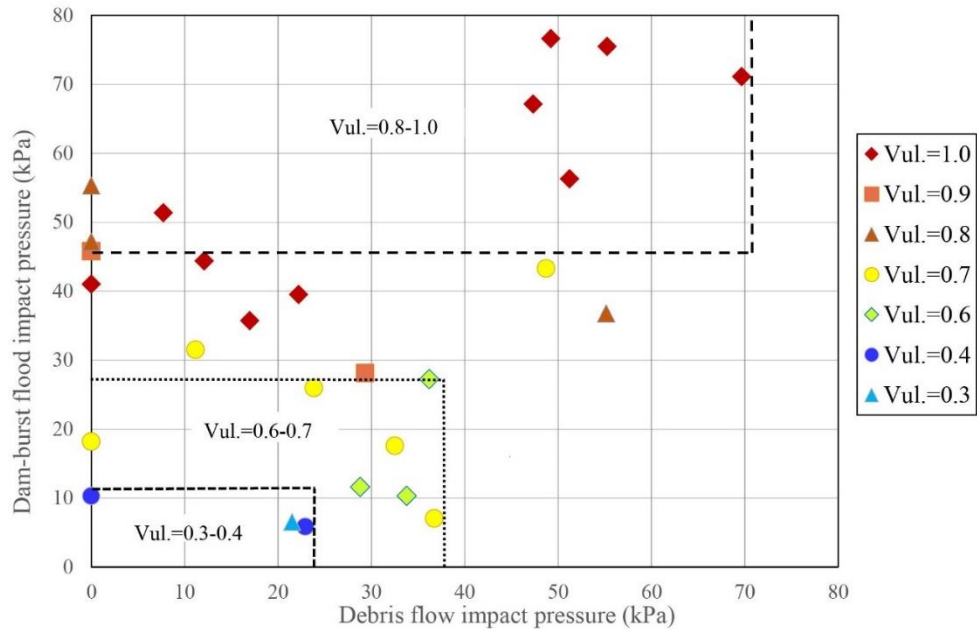
437 The building damage distribution chart shows building damage plotted as a function of debris
 438 flow and flood impact pressure (see Fig. 16). The figure includes aggregated damage to buildings
 439 impacted by the sequentially occurring hazards in Zone (III) and damage caused by a single hazard
 440 in Zone (II). Damage is divided into three categories based on the threshold impact pressure: slight
 441 damage (0.3-0.4), moderate damage (0.6-0.7), and heavy and complete damage (0.8-1.0). Heavy
 442 and complete damage mainly occurs at impact pressures greater than 60 kPa.

443 , while slight damage occurs below 30 kPa. Moderate damage mainly occurs at impact pressures
 444 between 40 kPa and 60 kPa. The threshold impact pressure is compared with that proposed by Hu
 445 et al. (2012) and Zanchetta et al. (2004), which were derived from a single debris flow disaster in
 446 China and Italy, respectively. Although the detailed definition of the damage scales differs, the
 447 threshold of the impact pressure for buildings at the slight, heavy, and complete damage scales is
 448 generally larger than that for the brick-concrete structures presented in Hu et al. (2012) and smaller
 449 than that for the reinforced concrete frames also presented in Hu et al. (2012) and the masonry
 450 structures with basements presented in Zanchetta et al. (2004). A similar trend for the threshold of
 451 the impact pressure for buildings with a moderate damage scale can be observed.

Figure 16 Accumulation of building damage due to debris flow and dam-burst flood. The damage distribution is based on the debris flow and flood impact pressure (Vul. refers to vulnerability).
