# The vulnerability of buildings to a large-scale debris flow and outburst flood hazard cascade that occurred on 30 August 2020 in Ganluo, Southwest China

**Abstract:** In mountainous areas, damage caused by debris flows is often aggravated by subsequent dam-burst floods within the main river confluence zone. On 30 August 2020, a catastrophic disaster chain occurred at the confluence of the Heixiluo Gully and Niri River in Ganluo County, Southwest China, ~~that consisted~~ consisting of a debris flow, the formation of a barrier lake and subsequent dam break that flooded the community. This study presents a comprehensive analysis of the characteristics of the two hazards and the resulting damage to buildings from the cascading hazards. The peak discharge of the debris flow in the gully mouth reached 1,871 m<sup>3</sup>/s~~-. Following the dam break, the~~ and the change in the main river channel resulting from the dam-burst flood, which had with a peak discharge of 2,737 m<sup>3</sup>/s, significantly altered the main river channel, resulted incausing a fourfold increase in ~~the extent of~~ flood inundation compared to an ordinary flood. Three hazard zones were established based o

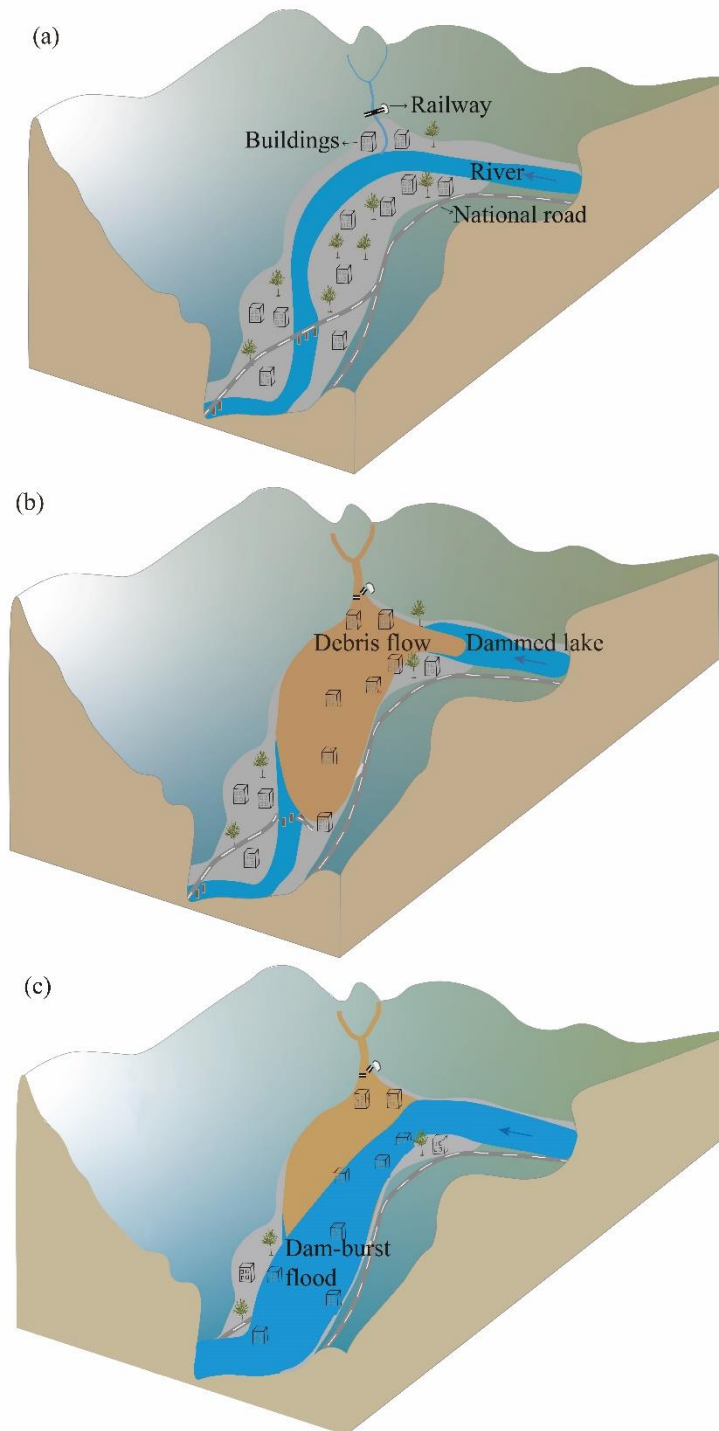
219 The debris flows firstly transported approximately 1,050,000 m<sup>3</sup> of material sediment to the Niri  
220 River, forming a temporary debris dam. ~~The debris flow swept away the railway bridge that crossed~~  
221 ~~the gully mouth and impacted the national road across the river. It also destroyed the buildings~~  
222 ~~close to the gully mouth and those on the opposite bank of the main river. Approximately 40~~  
223 ~~minutes later, the debris flow barrier dam was breached, triggering a massive high-magnitude flash~~  
224 ~~flood that damaged the national road and buildings near the altered flooding path (Fig. 3). that~~  
225 ~~breached after approximately 40 minutes, resulting in a massive flash flood. The debris flow flash~~  
226 ~~flood event caused significant damages, including the destruction of 108 buildings, the Chengdu~~  
227 ~~Kunming railway bridge near the gully mouth, 1.2 km along national road G245, and 5 highway~~

233 **Figure 3** Illustration of the hazard cascade process: (a) the normal flow of river flow before the occurrence

235 buildings; (c) the dammed lake bursts, causing a flood that damaged and the road and buildings

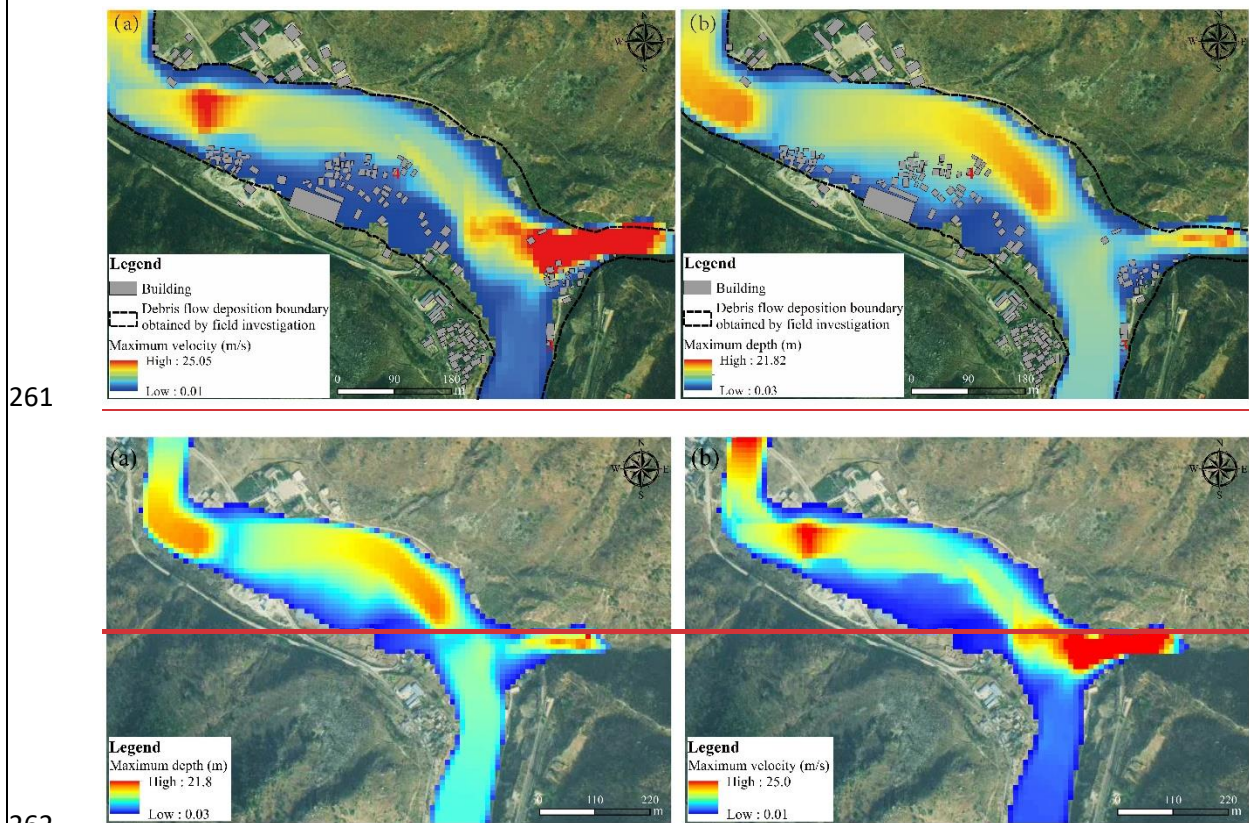
248 The temporal distributions of the maximum depth and velocity of the debris flow are presented  
249 in Fig. 6. Majority of buildings close to the river channel and debris flow channel were buried by  
250 the debris flow. The debris flow lasted for approximately 40 minutes and transported ~~approximately~~  
251 great volume of 1,050,000 m<sup>3</sup> of sediment downstream. The deposition zone extended from the  
252 gully mouth to the floodplain of the Niri River, covering a length of 320 m. The deposition area  
253 obtained from the simulation is 0.15 km<sup>2</sup>, ~~The~~ which is close to the area measured from the UAV  
254 image, ~~was~~ approximately 0.15-16 km<sup>2</sup>. The thickness of the sediment deposits ranged from 5 m  
255 to 15 m, with an average value of 7 m. Fig. 7 shows that the debris flow buried one floor of Building  
256 3 and nearly two floors of Building 4 (locations indicated in Fig. 6). The simulated maximum

257 depths at Buildings 3 and 4 are 3.2 m and 5.5 m, respectively, close to the actual deposition heights.  
258 The debris flow flushed into the main river and blocked the Niri River. The river channel was filled  
259 with sediment, which led to the formation of a dammed lake that raised the water level by 7-8 m.  
260 After 40 minutes, the unstable dammed lake breached, which resulted in a massive flash flood.

Figure 6 Distribution of maximum depth and velocity of the debris flow

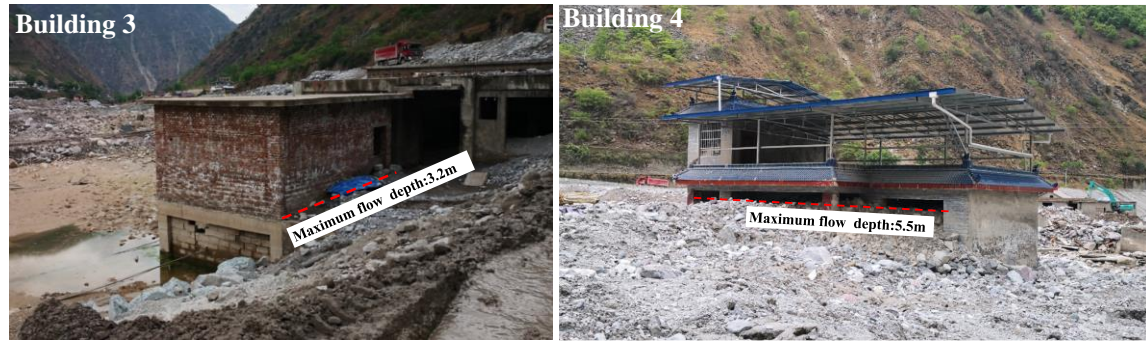
Figure 7 Simulated maximum flow depth of debris flow at the location of Building 3 and Building 4

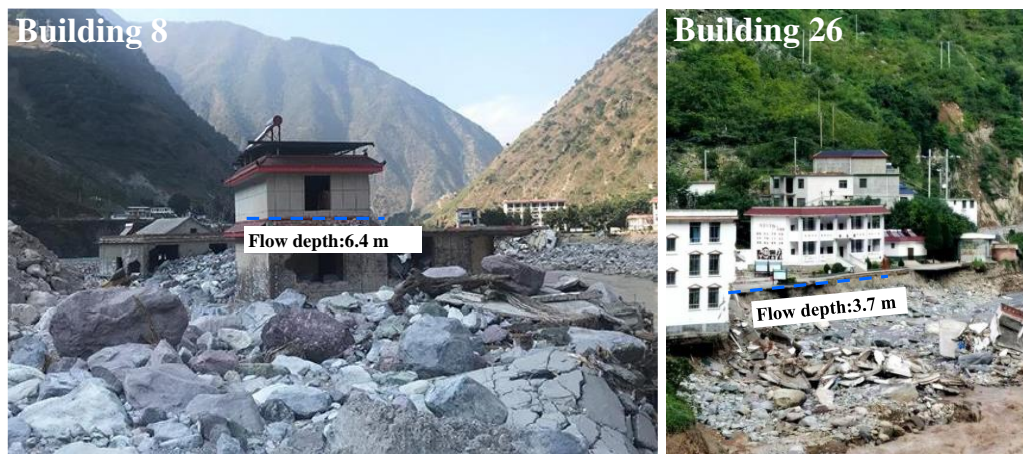
**Figure 9** Simulated maximum flow depth of the dam-burst flood at the location of Buildings 8 and Building 26

Buildings located in Zone (II) were only severely impacted by the dam-burst flood. For instance, the foundation of the three-story school building (building 26) was severely eroded by the flood to a scour depth of 1 m, and the floors on the right collapsed. There was no evidence on the walls of the building that the debris flow had abraded the structure. The velocity and shear stress of the flood in this location were 4.4 m/s and 463 Pa, respectively. Buildings 23-25, which were close to the new river channel, were thoroughly buried by the sediment transported by the flood and inundated by floodwater.

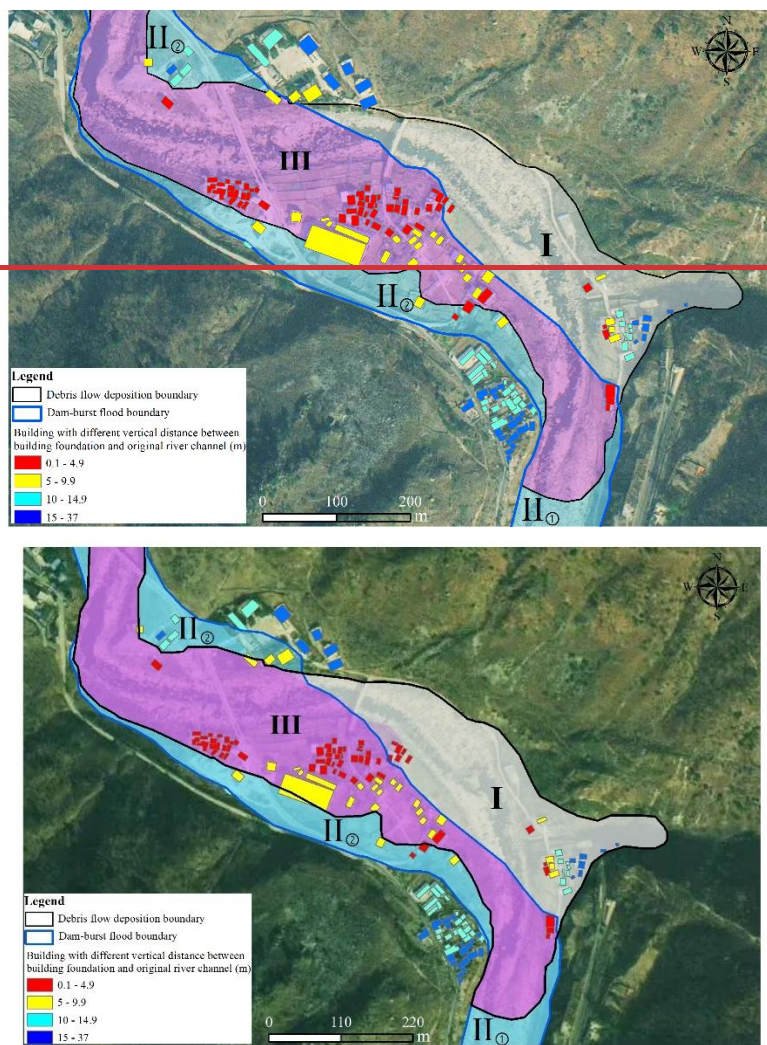
341 Fig. 9-11 illustrates the boundary of debris flow deposition and dam-burst flood inundation. The  
342 debris flow deposition boundary was determined by the simulation. Flooding boundary was  
343 obtained by combining the results of the HEC-RAS simulation with field survey data. The  
344 confluence area was heavily impacted by the debris flow, resulting in the transportation of a  
345 significant amount of solid materials over an area of 0.157-189 km<sup>2</sup>. As a result, the majority of the  
346 village's buildings were inundated by the debris flow. The dam-burst flood caused serious damage  
347 to buildings by flushing a large volume of debris flow sediment and riverbank material downstream.

381 **Figure 9-11** Inundation boundary of debris flow and dam-burst flood and spatial division of the hazard  
 382 zone based on building damage patterns: (I) buried by debris flow; (II) inundated by dam-burst flood; (III)  
 383 buried by debris flow and the inundated by dam-burst flood.

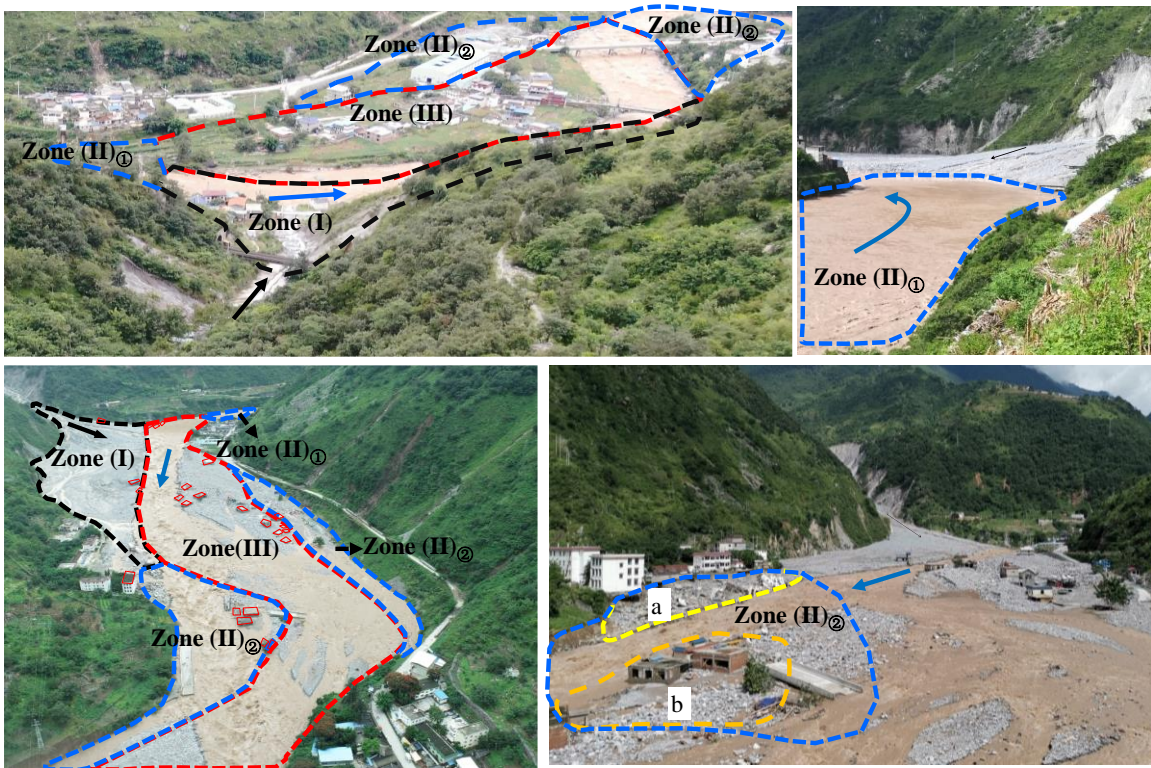
365 flood (part (a) in Fig. 4012(d)). A three-story building was partially destroyed due to foundation  
366 erosion. The buildings on the lower part of Zone (II) ② were simultaneously buried by the sediment  
367 transported by floods and inundated by floodwater (part (b) in Fig. 4012(d)).

405 **Figure 10-12** Spatial distribution of the three hazard zones before and after the disaster: (a) before the  
 406 disaster; (b) (c) (d) after the disaster.

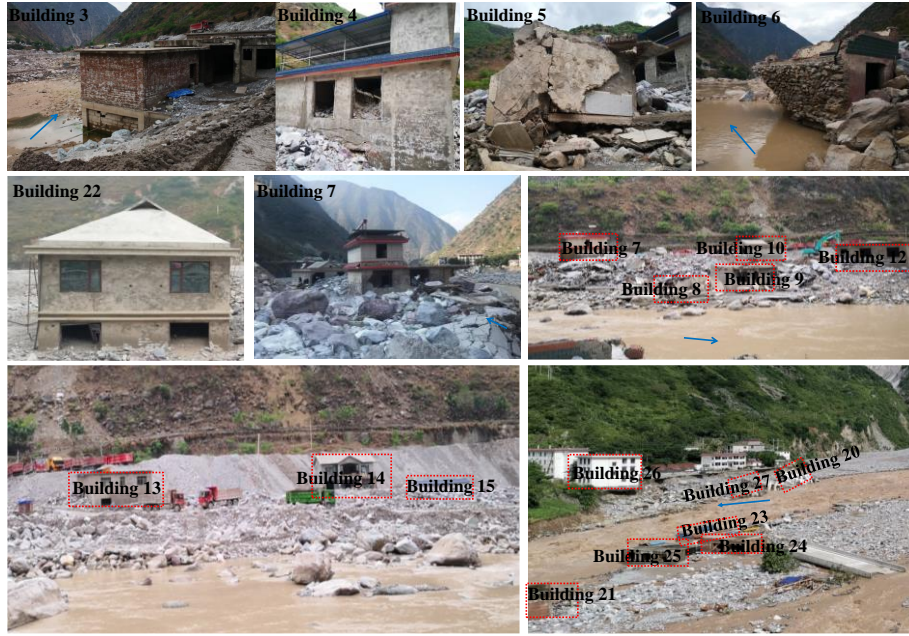
The building characteristics and hazard intensity are presented in Table 6. In Zone (III), buildings located near the debris flow dam (such as buildings 1, 2, and 3) were first buried by the debris flow and then inundated by water from the dammed lake for 40 minutes. These buildings were then impacted by the dam-burst flood. Additionally, buildings near the new river channel suffered greater impact pressure than other buildings. For example, the residual broken structures of buildings 5 and 6 were heavily damaged by the direct impact of the flood in the vertical direction. The walls of the two buildings were severely abraded by impact pressures of ~~75.5-1~~ kPa and ~~71.1~~ 59 kPa, respectively. Additionally, the foundations of the two buildings were partially scoured by floods with high shear stresses of 562 Pa and 553 Pa, respectively.

**Figure 11-13** Buildings with different degrees of damage within three hazard zones.

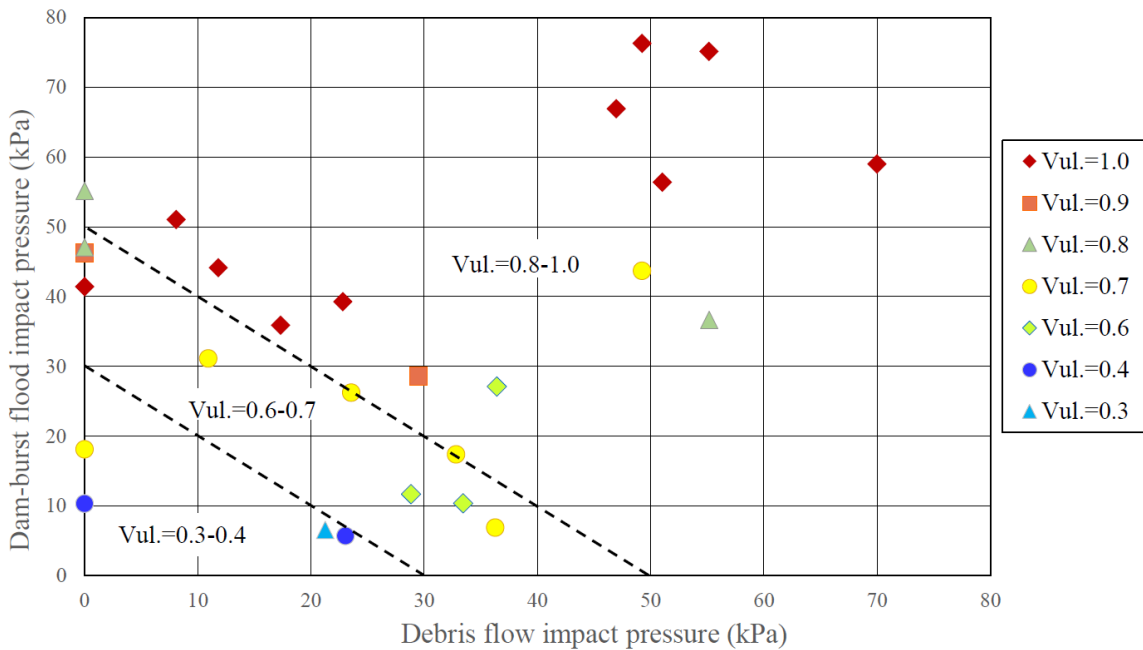
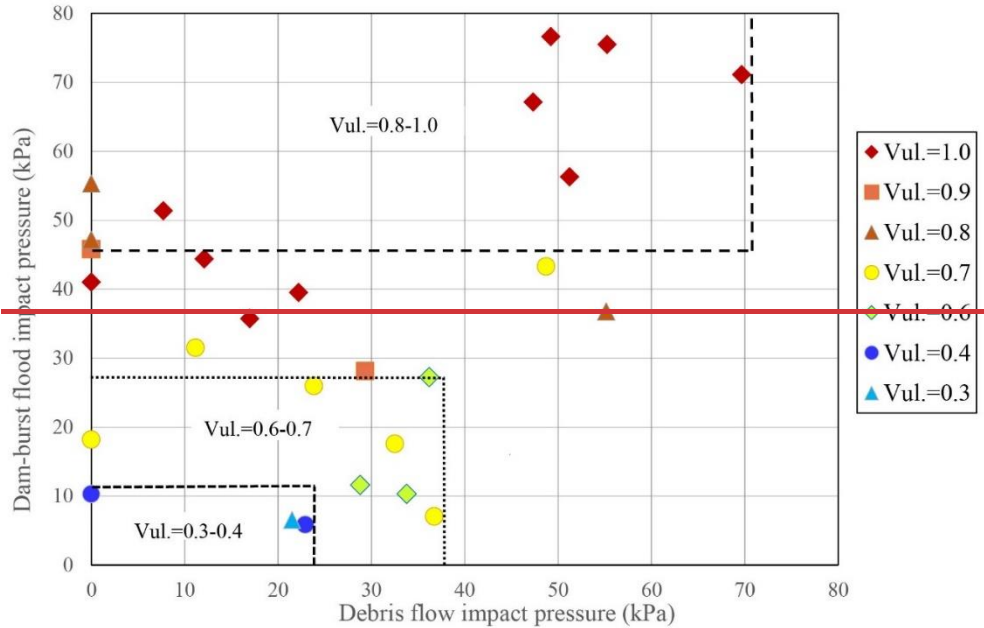
469 The building damage distribution chart shows building damage plotted as a function of debris  
 470 flow and flood impact pressure (see Fig. 4618). The figure includes aggregated damage to buildings  
 471 impacted by the sequentially occurring hazards in Zone (III) and damage caused by a single hazard  
 472 in Zone (II). Damage is divided into three categories based on the threshold impact pressure: slight  
 473 damage (0.3-0.4), moderate damage (0.6-0.7), and heavy and complete damage (0.8-1.0). Heavy  
 474 and complete damage mainly occurs at impact pressures greater than 60-50 kPa, while slight  
 475 damage occurs below 30 kPa. Moderate damage mainly occurs at impact pressures between 40-30  
 476 kPa and 60-50 kPa. The threshold impact pressure is compared with that proposed by Hu et al. (2012)  
 477 and Zanchetta et al. (2004), which were derived from a single debris flow disaster in China and

478 Italy, respectively. Although the detailed definition of the damage scales differs, the threshold of  
 479 the impact pressure for buildings at the slight, heavy, and complete damage scales is generally  
 480 larger than that for the brick-concrete structures presented in Hu et al. (2012) and smaller than that  
 481 for the reinforced concrete frames also presented in Hu et al. (2012) and the masonry structures  
 482 with basements presented in Zanchetta et al. (2004). A similar trend for the threshold of the impact  
 483 pressure for buildings with a moderate damage scale can be observed.

**Figure 16-18** Accumulation of building damage due to debris flow and dam-burst flood. The damage distribution is based on the debris flow and flood impact pressure (Vul. refers to vulnerability).

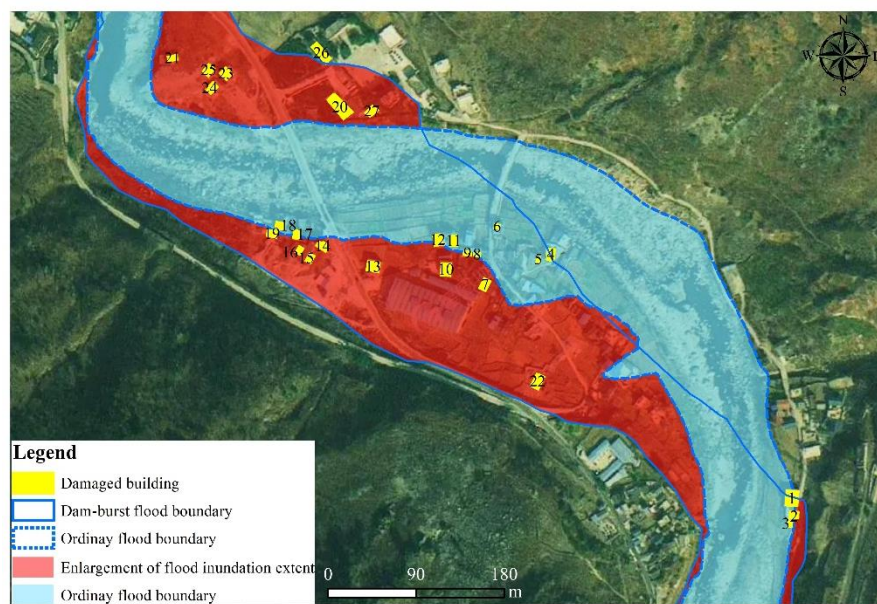
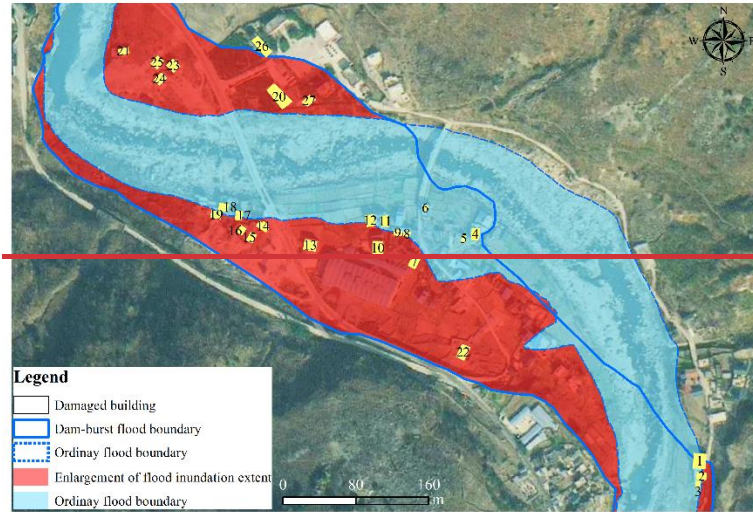
504 As a result of the confluence zone's location on a river bend, the dam-burst flood typically flows  
505 in a straight direction and creates a new straight channel when the river channel becomes  
506 completely blocked. This channel translocation leads to a larger flooded area and causes more  
507 severe damage to buildings on the floodplain. The flood inundation zones in the village expanded  
508 to  $110^5 \text{ m}^2$ , which is up to 4 times the area of an ordinary flood due to flood amplification (Fig.  
509 [4719](#)). In the expanded inundation zone, 41 buildings, a traffic road spanning 410 m, and farmland  
510 with an area of  $10 \times 10^4 \text{ m}^2$  were submerged. The buildings located in the middle of the inundation  
511 zones suffered the most severe damage due to the floodwater's high scouring capability and  
512 sediment transport capacity. Many buildings near the flow collapsed, and most structures were

514 Table 7 presents a comparison of the dynamic characteristics and damage increments between  
515 ordinary and dam-burst floods in different locations. The damage increment is calculated based on  
516 the proposed function in Zone II and is the ratio of the damage caused by the two floods. Buildings  
517 4, 5, 6, 9, 11, 18, and 19 were situated close to the new river channel, and the average bed shear  
518 stress and impact pressure increased up to 14.2 times and 3.8 times that of an ordinary flood,  
519 respectively, due to flood amplification. The average damage to the seven buildings located near  
520 the new channel increased by 140% due to the lake created by the debris flow barrier.

**Figure 17-19** The inundation extent of ordinary floods and dam-burst floods.
