The vulnerability of buildings to a large-scale debris flow and outburst flood hazard cascade that occurred on 30 August 2020 in Ganluo, Southwest China

Abstract: In mountainous areas, damage caused by debris flows is often aggravated by subsequent dam-burst floods within the main river confluence zone. On 30 August 2020, a catastrophic disaster chain occurred at the confluence of the Heixiluo Gully and Niri River in Ganluo County, Southwest China, that consisted of a debris flow, the formation of a barrier lake and subsequent dam break that flooded the community. This study presents a comprehensive analysis of the characteristics of two hazards and the resulting damage to buildings from the cascading hazards. The peak discharge of the debris flow in the gully mouth reached 1,871 m³/s, and the change in the main river channel resulting from the dam-burst flood, which had a peak discharge of 2,737 m³/s, resulted in a fourfold increase in the extent of flood inundation compared to an ordinary flood. Three hazard zones were established based on the building damage patterns: (I) primary debris flow burial; (II) secondary dam-burst flood inundation and (III) sequential debris flow buri

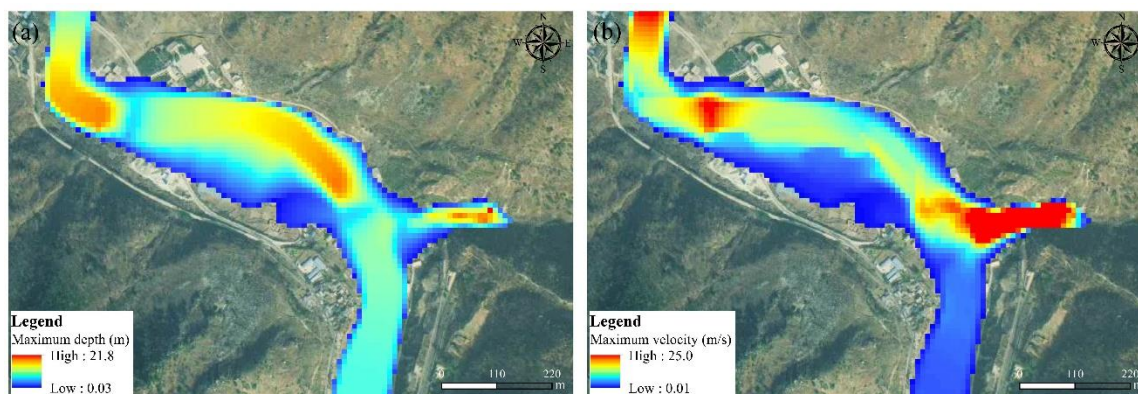
234 The temporal distributions of the maximum depth and velocity of the debris flow are presented
235 in Fig. 6. Majority of buildings close to the river channel and debris flow channel were buried by
236 the debris flow. The debris flow lasted for approximately 40 minutes and transported approximately
237 1,050,000 m³ of sediment downstream. The deposition zone extended from the gully mouth to the
238 floodplain of the Niri River, covering a length of 320 m. The area measured from the UAV image
239 was approximately 0.15 km². The thickness of the sediment deposits ranged from 5 m to 15 m, with
240 an average value of 7 m. The debris flow flushed into the main river and blocked the Niri River.
241 The river channel was filled with sediment, which led to the formation of a dammed lake that raised
242 the water level by 7-8 m. After 40 minutes, the unstable dammed lake breached, which resulted in
243 a massive flash flood.

Figure 6 Distribution of maximum depth and velocity of the debris flow

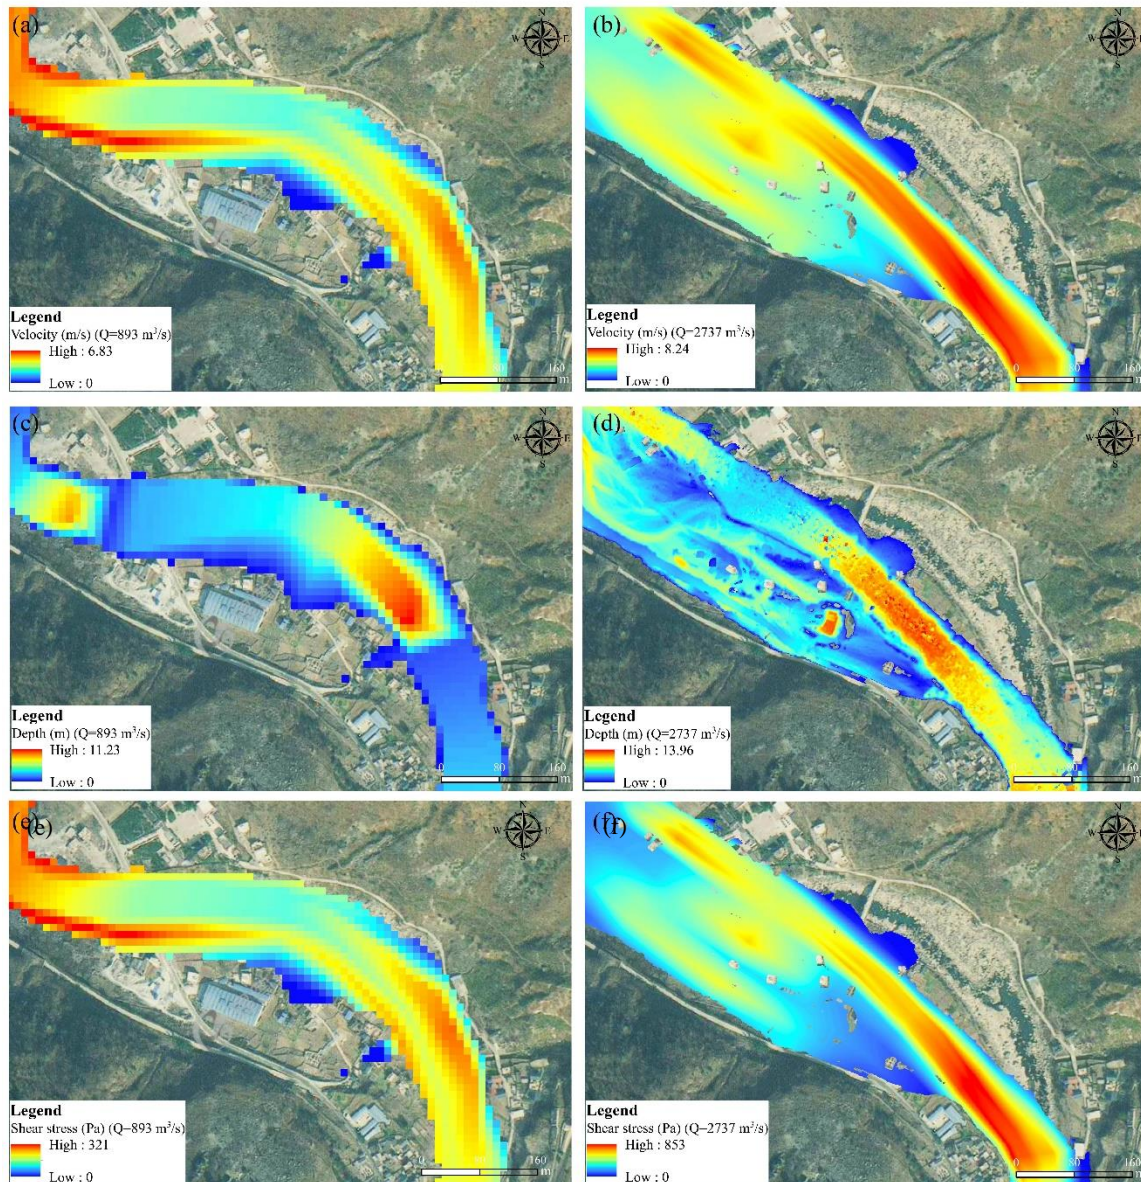
290 the right bank due to the severe erosion of the original river terrace and had a maximum depth of
 291 10 m (Fig. 8). The channel width increased to approximately 100 m, and the channel depth
 292 decreased to less than 5 m.

293 **Figure 7** Distribution of depth, velocity, and shear stress of ordinary flood and dam-burst flood: (a)
 294 Maximum velocity distribution of ordinary flood; (b) Maximum velocity distribution of dam-burst
 295 flood; (c) Maximum depth distribution of ordinary flood; (d) Maximum depth distribution of dam-burst
 296 flood; (e) Maximum shear stress distribution of ordinary flood; (f) Maximum shear stress distribution of
 297 dam-burst flood.
 298

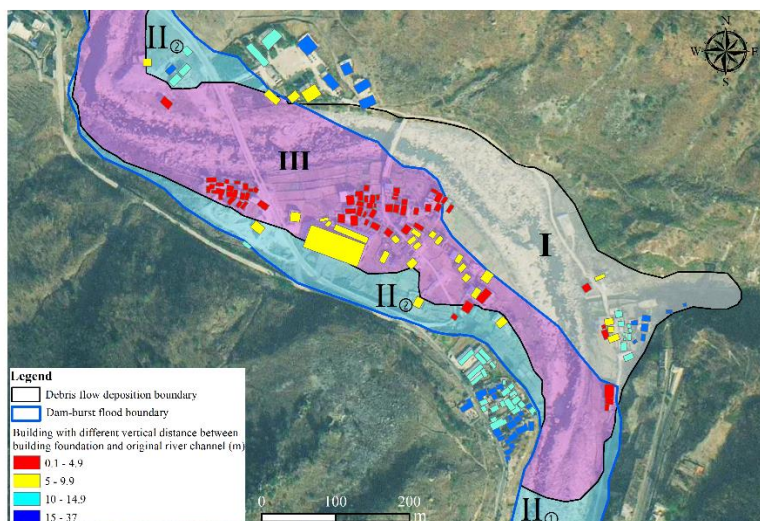
318 Three hazard zones are identified based on the boundary of the debris flow and dam-burst flood,
319 as shown in Fig. 9 and Fig. 10. The damage patterns of buildings in the different hazard zones can
320 be classified into three categories, namely, (I) buildings only buried by debris flow; (II) buildings
321 only inundated by dam-burst flood; and (III) buildings sequentially buried by debris flow and
322 inundated by dam-burst flood. Zone (I) is situated near the Heixiluo gully mouth, where the debris
323 flow transported a large volume of sediment and seriously eroded the sidewall and bed of the
324 channel, expanding the channel's width from 10 m to 40 m. All buildings were inundated by
325 sediment to a depth of over 6 m.

349 **Figure 9** Inundation boundary of debris flow and dam-burst flood and spatial division of the hazard zone
350 based on building damage patterns: (I) buried by debris flow; (II) inundated by dam-burst flood; (III)
351 buried by debris flow and the inundated by dam-burst flood.
352

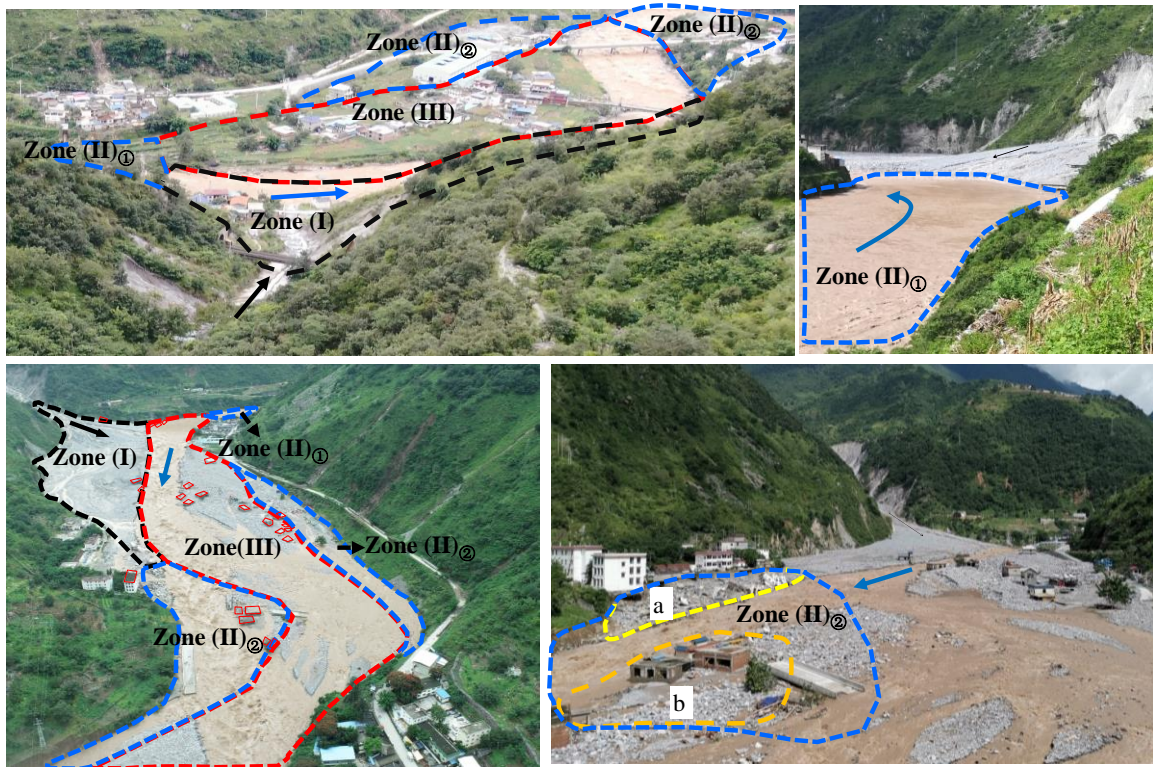
335 Fig. 10(d)). A three-story building was partially destroyed due to foundation erosion. The buildings
336 on the lower part of Zone (II) ② were simultaneously buried by the sediment transported by floods
337 and inundated by floodwater (part (b) in Fig. 10(d)).

Figure 10 Spatial distribution of the three hazard zones before and after the disaster: (a) before the disaster; (b) (c) (d) after the disaster.

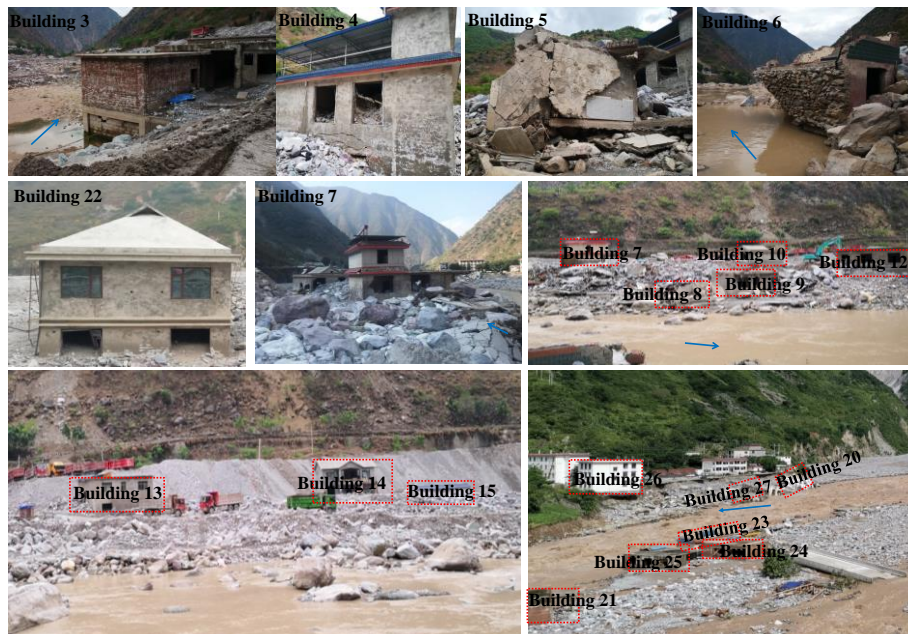
384 The building characteristics and hazard intensity are presented in Table 6. In Zone (III),
385 buildings located near the debris flow dam (such as buildings 1, 2, and 3) were first buried by the
386 debris flow and then inundated by water from the dammed lake for 40 minutes. These buildings
387 were then impacted by the dam-burst flood. Additionally, buildings near the new river channel
388 suffered greater impact pressure than other buildings. For example, the residual broken structures
389 of buildings 5 and 6 were heavily damaged by the direct impact of the flood in the vertical direction.
390 The walls of the two buildings were severely abraded by impact pressures of 75.5 kPa and 71.1
391 kPa, respectively. Additionally, the foundations of the two buildings were partially scoured by
392 floods with high shear stresses of 562 Pa and 553 Pa, respectively.

393 Buildings located in Zone (II) were only severely impacted by the dam-burst flood. For instance,
394 the foundation of the three-story school building (building 26) was severely eroded by the flood to
395 a scour depth of 1 m, and the floors on the right collapsed. There was no evidence on the walls of
396 the building that the debris flow had abraded the structure. The velocity and shear stress of the
397 flood in this location were 4.4 m/s and 463 Pa, respectively. Buildings 23-25, which were close to
398 the new river channel, were thoroughly buried by the sediment transported by the flood and
399 inundated by floodwater.

Figure 11 Buildings with different degrees of damage within three hazard zones.
