The vulnerability of buildings to a large-scale debris flow and outburst flood hazard cascade that occurred on 30 August 2020 in Ganluo, Southwest China

Abstract: In mountainous areas, damage caused by debris flows is often aggravated by subsequent dam-burst floods within the main river confluence zone. On 30 August 2020, a catastrophic disaster chain occurred at the confluence of the Heixiluo Gully and Niri River in Ganluo County, Southwest China, consisting of a debris flow, the formation of a barrier lake and subsequent dam break that flooded the community. This study presents a comprehensive analysis of the characteristics of the two hazards and the resulting damage to buildings from the cascading hazards. The peak discharge of the debris flow in the gully mouth reached 1,871 m³/s. Following the dam break, the flood with a peak discharge of 2,737 m³/s, significantly altered the main river channel, causing a fourfold increase in flood inundation compared to an ordinary flood. Three hazard zones were established based on the building damage patterns: (I) primary debris flow burial; (II) secondary dam-burst flood inundation and (III) sequential debris flow burial and dam-burst in

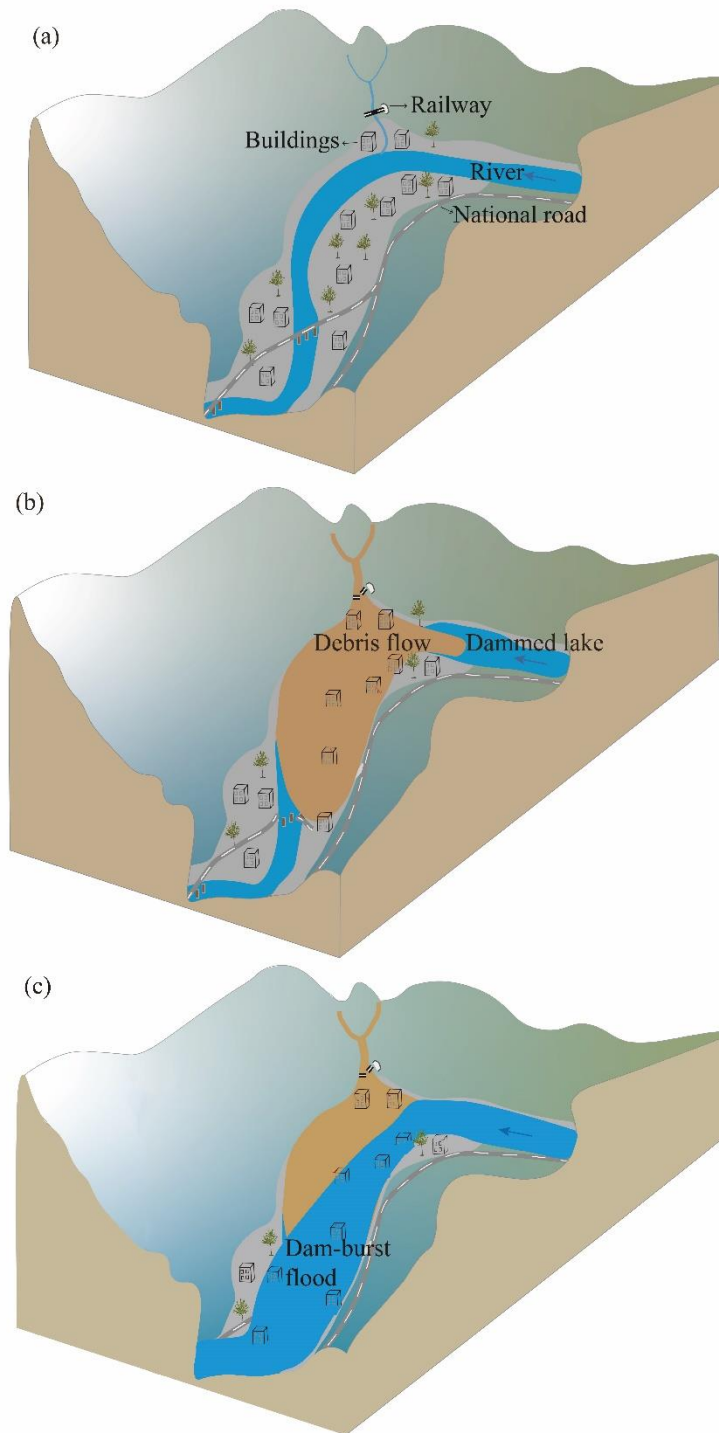
209 The debris flows firstly transported approximately 1,050,000 m³ of sediment to the Niri River,
210 forming a temporary debris dam. The debris flow swept away the railway bridge that crossed the
211 gully mouth and impacted the national road across the river. It also destroyed the buildings close
212 to the gully mouth and those on the opposite bank of the main river. Approximately 40 minutes
213 later, the debris flow dam was breached, triggering a high-magnitude flash flood that damaged the
214 national road and buildings near the altered flooding path (Fig.3).

219 **Figure 3** Illustration of the hazard cascade process: (a) the normal flow of river flow before the occurrence
 220 of debris flow; (b) debris flow blocks the river, creating a dammed lake that destroys the railway, roads, and
 221 buildings; (c) the dammed lake bursts, causing a flood that damaged and the road and buildings

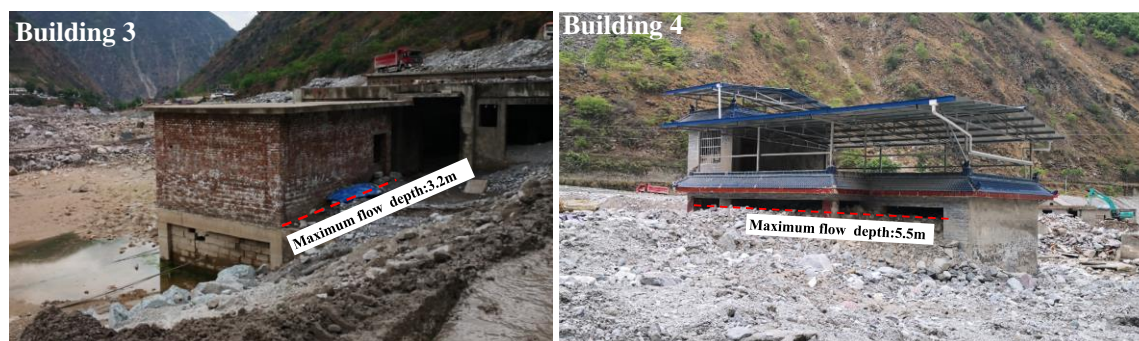
Figure 7 Simulated maximum flow depth of debris flow at the location of Building 3 and Building 4

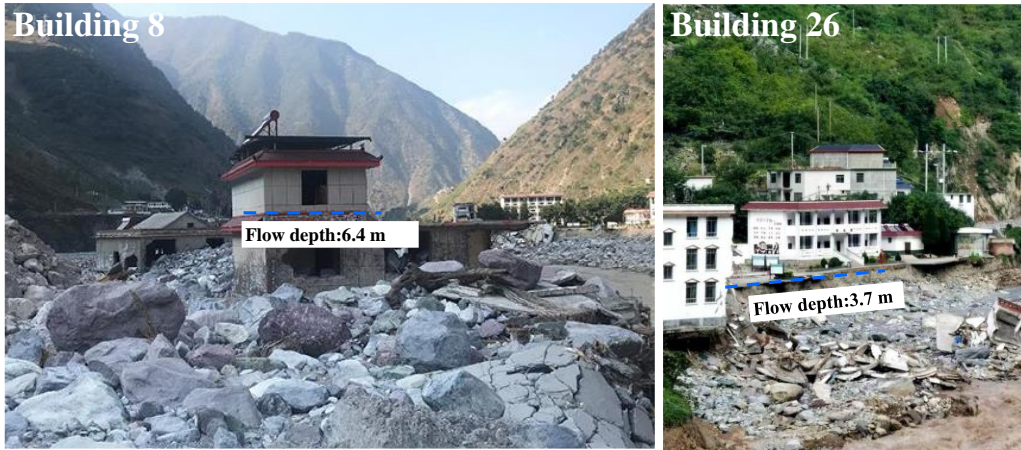
Figure 9 Simulated maximum flow depth of the dam-burst flood at the location of Buildings 8 and Building 26

Buildings located in Zone (II) were only severely impacted by the dam-burst flood. For instance, the foundation of the three-story school building (building 26) was severely eroded by the flood to a scour depth of 1 m, and the floors on the right collapsed. There was no evidence on the walls of the building that the debris flow had abraded the structure. The velocity and shear stress of the flood in this location were 4.4 m/s and 463 Pa, respectively. Buildings 23-25, which were close to the new river channel, were thoroughly buried by the sediment transported by the flood and inundated by floodwater.

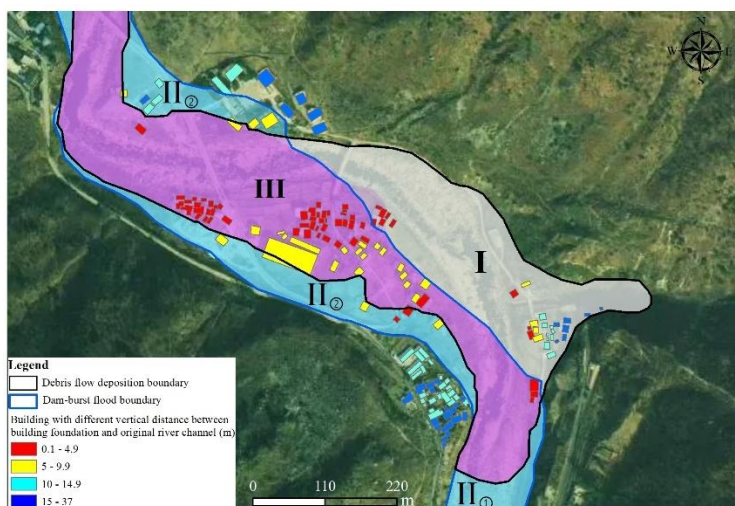
322 Fig. 11 illustrates the boundary of debris flow deposition and dam-burst flood inundation. The
323 debris flow deposition boundary was determined by the simulation. Flooding boundary was
324 obtained by combining the results of the HEC-RAS simulation with field survey data. The
325 confluence area was heavily impacted by the debris flow, resulting in the transportation of a
326 significant amount of solid materials over an area of 0.189 km². As a result, the majority of the
327 village's buildings were inundated by the debris flow. The dam-burst flood caused serious damage
328 to buildings by flushing a large volume of debris flow sediment and riverbank material downstream.

329 Three hazard zones are identified based on the boundary of the debris flow and dam-burst flood,
330 as shown in Fig. 11 and Fig. 12. The damage patterns of buildings in the different hazard zones can
331 be classified into three categories, namely, (I) buildings only buried by debris flow; (II) buildings
332 only inundated by dam-burst flood; and (III) buildings sequentially buried by debris flow and
333 inundated by dam-burst flood. Zone (I) is situated near the Heixiluo gully mouth, where the debris
334 flow transported a large volume of sediment and seriously eroded the sidewall and bed of the
335 channel, expanding the channel's width from 10 m to 40 m. All buildings were inundated by
336 sediment to a depth of over 6 m.

360
361 **Figure 11** Inundation boundary of debris flow and dam-burst flood and spatial division of the hazard zone
362 based on building damage patterns: (I) buried by debris flow; (II) inundated by dam-burst flood; (III)
363 buried by debris flow and the inundated by dam-burst flood.

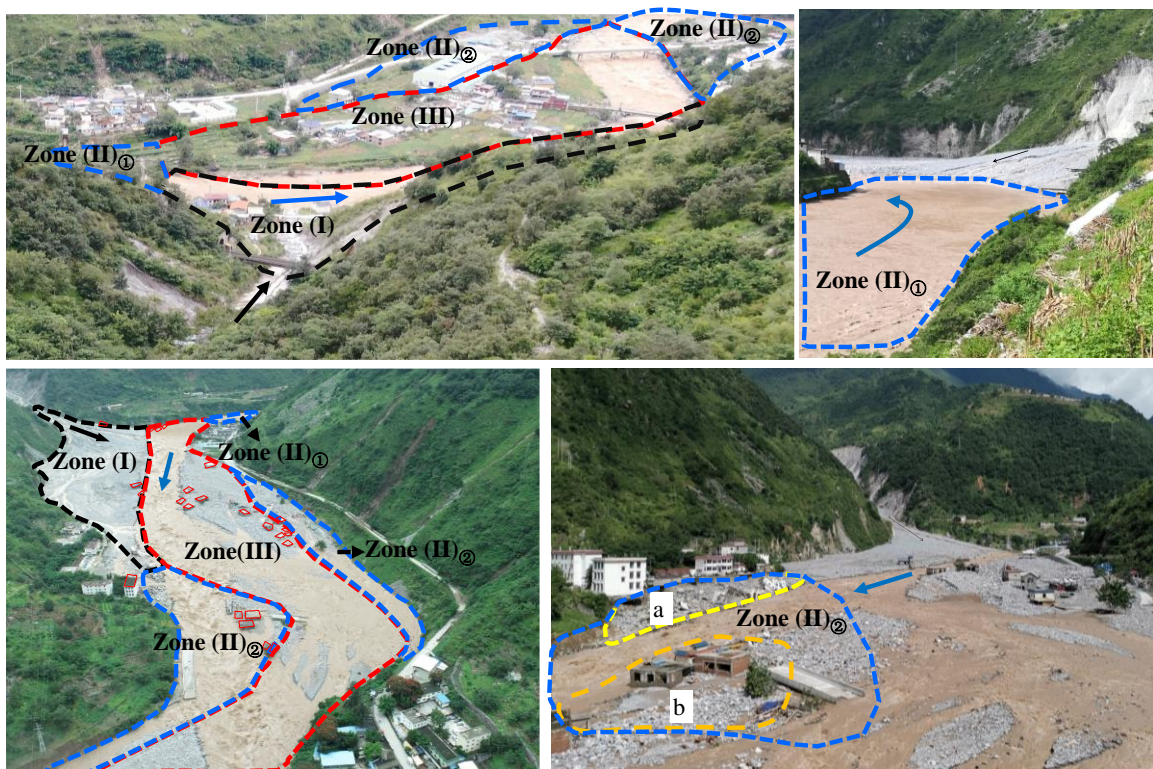
346 Fig. 12(d)). A three-story building was partially destroyed due to foundation erosion. The buildings

383
 384 **Figure 12** Spatial distribution of the three hazard zones before and after the disaster: (a) before the
 385 disaster; (b) (c) (d) after the disaster.

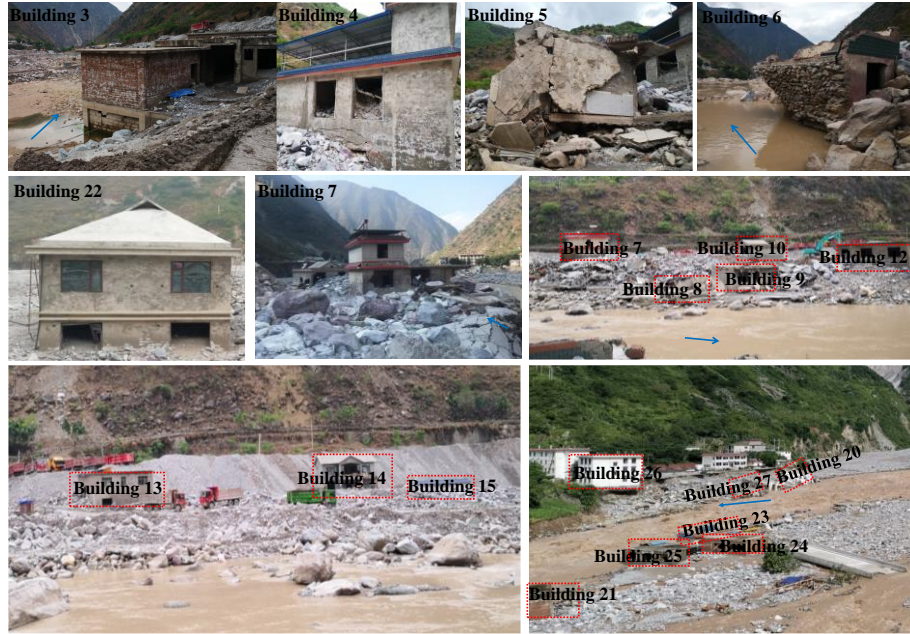
Most of the buildings in the village were completely buried by sediments or collapsed with no visible remains. To construct vulnerability curves, 27 damaged buildings with brick-concrete structures located in the three hazard zones were selected (Fig. 12(c), Fig. 13). Of these, 6 buildings were located in Zone (II), and the rest were distributed throughout Zone (III).

The building characteristics and hazard intensity are presented in Table 6. In Zone (III), buildings located near the debris flow dam (such as buildings 1, 2, and 3) were first buried by the debris flow and then inundated by water from the dammed lake for 40 minutes. These buildings were then impacted by the dam-burst flood. Additionally, buildings near the new river channel suffered greater impact pressure than other buildings. For example, the residual broken structures of buildings 5 and 6 were heavily damaged by the direct impact of the flood in the vertical direction. The walls of the two buildings were severely abraded by impact pressures of 75.1 kPa and 59 kPa, respectively. Additionally, the foundations of the two buildings were partially scoured by floods with high shear stresses of 562 Pa and 553 Pa, respectively.

Figure 13 Buildings with different degrees of damage within three hazard zones.

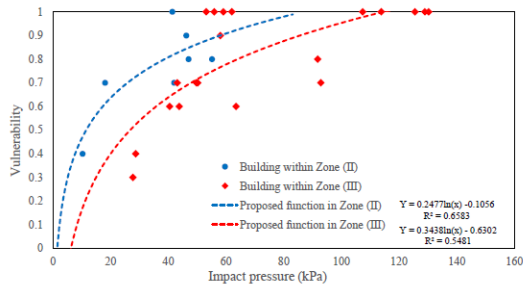
414 The vulnerability curve in Zone (II) and Zone (III) was developed by summing up the damage
415 caused by the multiple hazards and impact pressure (Fig. 14). Logistic functions were proposed
416 separately for the two hazard zones, and the corresponding determination coefficient (R^2) and root
417 mean square error (RMSE) were also obtained. The determination coefficients of the two regression
418 curves in Zone (III) have a higher R^2 . The RMSEs of the curves in Zone (II) and Zone (III) are 0.66
419 and 0.55, respectively. The correlation between vulnerability and inundation depth in the two zones
420 is shown in Fig. 15, with an R^2 lower than impact pressure ($R^2=0.55$ for Zone (II) and $R^2=0.45$ for
421 Zone (III)). Building vulnerability increases with increasing hazard intensity, and the trend is similar
422 in the two zones. The impact pressure thresholds for Zones II and III, where vulnerability is equal

423 to 1, are 84 kPa and 116 kPa, respectively. For the same impact pressure and inundation depth, the
424 damage to buildings in Zone (II) is greater than that in Zone (III).

Figure 14 Proposed vulnerability functions based on the impact pressure in Zone (II) and Zone (III).

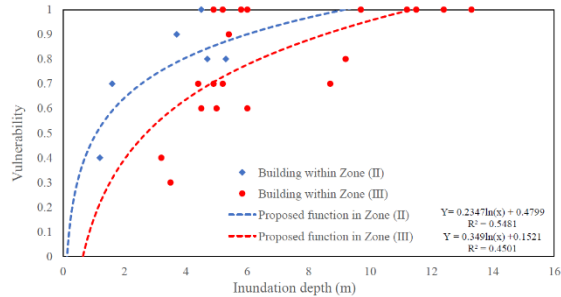
Figure 15 Proposed vulnerability functions based on the inundation depth in Zone (II) and Zone (III).
