The vulnerability of buildings to a large-scale debris flow and outburst flood hazard cascade that occurred on 30 August 2020 in Ganluo, Southwest China

Abstract: In mountainous areas, damage caused by debris flows is often aggravated by subsequent dam-burst floods within the main river confluence zone. On 30 August 2020, a catastrophic disaster chain occurred at the confluence of the Heixiluo Gully and Niri River in Ganluo County, Southwest China, consisting of a debris flow, the formation of a barrier lake and subsequent dam break that flooded the community. This study presents a comprehensive analysis of the characteristics of the two hazards and the resulting damage to buildings from the cascading hazards. The peak discharge of the debris flow in the gully mouth reached 1,871 m³/s. Following the dam break, the flood with a peak discharge of 2,737 m³/s, significantly altered the main river channel, causing a fourfold increase in flood inundation compared to an ordinary flood. Three hazard zones were established based on the building damage patterns: (I) primary debris flow burial; (II) secondary dam-burst flood inundation and (III) sequential debris flow burial and dam-burst in

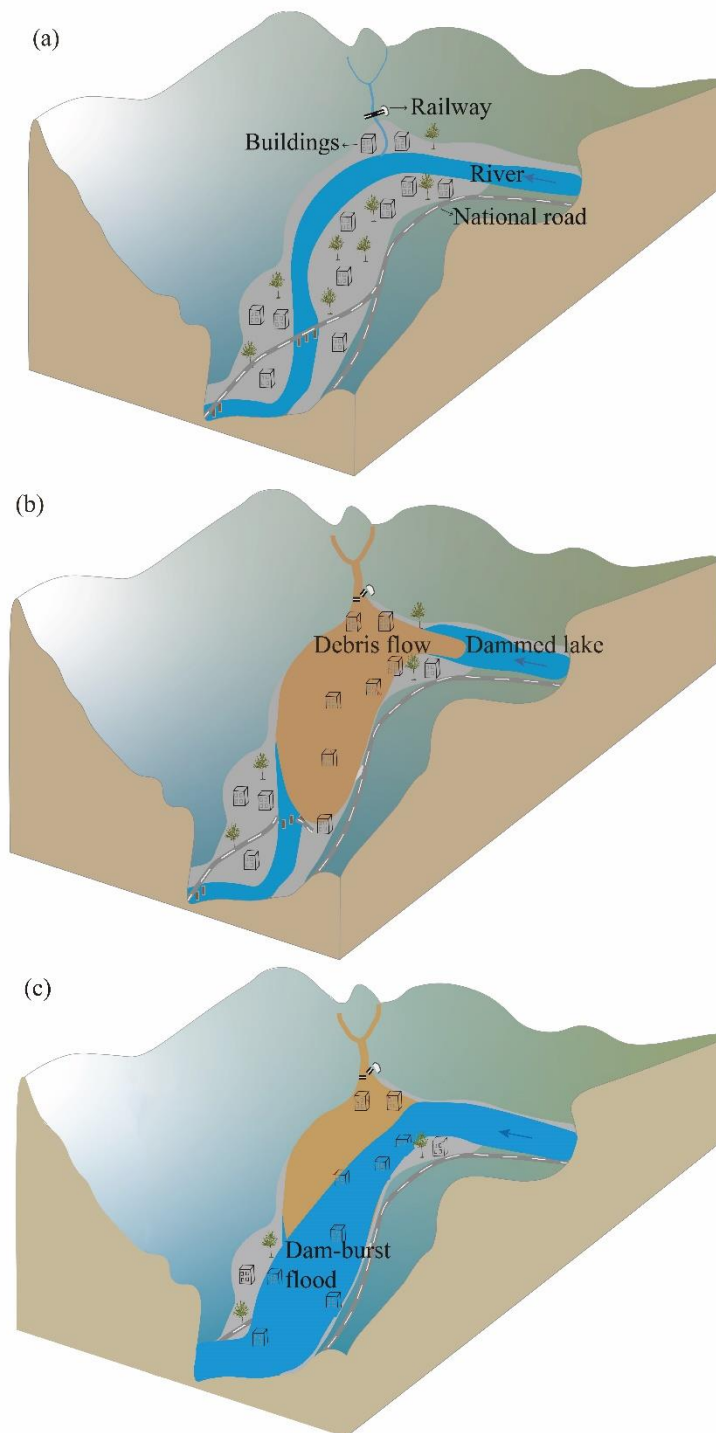
209 The debris flows firstly transported approximately 1,050,000 m³ of sediment to the Niri River,
210 forming a temporary debris dam. The debris flow swept away the railway bridge that crossed the
211 gully mouth and impacted the national road across the river. It also destroyed the buildings close
212 to the gully mouth and those on the opposite bank of the main river. Approximately 40 minutes
213 later, the debris flow dam was breached, triggering a high-magnitude flash flood that damaged the
214 national road and buildings near the altered flooding path (Fig.3).

219 **Figure 3** Illustration of the hazard cascade process: (a) the normal flow of river flow before the occurrence
 220 of debris flow; (b) debris flow blocks the river, creating a dammed lake that destroys the railway, roads, and
 221 buildings; (c) the dammed lake bursts, causing a flood that damaged and the road and buildings

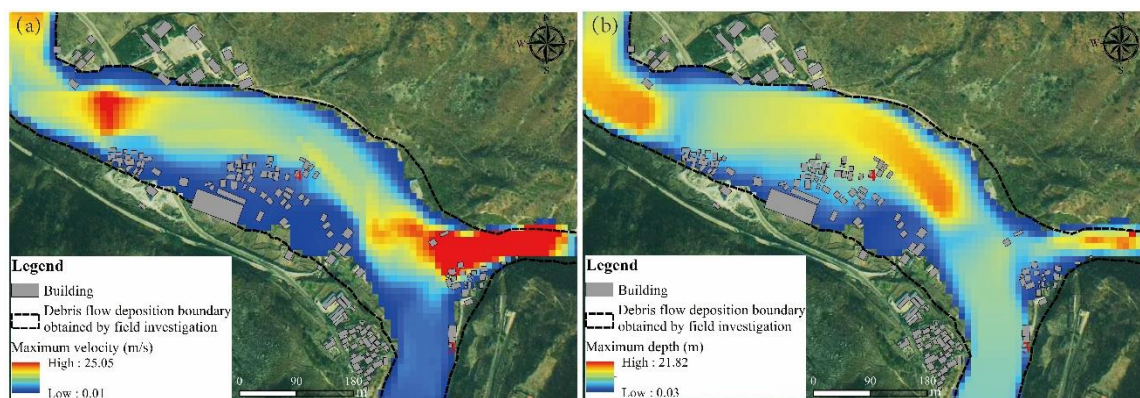
234 The temporal distributions of the maximum depth and velocity of the debris flow are presented
235 in Fig. 6. Majority of buildings close to the river channel and debris flow channel were buried by
236 the debris flow. The debris flow lasted approximately 40 minutes and transported great volume of
237 sediment downstream. The deposition zone extended from the gully mouth to the floodplain of the
238 Niri River, covering a length of 320 m. The deposition area obtained from the simulation is 0.15
239 km², which is close to the area measured from the UAV image, approximately 0.16 km². The
240 thickness of the sediment deposits ranged from 5 m to 15 m, with an average value of 7 m. Fig. 7
241 shows that the debris flow buried one floor of Building 3 and nearly two floors of Building 4
242 (locations indicated in Fig. 6). The simulated maximum depths at Buildings 3 and 4 are 3.2 m and
243 5.5 m, respectively, close to the actual deposition heights. The debris flow flushed into the main

244 river and blocked the Niri River. The river channel was filled with sediment, which led to the
245 formation of a dammed lake that raised the water level by 7-8 m. After 40 minutes, the unstable
246 dammed lake breached, which resulted in a massive flash flood.

Figure 6 Distribution of maximum depth and velocity of the debris flow
(Satellite image obtained from <https://www.jl1mall.com>)

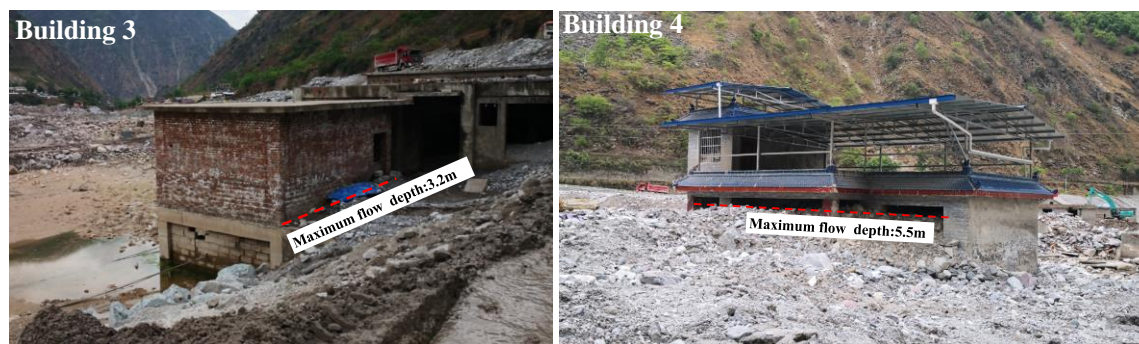
Figure 7 Simulated maximum flow depth of debris flow at the location of Building 3 and Building 4

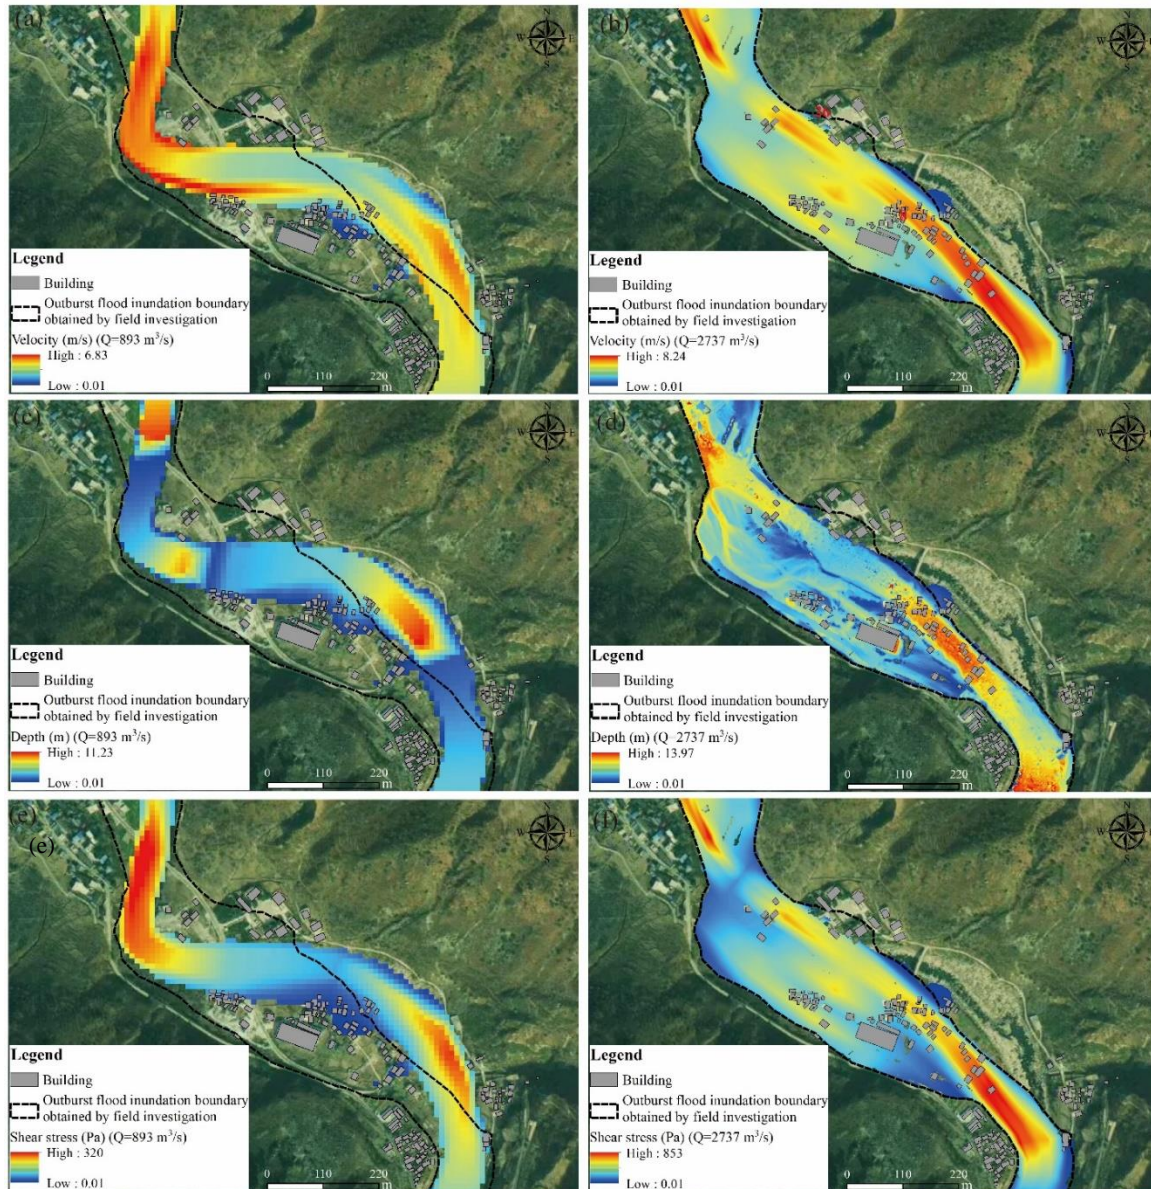
286 diameter (Petit et al., 2015). The dam-burst flood had the potential to transport large boulders up to
287 1.3 m in diameter, while an ordinary flood could only move gravel up to 0.49 m in diameter. Such
288 high shear stress also demonstrated the strong erosional ability of the dam-burst flood, which
289 seriously scoured the debris sediment deposit and original riverbank, transporting coarse gravel and
290 forming a new straight river channel. The new channel is straighter and steeper than the original
291 channel, raising the bed of the Niri River by 1-17 m and burying buildings up to 1 km downstream
292 of Heixluo Gully. The channel length shortened from 1010 m to 842 m, and the channel gradient
293 increased from 1.71% to 2.72%. The change in the river channel led to an inundation area that
294 deflected to the left. Buildings built on the original left riverbank were first impacted by debris flow

295 and subsequently destroyed by the flood. The river terrace on the original right bank was strongly
296 eroded by the flood, leading to the collapse and demolition of buildings. Five river sections (Section
297 1 to Section 5) were selected to analyze the terrain changes (see Fig. 4). From Section 1 to Section
298 3, the main channel varied from the right bank to the left bank with a distance between 40 m and
299 100 m, the average width of the new river channel was 50 m, and the vertical distance between the
300 new riverbed and floodplain was 11.23 m. In Section 5, the channel migrated from the left bank to
301 the right bank due to the severe erosion of the original river terrace and had a maximum depth of
302 10 m (Fig. 10). The channel width increased to approximately 100 m, and the channel depth
303 decreased to less than 5 m.

Figure 8 Distribution of depth, velocity, and shear stress of ordinary flood and dam-burst flood: (a) Maximum velocity distribution of ordinary flood; (b) Maximum velocity distribution of dam-burst flood; (c) Maximum depth distribution of ordinary flood; (d) Maximum depth distribution of dam-burst flood; (e) Maximum shear stress distribution of ordinary flood; (f) Maximum shear stress distribution of dam-burst flood.

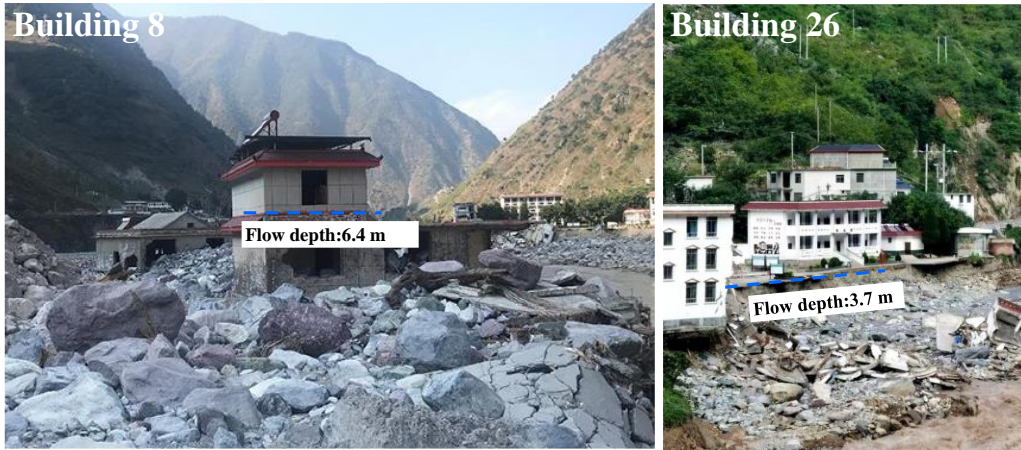
Figure 9 Simulated maximum flow depth of the dam-burst flood at the location of Buildings 8 and Building 26

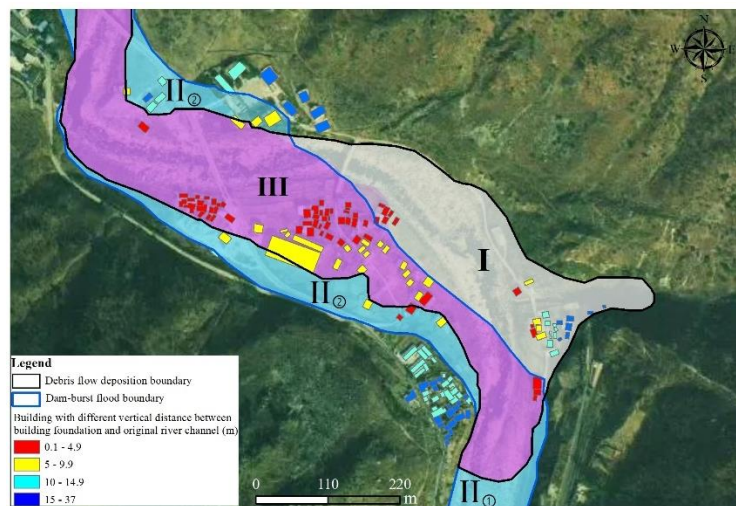
326 Fig. 11 illustrates the boundary of debris flow deposition and dam-burst flood inundation. The
327 debris flow deposition boundary was determined by the simulation. Flooding boundary was
328 obtained by combining the results of the HEC-RAS simulation with field survey data. The
329 confluence area was heavily impacted by the debris flow, resulting in the transportation of a
330 significant amount of solid materials over an area of 0.189 km². As a result, the majority of the
331 village's buildings were inundated by the debris flow. The dam-burst flood caused serious damage
332 to buildings by flushing a large volume of debris flow sediment and riverbank material downstream.

333 Three hazard zones are identified based on the boundary of the debris flow and dam-burst flood,
334 as shown in Fig. 11 and Fig. 12. The damage patterns of buildings in the different hazard zones can
335 be classified into three categories, namely, (I) buildings only buried by debris flow; (II) buildings
336 only inundated by dam-burst flood; and (III) buildings sequentially buried by debris flow and
337 inundated by dam-burst flood. Zone (I) is situated near the Heixiluo gully mouth, where the debris
338 flow transported a large volume of sediment and seriously eroded the sidewall and bed of the
339 channel, expanding the channel's width from 10 m to 40 m. All buildings were inundated by
340 sediment to a depth of over 6 m.

364 **Figure 11** Inundation boundary of debris flow and dam-burst flood and spatial division of the hazard zone
365 based on building damage patterns: (I) buried by debris flow; (II) inundated by dam-burst flood; (III)
366 buried by debris flow and the inundated by dam-burst flood.
367 (Satellite image obtained form <https://www.jl1mall.com>)
368

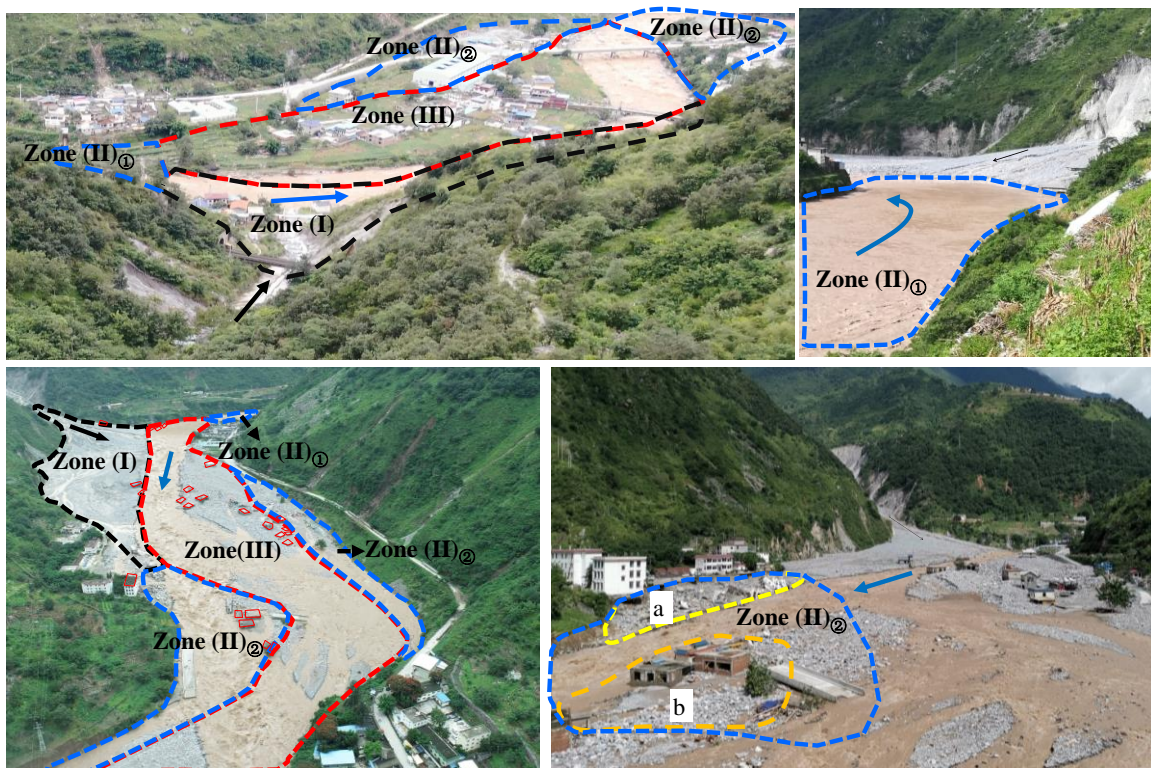
350 Fig. 12(d)). A three-story building was partially destroyed due to foundation erosion. The buildings

353 Zone (III) is primarily located on the left bank of the original river and the lower part of the
354 debris flow fan. The original river channel is filled with debris up to a depth of 10 m. The debris
355 flow transported sediment across the raised riverbed into villages and formed a slope that was high
356 on the right and low on the left in the confluence area. Then, the flood breached the debris flow
357 dam and severely eroded the deposited debris and the original floodplain surface, resulting in a new
358 straight channel. The buildings on the left bank of the river, which were buried by the debris flow,
359 were sequentially impacted by the dam-breach flood. The flood heavily damaged buildings near
360 the new river channel and floodwater from the channel was observed to always inundate the
361 buildings. Notably, the boundaries of the different damage zones are not static. The extent of the

388
 389 **Figure 12** Spatial distribution of the three hazard zones before and after the disaster: (a) before the
 390 disaster; (b) (c) (d) after the disaster.

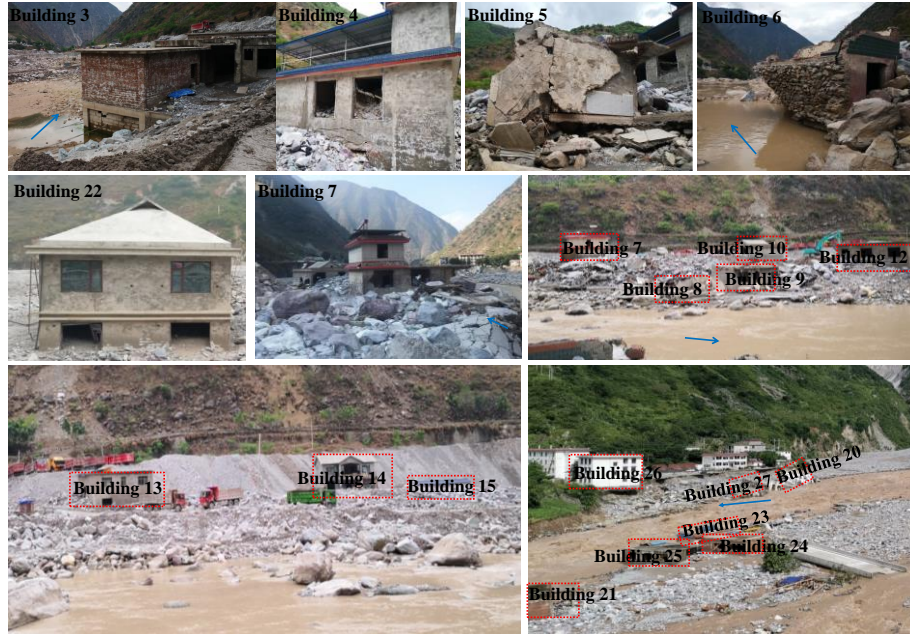
The building characteristics and hazard intensity are presented in Table 6. In Zone (III), buildings located near the debris flow dam (such as buildings 1, 2, and 3) were first buried by the debris flow and then inundated by water from the dammed lake for 40 minutes. These buildings were then impacted by the dam-burst flood. Additionally, buildings near the new river channel suffered greater impact pressure than other buildings. For example, the residual broken structures of buildings 5 and 6 were heavily damaged by the direct impact of the flood in the vertical direction. The walls of the two buildings were severely abraded by impact pressures of 75.1 kPa and 59 kPa, respectively. Additionally, the foundations of the two buildings were partially scoured by floods with high shear stresses of 562 Pa and 553 Pa, respectively.

Buildings located in Zone (II) were only severely impacted by the dam-burst flood. For instance, the foundation of the three-story school building (building 26) was severely eroded by the flood to a scour depth of 1 m, and the floors on the right collapsed. There was no evidence on the walls of the building that the debris flow had abraded the structure. The velocity and shear stress of the flood in this location were 4.4 m/s and 463 Pa, respectively. Buildings 23-25, which were close to the new river channel, were thoroughly buried by the sediment transported by the flood and inundated by floodwater.

Figure 13 Buildings with different degrees of damage within three hazard zones.

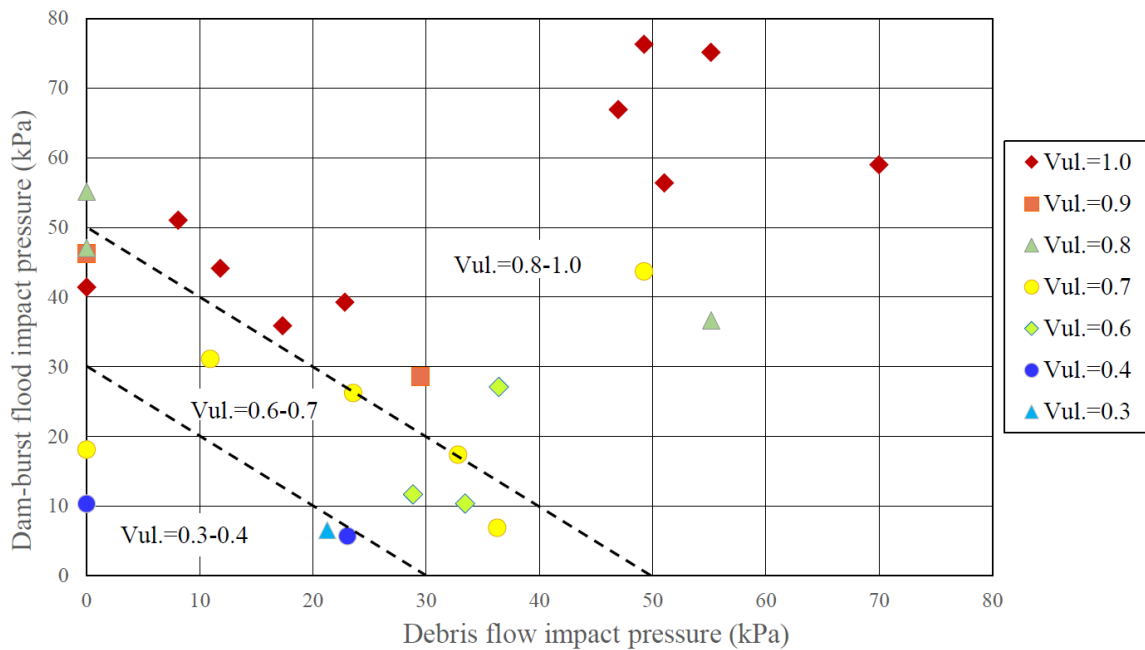
452 The building damage distribution chart shows building damage plotted as a function of debris
 453 flow and flood impact pressure (see Fig. 18). The figure includes aggregated damage to buildings
 454 impacted by the sequentially occurring hazards in Zone (III) and damage caused by a single hazard
 455 in Zone (II). Damage is divided into three categories based on the threshold impact pressure: slight
 456 damage (0.3-0.4), moderate damage (0.6-0.7), and heavy and complete damage (0.8-1.0). Heavy
 457 and complete damage mainly occurs at impact pressures greater than 50 kPa, while slight damage
 458 occurs below 30 kPa. Moderate damage mainly occurs at impact pressures between 30 kPa and 50
 459 kPa. The threshold impact pressure is compared with that proposed by [Hu et al. \(2012\)](#) and
 460 [Zanchetta et al. \(2004\)](#), which were derived from a single debris flow disaster in China and Italy,

461 respectively. Although the detailed definition of the damage scales differs, the threshold of the
 462 impact pressure for buildings at the slight, heavy, and complete damage scales is generally larger
 463 than that for the brick-concrete structures presented in [Hu et al. \(2012\)](#) and smaller than that for the
 464 reinforced concrete frames also presented in [Hu et al. \(2012\)](#) and the masonry structures with

465 basements presented in Zanchetta et al. (2004). A similar trend for the threshold of the impact
 466 pressure for buildings with a moderate damage scale can be observed.

467
 468 **Figure 18** Accumulation of building damage due to debris flow and dam-burst flood. The damage
 469 distribution is based on the debris flow and flood impact pressure (Vul. refers to vulnerability).

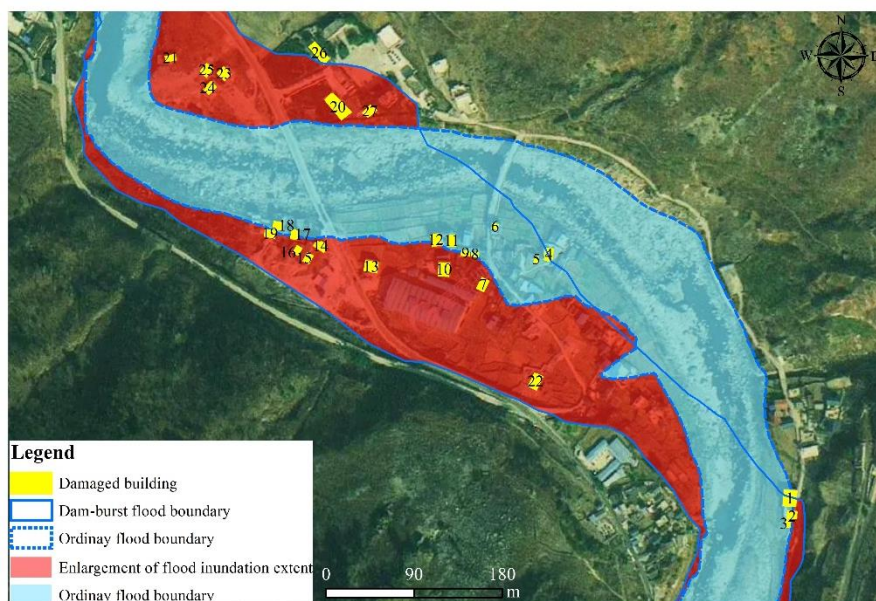
486 As a result of the confluence zone's location on a river bend, the dam-burst flood typically flows
487 in a straight direction and creates a new straight channel when the river channel becomes
488 completely blocked. This channel translocation leads to a larger flooded area and causes more
489 severe damage to buildings on the floodplain. The flood inundation zones in the village expanded
490 to 110^5 m^2 , which is up to 4 times the area of an ordinary flood due to flood amplification (Fig. 19).
491 In the expanded inundation zone, 41 buildings, a traffic road spanning 410 m, and farmland with
492 an area of $10 \times 10^4 \text{ m}^2$ were submerged. The buildings located in the middle of the inundation zones
493 suffered the most severe damage due to the floodwater's high scouring capability and sediment
494 transport capacity. Many buildings near the flow collapsed, and most structures were carried away

496 Table 7 presents a comparison of the dynamic characteristics and damage increments between
497 ordinary and dam-burst floods in different locations. The damage increment is calculated based on
498 the proposed function in Zone II and is the ratio of the damage caused by the two floods. Buildings
499 4, 5, 6, 9, 11, 18, and 19 were situated close to the new river channel, and the average bed shear
500 stress and impact pressure increased up to 14.2 times and 3.8 times that of an ordinary flood,
501 respectively, due to flood amplification. The average damage to the seven buildings located near
502 the new channel increased by 140% due to the lake created by the debris flow barrier.

Figure 19 The inundation extent of ordinary floods and dam-burst floods.
(Satellite image obtained form <https://www.jl1mall.com>)

514 Risk assessment for debris flow-outburst flood hazard cascades is crucial to mitigate the damage
 515 posed to structures in the confluence zone. Risk analysis should incorporate both the debris flow
 516 initiation mechanism and the mechanism that generates the dam-burst flood (Chen et al., 2022). A
 517 detailed investigation should be conducted for the exposed elements in the confluence zone and
 518 both the upstream and downstream reaches of the river. Based on the disaster transformation
 519 process and the failure mechanisms of structures, hazard zones should be identified, and
 520 corresponding disaster reduction measures should be developed (Cui and Guo, 2021). Moreover,
 521 specific structural measures are urgently needed. First, engineering measures should be
 522 implemented in the watershed to mitigate debris flows (Cui and Lin, 2013). Second, buildings
 523 should not be constructed near debris flow gullies, and new buildings should be built on elevated
